# NPS Wildfire Risk Assessments Assessment Locations

## Aztec Ruins National Monument

NPS Wildfire Risk Assessment Project

# NPS Wildand Fire Risk Assessment - Facility Assessment

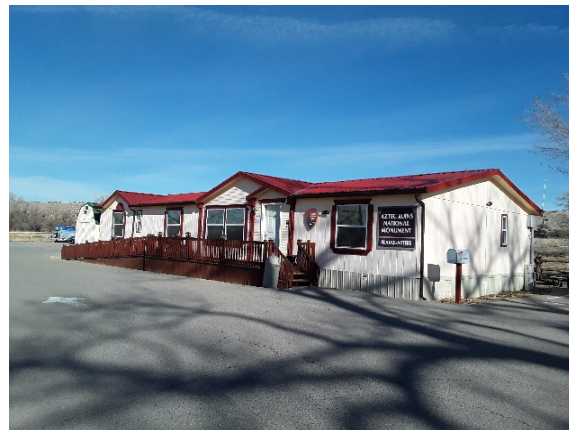
2021\_AZRU\_72754\_Administrative Trailer\_Front.jpg

**Score: 25**  
**Rating: Low**

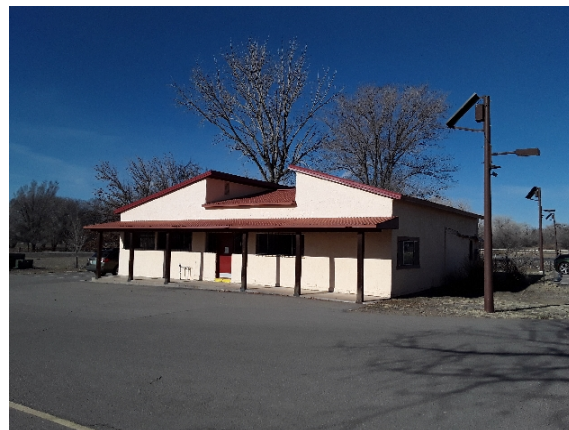
2021\_AZRU\_74739\_Aztec Ruins Trading Post\_Front.jpg

**Assessment Comments:** Powerlines at entrance

**Score: 25**  
**Rating: Low**

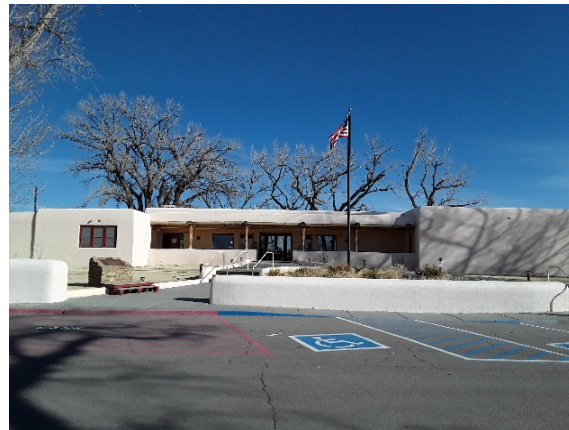
2021\_AZRU\_72751\_Visitor Center\_Front.jpg

**Score: 21**  
**Rating: Low**

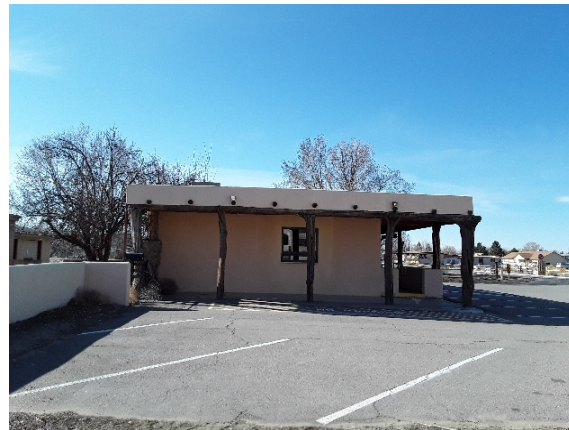
2021\_AZRU\_91476\_Cultural Resource Office\_Front.jpg

**Score: 25**  
**Rating: Low**

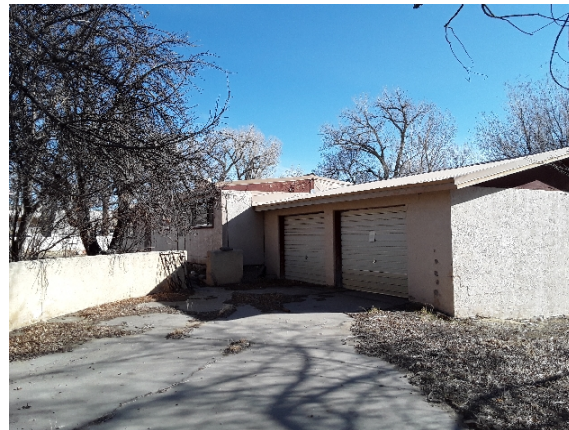
2021\_AZRU\_not found \_House\_Front.jpg

**Score: 22**  
**Rating: Low**

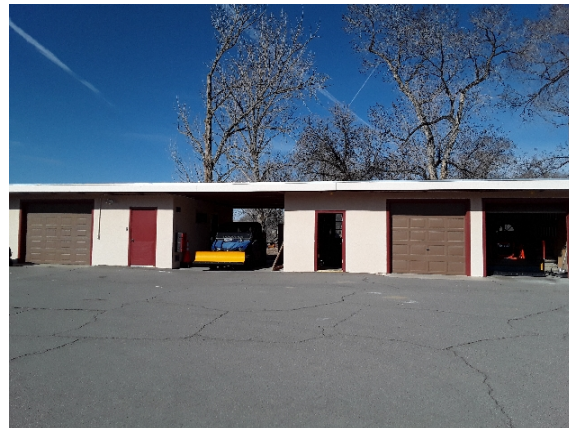
2021\_AZRU\_72764/72770\_Maintenance Shop\_Front.jpg

**Siding Material:** Rock, concrete, metal  
**Foundation:** Closed, >30in masonry exposed or N/A  
**Fences/Decks:** None or noncombustible  
**Firewood:** Adjacent to/under deck of facility

**Score: 28**  
**Rating: Low**

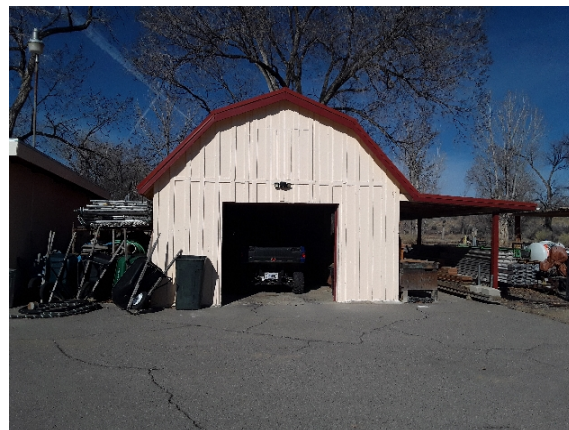
2021\_AZRU\_72768\_Preservation Barn\_Front.jpg

**Defensible Space:** <30 ft treated

**Siding Material:** Wood or open sided

**Foundation:** Closed, < 6in masonry exposed

**Firewood:** Adjacent to/under deck of facility

**Score: 49**  
**Rating: Moderate**

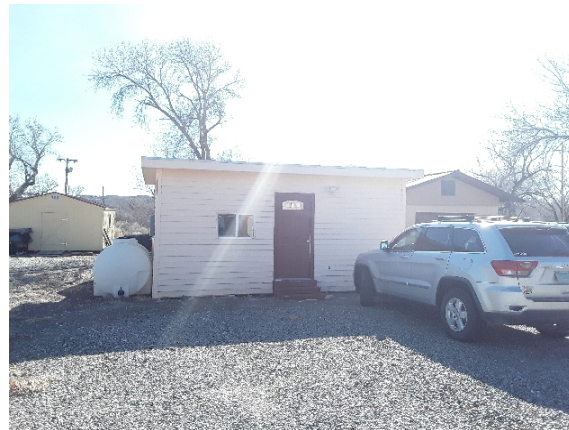
2021\_AZRU\_\_Maintenance Storage\_Front.jpg

**Siding Material:** Wood or open sided

**Score: 31**  
**Rating: Low**

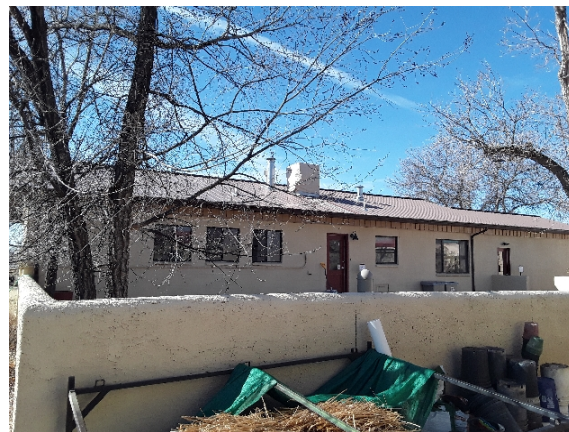
2021\_AZRU\_72758\_Maintenance Office\_Front.jpg

**Score: 22**  
**Rating: Low**

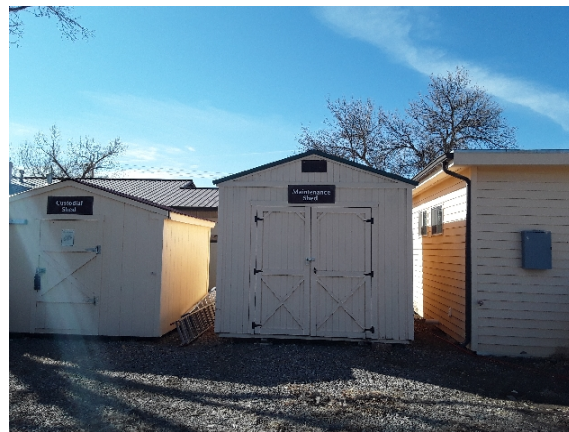
2021\_AZRU\_not found \_Maintenance Shed\_Front.jpg

**Siding Material:** Wood or open sided  
**Foundation:** Open or deck  
**Fences/Decks:** None or noncombustible  
**Firewood:** None  
**Propane Tanks:** None

**Score: 32**  
**Rating: Low**

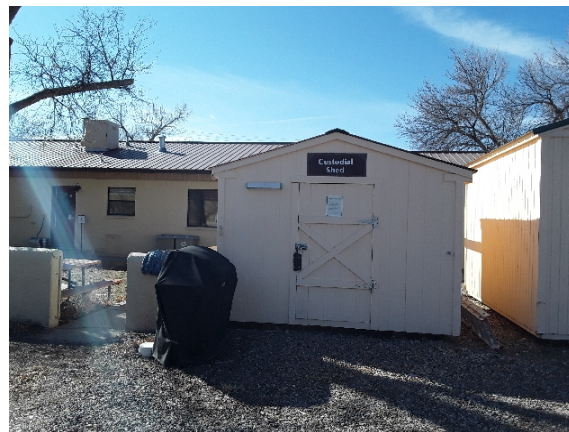
2021\_AZRU\_not found \_Custodial Shed\_Front.jpg

**Siding Material:** Wood or open sided

**Foundation:** Open or deck

**Firewood:** Adjacent to/under deck of facility

**Score: 35**  
**Rating: Low**

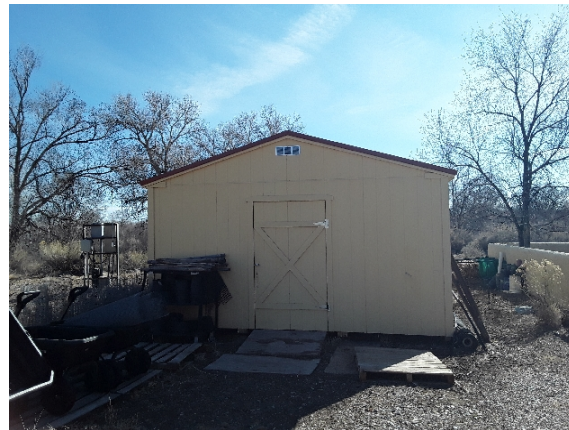
2021\_AZRU\_not found \_Shed\_Front.jpg

**Foundation:** Open or deck

**Score: 32**  
**Rating: Low**
