# NPS Wildfire Risk Assessments Assessment Locations

## SACN - St. Croix National Scenic Riverway - Overview

# NPS Wildland Fire Risk Assessment - Facility Assessment

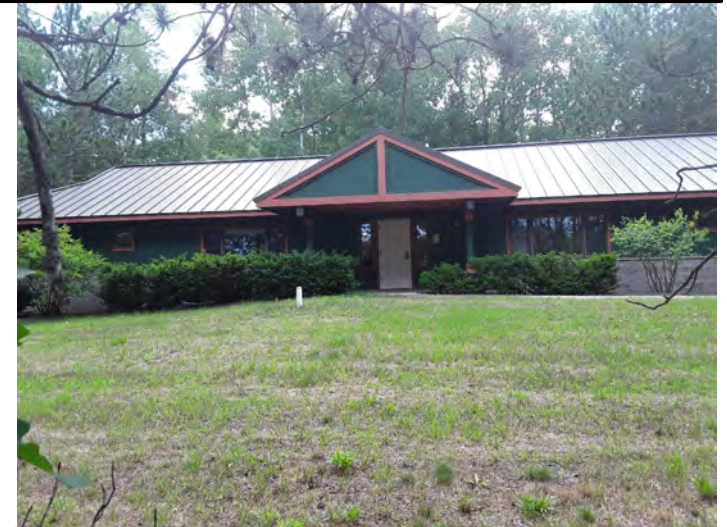
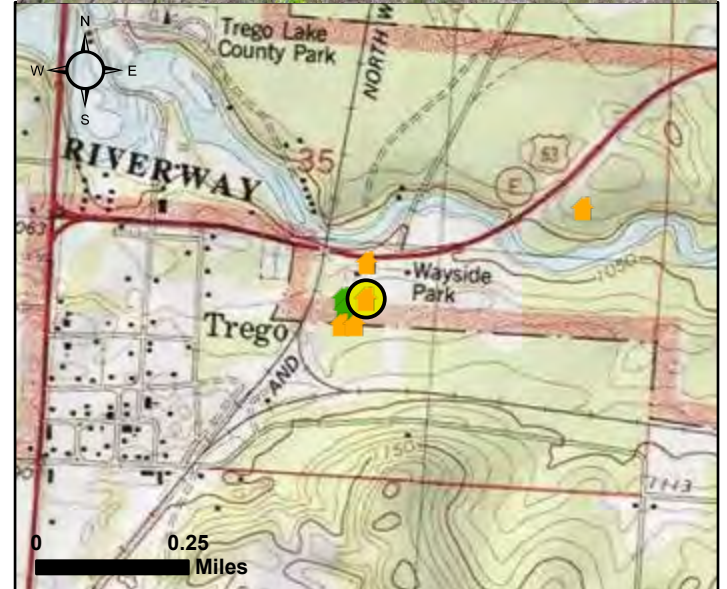
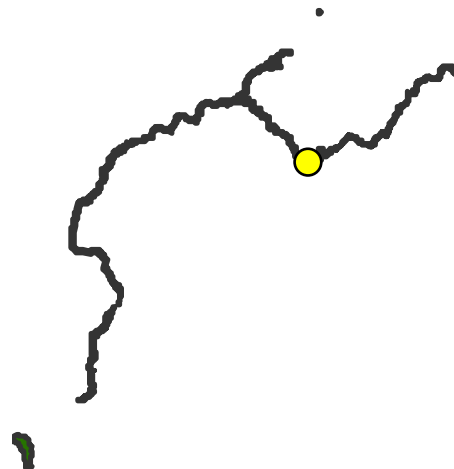
**Rating:** Moderate

**Fuel Type:** Shrub or timber

**Fuel Load:** Moderate

**Defensible Space:** Less than 30 ft treated

**Siding Material:** Wood or open sided

**Overhead Hazards:** Overhead hazards will limit aircraft

08/10/2020 - No treatment needed on this structure.

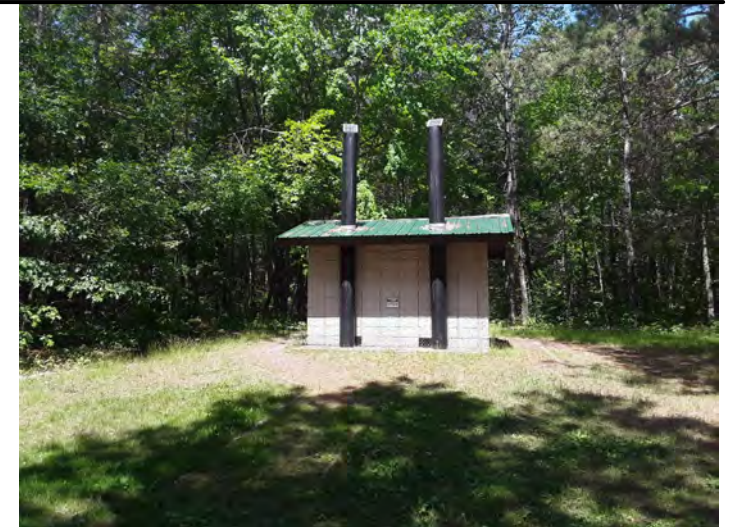
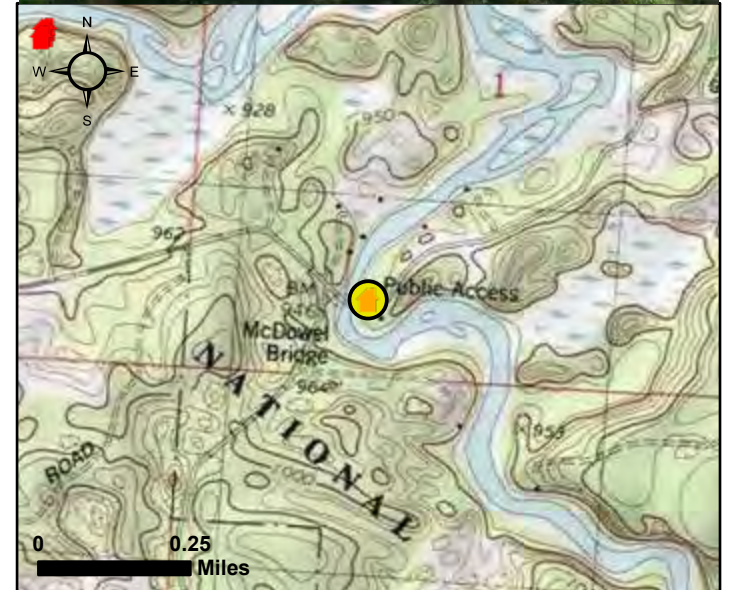
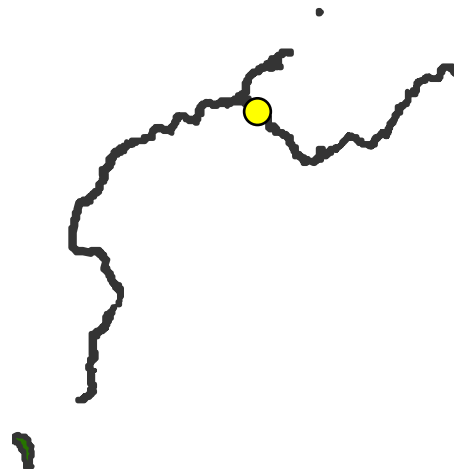
**Rating:** Moderate

**Fuel Type:** Shrub or timber

**Fuel Load:** Moderate

**Defensible Space:** Less than 30 ft treated

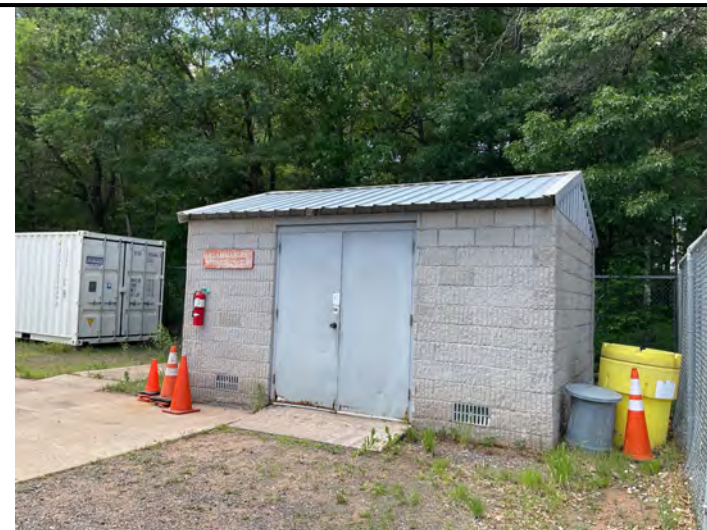
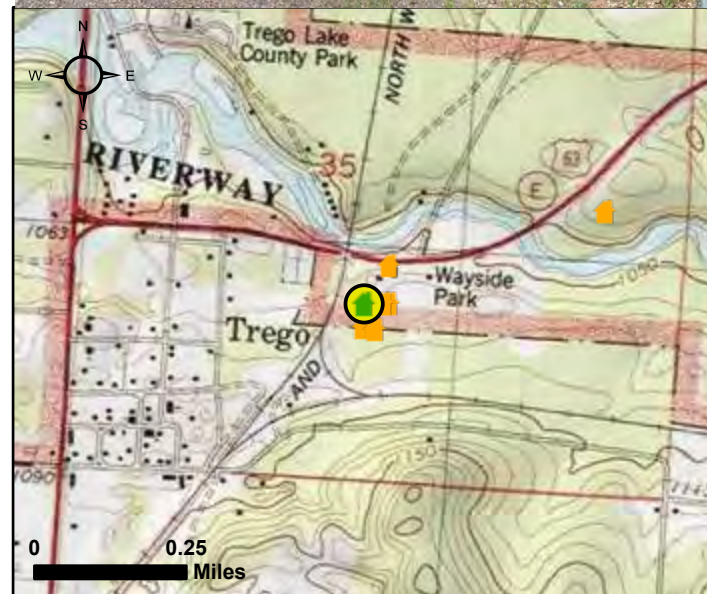
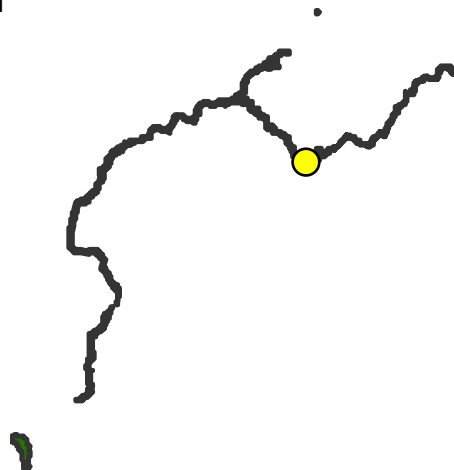
**Rating:** Low

**Defensible Space:** 30 ft treated

**Water Supply:** No reliable water source nearby

**Comments:** Spatial data comes from the FRPP section of FMSS. Each point was verified for positional accuracy. 08/10/2020-30ft treatment completed. Veg cut and chipped around the west side of the building.

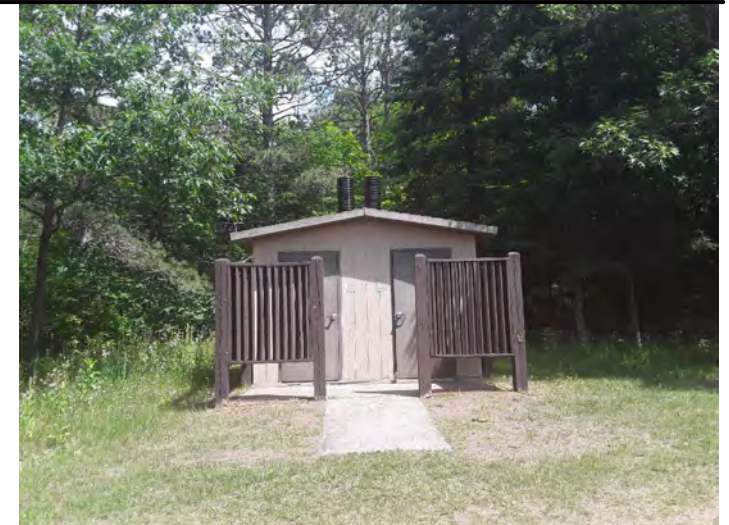
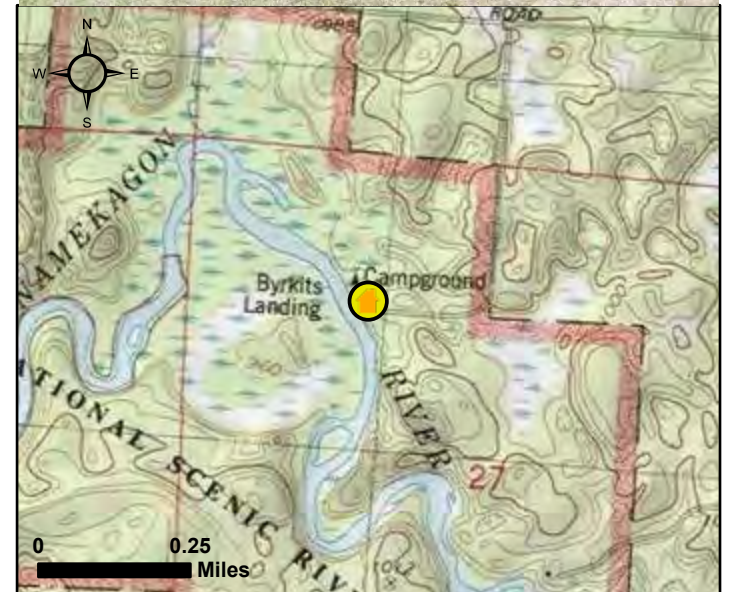
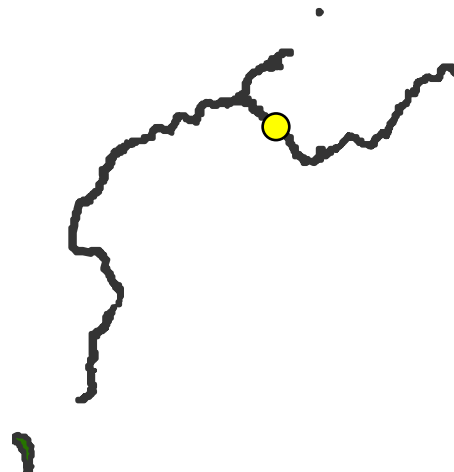
**Rating:** Moderate

**Defensible Space:** Less than 30 ft treated

**Comments:** Spatial data comes from the FRPP section of FMSS. Each point was verified for positional accuracy. 08/08/2020-30ft treatment completed. Many oaks in the area that were left due to oak wilt.

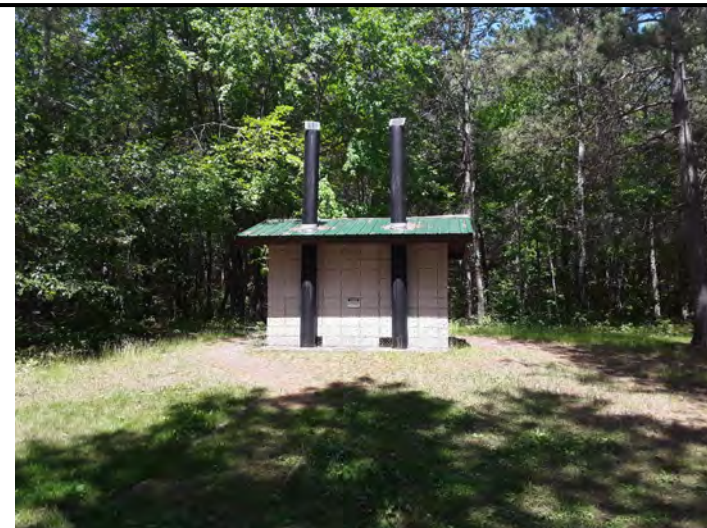
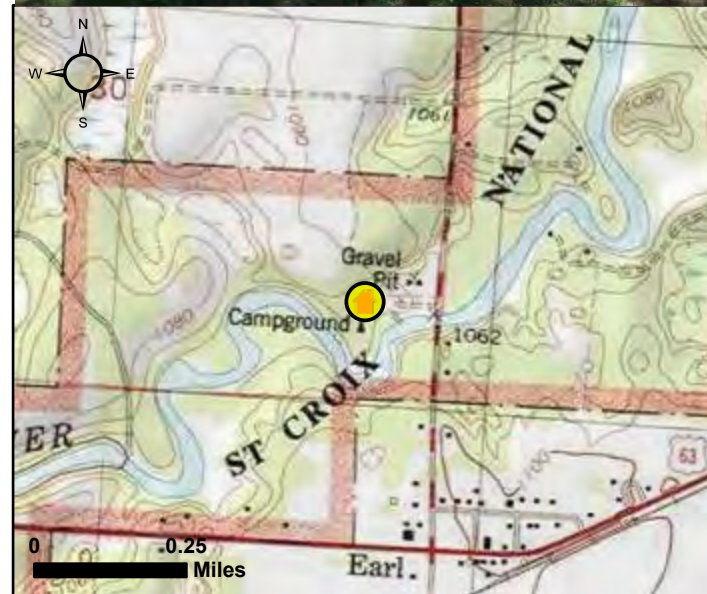
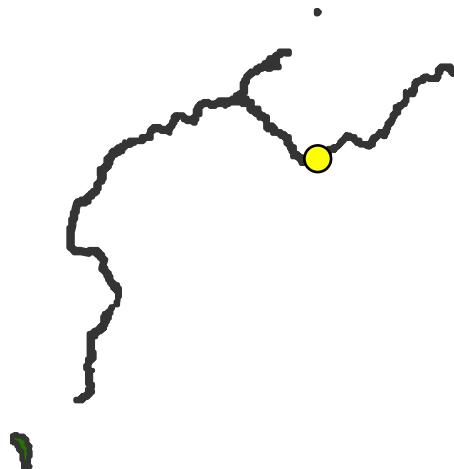
**Rating:** Moderate

**Defensible Space:** Less than 30 ft treated

08/10/2020- 30ft treatment completed

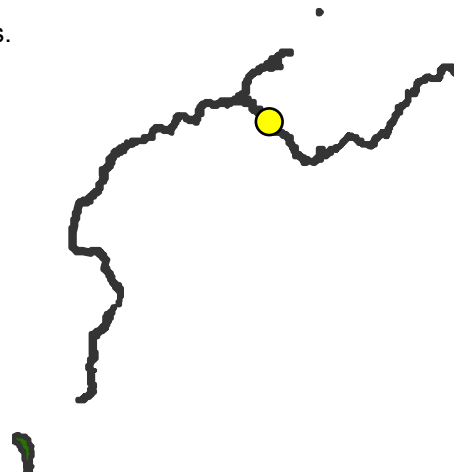
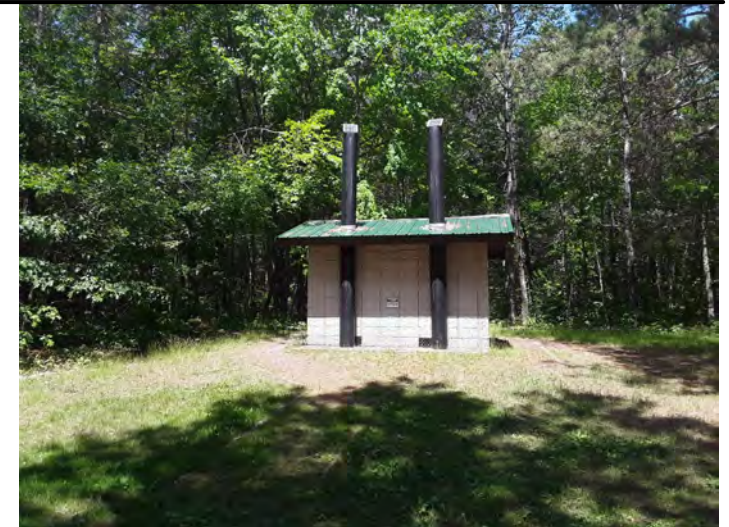
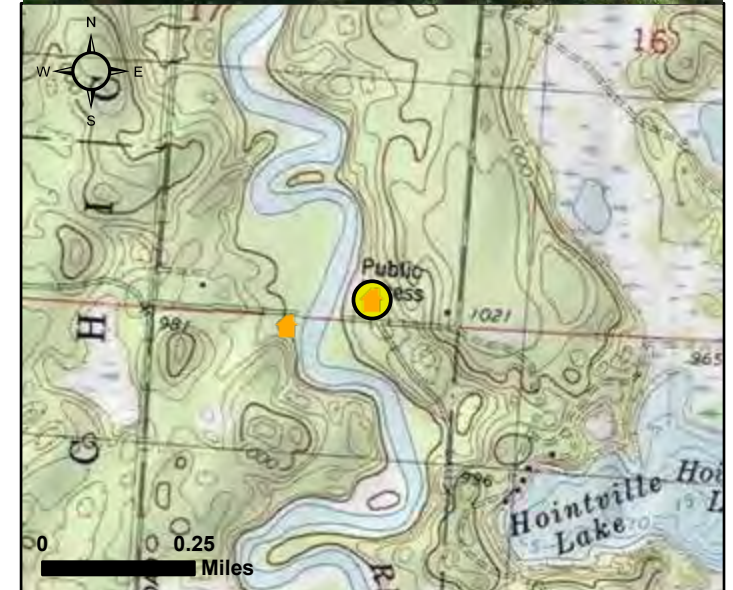
Trego - 45

**Rating:** Moderate  
**ProtectionLevel:** Full,  
**Resources of Concern:** Unknown  
**Occupied:** No  
**In Community:** No,  
**Revisit Interval:** 4 yrs  
**Map Label:** 45

**Fuel Type:** Shrub or timber  
**Fuel Load:** Moderate  
**Defensible Space:** Less than 30 ft treated  
**Topography:** Slope Less than 5%  
**Roof Material:** Fire resistant- tar,rubberized

**Propane:** None  
**Overhead Hazards:** No overhead hazards  
**Comments:** Spatial data comes from the FRPP section of FMSS. Each point was verified for positional accuracy. 08/09/2020 30ft treatment completed. There is a lot of oak in this area that could not be cut due to oak wilt restrictions. Also a lot of poison ivy.

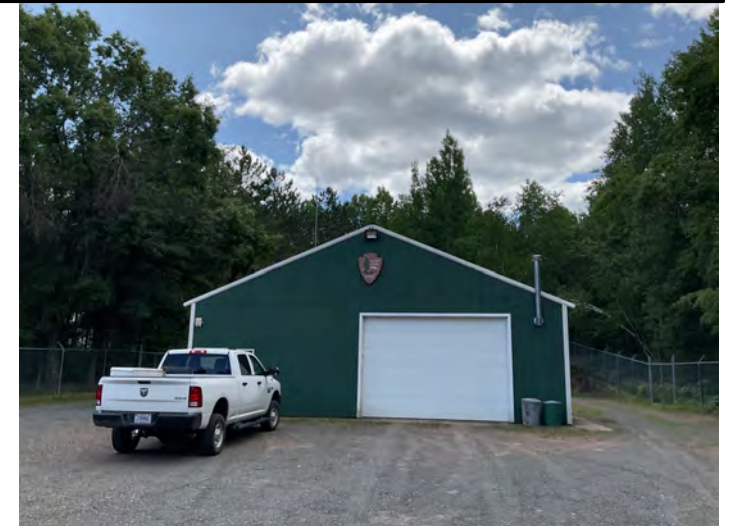
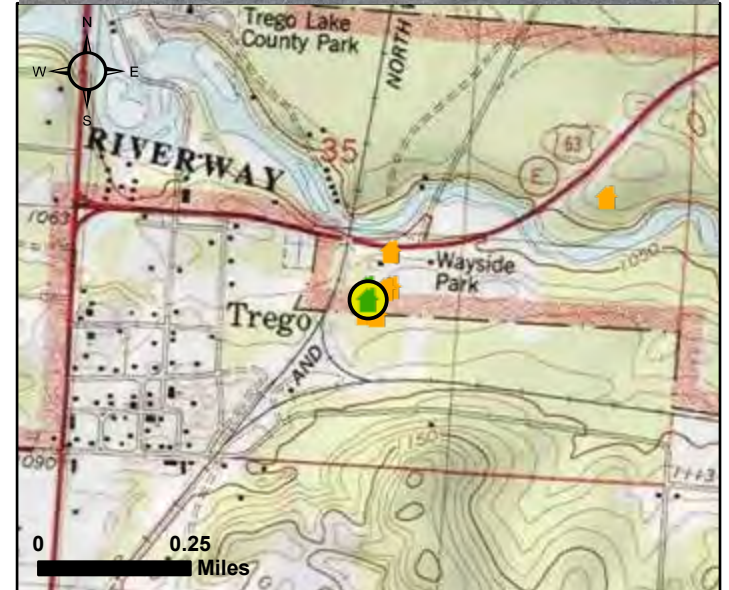
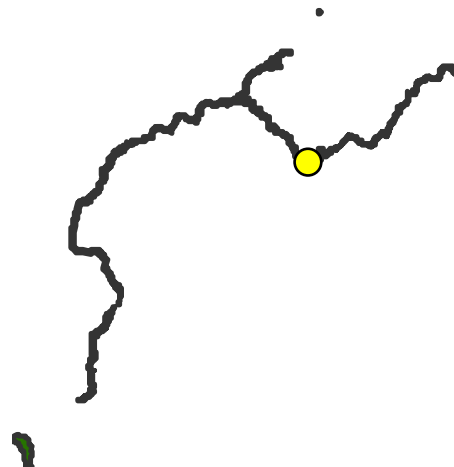
**Rating:** Low

**Defensible Space:** 30 ft treated

08/10/20- No 30ft treatment needed on this structure

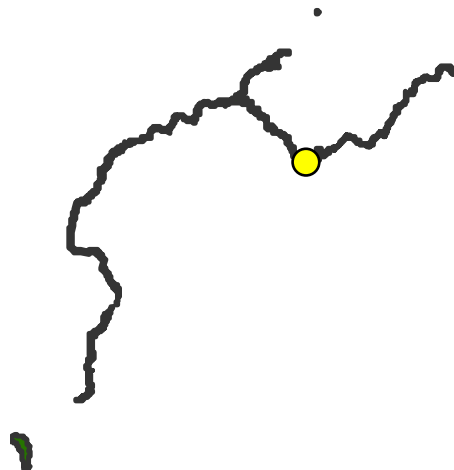
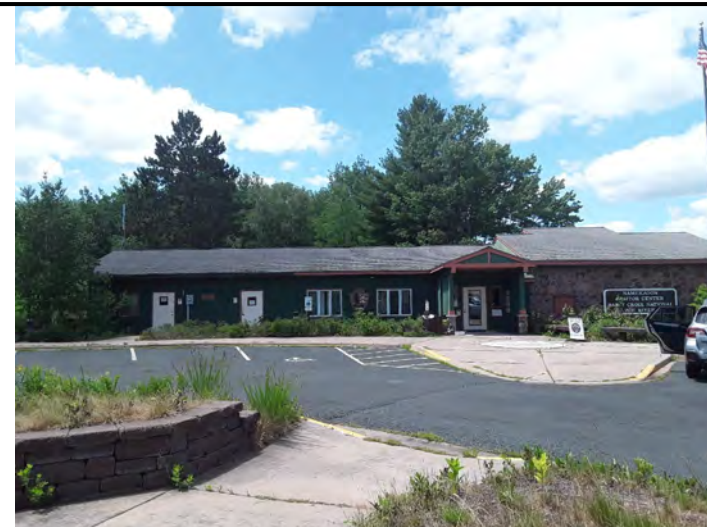
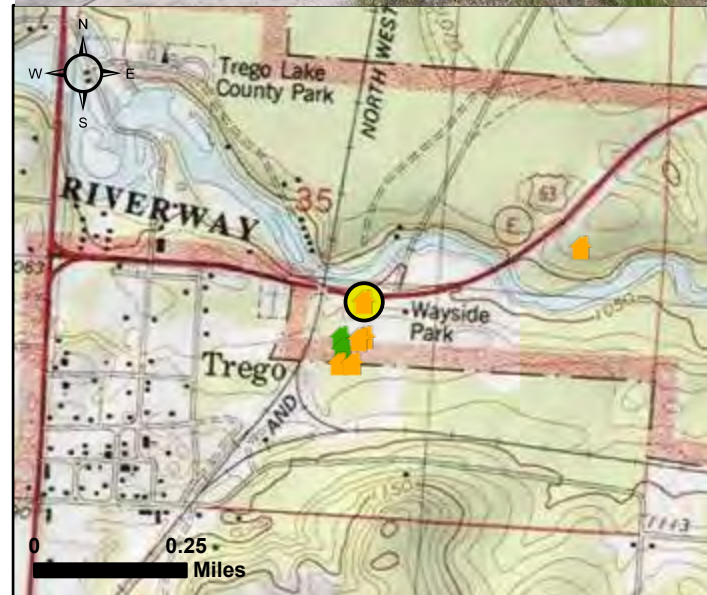
**Rating:** Moderate

**Fuel Type:** Grass and shrub, hardwood litter

**Defensible Space:** Less than 30 ft treated

**Siding Material:** Wood or open sided

Facilit backs into side of a hill. The area around the facility is planted with native plants and not mowed. 08/10/2020-30ft treatment completed grass has been mowed to 30ft mark, large red pine limbed up & reprod on northwest corner of the building has been thinned.

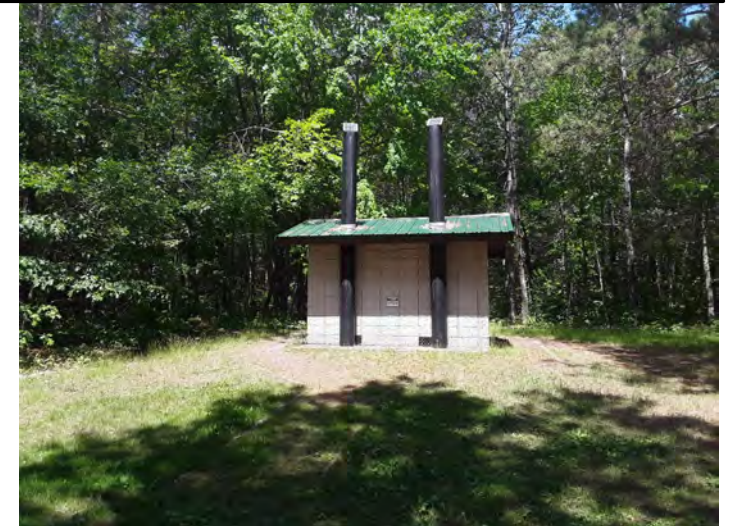
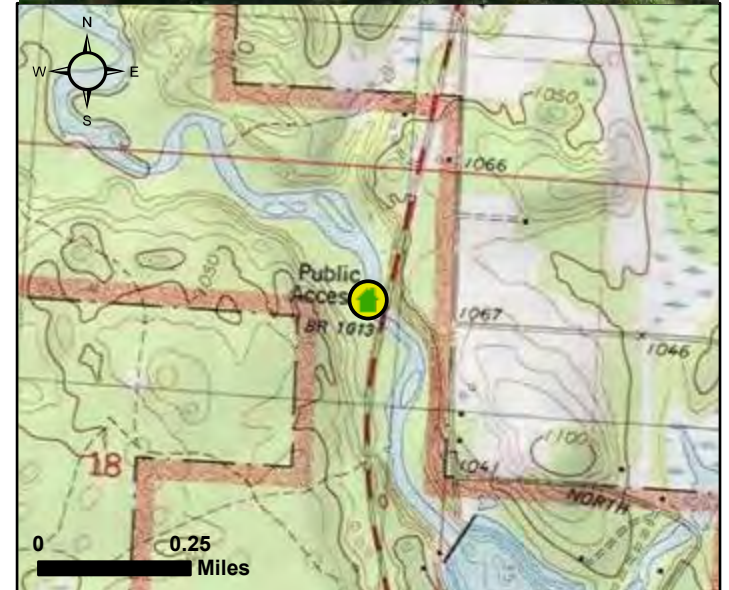
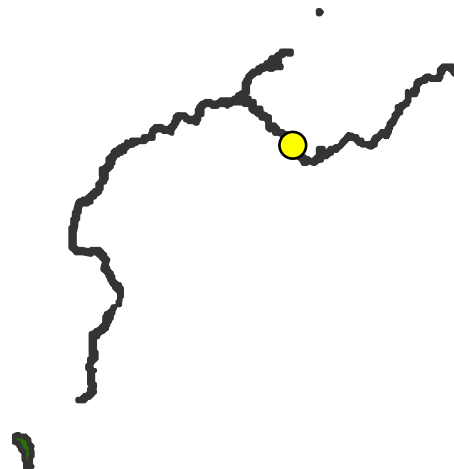
**Rating:** Low

**Defensible Space:** Less than 30 ft treated

**Comments:** Spatial data comes from the FRPP section of FMSS. Each point was verified for positional accuracy. 08/09/2020-30ft treatment completed. Vegetation removed and chipped. Pines limbed up. Wet area on east side of building 15ft away.

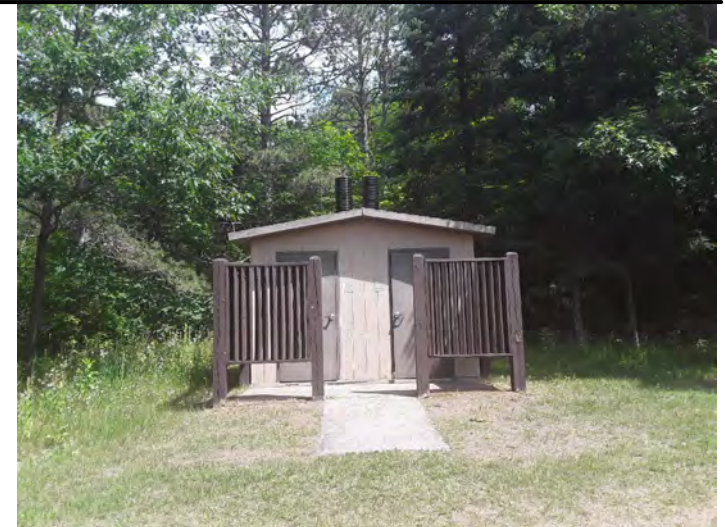
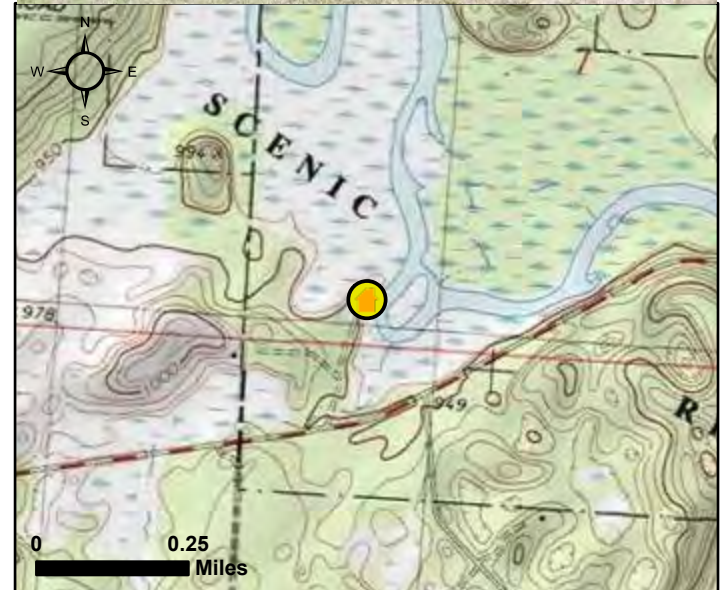
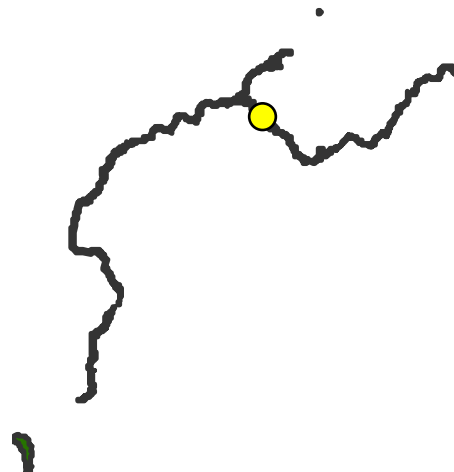
**Rating:** Moderate

**Defensible Space:** Less than 30 ft treated

08/08/2020-30's; treatment completed. A lot of dead and down beyond the 30ft mark.

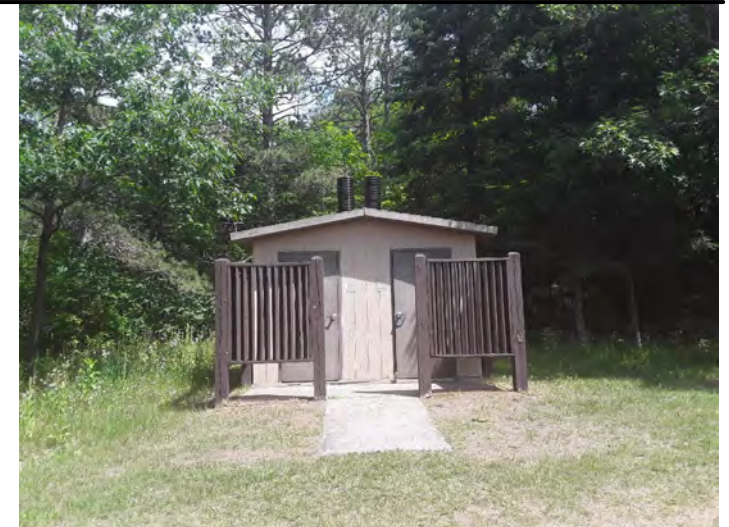
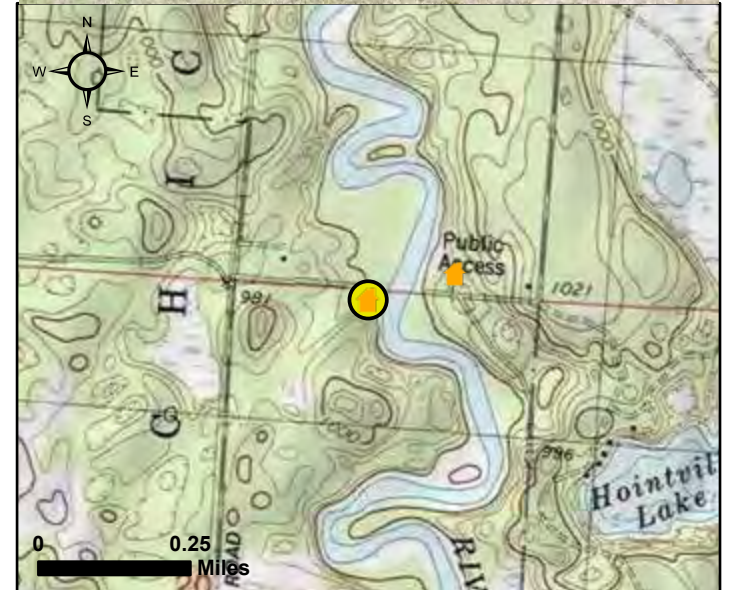
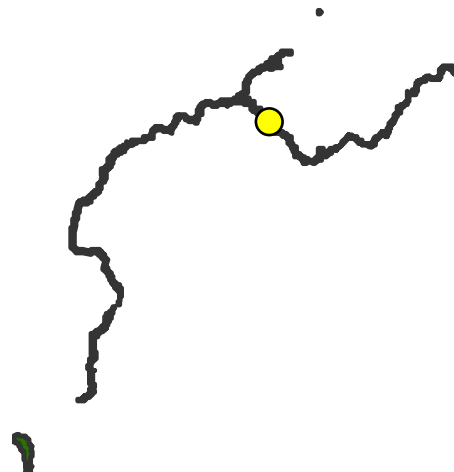
**Rating:** Moderate

**Comments:** 08/09/2020-30ft treatment completed, Access to area is with chipper is difficult, you must use an access road (back to straitened up the chipper) to get in between the bollards. Many oaks left in the 30ft range(oak wilt restrictions)

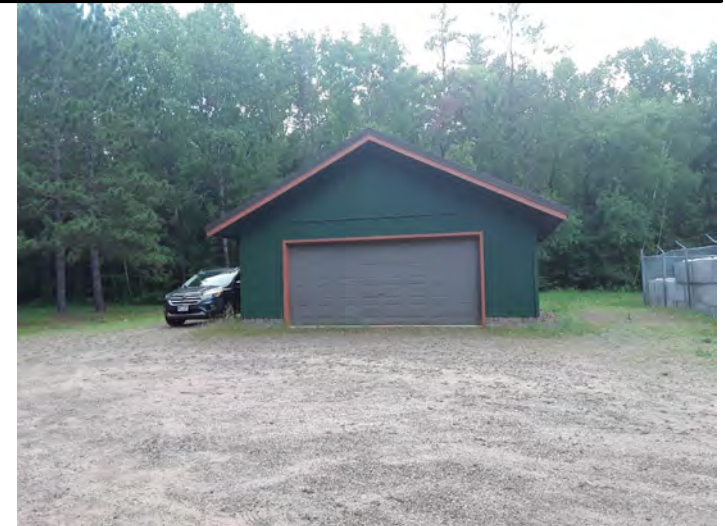
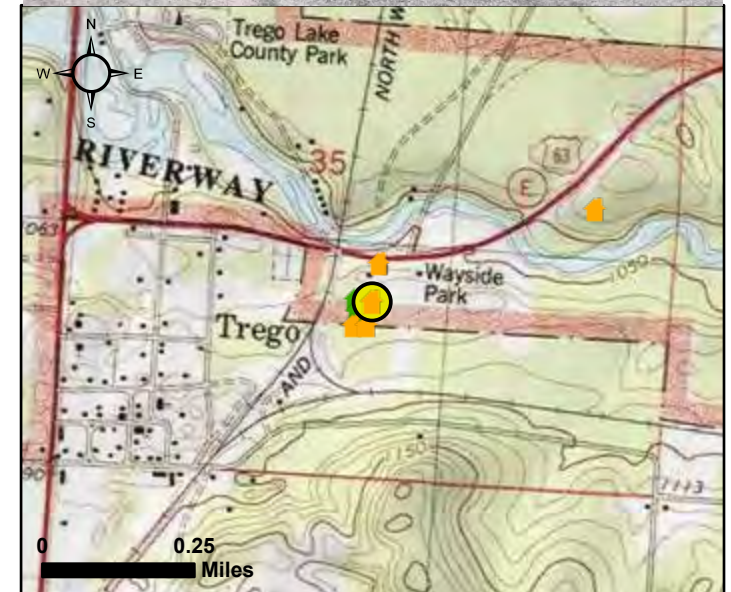
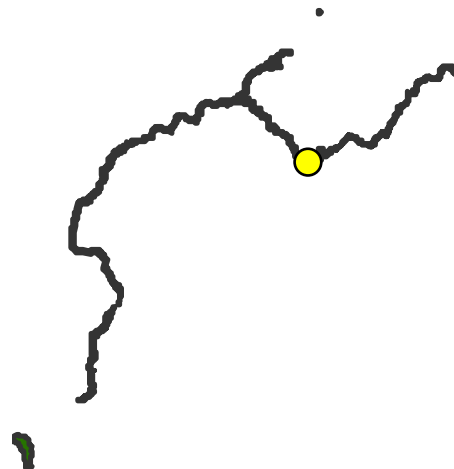
**Overhead Hazards:** Overhead hazards will limit aircraft

**Comments:** 08/10/2020- No treatment needed on this structure
