# NPS Wildfire Risk Assessments Assessment Locations

## De Soto National Memorial Overview

# NPS Wildand Fire Risk Assessment - Facility Assessment

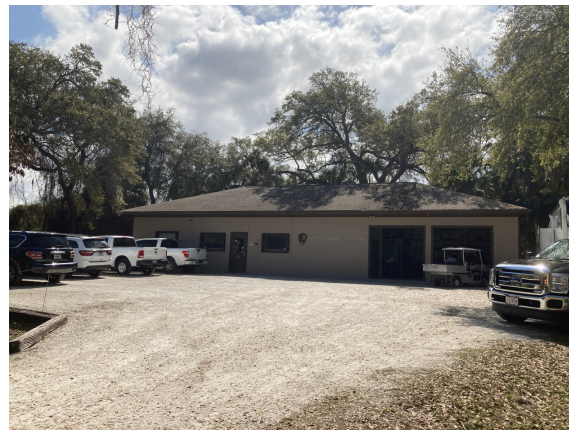
2022\_DESO\_75316\_Maintenance/Administration Building\_Front.jpg

**Access & Turnarounds:** Access is <300 ft from facility w/turnaround  
**Facility Number/Sign:** Marked and clearly visible  
**Defensible Space:** 30 ft treated

**Fuel Load (w/in 300 ft):** Moderate  
**Fuel Type (w/in 300ft):** Shrub or timber  
**Topography (w/in 300ft):** Slope <5%  
**Roof Material:** Noncombustible or not applicable

Score: 40  
Rating: Low

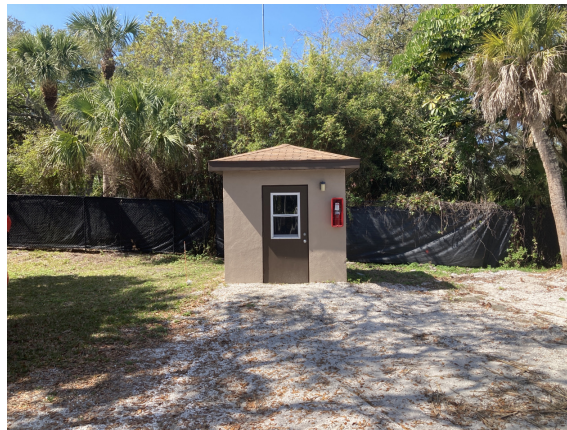
2022\_DESO\_75320\_Irrigation Pump House\_Front.jpg

**Access & Turnarounds:** Access is <300 ft from facility w/turnaround  
**Facility Number/Sign:** Marked and clearly visible  
**Defensible Space:** <30 ft treated

**Fuel Load (w/in 300 ft):** Light  
**Fuel Type (w/in 300ft):** Grass,shrub,hardwood litter  
**Topography (w/in 300ft):** Slope <5%  
**Roof Material:** Fire resistant- tar,rubberized

**Additional Obstacles:** Hazmat, UXO,etc. , PLEASE COMMENT  
**Triage Category:**  
**Hazmat:** Nothing there  
**Assessment Comments:** Road into maintenance area is one lane.

**Score: 47** **Asset Priority Index (API): 40**  
**Rating: Moderate**

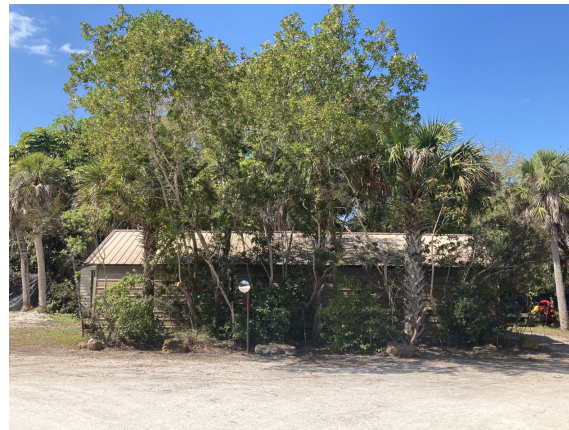
2022\_DESO\_NA\_Open Storage Garage\_Front.jpg

**Defensible Space:** <30 ft treated

**Fuel Load (w/in 300 ft):** Moderate

**Firewood:** Adjacent to/under deck of facility

**Score: 52**  
**Rating: Moderate**

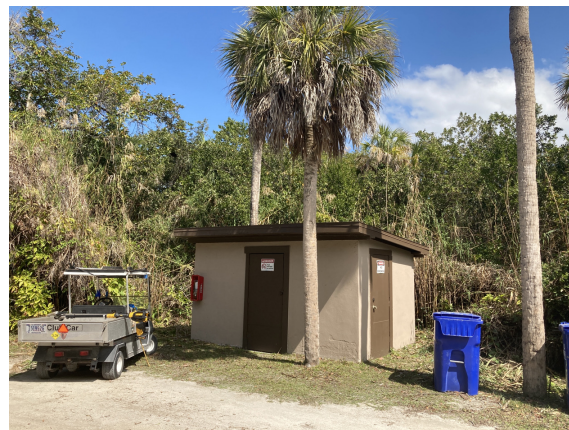
2022\_DESO\_75317\_Fuel and Paint Shed\_Front.jpg

Defensible Space: No defensible space

Fuel Load (w/in 300 ft): Very Heavy

Roof Material: Combination of fire resisitant and combustible

Score: 78  
Rating: High

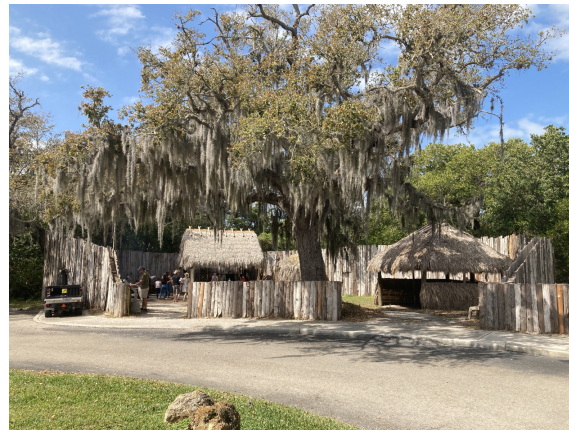
2022\_DESO\_1057820\_Interpretation center\_Front.jpg

**Defensible Space:** <30 ft treated  
**Fuel Load (w/in 300 ft):** Heavy  
**Fuel Type (w/in 300ft):** Grass,shrub,hardwood litter  
**Topography (w/in 300ft):** Slope <5%

**Roof Material:** Combustible or no roof  
**Siding Material:** Log  
**Foundation:** Open or deck  
**Fences/Decks:** Combustible,adjacent,no veg/debris clearance

**Firewood:** Adjacent to/under deck of facility  
**Propane Tanks:** None  
**Water Supply:** Reliable water source nearby  
**Overhead Hazards:** No overhead hazards

**Safety Zones:** Potential safety zone(s) in area  
**Additional Obstacles:** None  
**Triage Category:**  
**Hazmat:**  
**Assessment Comments:** This area consists of two chickee huts and a wooden wall.

**Score: 83**  
**Rating: High**

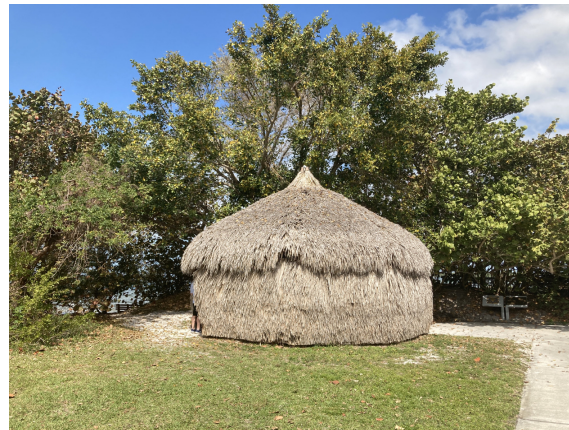
2022\_DESO\_1057645\_Chickee Hut\_Front.jpg

**Defensible Space:** <30 ft treated  
**Fuel Load (w/in 300 ft):** Moderate  
**Fuel Type (w/in 300ft):** Shrub or timber  
**Topography (w/in 300ft):** Slope <5%

**Roof Material:** Combustible or no roof  
**Siding Material:** Wood or open sided  
**Foundation:** Open or deck  
**Fences/Decks:** None or noncombustible

**Score: 74**  
**Rating: High**

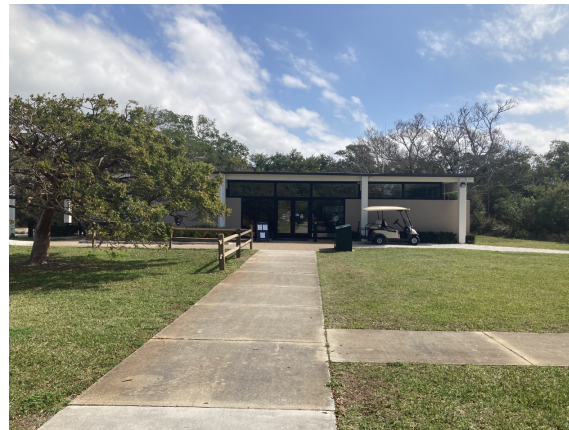
2022\_DESO\_50396\_Visitor Center\_Front.jpg

Defensible Space: <30 ft treated

Score: 42  
Rating: Low
