# NPS Wildfire Risk Assessments Assessment Locations

## Canaveral National Seashore-Overview

# Apollo Beach

# NPS Wildand Fire Risk Assessment - Facility Assessment

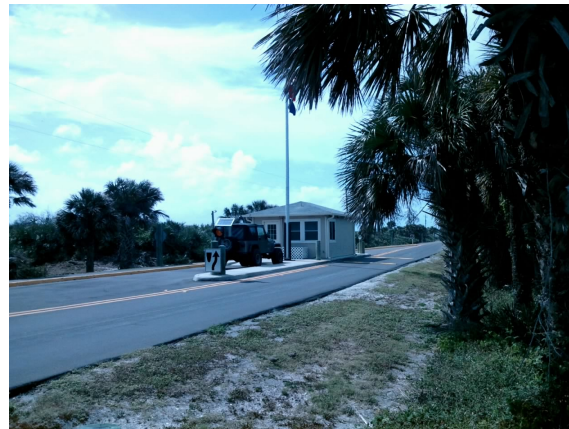
2017\_CANA\_60912\_ND Entrance Station\_Front.jpg

Defensible Space: 30 ft treated

Fuel Load (w/in 300 ft): Heavy

Fuel Type (w/in 300ft): Grass,shrub,hardwood litter

Score: 50  
Rating: Moderate

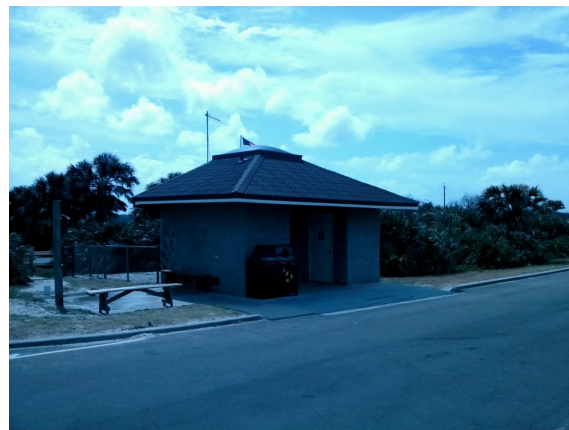
2017\_CANA\_60150\_ND Comfort Station 1\_Front. jpg

**Defensible Space:** <30 ft treated

**Fuel Load (w/in 300 ft):** Heavy

**Fuel Type (w/in 300ft):** Grass,shrub,hardwood litter

**Score: 55**  
**Rating: Moderate**

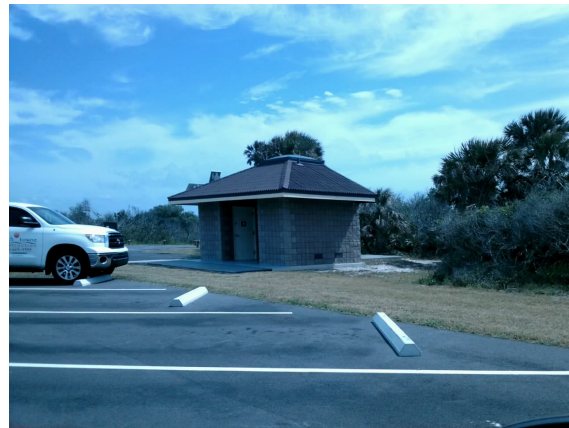
2017\_CANA\_60157\_ND Comfort Station Boat Ramp\_Front.jpg

**Defensible Space:** <30 ft treated

**Fuel Load (w/in 300 ft):** Heavy

**Fuel Type (w/in 300ft):** Grass,shrub,hardwood litter

**Score: 53**  
**Rating: Moderate**

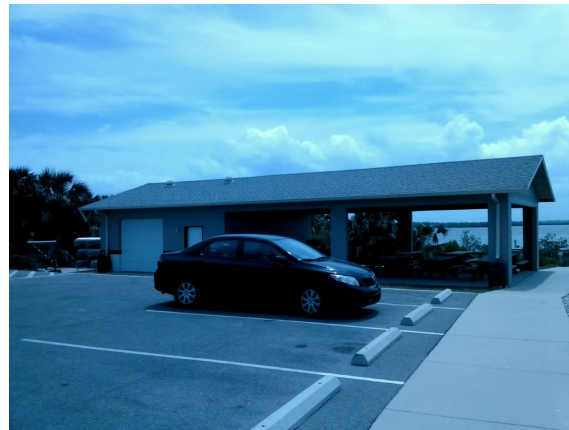
2017\_CANA\_88119\_ND Interp Pavillion\_Front. jpg

**Defensible Space:** <30 ft treated

**Fuel Load (w/in 300 ft):** Moderate

**Fuel Type (w/in 300ft):** Shrub or timber

**Siding Material:** Wood or open sided

**Score: 63**  
**Rating: High**

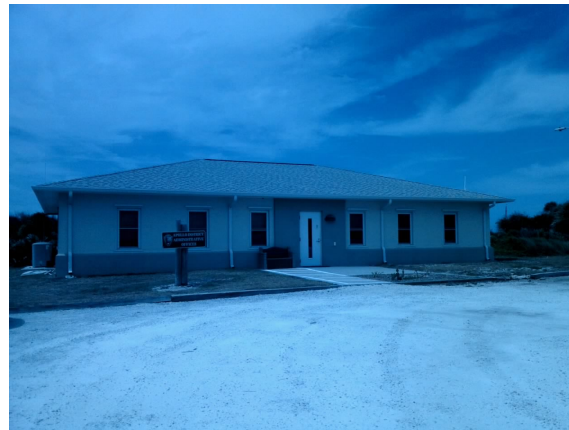
2017\_CANA\_\_Apollo District Admin Offices\_Front. jpg

**Defensible Space:** <30 ft treated

**Fuel Load (w/in 300 ft):** Heavy

**Fuel Type (w/in 300ft):** Grass,shrub,hardwood litter

**Water Supply:** No reliable water source nearby

**Score: 63**  
**Rating: High**

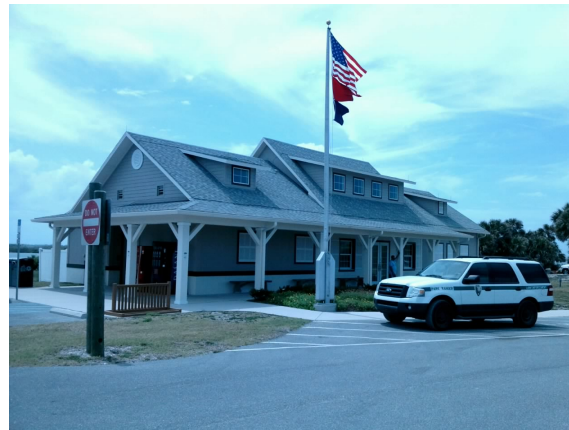
2017\_CANA\_\_Apollo Beach Visitors Center\_Front. jpg

Defensible Space: <30 ft treated

Fuel Load (w/in 300 ft): Moderate

Fuel Type (w/in 300ft): Grass,shrub,hardwood litter

Siding Material: Vinyl

Water Supply: No reliable water source nearby

Score: 59  
Rating: Moderate

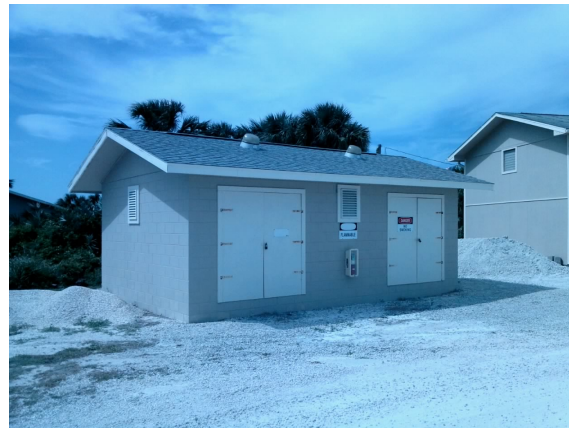
2017\_CANA\_\_Hazmat storage\_Front.jpg

**Access & Turnarounds:** Access is <300 ft from facility w/turnaround  
**Facility Number/Sign:** None or not clearly visible  
**Defensible Space:** <30 ft treated

**Fuel Load (w/in 300 ft):** Heavy  
**Fuel Type (w/in 300ft):** Grass,shrub,hardwood litter  
**Topography (w/in 300ft):** Slope <5%  
**Roof Material:** Fire resistant- tar,rubberized

**Siding Material:** Wood or open sided  
**Foundation:** Closed, >30in masonry exposed or N/A  
**Fences/Decks:** None or noncombustible  
**Firewood:** None

**Propane Tanks:** None  
**Water Supply:** No reliable water source nearby  
**Overhead Hazards:** No overhead hazards  
**Safety Zones:** Potential safety zone(s) in area

**Score: 67**  
**Rating: High**

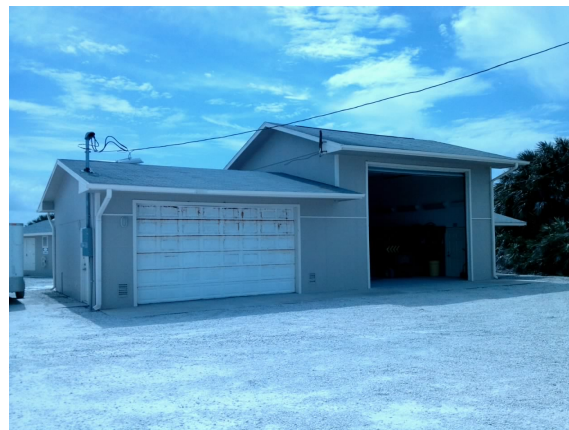
2017\_CANA\_60159\_ND Equipment Repair Shop\_Front.jpg

**Defensible Space:** <30 ft treated

**Fuel Load (w/in 300 ft):** Heavy

**Fuel Type (w/in 300ft):** Grass,shrub,hardwood litter

**Score: 63**  
**Rating: High**

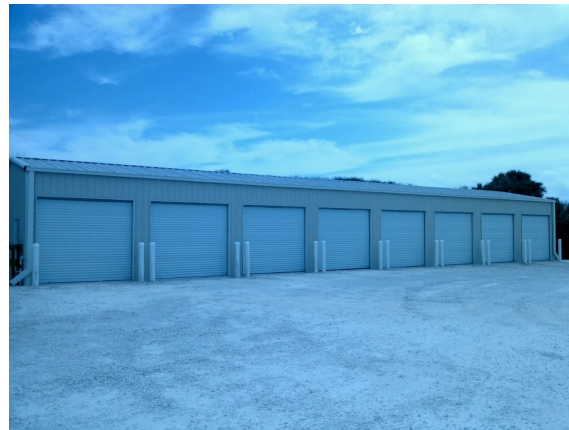
2017\_CANA\_60160\_ND Pole Shed 1\_Front.jpg

**Score: 54**  
**Rating: Moderate**

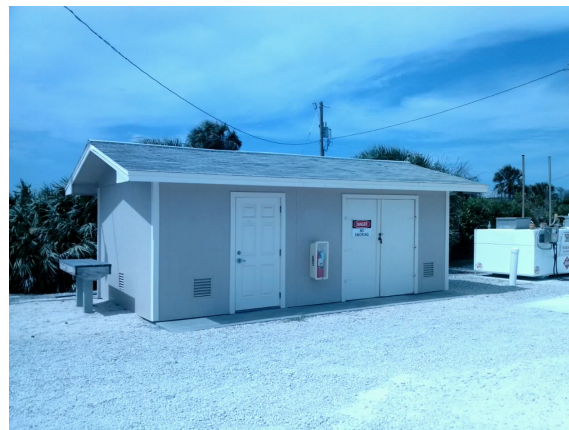
2017\_CANA\_60162\_ND P.O.L. Building\_Front.jpg

**Score: 63**  
**Rating: High**

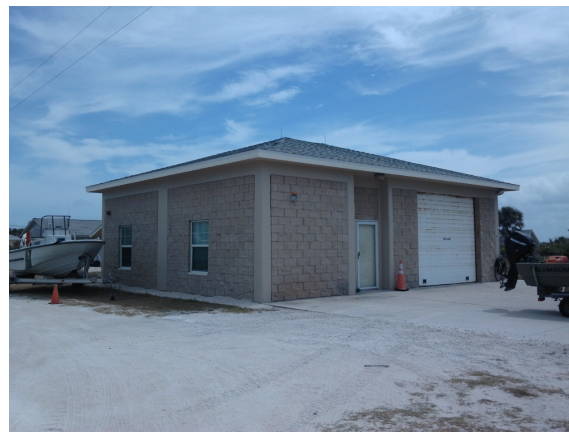
2017\_CANA\_99410\_ND Fire Cache Building\_Front.jpg

**Score: 61**  
**Rating: Moderate**

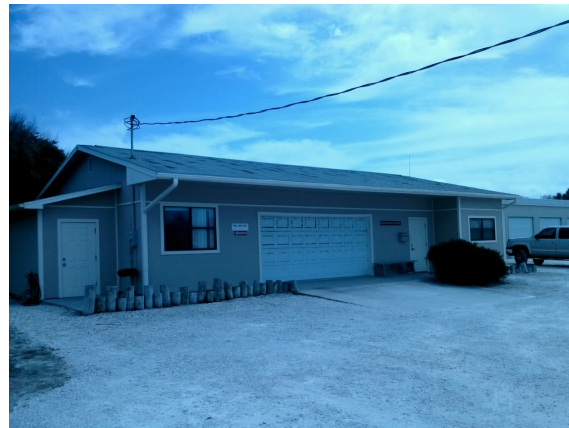
2017\_CANA\_60158\_ND Maintenance Shop\_Front. jpg

**Score: 67**  
**Rating: High**

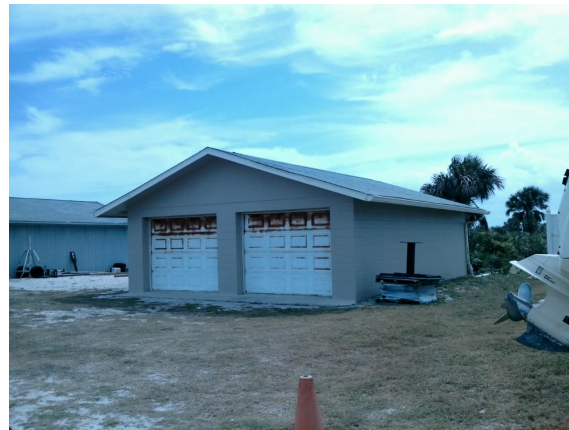
2017\_CANA\_95003\_ND Carpenter Shop\_Front.jpg

**Score: 61**  
**Rating: Moderate**

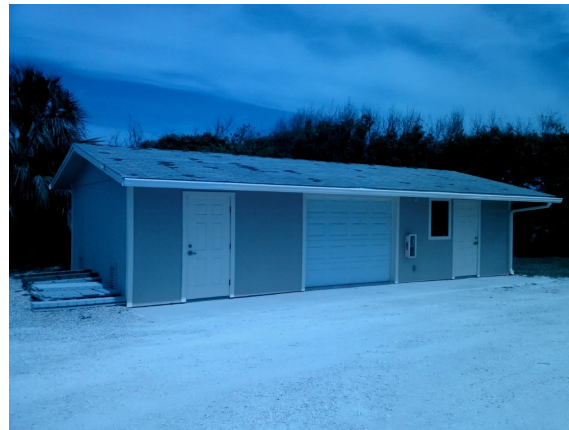
2017\_CANA\_60161\_ND Maintenance Storage Building\_Front. jpg

**Score: 67**  
**Rating: High**

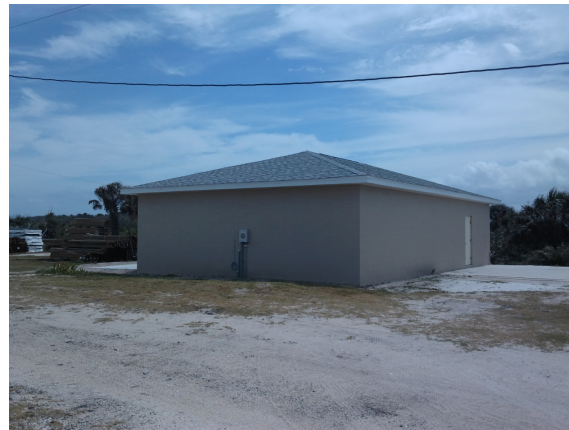
2017\_CANA\_65908\_ND Ranger Beach Garage Henderson\_Front. jpg

**Score: 63**  
**Rating: High**
