# NPS Wildfire Risk Assessments Assessment Locations

Fort Matanzas National Monument-Overview

## FOMA - Fort Matanzas National Monument

# NPS Wildand Fire Risk Assessment - Facility Assessment

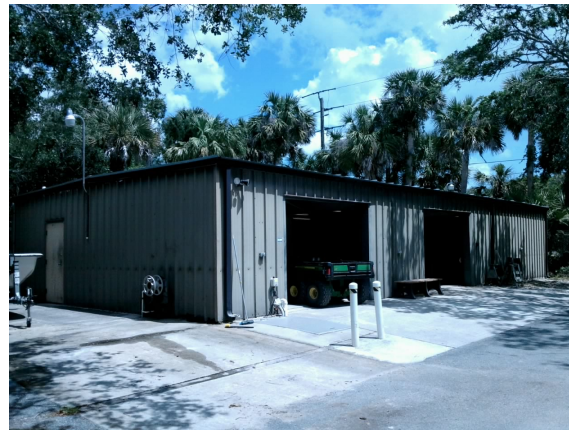
2017\_CASA\_37050\_FOMA Maintenance Shop\_Front.jpg

**Access & Turnarounds:** Access is <300 ft from facility w/turnaround  
**Facility Number/Sign:** Marked and clearly visible  
**Defensible Space:** <30 ft treated

**Fuel Load (w/in 300 ft):** Heavy  
**Fuel Type (w/in 300ft):** Shrub or timber  
**Topography (w/in 300ft):** Slope <5%  
**Roof Material:** Noncombustible or not applicable

**Propane Tanks:** None  
**Water Supply:** Limited or dependent on electricity  
**Overhead Hazards:** No overhead hazards  
**Safety Zones:** Potential safety zone(s) in area

**Score: 57** **Asset Priority Index (API): 30**  
**Rating: Moderate**

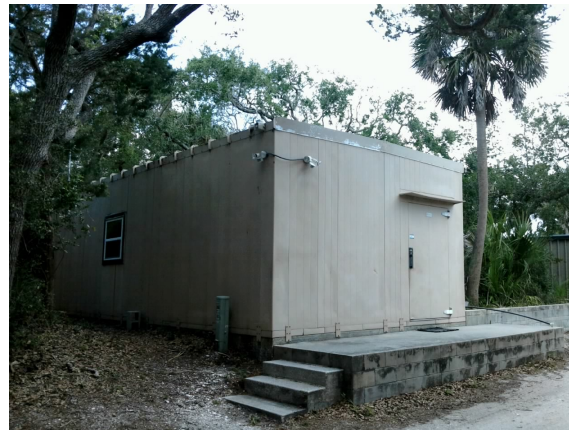
2017\_CASA\_37049\_FOMA Balley Building\_Front.jpg

**Defensible Space:** <30 ft treated

**Fuel Load (w/in 300 ft):** Heavy

**Fuel Type (w/in 300ft):** Shrub or timber

**Score: 57**  
**Rating: Moderate**

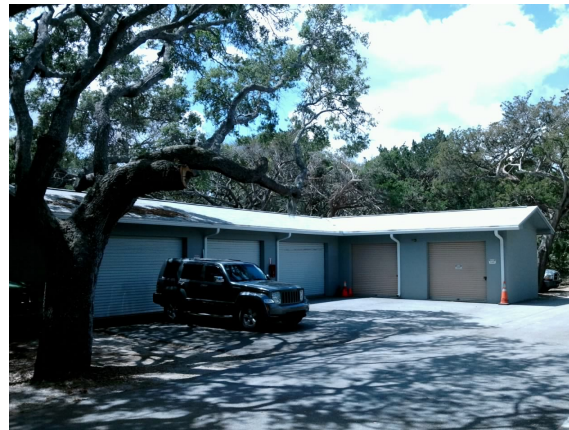
2017\_CASA\_37051\_FOMA Maintenance Outbuildings\_Front.jpg

**Defensible Space:** <30 ft treated

**Fuel Load (w/in 300 ft):** Heavy

**Roof Material:** Fire resistant- tar,rubberized

**Score: 58**  
**Rating: Moderate**

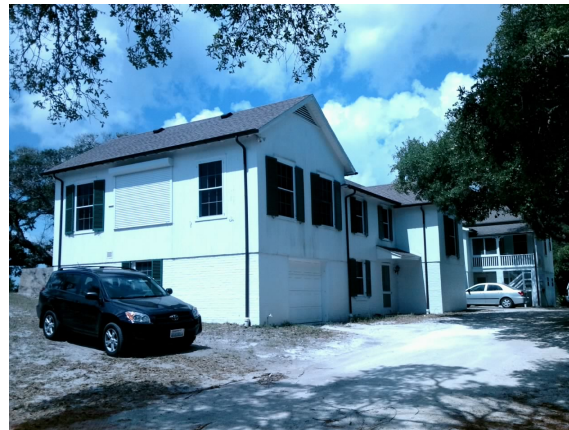
2017\_CASA\_24421\_QMIS 0000008C FOMA Quarters 8C Johnson House\_Front.jpg

Fuel Load (w/in 300 ft): Heavy

Siding Material: Wood or open sided

Score: 57  
Rating: Moderate

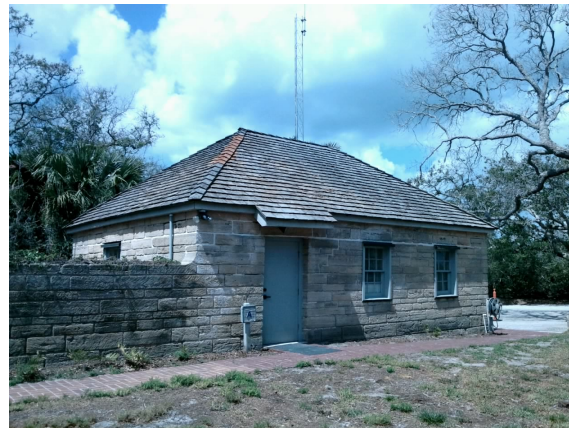
2017\_CASA\_13596\_FOMA Ranger Office\_Front.jpg

**Defensible Space:** <30 ft treated

**Fuel Load (w/in 300 ft):** Heavy

**Roof Material:** Combustible or no roof

**Hazmat:** Fuel storage tanks adjacent.

**Score: 80**  
**Rating: High**

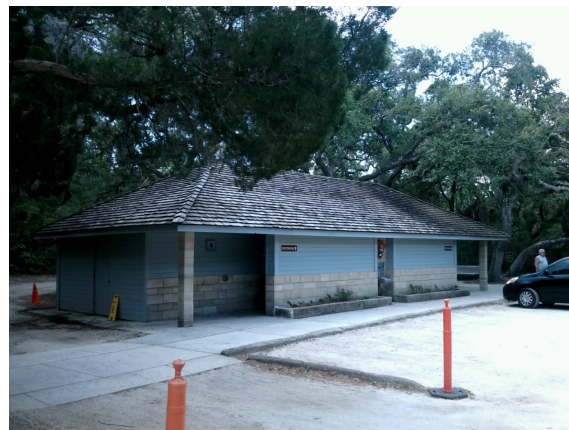
2017\_CASA\_13594\_FOMA Public Restrooms\_Front.jpg

**Defensible Space:** <30 ft treated

**Fuel Load (w/in 300 ft):** Heavy

**Roof Material:** Combustible or no roof

**Siding Material:** Wood or open sided

**Score: 84**  
**Rating: High**

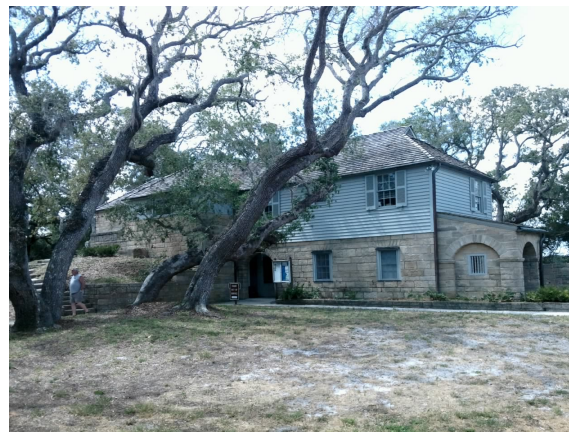
2017\_CASA\_13568\_FOMA Visitor Center\_Front.jpg

Defensible Space: <30 ft treated

Fuel Load (w/in 300 ft): Heavy

Roof Material: Combustible or no roof

Score: 80  
Rating: High

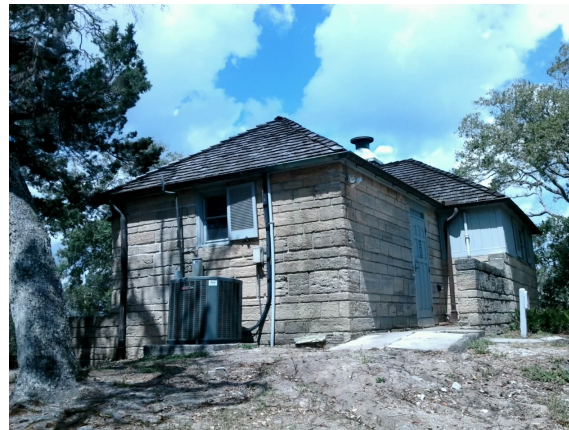
2017\_FOMA\_24424\_QMIS 00000002 FOMA Quarters 2\_Front.jpg

Fuel Load (w/in 300 ft): Heavy

Roof Material: Combustible or no roof

Score: 70  
Rating: High
