# NPS Wildfire Risk Assessments Assessment Locations

## MORR - Morristown National Historic Park - Overview

Washington's Headquarters  
MORR - Morristown National Historical Park

# NPS Wildland Fire Risk Assessment - Facility Assessment

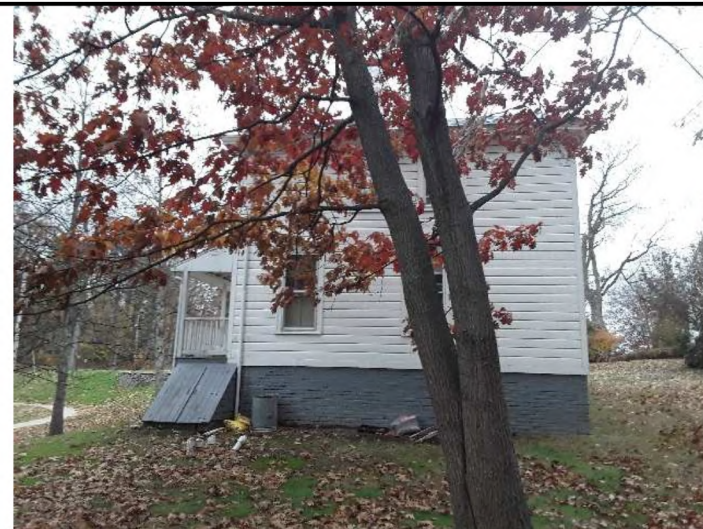
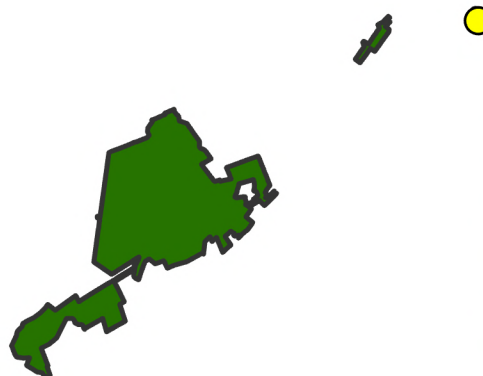
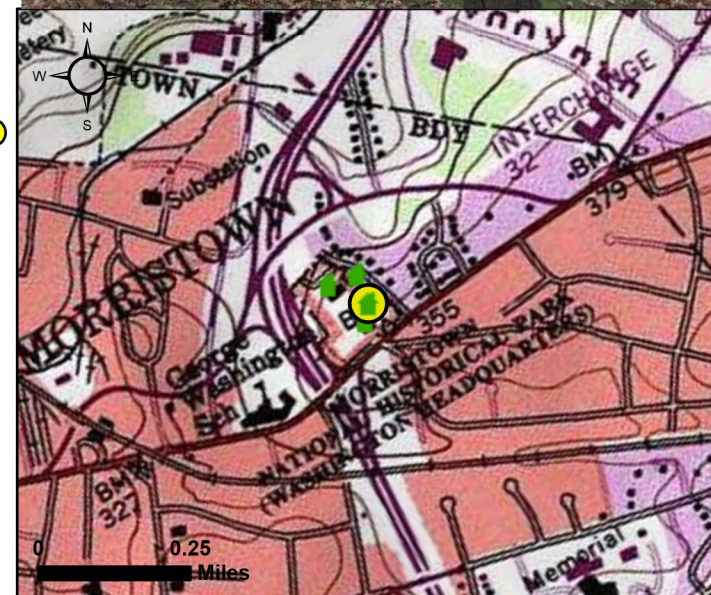
**Facility Name:** Caretakers Cottage

**Rating:** Low

**Fuel Type:** Grass/tundra,northern hardwood litter

**Fuel Load:** Light or no wildland fuels

**Defensible Space:** Greater than 100ft treated

**Roof Material:** Noncombustible or not applicable

**Siding Material:** Wood or open sided

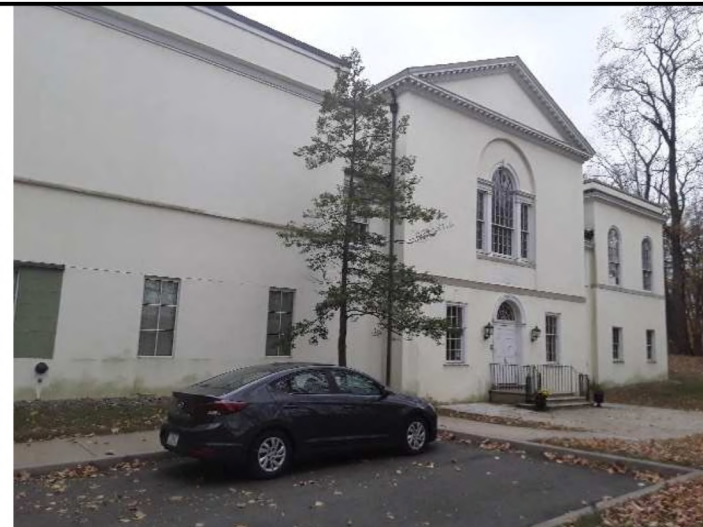
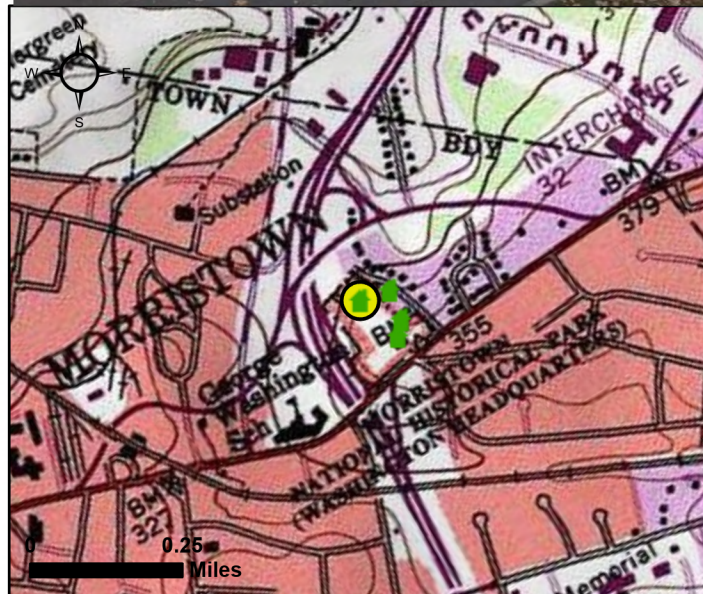
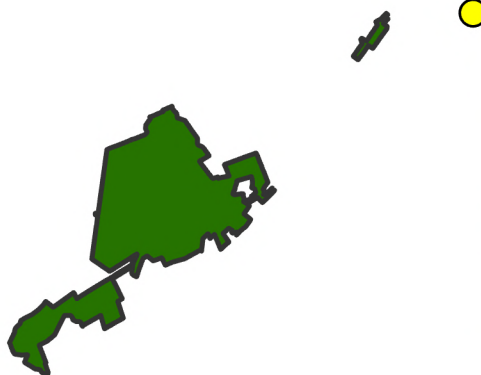
**Facility Name:** Museum

**Rating:** Low

**Defensible Space:** 30 ft treated

**Topography:** Slope 5% to 20%

**Roof Material:** Noncombustible or not applicable

**Siding Material:** Rock, concrete, metal

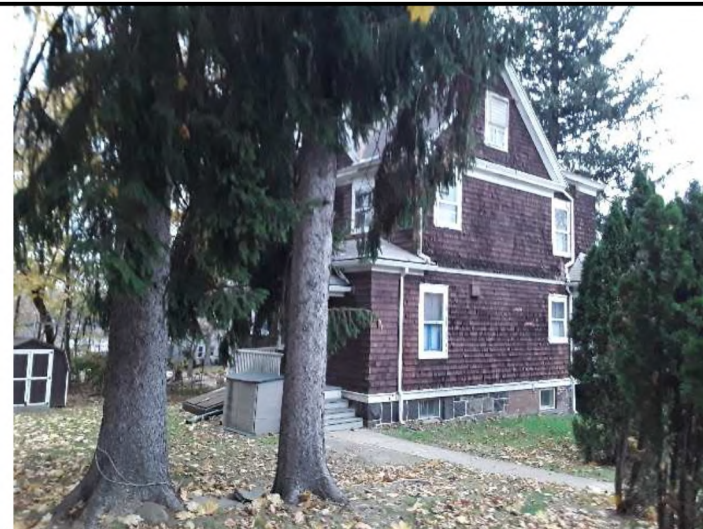
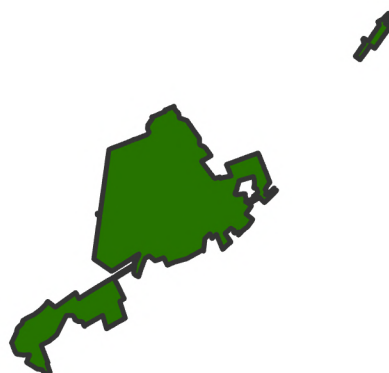
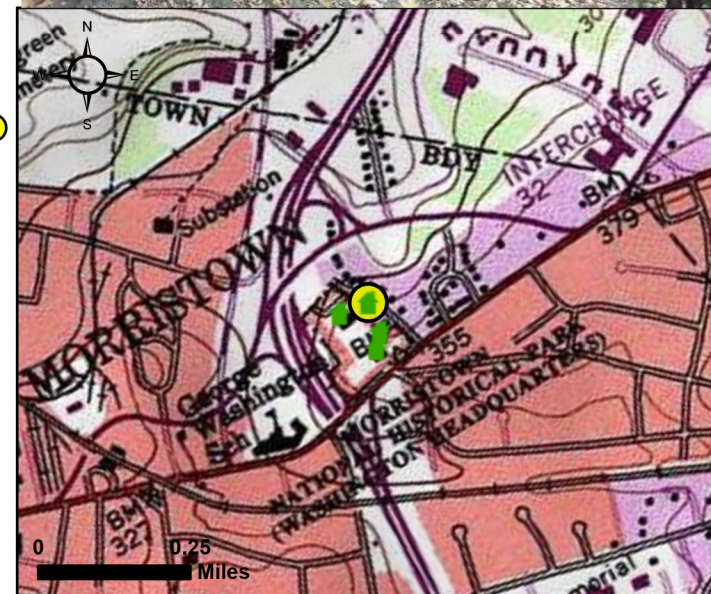
**Facility Name:** Quarters # 47

**Rating:** Low

**Fuel Type:** Grass and shrub, hardwood litter

**Defensible Space:** Greater than 100ft treated

**Roof Material:** Fire resistant- tar,rubberized

**Siding Material:** Wood or open sided

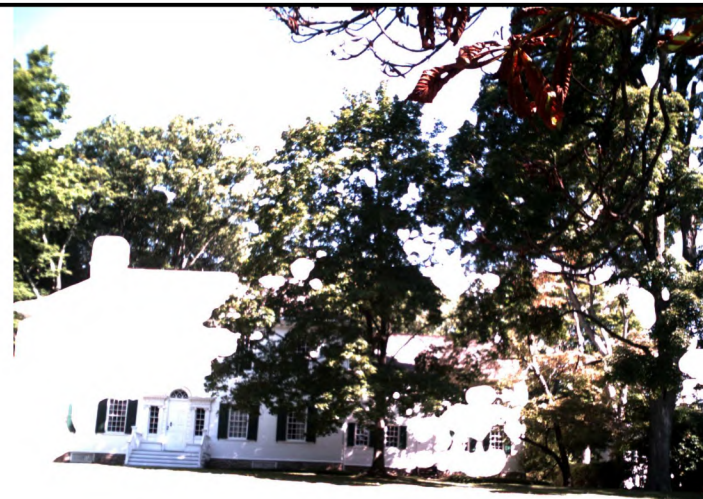
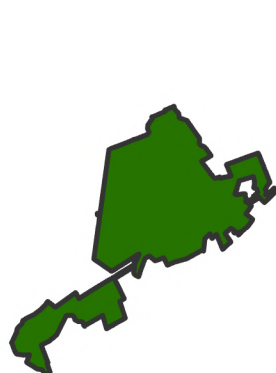
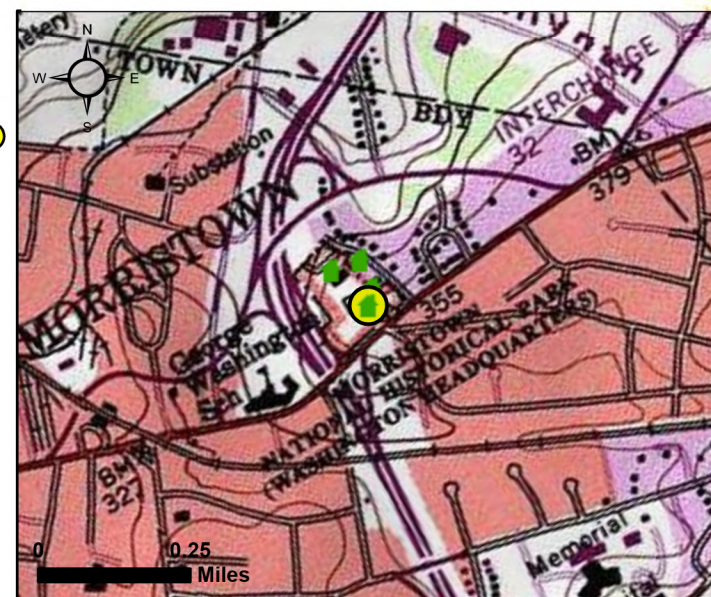
**Facility Name:** Ford Mansion

**Rating:** Low

**Defensible Space:** 100 ft treated

**Roof Material:** Combustible or no roof

**Siding Material:** Wood or open sided

**Foundation:** Closed, 6in to 30in masonry exposed
