# NPS Wildfire Risk Assessments Assessment Locations

## BITH - Big Thicket National Preserve - Overview

# Village Creek Corridor Unit

# NPS Wildland Fire Risk Assessment - Facility Assessment

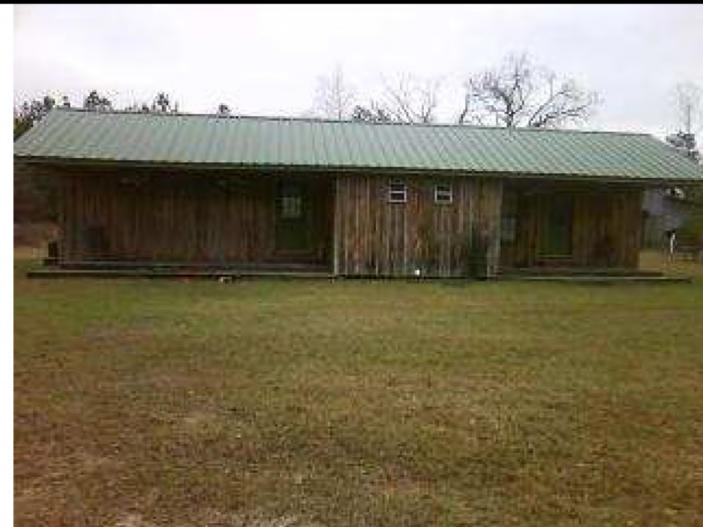
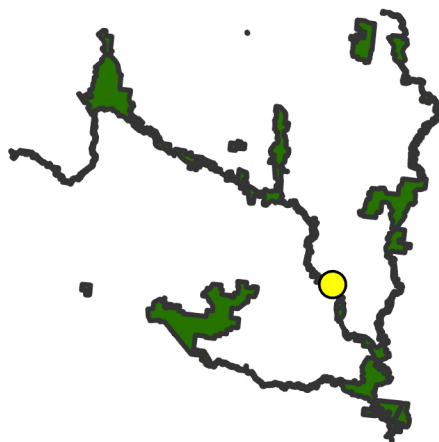
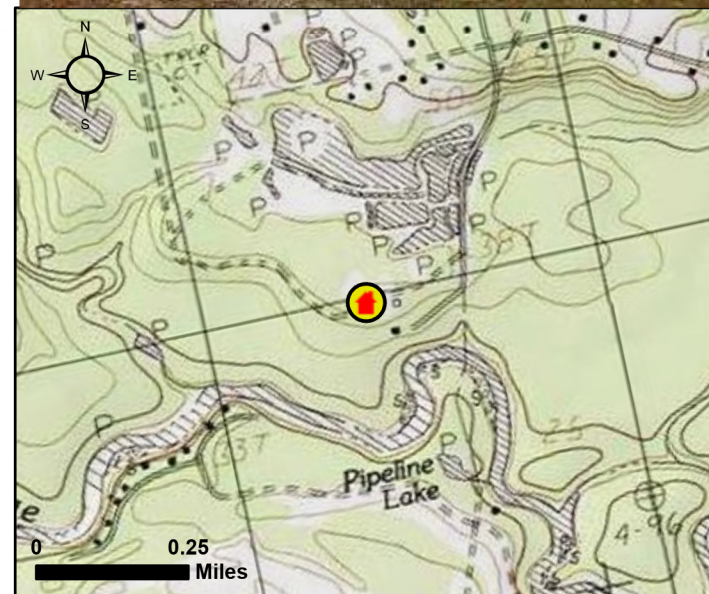
**Facility Name:** Seal House Ranger Office

**Rating:** High

**Facility Number or Sign:** None or not clearly visible

**Defensible Space:** Less than 30 ft treated

**Siding Material:** Wood or open sided

**Firewood:** 5ft to 30ft from facility

**Water Supply:** No reliable water source nearby

**Overhead Hazards:** Overhead hazards will limit aircraft

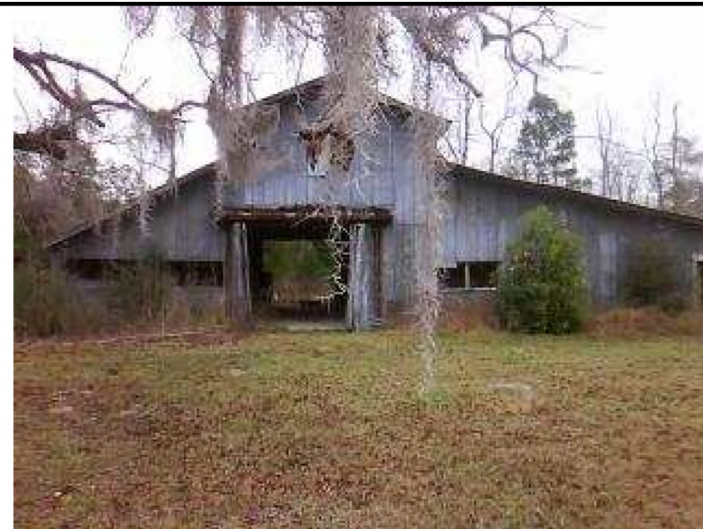
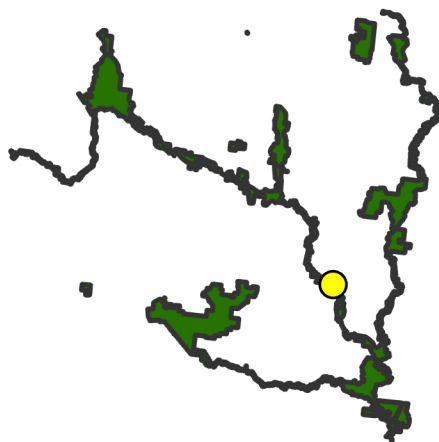
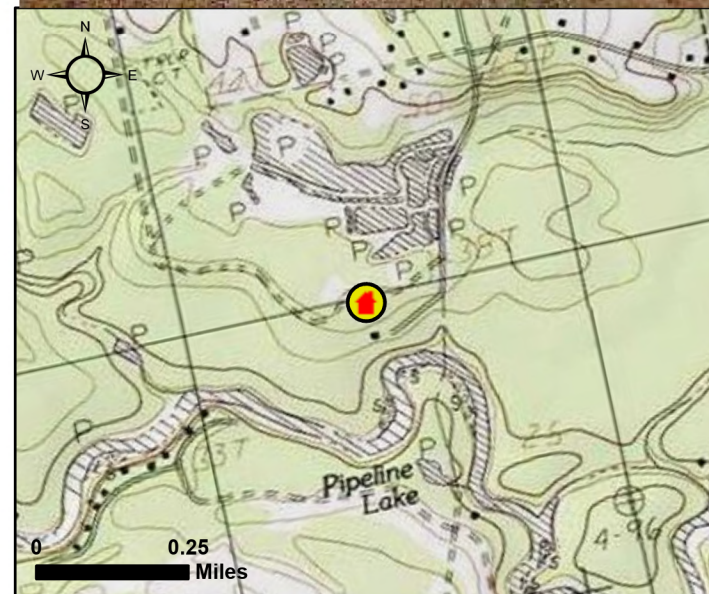
**Facility Name:** Seal House Barn

**Rating:** High

**Defensible Space:** Less than 30 ft treated

**Firewood:** 5ft to 30ft from facility

**Water Supply:** No reliable water source nearby

**Comments:** old barn future unknown

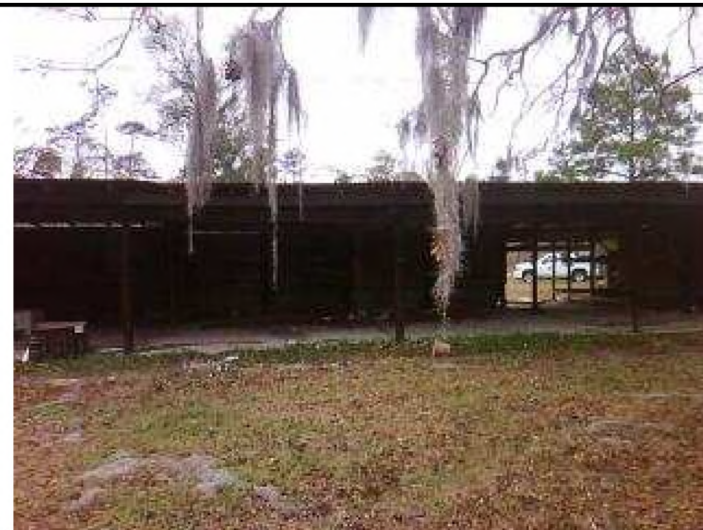
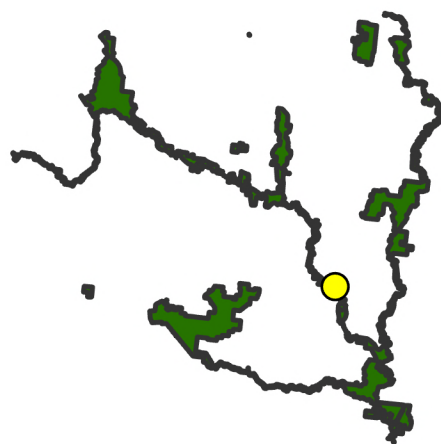
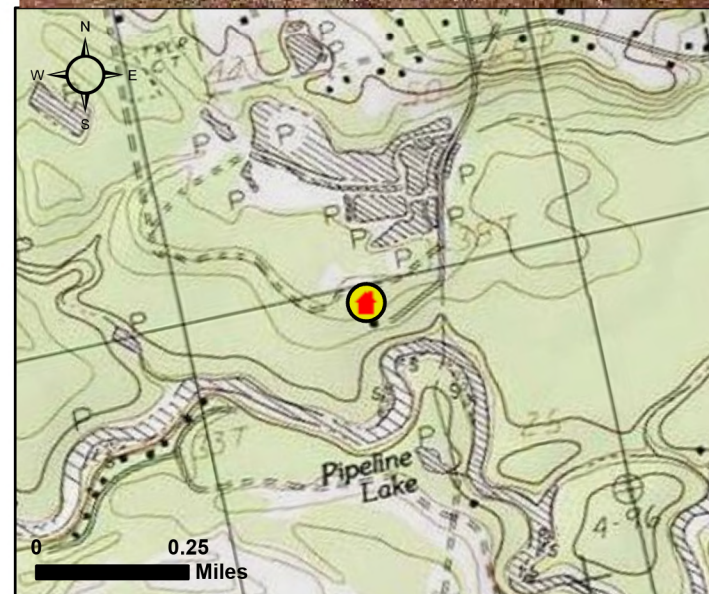
**Facility Name:** Seal House Pole Barn

**Rating:** High

**Defensible Space:** Less than 30 ft treated

**Firewood:** 5ft to 30ft from facility

**Water Supply:** No reliable water source nearby

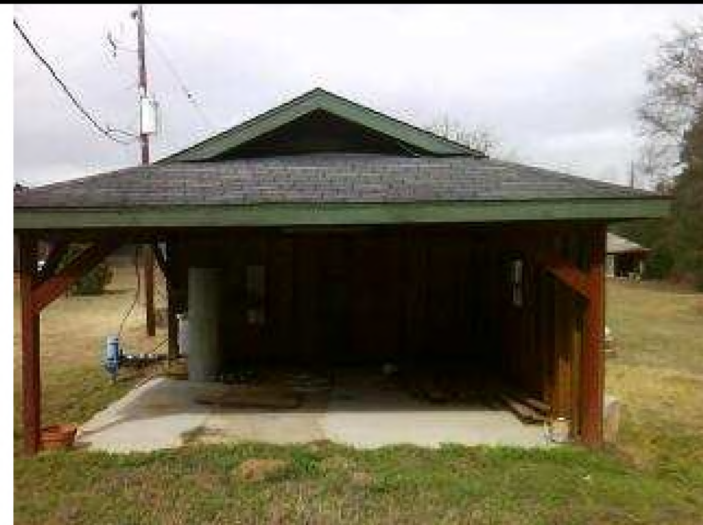
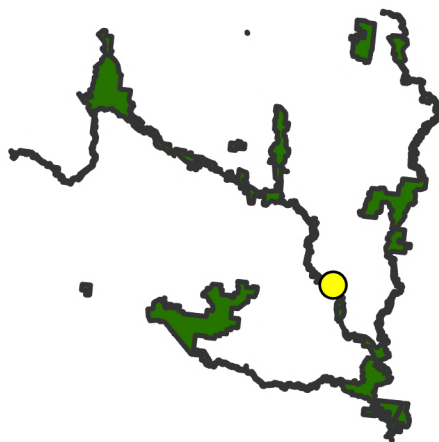
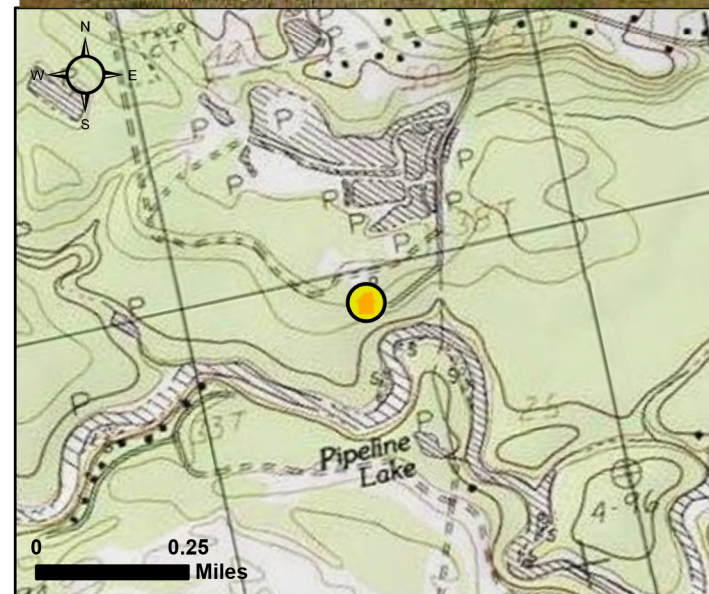
**Facility Name:** Seal Water System Pump House

**Rating:** Moderate

**Roof Material:** Combustible or no roof

**Siding Material:** Wood or open sided

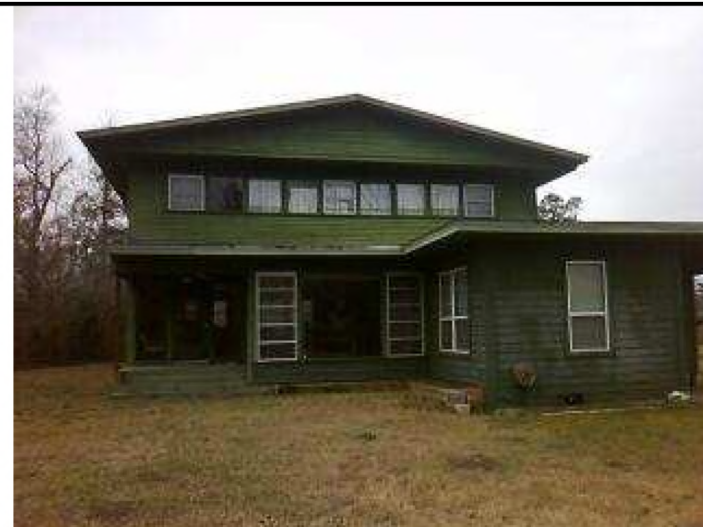
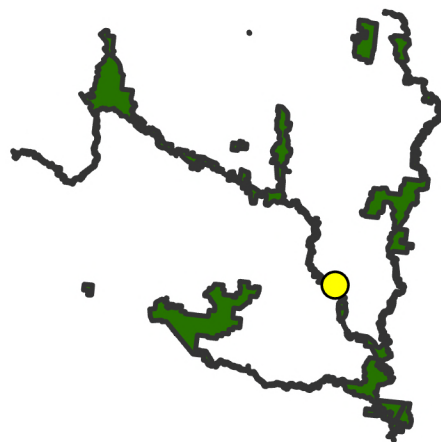
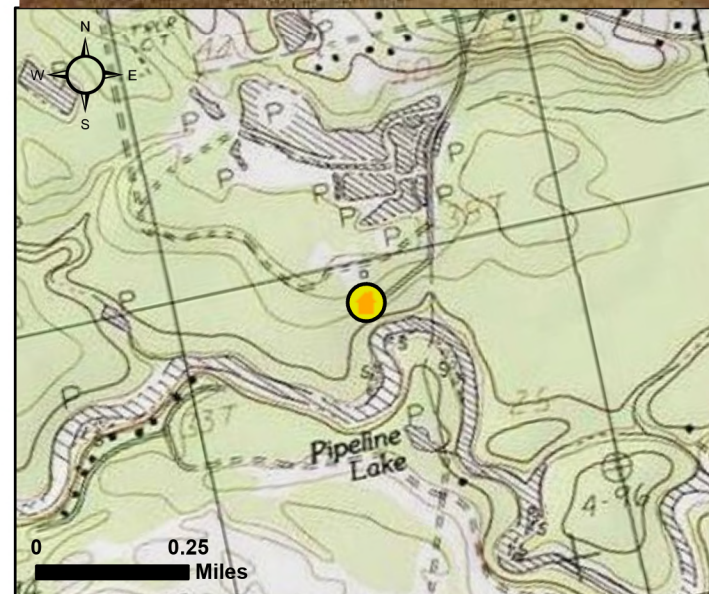
**Facility Name:** Seal House

**Rating:** Moderate

**Roof Material:** Combustible or no roof

**Siding Material:** Wood or open sided
