# Cedar Breaks

## CEBR - Cedar Breaks National Monument

# NPS Wildland Fire Risk Assessment - Facility Assessment

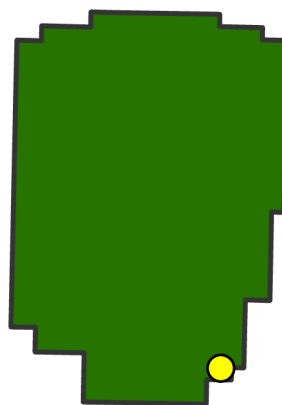
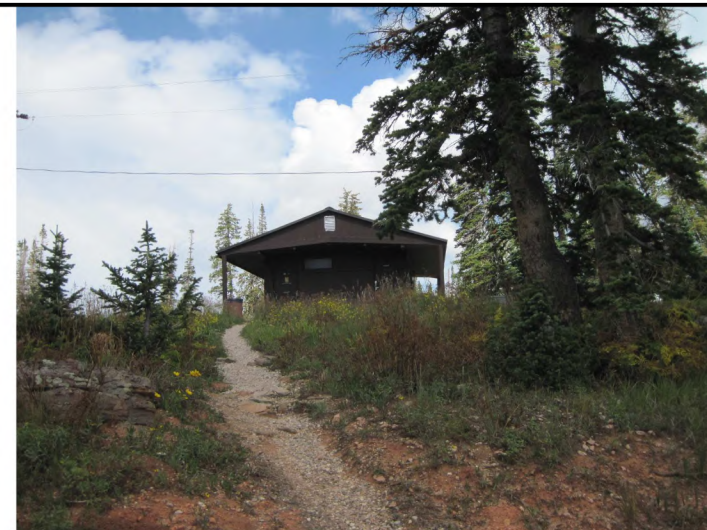
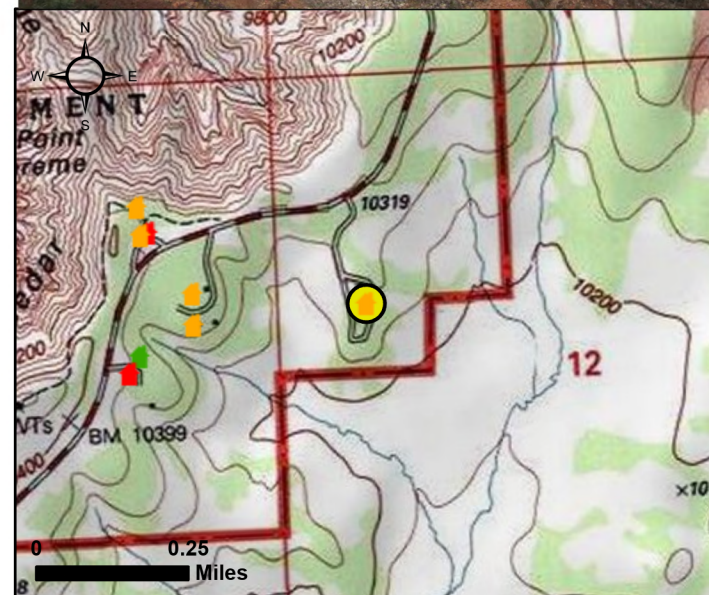
**Facility Name:** Campground RR

**Rating:** Moderate

**Fuel Type:** Grass/tundra,northern hardwood litter

**Fuel Load:** Light or no wildland fuels

**Defensible Space:** Less than 30 ft treated

**Siding Material:** Wood or open sided

**Propane:** Present and fuels clearance

**Overhead Hazards:** Overhead hazards will limit aircraft

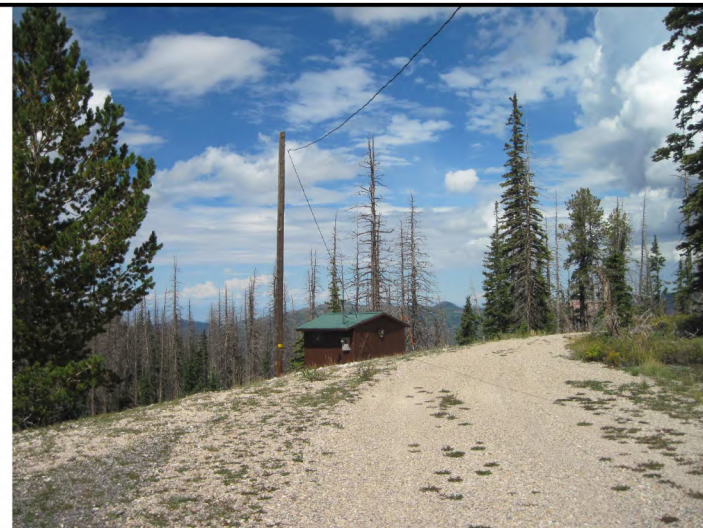
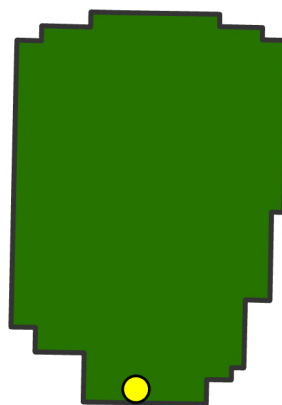
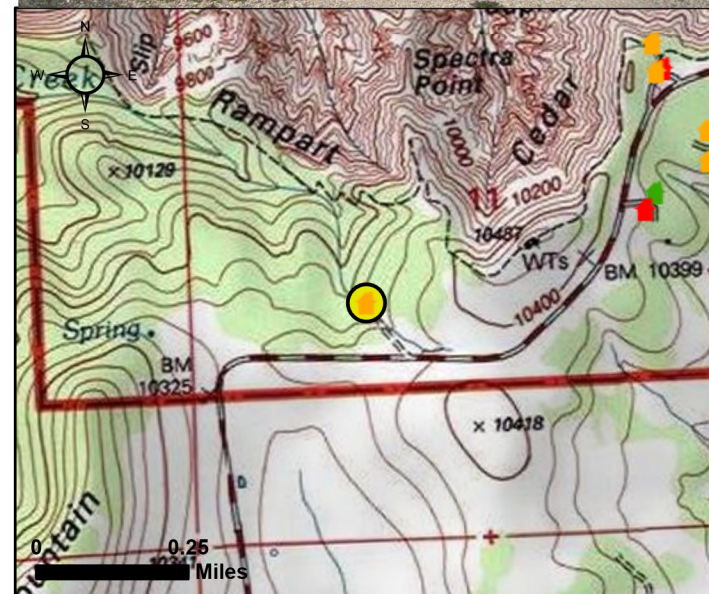
**Facility Name:** Pump House

**Rating:** Moderate

**Fuel Type:** Shrub or timber

**Fuel Load:** Moderate

**Defensible Space:** 30 ft treated

**Siding Material:** Wood or open sided

**Overhead Hazards:** Overhead hazards will limit aircraft

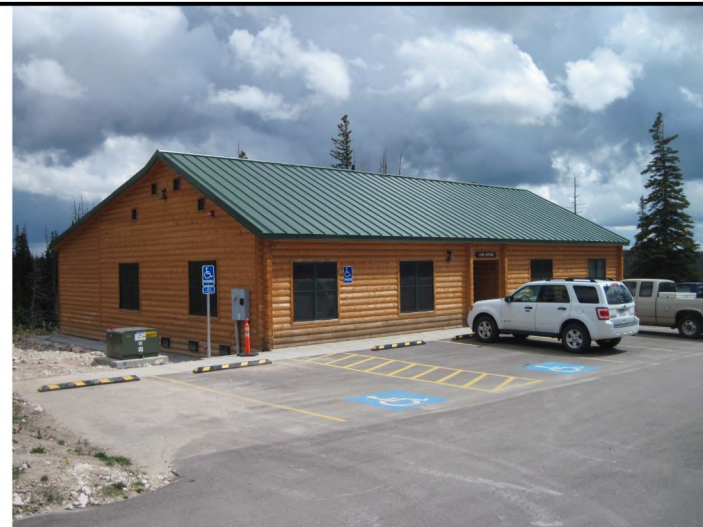
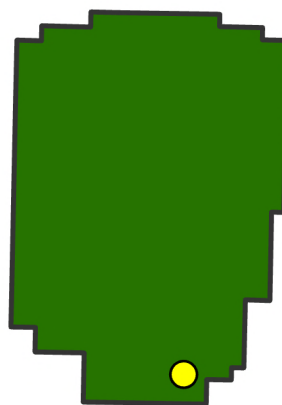
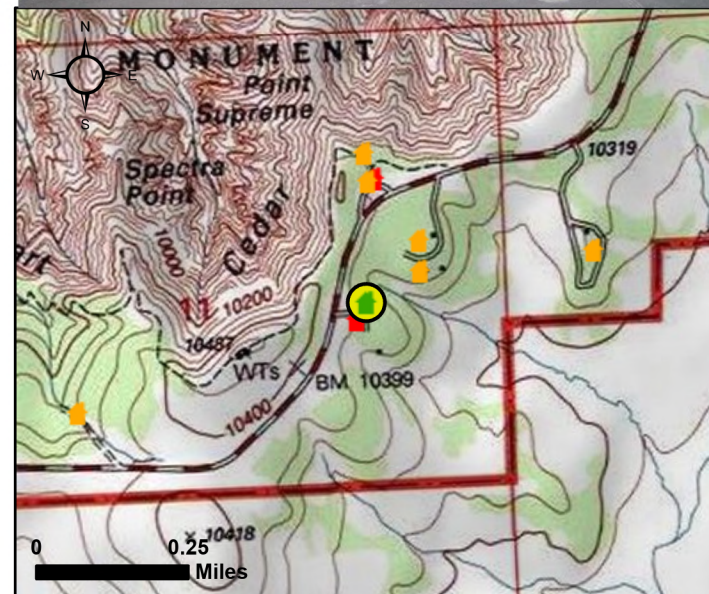
**Facility Name:** Ranger/Fee Office

**Rating:** Low

**Fuel Type:** Grass and shrub, hardwood litter

**Fuel Load:** Light or no wildland fuels

**Defensible Space:** 30 ft treated

**Siding Material:** Wood or open sided

**Foundation:** Open or deck

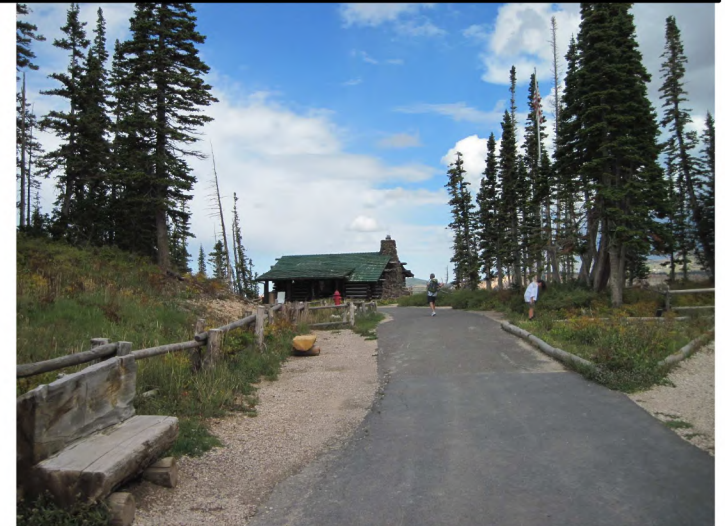
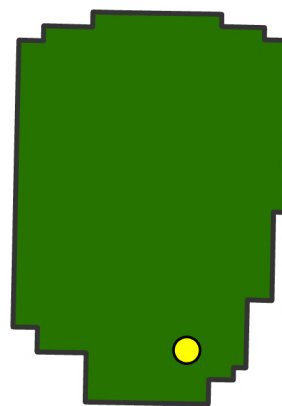
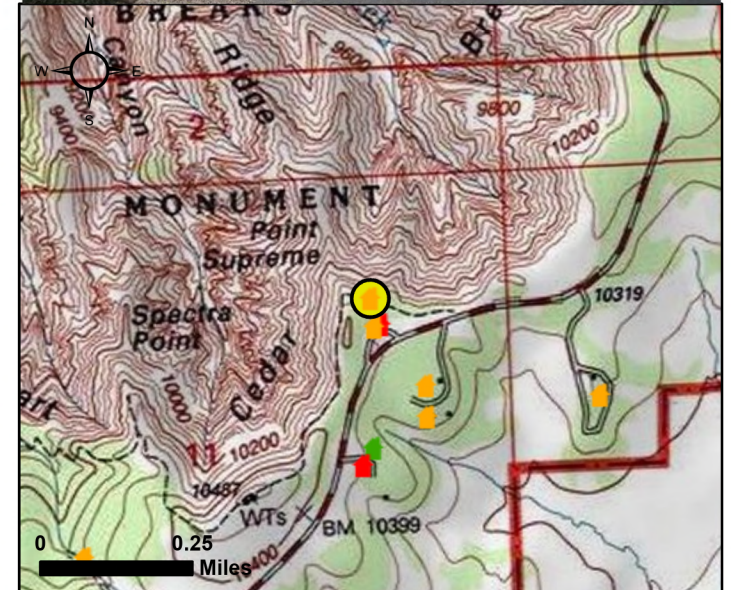
**Facility Name:** Vistor Center

**Rating:** Moderate

**Fuel Type:** Grass/tundra,northern hardwood litter

**Fuel Load:** Light or no wildland fuels

**Defensible Space:** Less than 30 ft treated

**Roof Material:** Combination of fire resisitant and combustible

**Siding Material:** Wood or open sided

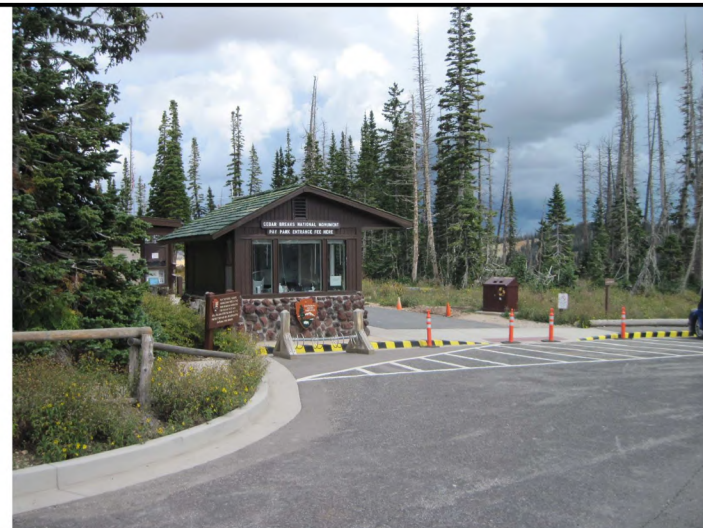
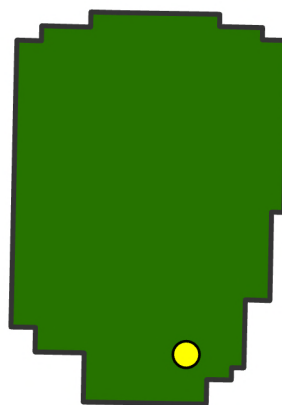
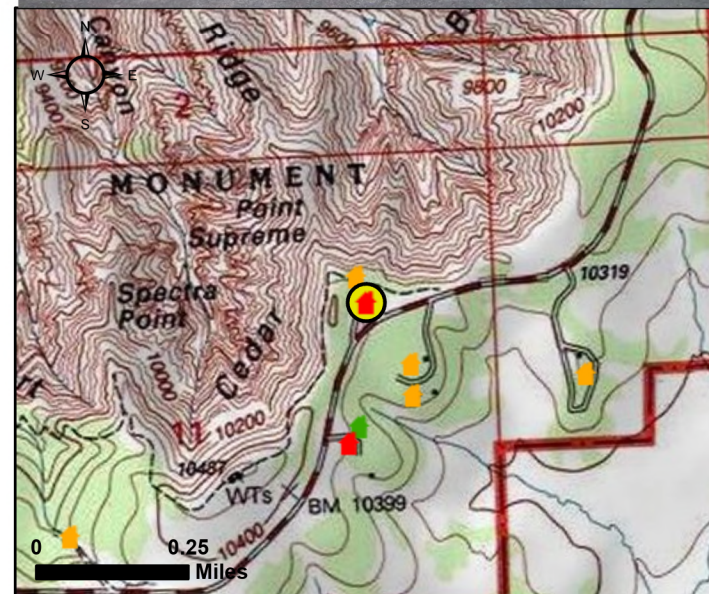
**Facility Name:** Fee Booth  
**Unit - Location:** CEBR - Cedar Breaks  
**FMSS ID:** 47011, **Local ID:**  
**Structure Type, Use:** Building, Administrative  
**Owner:** National Park Service  
**Field Crew, Visit Date:** Castillo, March 27, 2021  
**Coordinates (DDM):** 37° 36.74111196' N 112° 50.23458090' W

**Rating:** High  
**ProtectionLevel:** Not Designated,  
**Resources of Concern:** Unknown  
**Occupied:** Yes  
**In Community:** No,  
**Revisit Interval:** 10 yrs  
**Map Label:** 6

**Primary Access:** Road  
**Ingress Egress:** 1 road in/out  
**Access Width:** 2 lanes (Greater than 24')  
**Access Condition:** Surfaced-paved, gradeLess than 5%  
**Bridge Condition:** Less than 300 ft with turnaround  
**Access and Turnarounds:** Less than 300 ft with turnaround  
**Facility Number or Sign:** Marked and clearly visible  
**Fuel Type:** Shrub or timber  
**Fuel Load:** Moderate  
**Defensible Space:** Less than 30 ft treated  
**Topography:** Slope Less than 5%  
**Roof Material:** Combination of fire resitant and combustible  
**Siding Material:** Wood or open sided  
**Foundation:** Closed, Less than 6in masonry exposed  
**Firewood:** None  
**Water Supply:** Reliable water source nearby  
**Propane:** None  
**Overhead Hazards:** No overhead hazards  
**Comments:**

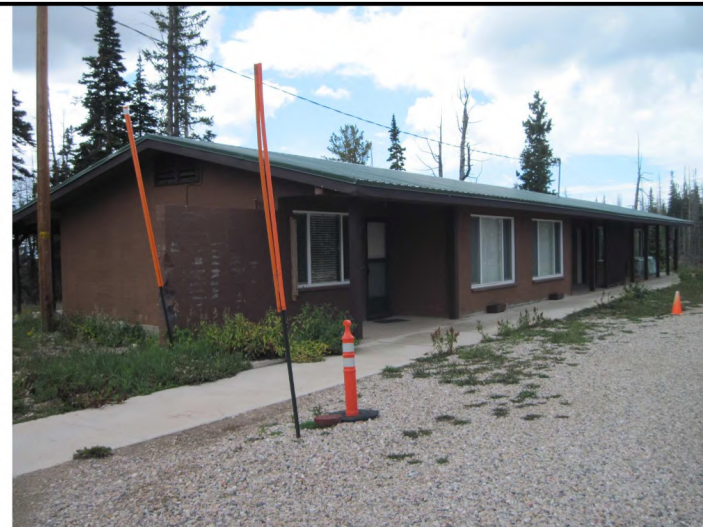
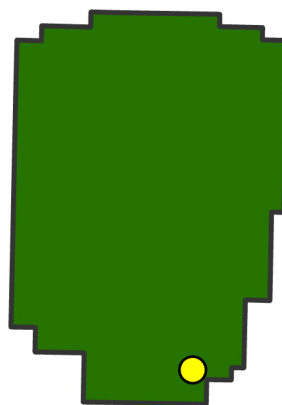
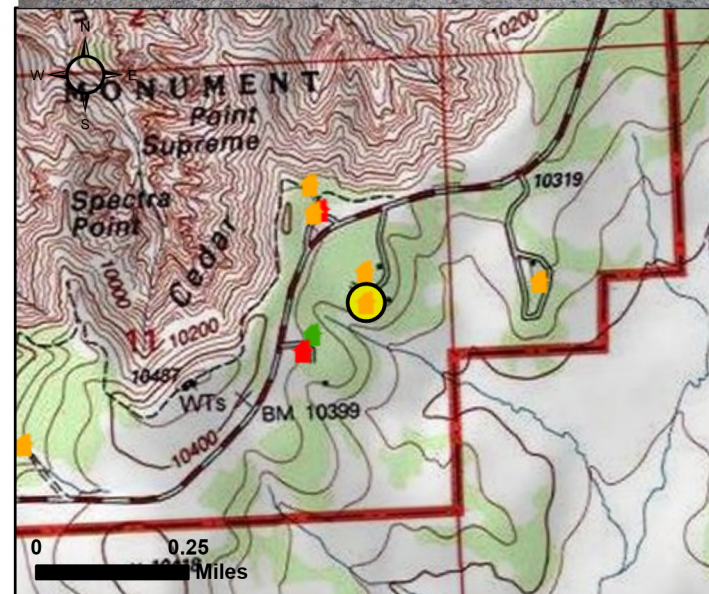
**Facility Name:** Apartments

**Rating:** Moderate

**Defensible Space:** Less than 30 ft treated

**Firewood:** 5ft to 30ft from facility

**Propane:** Present and little to no fuels clearance

**Overhead Hazards:** Overhead hazards will limit aircraft

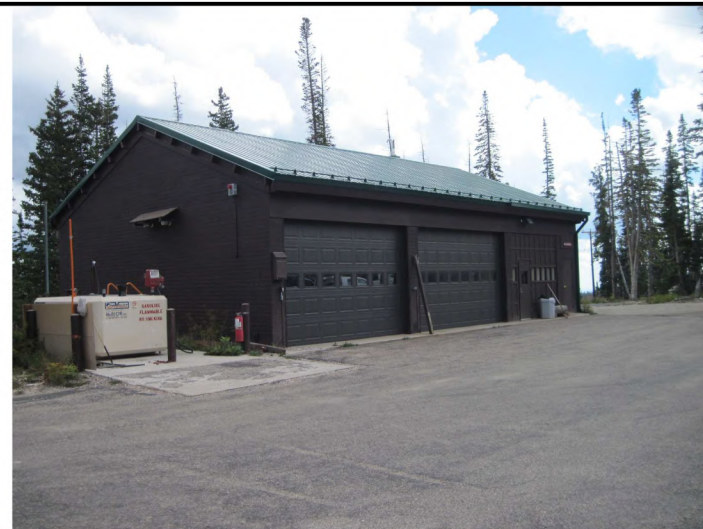
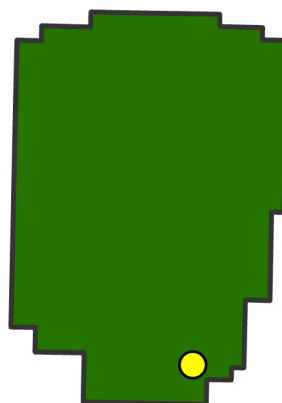
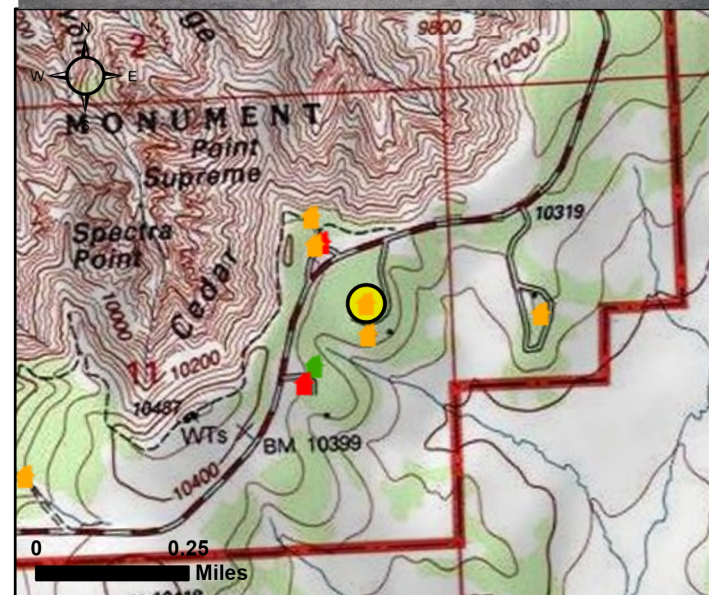
**Facility Name:** Maintenance Shed

**Rating:** Moderate

**Fuel Type:** Shrub or timber

**Fuel Load:** Moderate

**Defensible Space:** 30 ft treated

**Propane:** Present and little to no fuels clearance

**Overhead Hazards:** Overhead hazards will limit aircraft

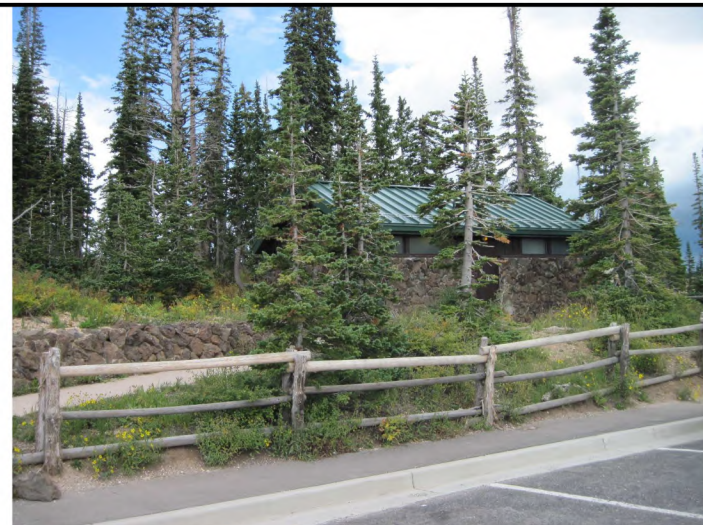
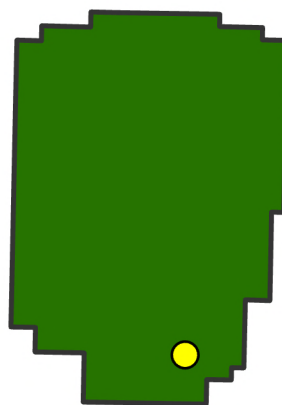
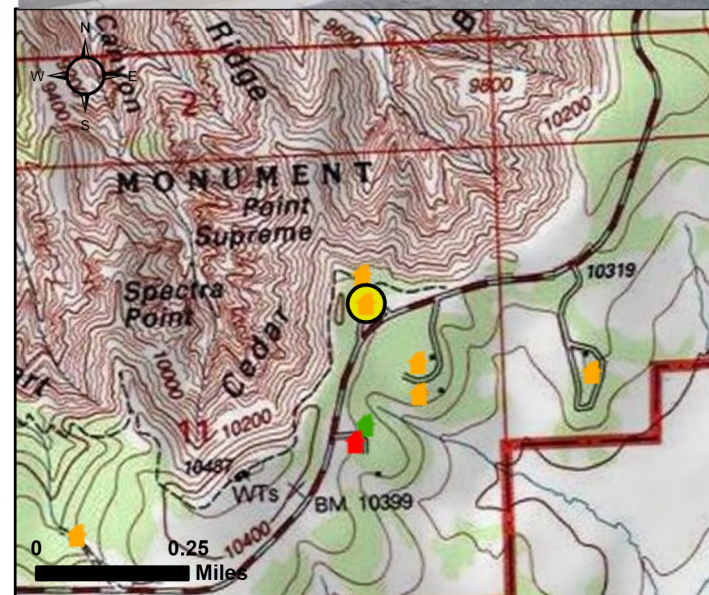
**Facility Name:** Visitor Center Restroom

**Rating:** Moderate

**Fuel Type:** Shrub or timber

**Fuel Load:** Moderate

**Defensible Space:** Less than 30 ft treated

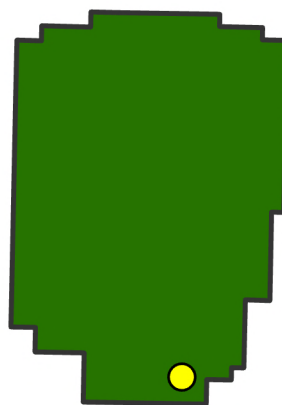
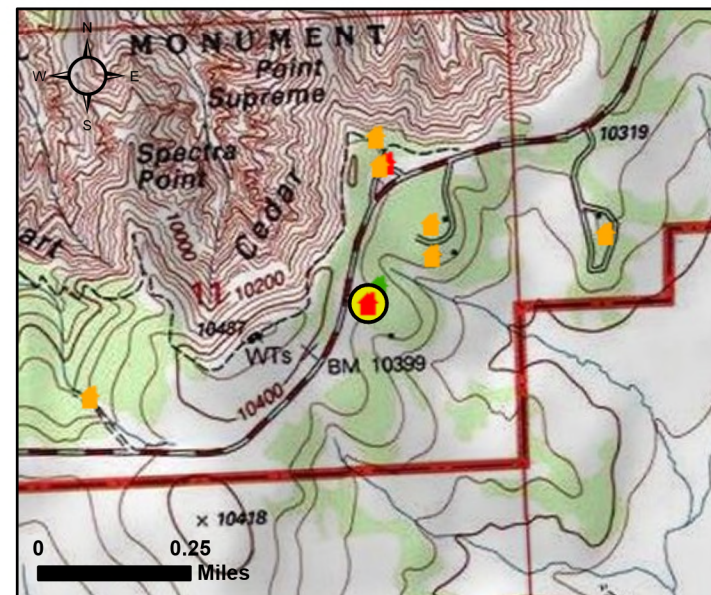
**Facility Name:** Log Cabin  
**Unit - Location:** CEBR - Cedar Breaks  
**FMSS ID:** , **Local ID:**  
**Structure Type, Use:** Building, Unknown  
**Owner:** National Park Service  
**Field Crew, Visit Date:** Castillo, March 27, 2021  
**Coordinates (DDM):** 37° 36.54141858' N 112° 50.27717826' W

**Rating:** High  
**ProtectionLevel:** Not Designated,  
**Resources of Concern:** Unknown  
**Occupied:** No  
**In Community:** No,  
**Revisit Interval:** 10 yrs  
**Map Label:** 2

**Primary Access:** Road  
**Ingress Egress:** 2 or more roads in/out  
**Access Width:** 2 lanes (Greater than 24')  
**Access Condition:** Surfaced-paved, gradeLess than 5%  
**Bridge Condition:** Less than 300 ft with turnaround  
**Access and Turnarounds:** Less than 300 ft with turnaround  
**Facility Number or Sign:** None or not clearly visible  
**Fuel Type:** Grass and shrub, hardwood litter  
**Fuel Load:** Light or no wildland fuels  
**Defensible Space:** Less than 30 ft treated  
**Topography:** Slope 5% to 20%  
**Roof Material:** Combustible or no roof  
**Siding Material:** Log construction  
**Foundation:** Closed, Less than 6in masonry exposed  
**Firewood:** None  
**Water Supply:** Pressurized hydrant(s) or fixed sprinkler system  
**Propane:** None  
**Overhead Hazards:** Overhead hazards will limit aircraft  
**Comments:**
