# NPS Wildfire Risk Assessments Assessment Locations

## ARCH - Arches National Park - Overview

# Park Headquarters

# NPS Wildland Fire Risk Assessment - Facility Assessment

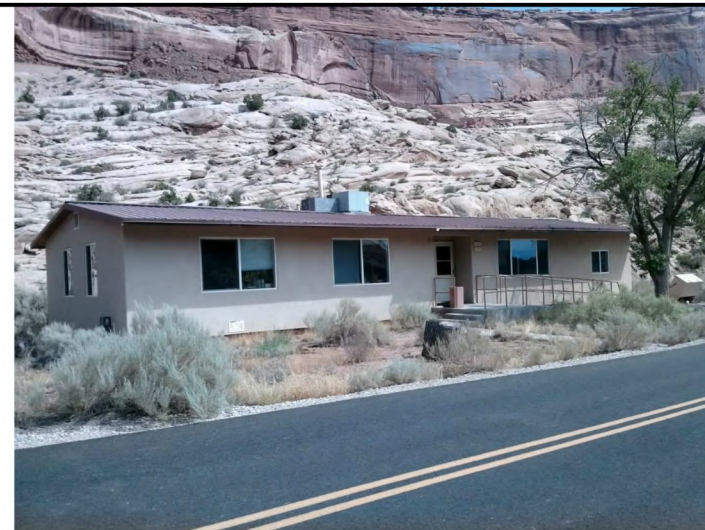
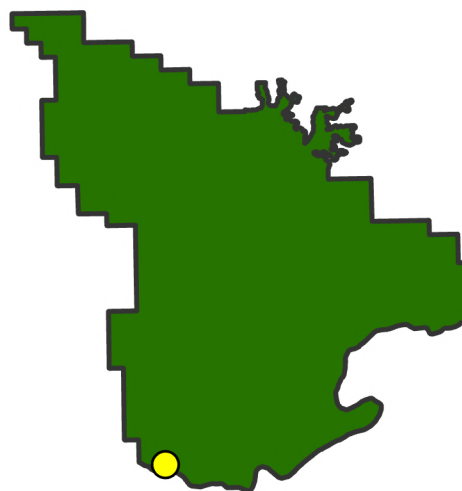
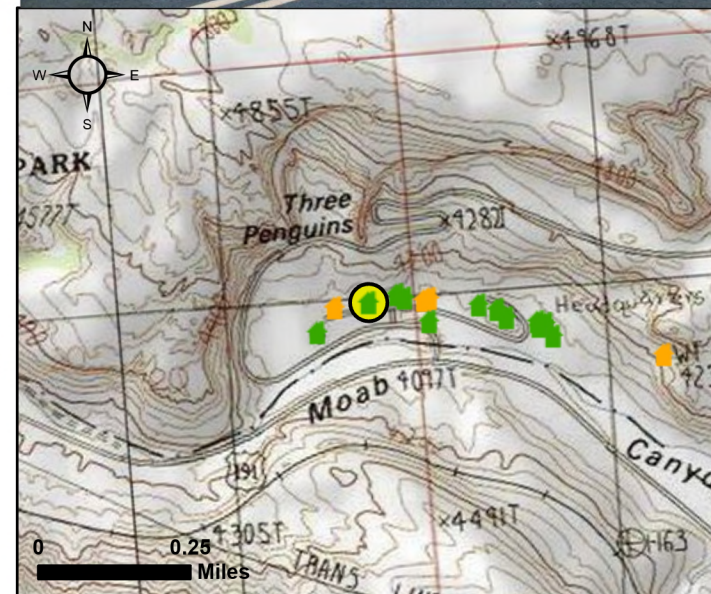
**Comments:** Flammable materials behind house
