# Golden Spike National Historical Park

## GOSP - Golden Spike National Historic Site

# NPS Wildland Fire Risk Assessment - Facility Assessment

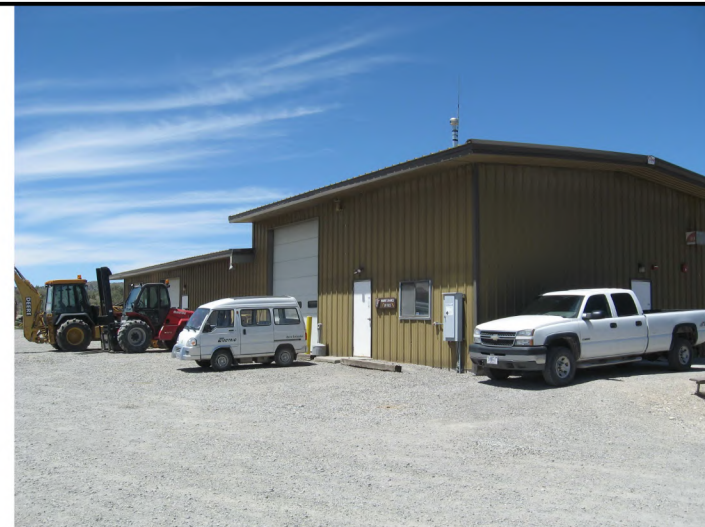
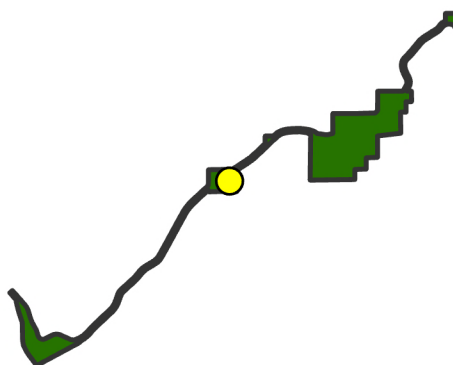
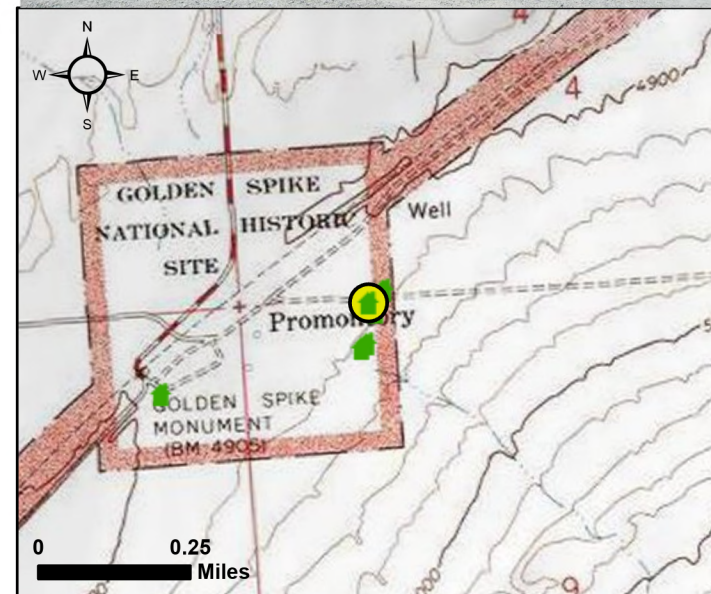
**Facility Name:** Maintenance Building

**Comments:** Wooden beams adjacent to bldg. Hazmat inside and adjacent to bldg, diesel/gas feuling station 100 ft away.

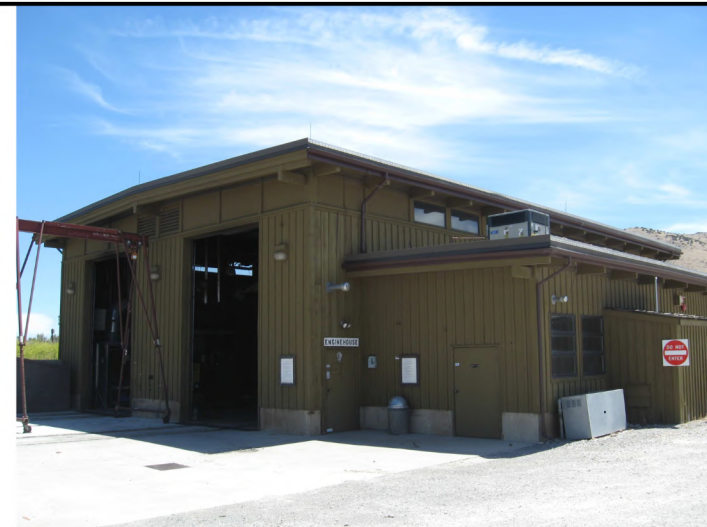
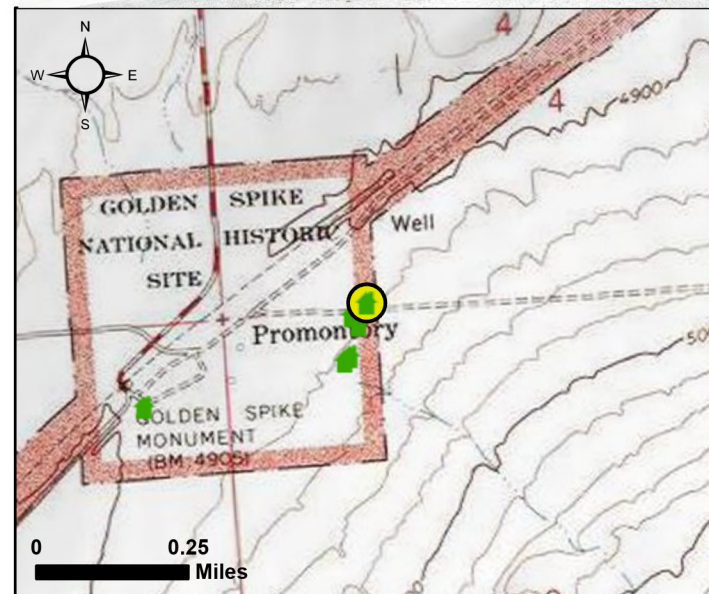
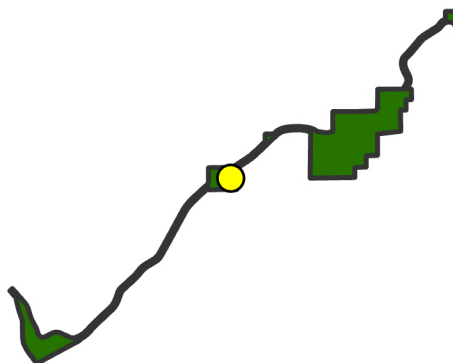
**Facility Name:** Engine House

**Comments:** pile of coal 50 ft from structure, pile of wood 100 ft from structure, propane tank 50 ft away next to coal pile. Bldg is full of chemicals, burnable fuels, hazmat.

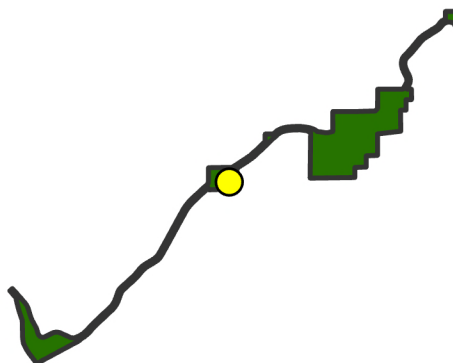
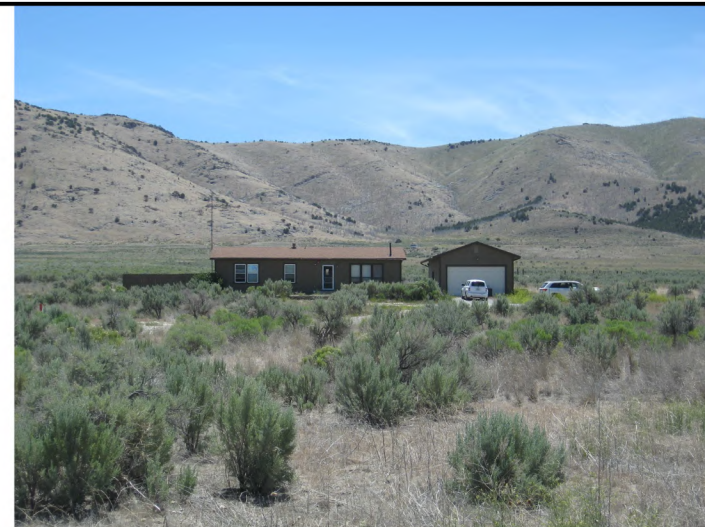
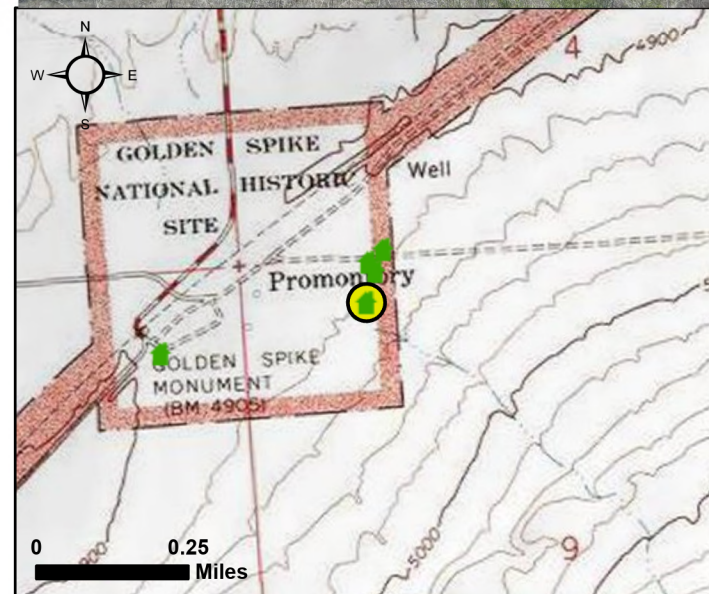
**Primary Access:** Road  
**Ingress Egress:** 2 or more roads in/out  
**Access Width:** 2 lanes (Greater than 24')  
**Access Condition:** Surfaced-paved, gradeLess than 5%  
**Bridge Condition:** Less than 300 ft with turnaround  
**Access and Turnarounds:** Less than 300 ft with turnaround  
**Facility Number or Sign:** None or not clearly visible  
**Fuel Type:** Grass and shrub, hardwood litter  
**Fuel Load:** Moderate  
**Defensible Space:** 30 ft treated  
**Topography:** Slope Less than 5%  
**Roof Material:** Noncombustible or not applicable  
**Siding Material:** Wood or open sided  
**Foundation:** Closed, 6in to 30in masonry exposed  
**Firewood:** None  
**Water Supply:** Pressurized hydrant(s) or fixed sprinkler system  
**Propane:** Present and fuels clearance  
**Overhead Hazards:** No overhead hazards  
**Comments:** Detached garage FMSS ID 236390

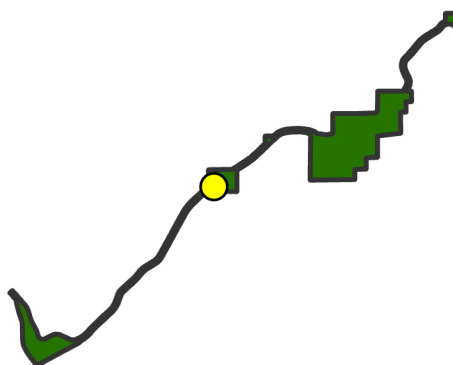
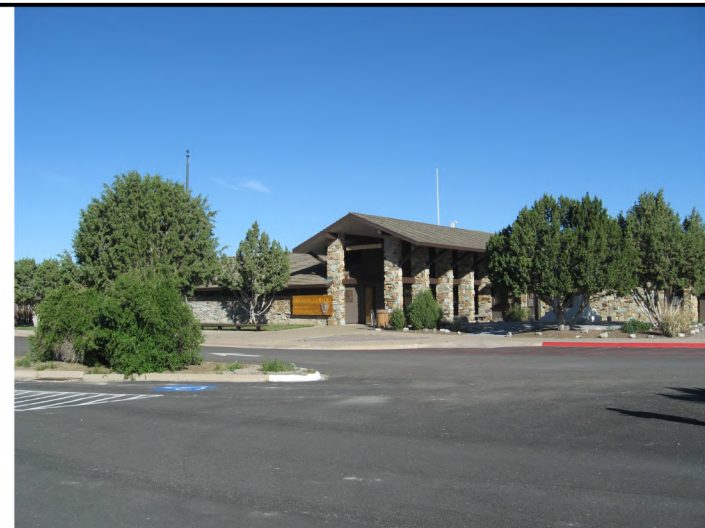
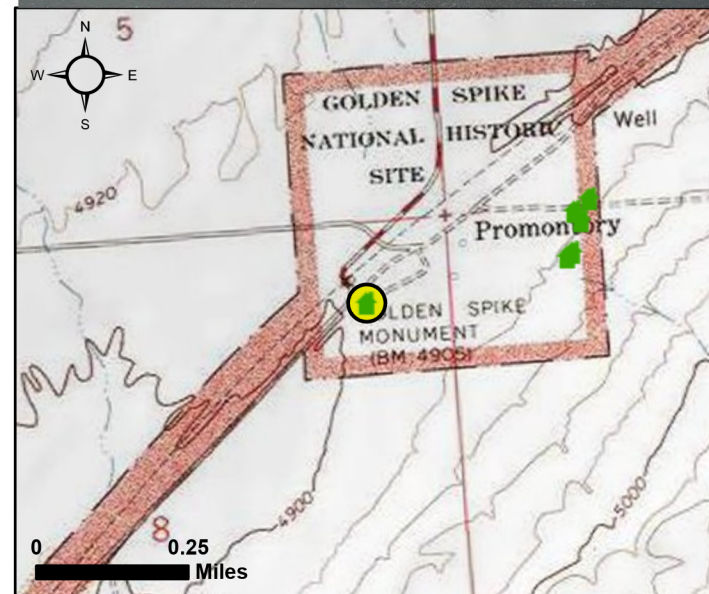
**Facility Name:** Visitors Center Building

**Comments:** this assessment incl Ranger Storage Unit (FMSS 32383), Living History Storage Unit (FMSS 32386), WNPA Storage Shed (FMSS 32388), Admin Storage Unit (FMSS 46473)

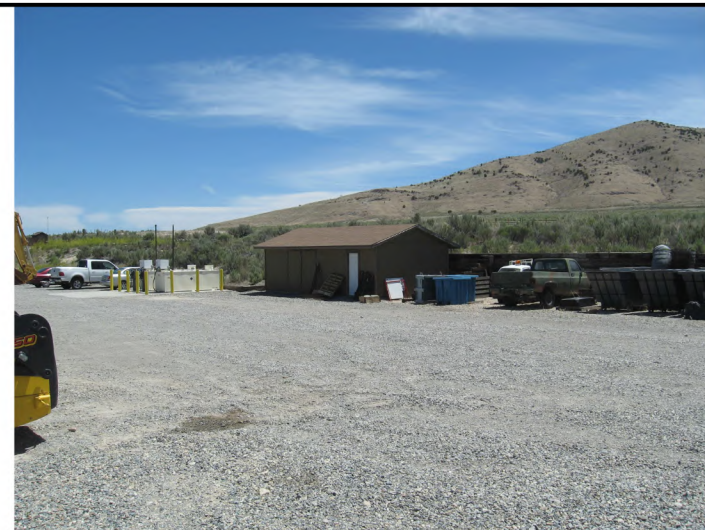
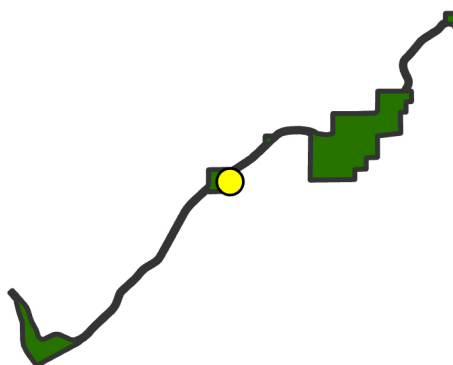
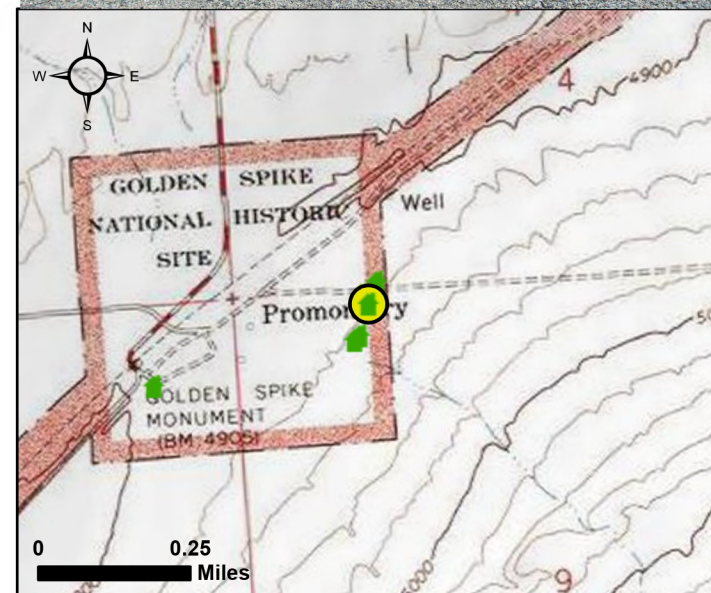
**Facility Name:** Maintenance Storage Shed

**Comments:** 10 feet from a diesel/gas fueling station.
