# NPS Wildfire Risk Assessments Assessment Locations

## GRTE- Two Ocean Lake - Overview

# NPS Wildland Fire Risk Assessment - Facility Assessment

**Unit - Location:** GRTE - Two Ocean Lake

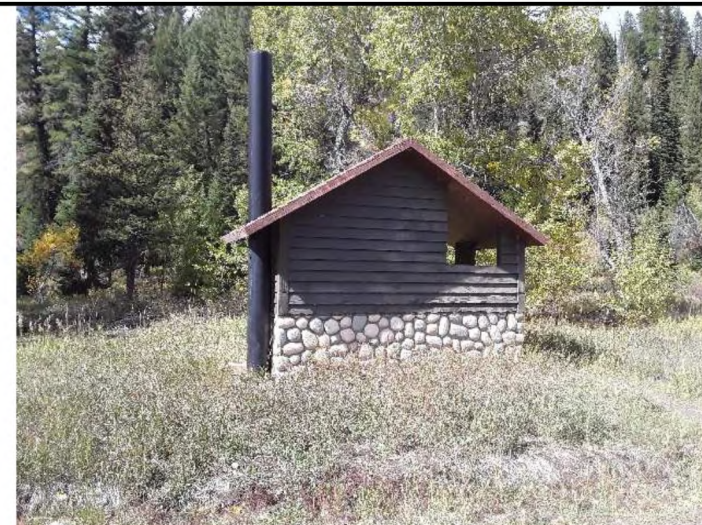
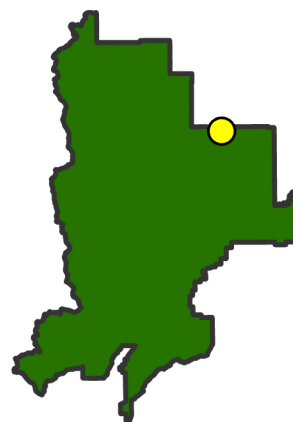
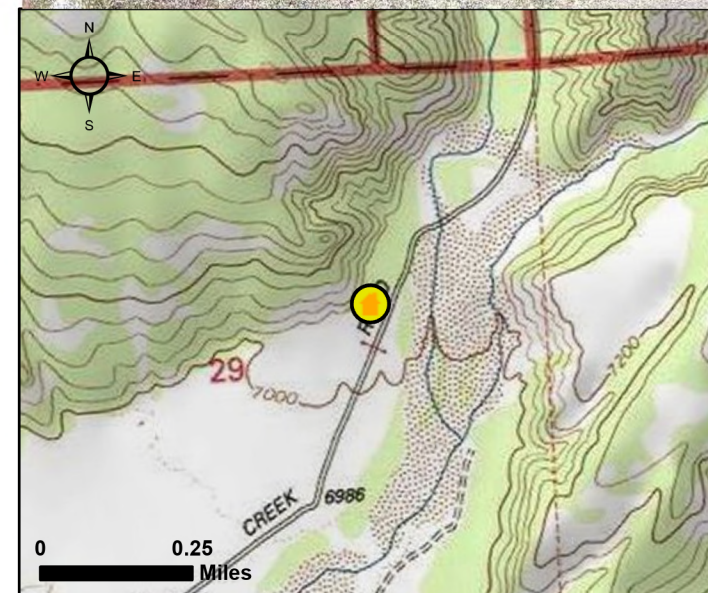
**Facility Name:** Vault Toilet

**Rating:** Moderate

**Fuel Type:** Shrub or timber

**Fuel Load:** Moderate

**Defensible Space:** Less than 30 ft treated

**Siding Material:** Rock, concrete, metal

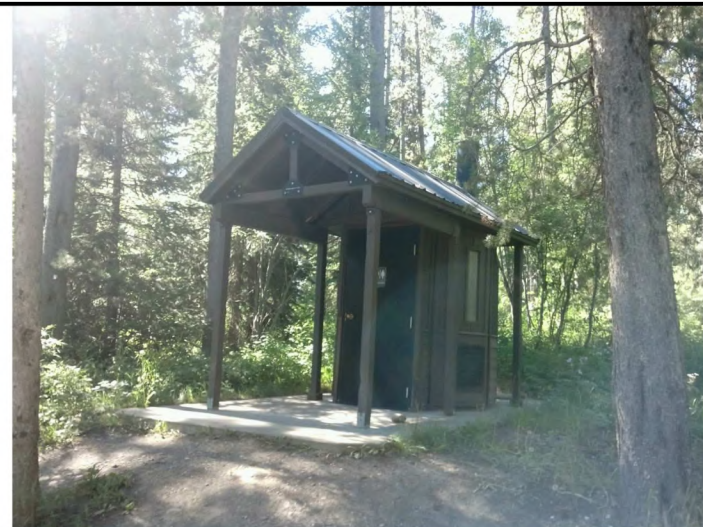
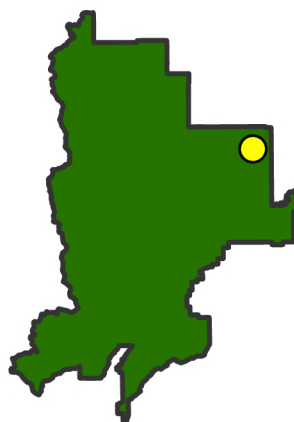
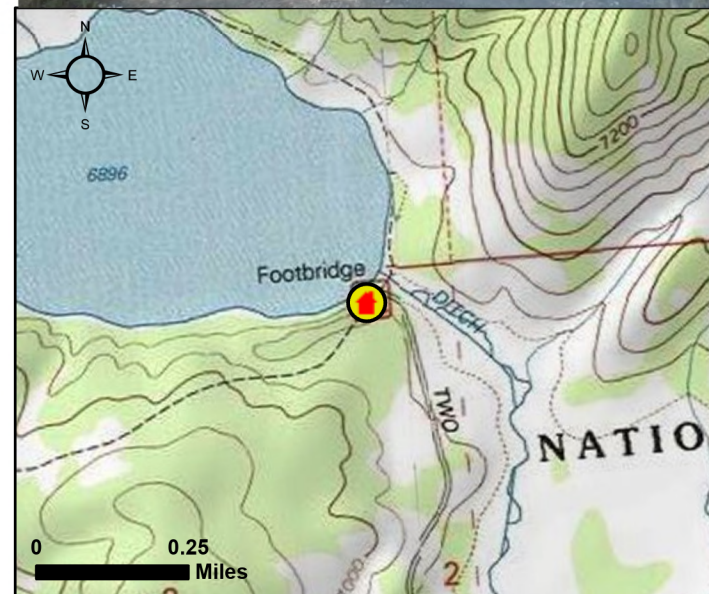
**Facility Name:** B - B2023 Romtec @ TWO OCEAN Lake

**Rating:** High

**Fuel Type:** Shrub or timber

**Fuel Load:** Heavy

**Defensible Space:** No defensible space

**Siding Material:** Wood or open sided

**Foundation:** Closed, Less than 6in masonry exposed

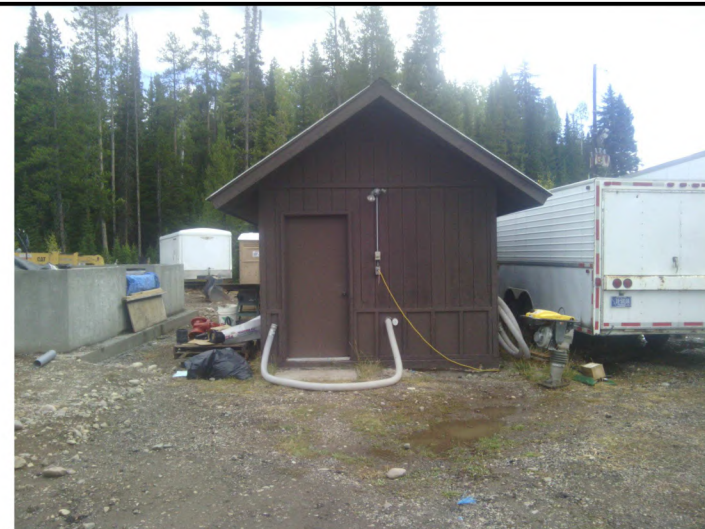
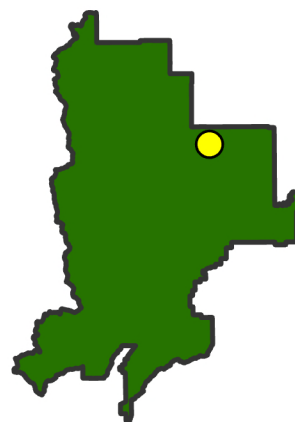
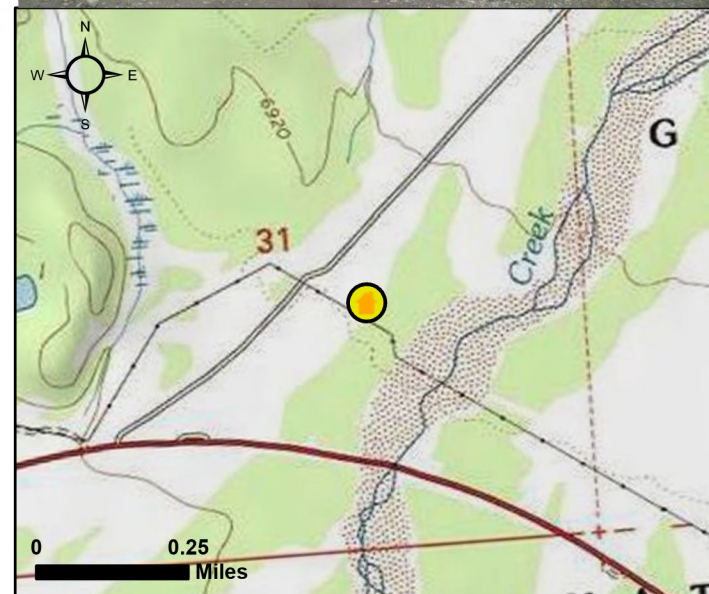
**Facility Name:** Wellhouse 2

**Rating:** Moderate

**Fuel Load:** Moderate

**Defensible Space:** 30 ft treated

**Siding Material:** Wood or open sided

**Water Supply:** No reliable water source nearby
