# Hydrological Interviews & Observations in Dyea, AK 2021-2024

*A Klondike Gold Rush National Historical Park – Natural Resources Management Data Record*

November, 2024

C. E. Furbish, NRM Volunteer

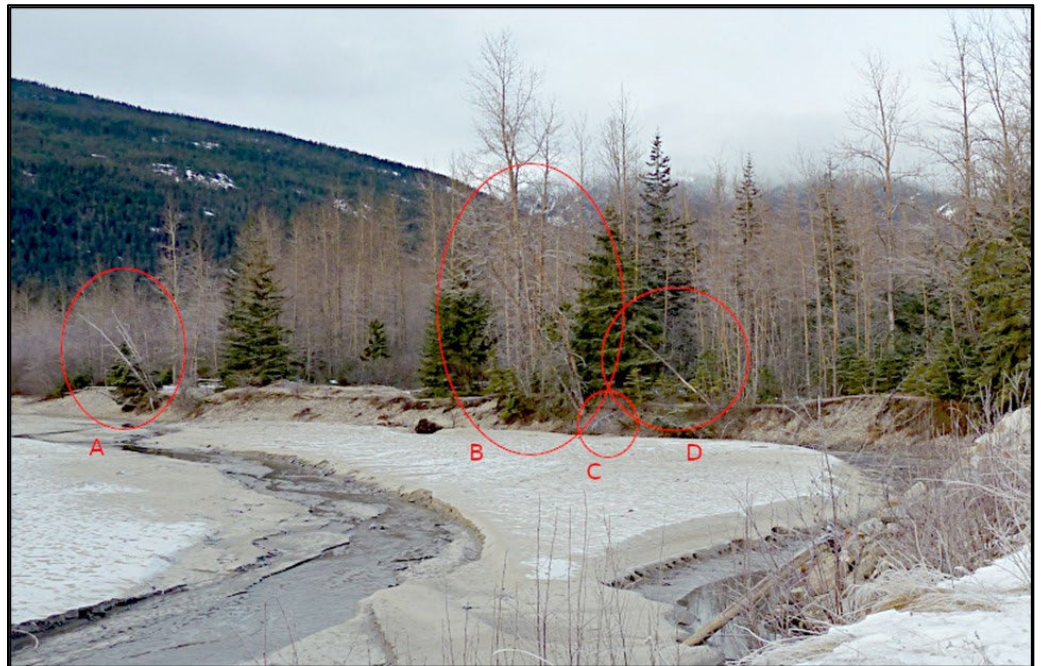
22 January 2021

- A) three dead tree trunks at berm edge, leaning away from shore
- B) a double trunk tree at berm edge, leaning away from shore
- C) a small live tree, sticking out horizontally from below the berm
- D) a small, dead tree trunk at berm edge, leaning away from shore

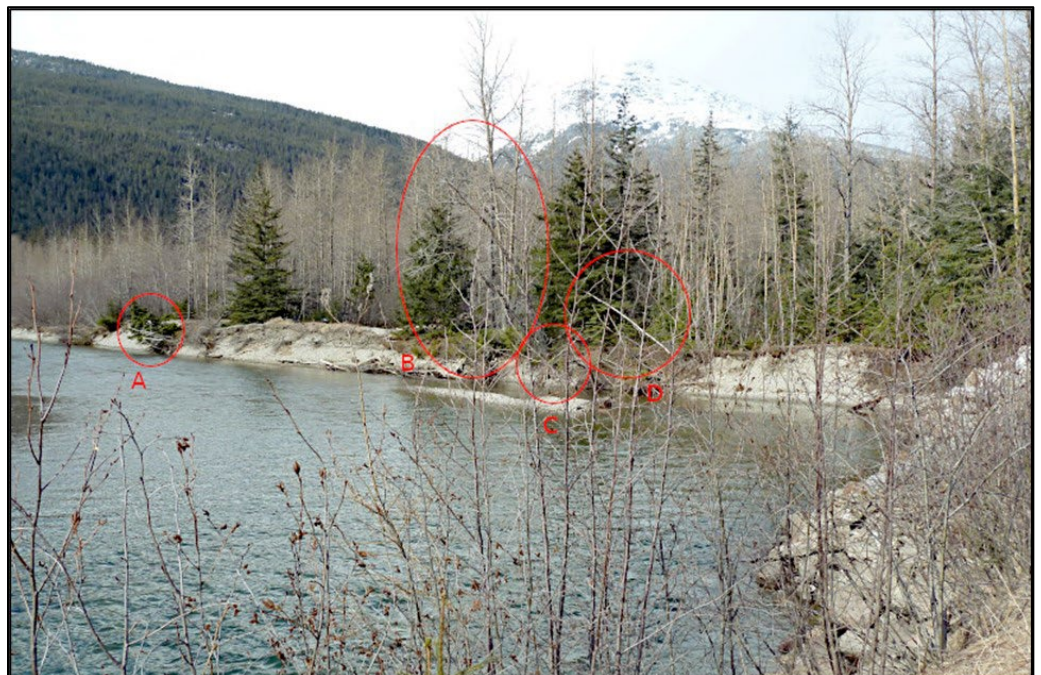
6 April 2024

- A) three dead tree trunks below the berm, broken off and leaning nearly horizontal
- B) double trunk tree at berm edge, but leaning more steeply away from shore
- C) small live tree, still in place sticking out horizontally from below the berm
- D) small, dead tree trunk at berm edge, unchanged

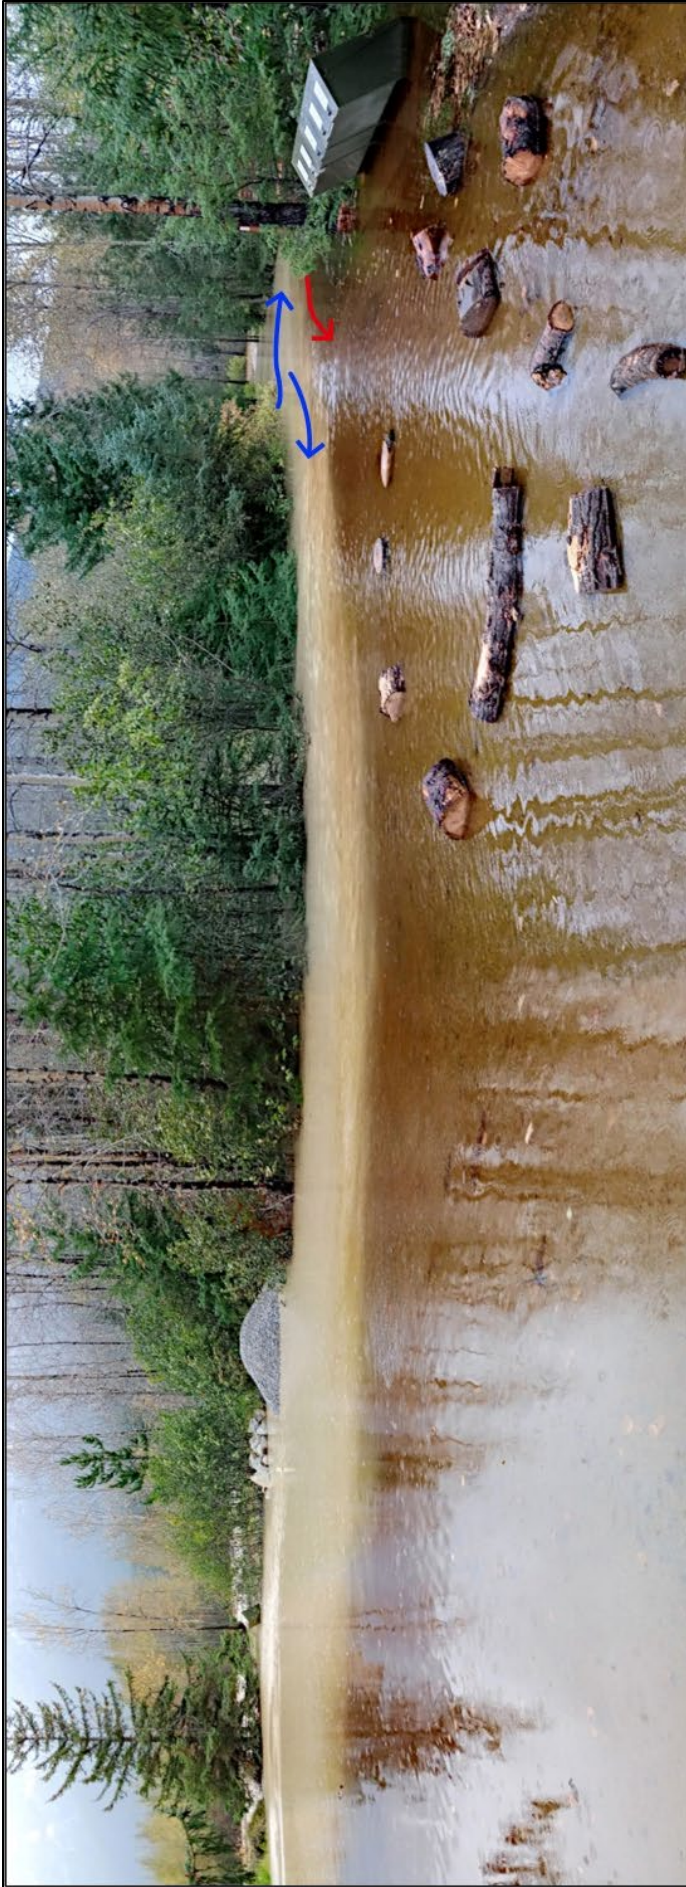
26 September 2022 flood (18.84ft) at about 5pm – near peak flow.

The panorama photo above was taken from the point on the map to the right, and covers the area shown by the arc. The photo was obtained on 26 Sept 2022 at about 5pm - near peak flow during an 18.84 ft. flood event.

Muddy river flood water has entered the channels from the south, and is covering the campground road and surrounding area.

Clear water from channel A is flowing from the north and is being pushed to the east onto the campground road and the entrance parking area.

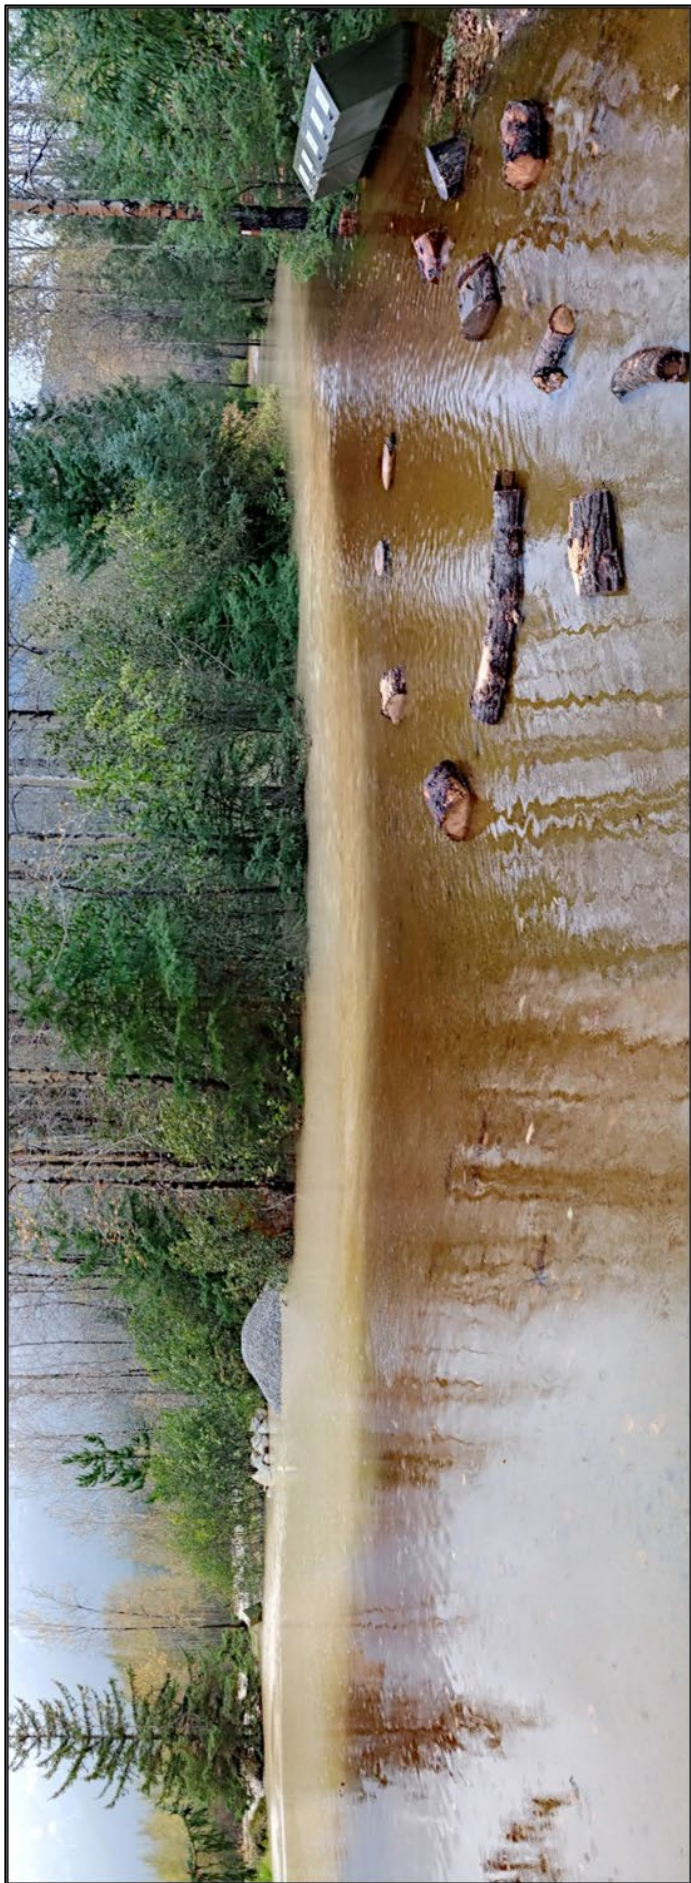
The panorama photo of backflow example without arrows. The photo was obtained on 26 Sept 2022 at about 5pm - near peak flow during an 18.84 ft. flood event.

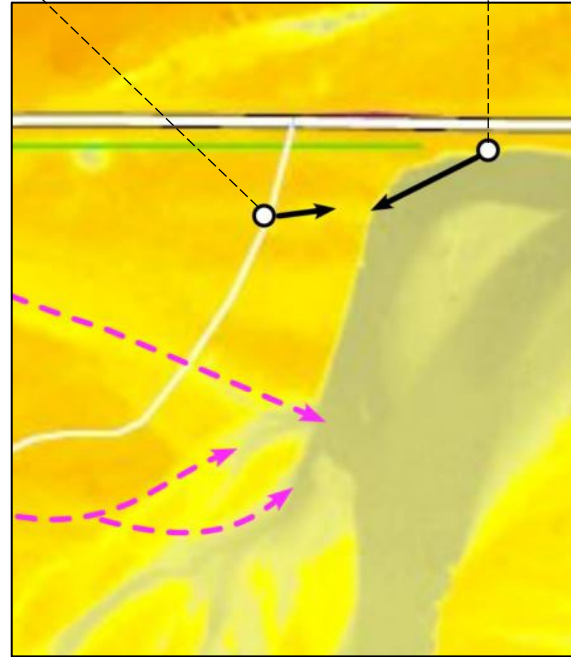
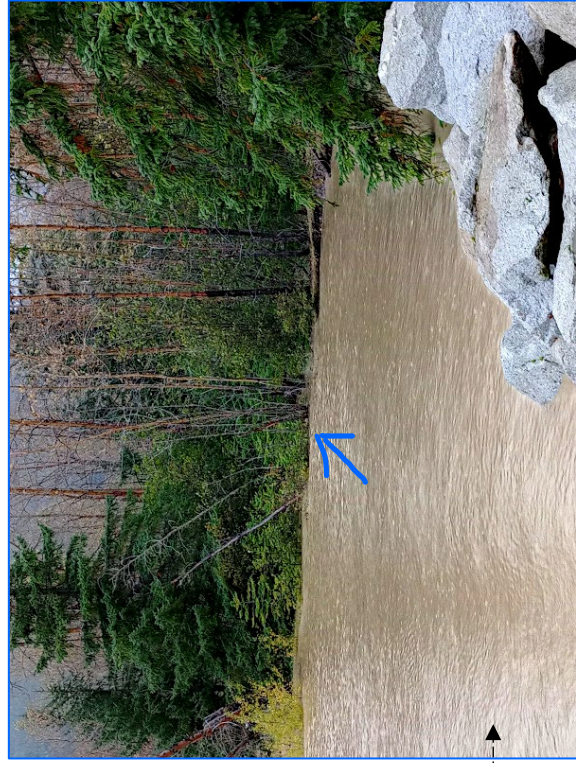
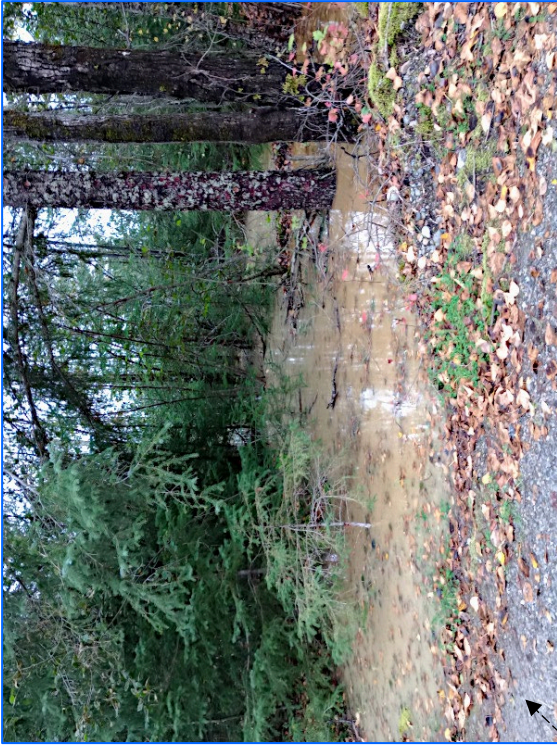
26 September 2022 flood (18.84ft), at about 5pm - near peak flow  
 A smaller incursion of muddy river water reached the edge of the campground road. The water topped the river berm where shown by the blue arrow.  
 This water did not connect with the larger backflow from channels A and B.

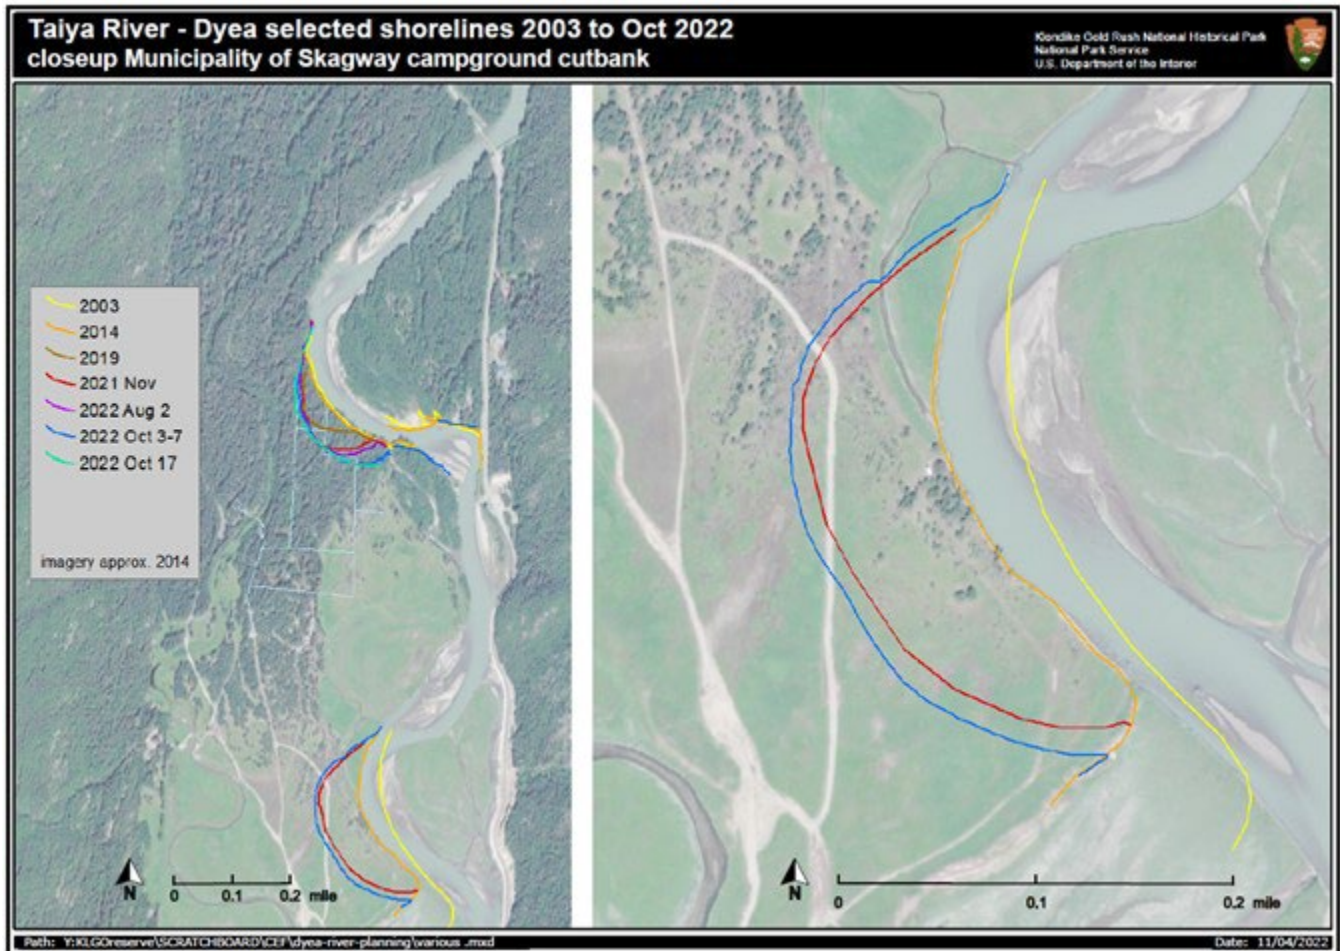
A large Taiya River main channel meander had existed for decades east of the Skagway municipal campground prior to October 2022. The meander caused substantial erosion of the campground area from 2014 to 2022. The right panel of the map below shows the meander channel moving westward into the campground infrastructure.

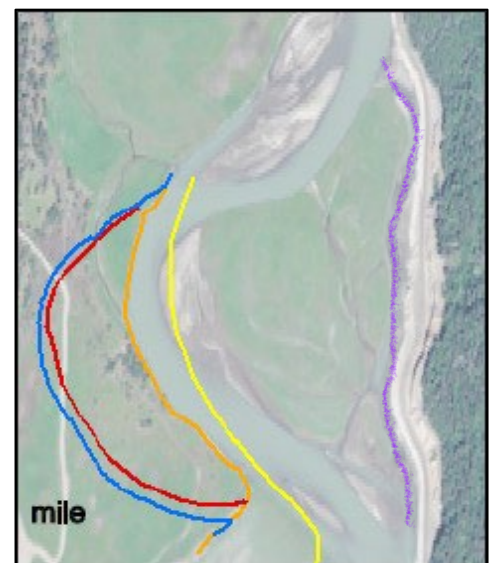
This excerpt from the left panel shows two small small side channels to the east in 2014.

One side channel roughly bisects the meadow vertically. The other hugs the base of the hillside to the east, next to the Dyea Road (purple highlight).

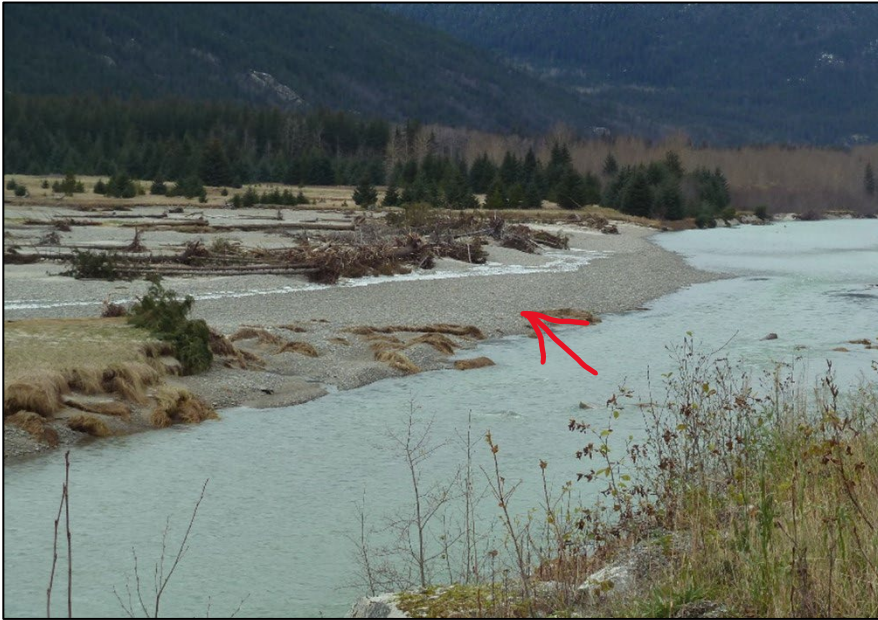
The 20.11 ft flood of 13 October 2022 caused extensive reworking of the sediments and channels in the meander area, closing off the upstream entrance to the meander and opening the side channel adjacent to Dyea road.

Arrow points to berm formation at former upstream opening to meander.

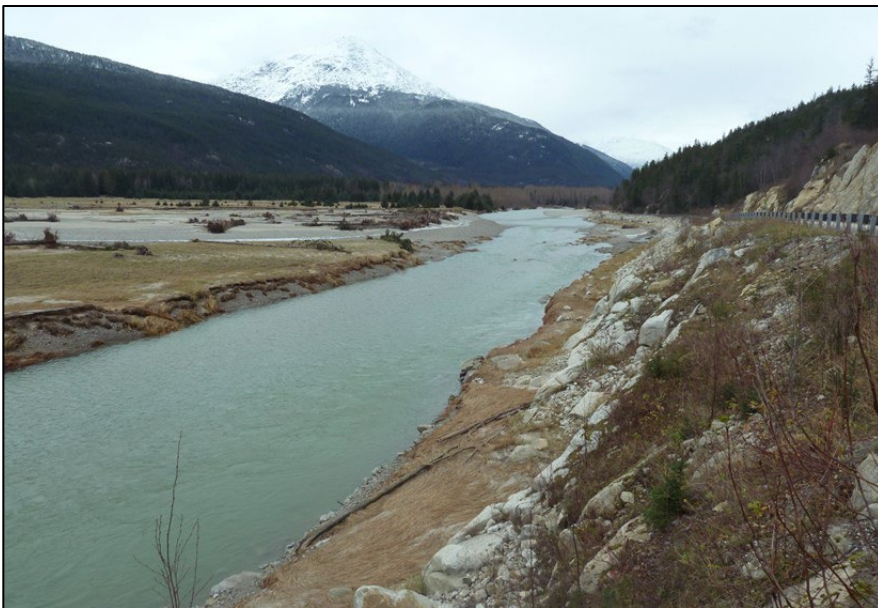
Main channel opens adjacent to Dyea Road.

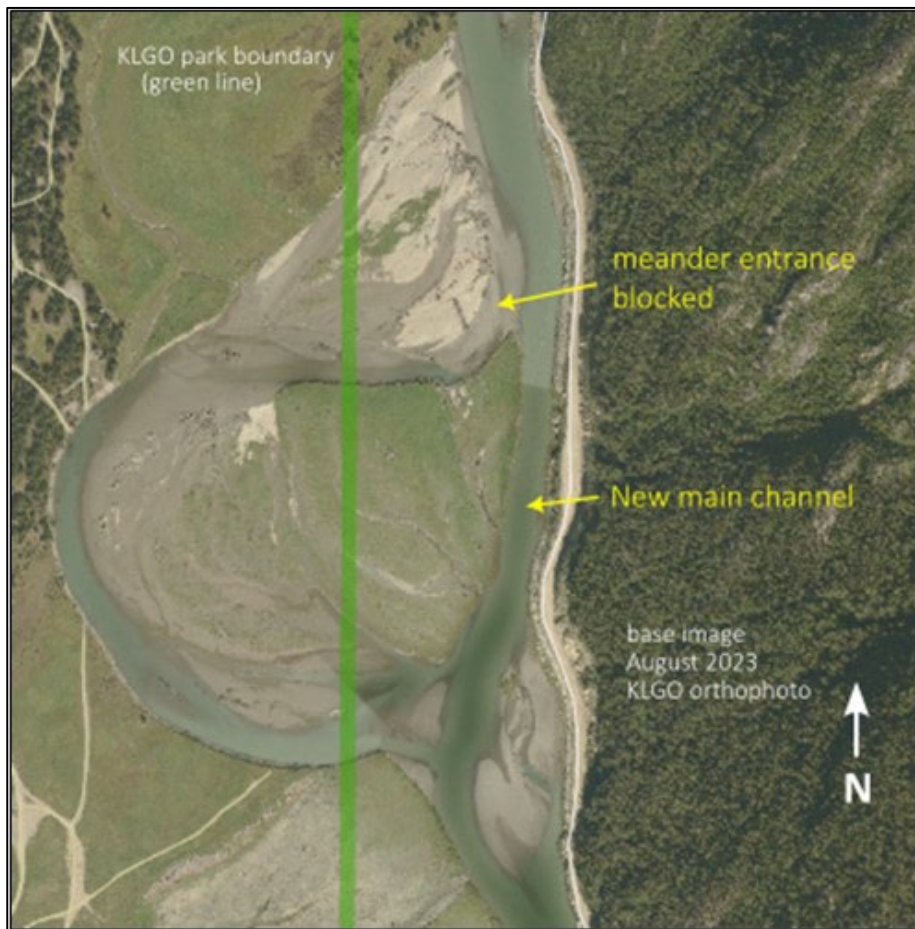
From November 2022 through 2024, the new main channel remained in place. The meander channel became a mostly isolated oxbow at low tide, and filled again at high tides.
