## Large Barnum Boat House, Small Barnum Boat House, and Johns Log Cabin

### Historic Property Project Documentation and Treatment Plan

PMIS 333132A

April 2025

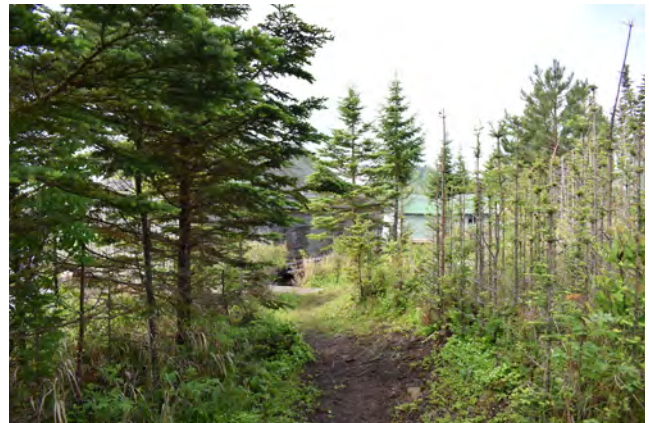
Figure 2-5. Trail to Large Barnum Boat House from Dunwoodie Cottage (source: Mundus Bishop, 2024).

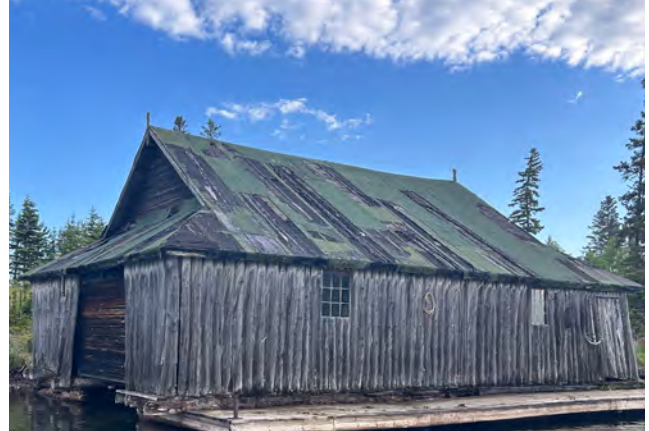
Missing roof covering, particularly above the north wall, has led to water infiltration, deterioration of sheathing, and deterioration of wood elements below. Overhanging roof covering at the eaves is in poor condition with wrinkles and tears.

Figure 2-22. Missing roof coverings on south slope (source: Anderson Hallas, 2024).

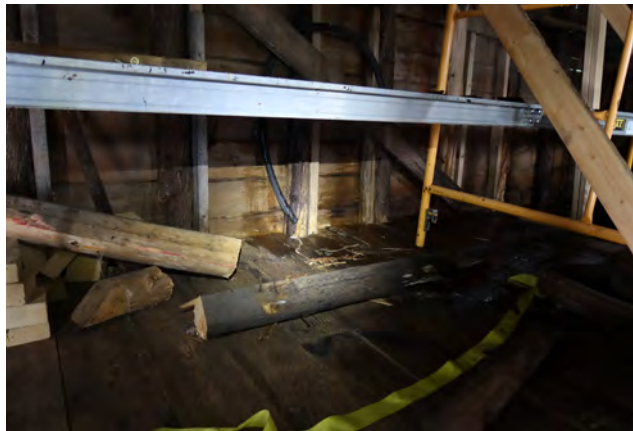
Figure 2-26. Water on interior floor decking, base of north wall (source: Anderson Hallas, 2024).

Provide an in-kind replacement of deteriorated decking. Replace weathered board ends which are exposed at the south façade. Anticipate approximately 15% board replacement overall.

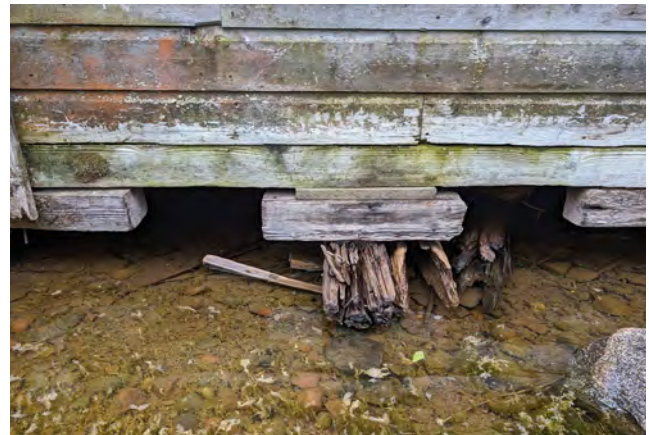
Figure 2-28. Crushed timber member (source: AMI, 2024).

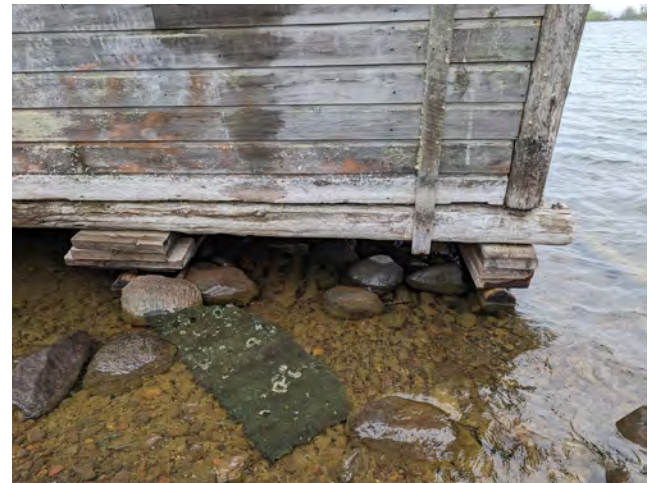
during storm events or from ice action. Cribs are defined as gravity structures and provide lateral stability to structures due to their self-weight. The loss of rock ballast from a crib causes the structure to be more susceptible to movement and damage from wave and ice forces.

Figure 2-29. Tilting shims and loss of rock ballast (source: AMI, 2024).

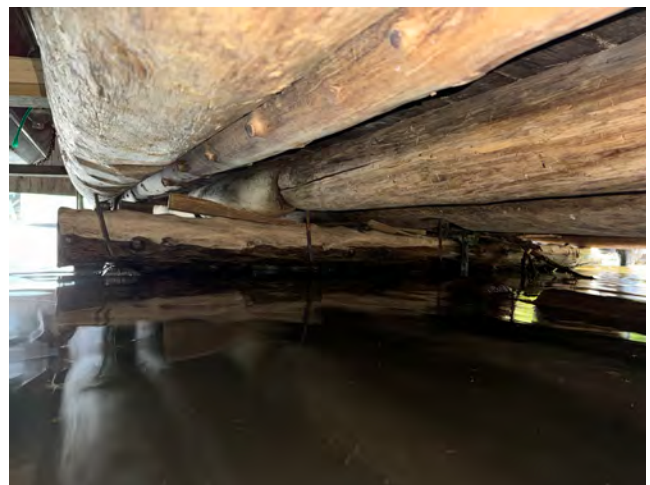
Figure 2-30. Log floor framing supported on cribs (source: JVA, 2024).

Provide anchorage of log floor framing to the cribs with fasteners suitable for a marine environment (assume 200 fasteners for estimating purposes).

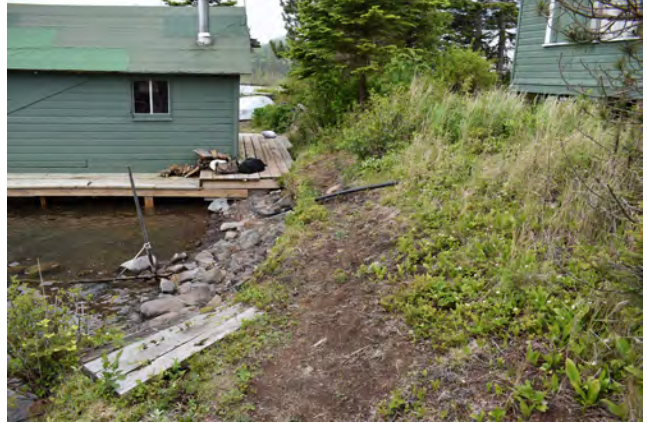
Figure 3-4. Trail from Small Barnum Boat House to Large Barnum Boat House (source: Mundus Bishop, 2024).

- Provide a boardwalk between Large Barnum Boat House and Small Barnum Boat House. Ensure the boardwalk does not impact the historic setting. Design the boardwalk to be compatible in scale with Large Barnum Boat House and materials are of a material and color that harmonizes with the historic setting and aesthetic. Repair trail erosion, soil compaction, and shoreline vegetation.
- Preserve trails from Small Barnum Boat House to Large Barnum Boat House, Barnum Residence, a gathering area to the west, and cottages to the east.

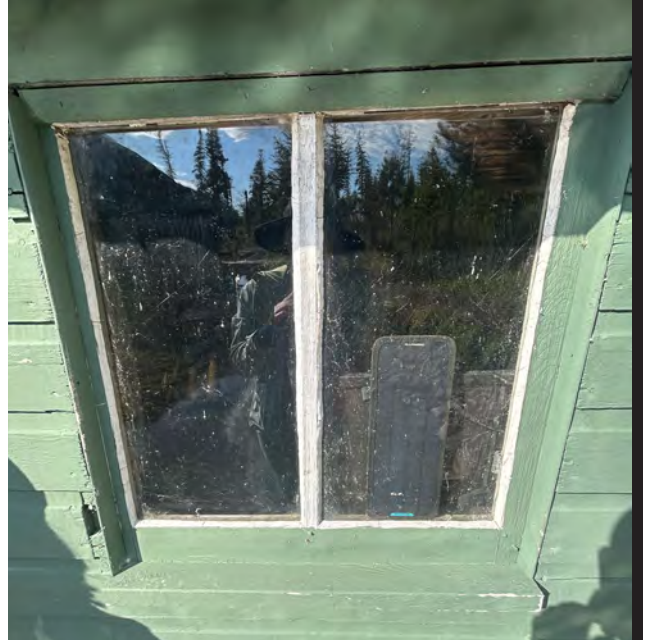
Figure 3-13. Missing trim around window (source: Anderson Hallas, 2024).

Rehabilitate the window, clean glazing, replace all glazing putty, and repaint the sash. Apply high quality latex primer and topcoats. Recommend historic paint analysis to determine appropriate paint selection.

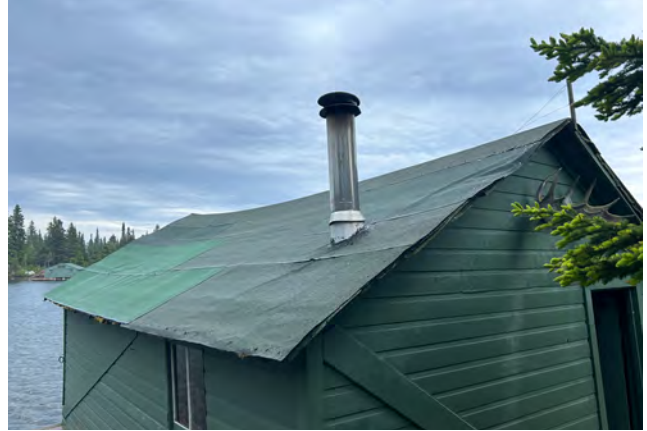
The top layer of roof covering appears to be functioning well and withstanding water intrusion. However, several concerning factors were observed. Roofing is wrinkled, perhaps due to structural movement and/or poor application. The previous roofing layer was not removed and where visible is deteriorated and hosting bio-growth. Additionally, significant deterioration of sheathing, rafter tails, and underlying roof coverings was observed at eaves. One barge board is missing at the north rake. At the south rake, barge boards are weathered.

Figure 3-17. Roof viewed from northeast (source: Anderson Hallas, 2024).

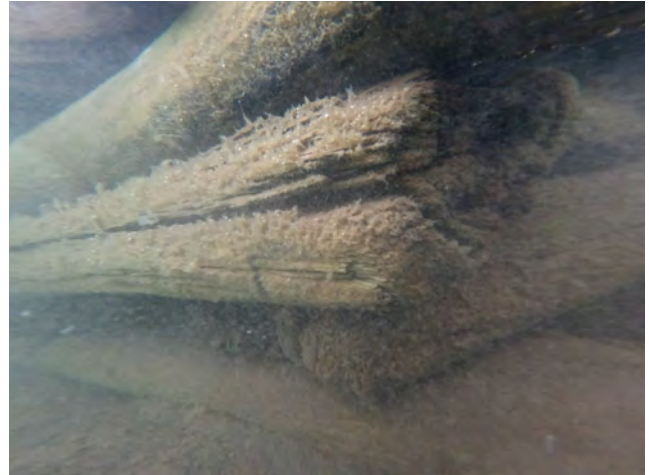
Figure 3-26. Lower crib member deterioration (source: AMI, 2024).

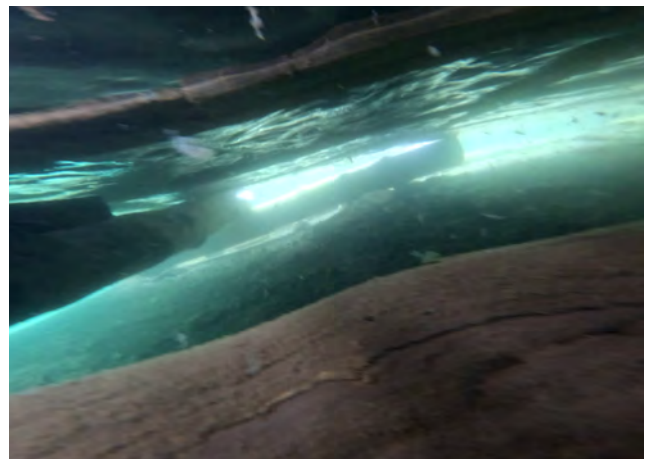
Little to no rock ballast was documented in the two cribs on the south side. These cribs were on either side of the boat slip. The loss of rock ballast from a crib causes the structure to be more susceptible to movement and damage from wave and ice forces.

Figure 3-27. Loss of rock ballast (source: AMI, 2024).

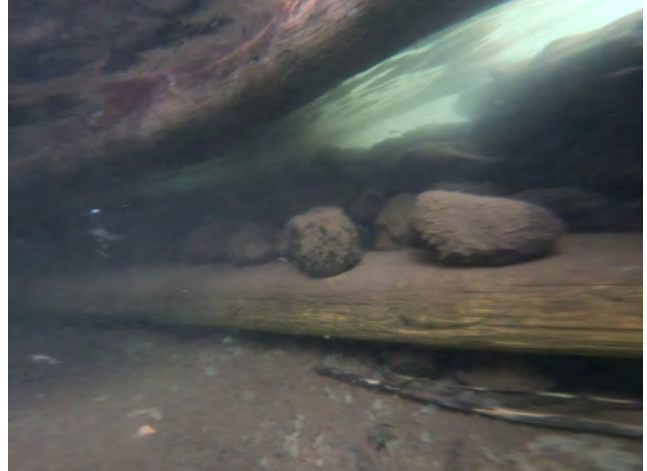
Figure 3-28. Loss of rock ballast (source: AMI, 2024).

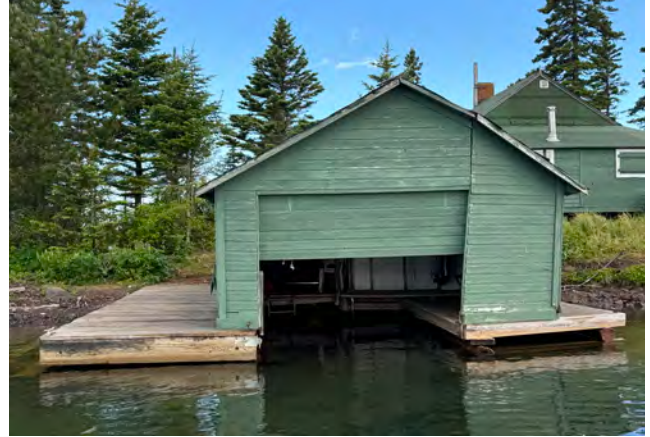
Figure 3-34. South wall elevation showing east wall leaning (source: JVA, 2024).

Provide anchorage of wall framing to floor framing with fasteners suitable for a marine environment.

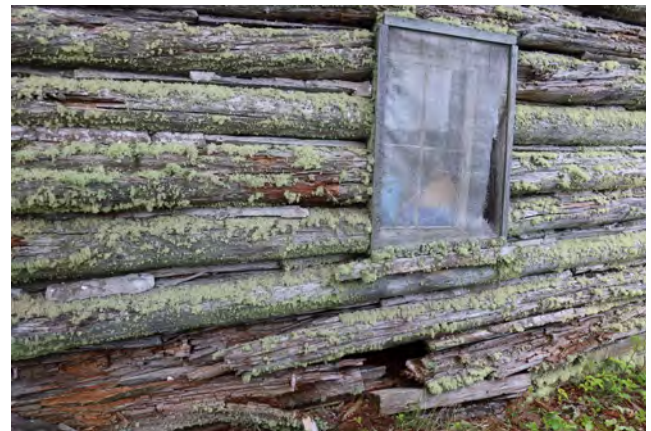
Figure 4-17. Deterioration at north façade (source: Anderson Hallas, 2024).

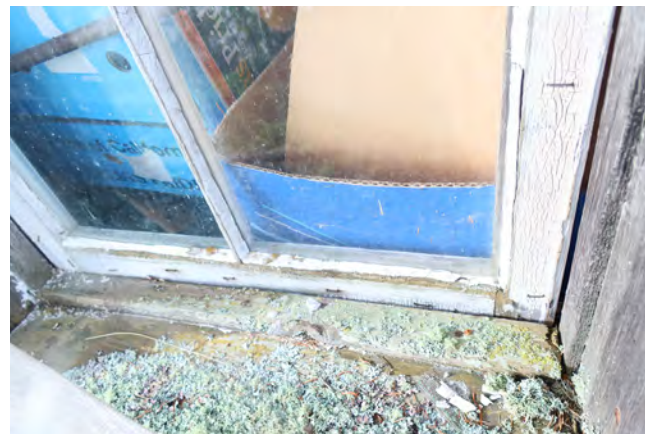
Figure 4-20. Deteriorated paint and putty at first-floor north window (source: Anderson Hallas, 2024).

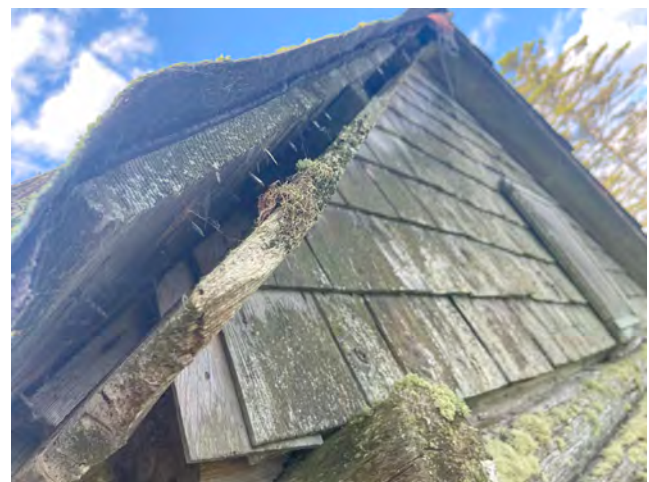
Figure 4-24. Soffit and missing barge board on north rake (source: Anderson Hallas, 2024).

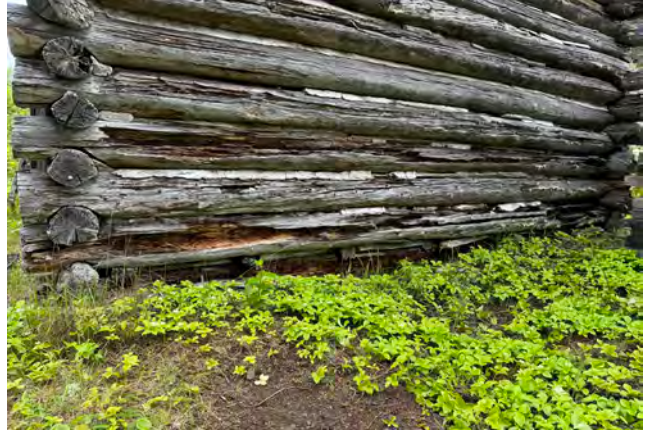
Figure 4-29. Lower logs in contact with soil, and no foundation (source: JVA, 2024).

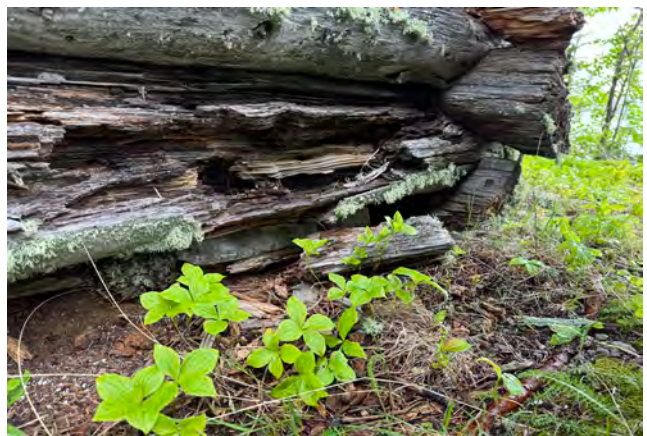
Figure 4-30. Logs in contact with soil (source: JVA, 2024).

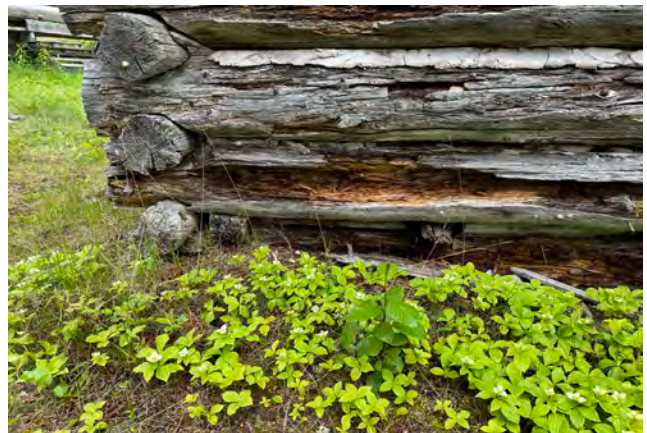
Figure 4-31. First-floor beam ends exposed to exterior and in close proximity to soil (source: JVA, 2024).
