## **Memorandum – Coastal Engineering Review**

### **George Washington Birthplace National Monument (GEWA) Trail Scour Mitigation**

#### **TAR 33213**

24 July 2024

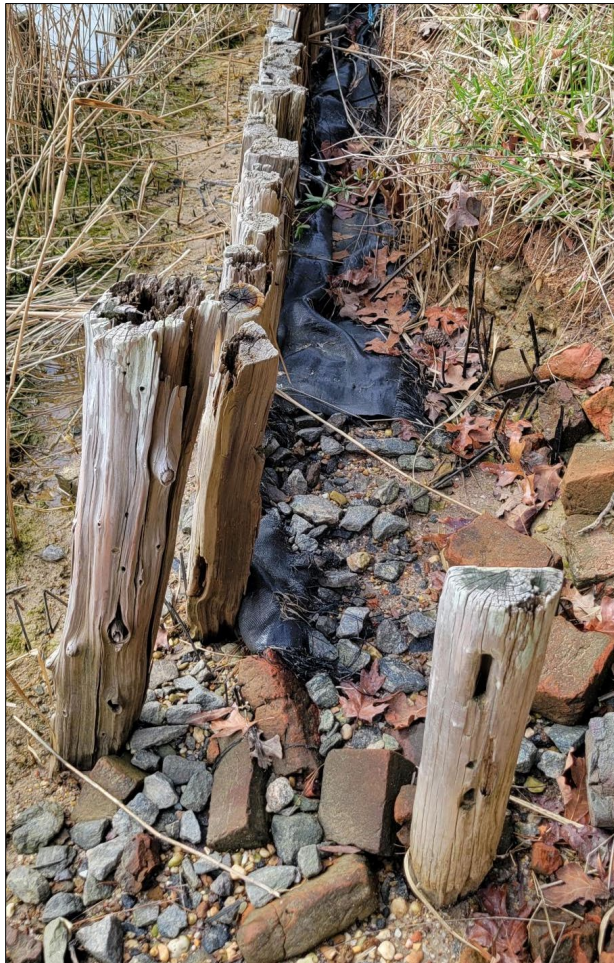
The erosion is occurring behind and between two existing sections of timber wall, one further east and one west, just south of the park office (figure 1). The walls are constructed of wooden posts lined with geotextile fabric (figures 2 and 3). GEWA staff noted that historical photographs indicate the shoreline was modified in the 1930s, and the shoreline appears to have retreated landward since that time. This is supported by the presence of an older wooden post in the creek, approximately 3 feet waterward of the current walls (figures 4 and 5). The history of these older wooden posts is not known. The current walls were installed in the 1990s. Park staff noted that during the 1990 wall installation, a backhoe was used to push the timber posts in. Gravel, bricks, and other fill material were observed behind the walls (figures 2, 3, and 5), which was likely placed during the 1990 installation although some may have been present prior. The condition of the timber walls varies, with some sections showing no signs of significant degradation (figure 6) and other sections in poor condition (figures 2, 3, 4, and 5). Shoreline erosion has resulted in portions of the trail behind the wall being lost from the formation of scour holes. The erosion varies in magnitude up to approximately 3 feet deep (figure 3) in some locations. Additionally, some areas have undercut up to 1 foot potentially leading to additional instability (figure 7). The section of the trail experiencing undercut lacks timber wall protection and has experienced more shoreline retreat.

**Figure 2. Timber Wall Scour Revealing  
Geotextile Fabric and Fill Material**

Replacing the existing timber walls in kind would require repeating similar maintenance to that which was conducted in the 1990s, replacing the existing wooden posts and refilling the eroded sections between the wall and the trail. While replacing the walls in kind follows the precedence of the existing structure, this solution would likely still require permitting, as discussed at the end of this section.

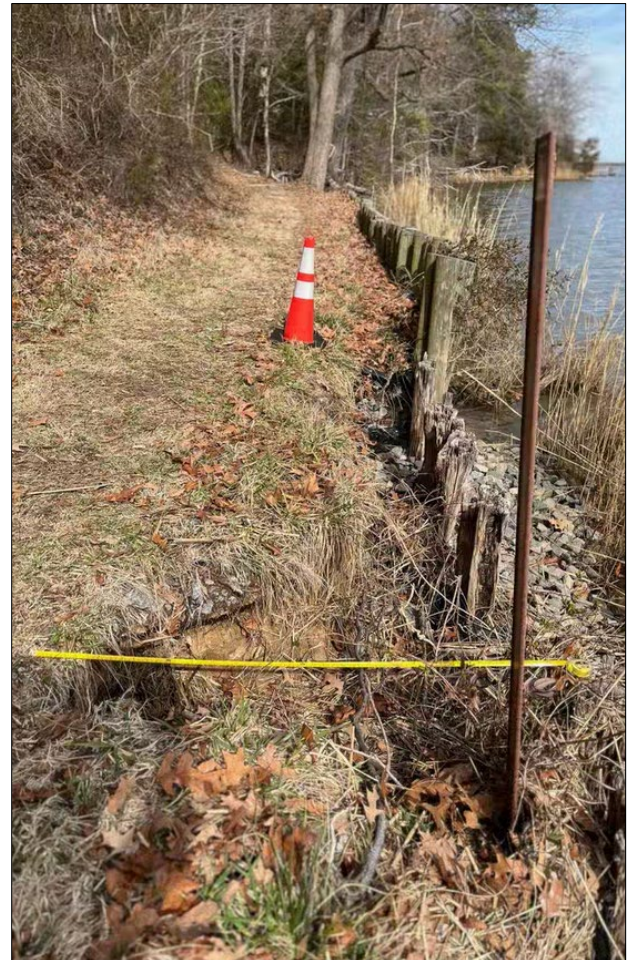
The erosion is affecting approximately 200 feet of trail along Popes Creek, a tidally influenced creek that flows into the Potomac River and the greater Chesapeake Bay. GEWA staff noted the increased frequency of tidal flooding with higher tides flooding the trail around once a month and the water level of Popes Creek sometimes reaching the bottom of the nearby footbridge. The trail connects the picnic area with the

**Figure 3. Trail Erosion Behind the Timber Wall  
(erosion is up to 3 feet wide)**

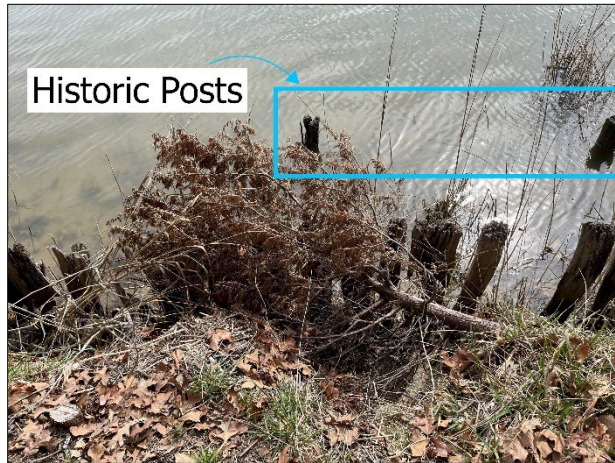
**Figure 4. Historic Timber Posts Behind  
Western Wall Section**

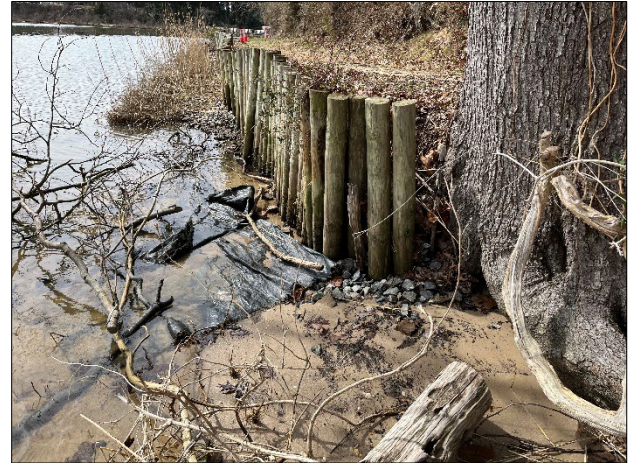
**Figure 6. Western Wall Section**

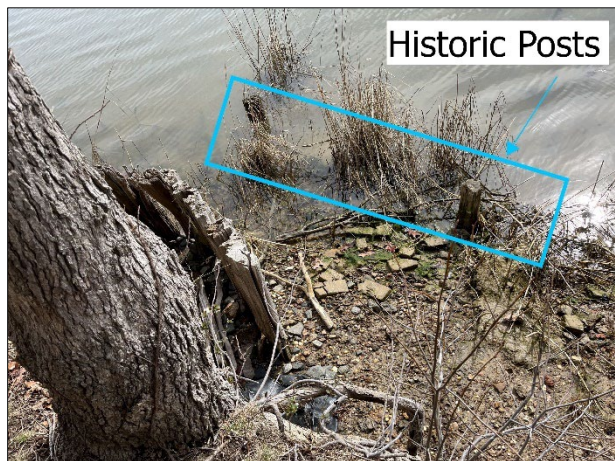
**Figure 5. Historic Timber Posts Behind Edge  
of Eastern Wall Section**

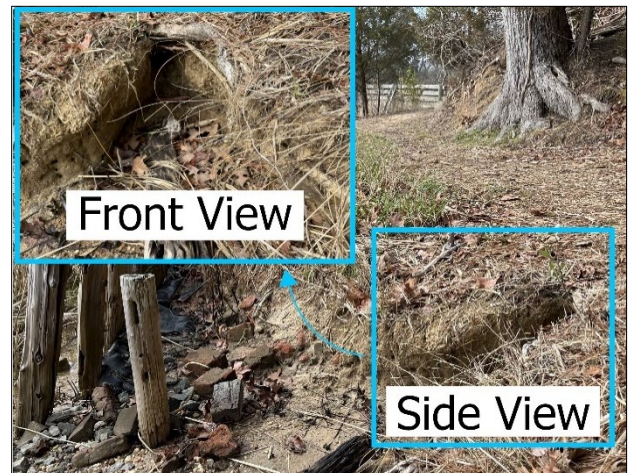
**Figure 7. Trail Undercut**

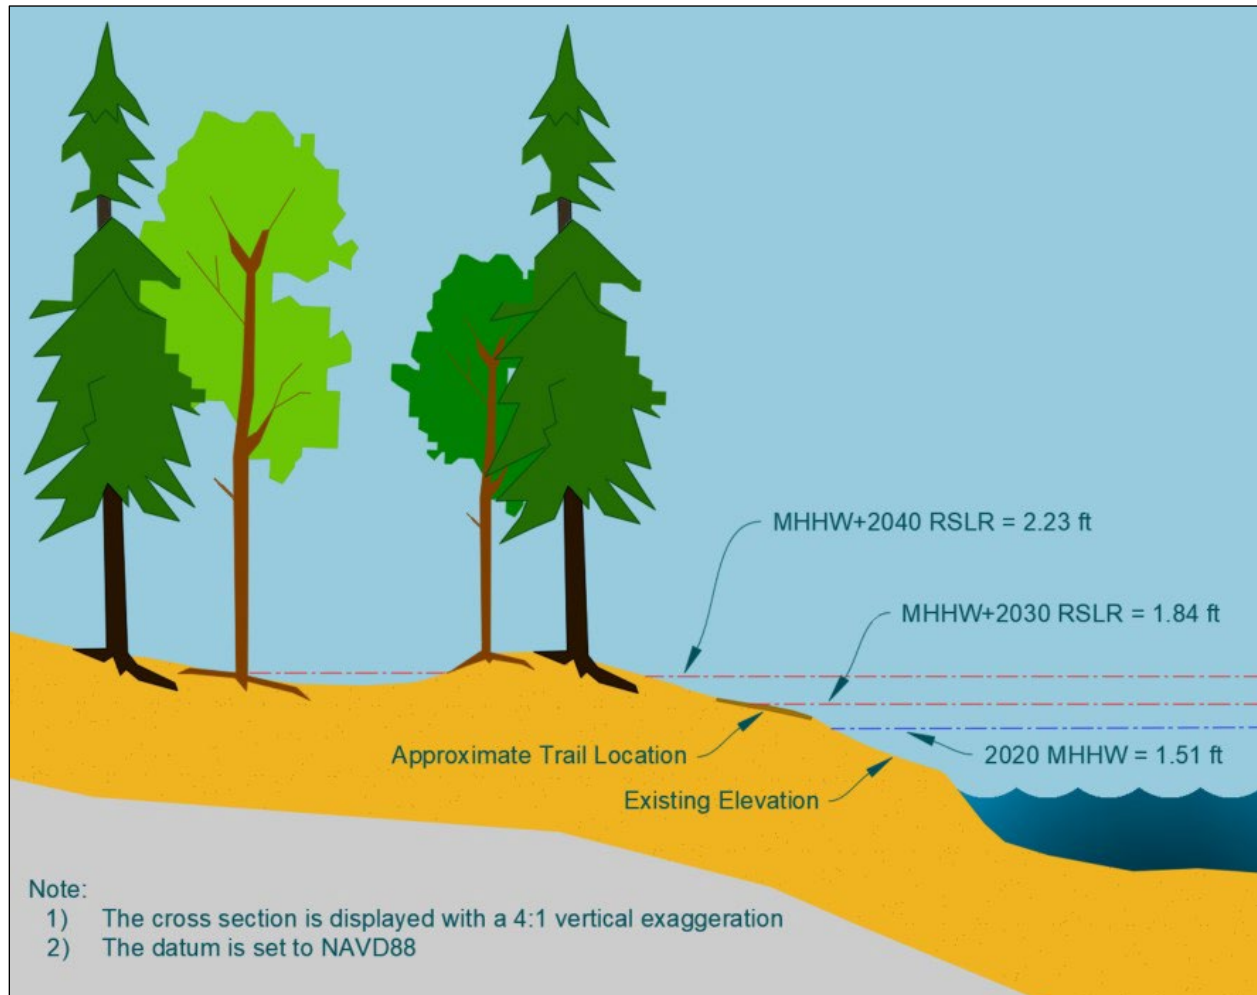
**Figure 11. Trail Cross Section with Project Sea Level Rise**

Figure 11 shows the mean higher high water (MHHW), the average of the highest tides within each tidal day, estimated for 2020 and projected for 2030 and 2040 over a cross-section of existing land elevation extracted from the 2018 LiDAR data (NOAA OCM 2024) discussed above.

The cross-section for figure 11 was taken across a section of trail that GEWA staff noted floods almost monthly during especially high tide events. Figure 11 shows the 2020 MHHW of 1.51 feet NAVD88 falls inches below the approximate trail location, supporting the observed flooding conditions. The projected 2030 MHHW reaches the trail elevation, indicating that within the next six years, this section of the trail will be flooded once a day, while the 2040 MHHW indicates the trail section will be almost a half-foot underwater once a day and flooded for a significant portion of the day within just over a decade. The section of trail represented by this cross section is at a relatively lower elevation than other sections of the

trail, therefore this image indicates the most severe flooding case, however other sections of the trail are also expected to experience increased flooding in the coming decade.

Installation of one of the shoreline protection options described above would address shoreline erosion; however, without trail elevation, nuisance flooding would not be resolved. The shoreline protection option could be paired with elevating the trail by the placement of fill material behind the shoreline protection structure. Sections of the trail (figure 11) are already experiencing monthly nuisance flooding and the frequency is likely to increase to daily within the next 5 to 10 years. Therefore, the trail needs to

be elevated to a height of at least 2 feet NAVD88 or greater by 2030 for it to remain operational (refer to table 3). Additional elevation will likely be required in the future to keep addressing sea level rise, and a higher elevation may be required to withstand future impacts of storm surge. Additionally, maintenance of the trail and shoreline protection structure may be needed after significant storm events. Trail elevation using fill material is something that should be discussed with Virginia state regulators early and may pose regulatory challenges due to the location within a tidal area. Fill material selection will require coordination with regulators, but may include gravel, rock, sand, soil, or another native material and should be assessed for appropriateness to the local environment (locally sourced if possible) and the comfort and safety of trail users.
