# Oregon Caves

## Historic Structures Report

This Historic Structure Report was completed as partial fulfillment of the requirements for the Master of Science in Historic Preservation at the University of Oregon. It represents an individual effort by the author as a student project. It is hoped that this report will serve the National Park Service and concessionaire at the Oregon Caves National Monument as a reference guide for the treatment of the historic Chateau, a National Historic Landmark, and other similar buildings on the Monument.

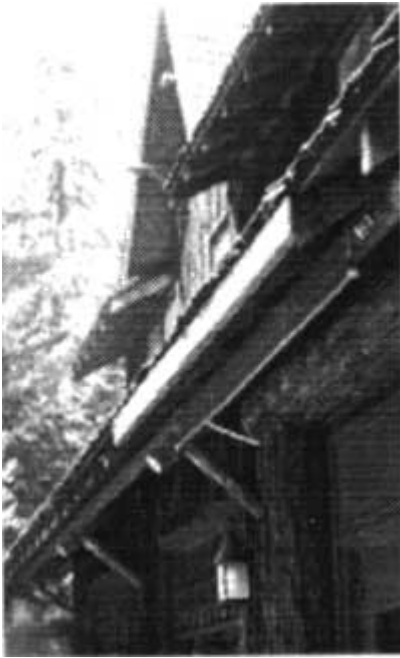
Fascia board for gutter.

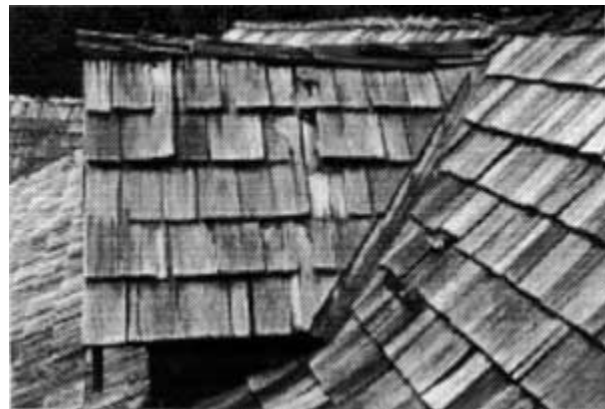
Another problem of the overhangs is that the rain is not allowed to reach all areas of the roof and wash them free of debris. Moss and lichens have begun to grow on the roof in areas that are protected from the weather, especially under the shed roof sections on the north and west sides. The growth is uphill of the drip line of the eave above. The shed roofs that project over the lower entrances to the building are suffering the same growth problems. The entrance to the coffee shop and dining room from the pond area are experiencing heavy growth, as are the roof structures over the stairs to the boiler room and outside entrance to the kitchen.

Growth uphill of drip line.

- The growth on the roof should be kept to a minimum. A moss killer should be applied to the roof to reduce the growth, protecting the shakes from accelerated decay. Care should be taken when applying the chemical so that excess does not fall to the ground and damage vegetation around the eave line of the building.

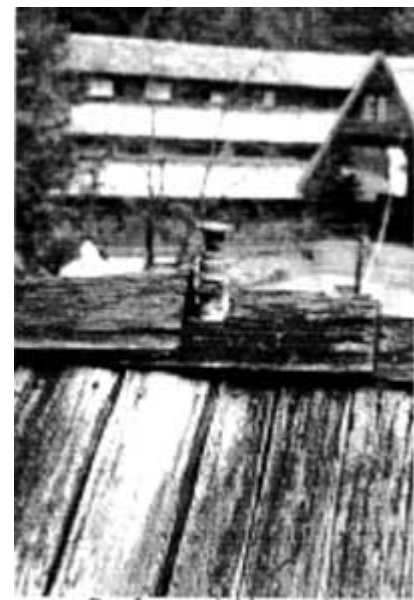
Small dormer, west side. Note the damage.

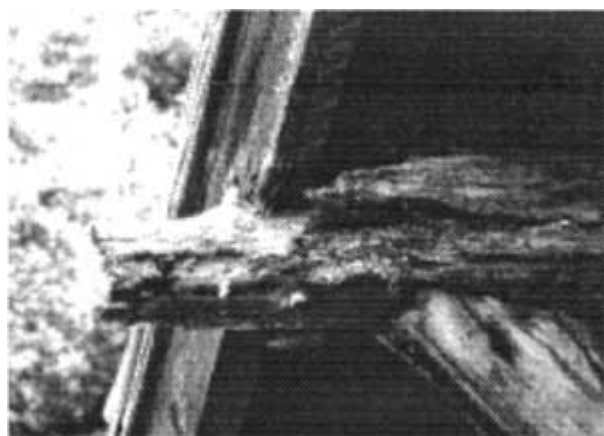
Typical decay of gable bracket end.

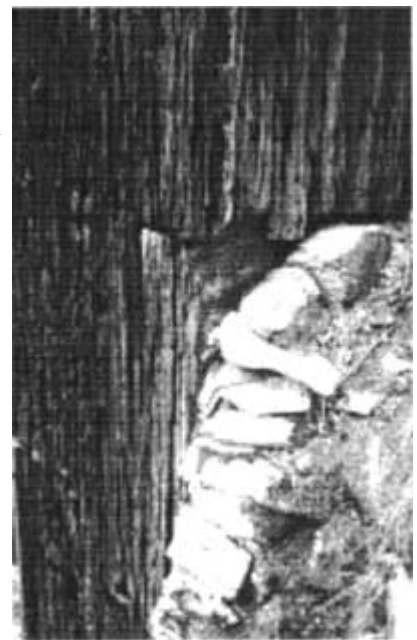
Exposed sheathing at northeast corner.

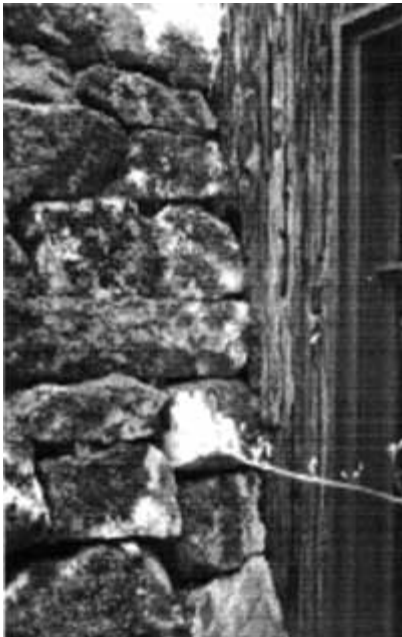
Moss growth at southeast corner.

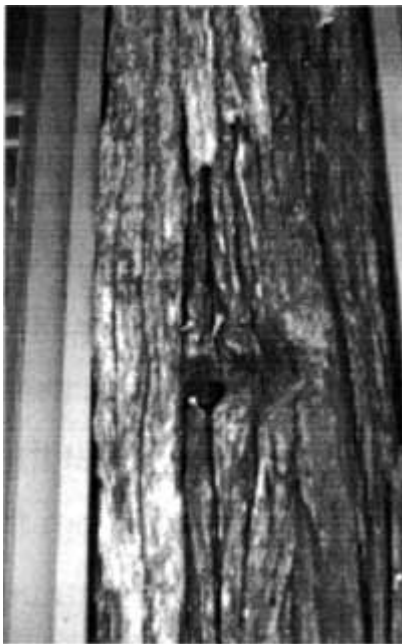
Siding fasteners.

A final observation on the Port Orford cedar bark siding is the use of steel nails for attaching the bark to the sheathing. These may have been galvanized originally, but now lack a protective zinc coating. If they are allowed to deteriorate and oxidize, the fasteners could create small pockets of degradation in the siding, loosening the bark and making reattachment through the historic holes impossible.

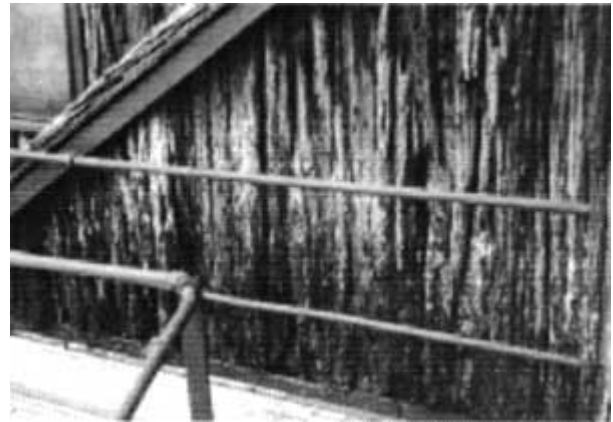
Growth at west stair enclosure.

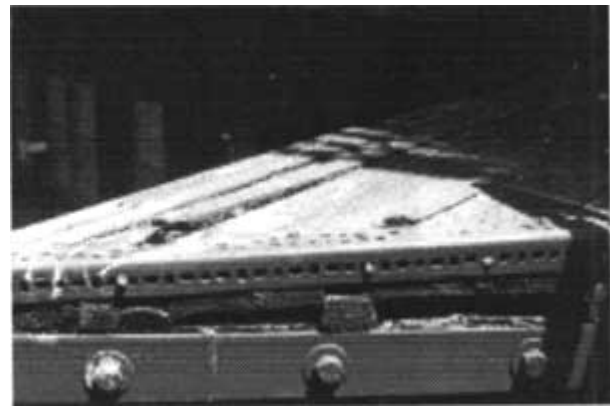
Uneven walking surface on the catwalk.

- Retain the paint coating on both the catwalks and fire escapes so they blend with the building, contrasting colors should not be allowed.
- The wood deck of the catwalk is in need of paint, and the boards have bowed enough to create an uneven walking surface. The boards should be evened out and repainted to preserve them.

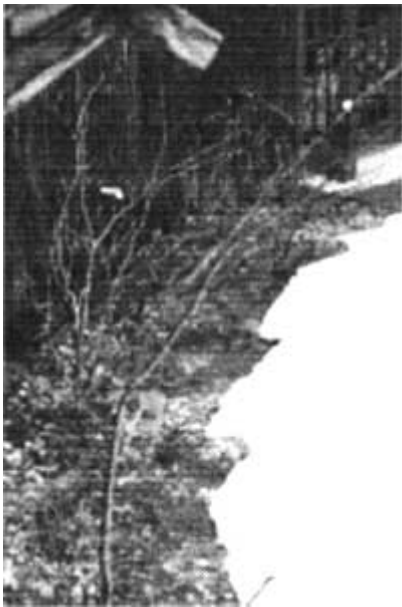
East side drainage.

Drainage is another issue, requiring much more effort to remedy. This aspect is critical around the entire perimeter of the structure, as it lacks a gutter system. Currently the east side near the pool is the worst drainage problem. Water running off the roof collects on the ground between the sidewalk and the building, and splashes back onto the foundation and siding. A drain pipe is in place leading to the culvert that takes the majority of Caves Creek beneath the Chateau, but it is frequently clogged and not effective.

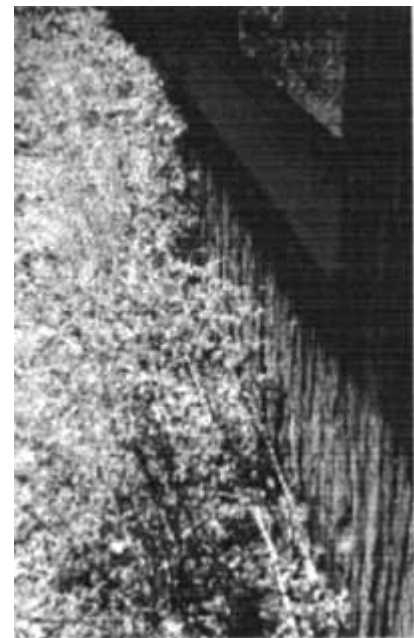
The vegetation and drainage around the Chateau is causing some problems eluded to in [Part D](#) of this Section (Siding). Both are causing damage to the historic fabric by placing excess moisture on the Port Orford cedar bark. Vegetation on the south side to the east and west of the lobby entrance are creating a microclimate near the building, and as stated earlier should be removed.

South side vegetation.

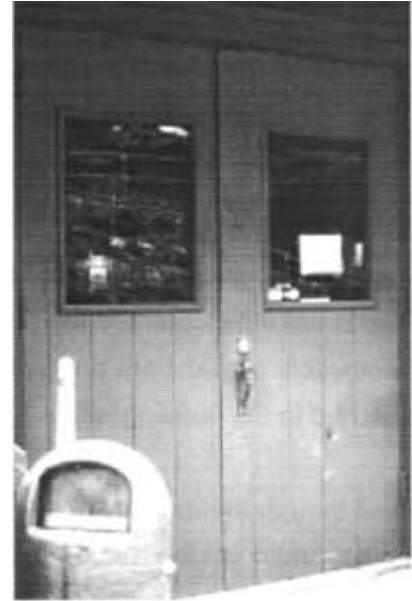
The lobby entrance doors are experiencing slight problems. Constructed of tongue and groove boards laid vertically with a steel bar at the inside edge of the east door, the doors have been re-hung on non-historic hinges. The doors originally pivoted on brass pins set into the head and jamb of the door, but now swing on modern hinges attached at the side jambs. The eastern door, which receives the most use, is bowing outward at the top on the west side. This prevents the door from providing a good seal, allowing air infiltration. However, the door is still fully operational.

Lobby entrance doors. Note the bow.

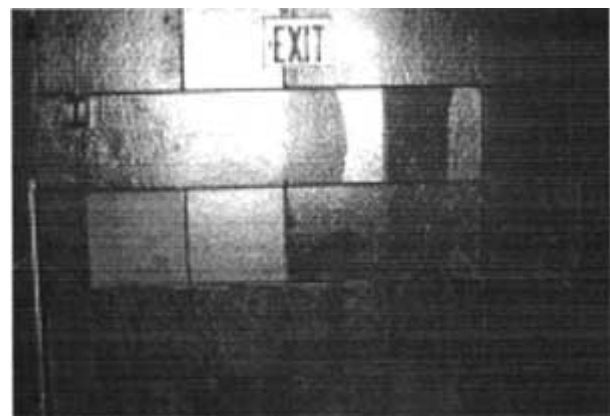
Typical interior hallway. Note the mismatched replacements.

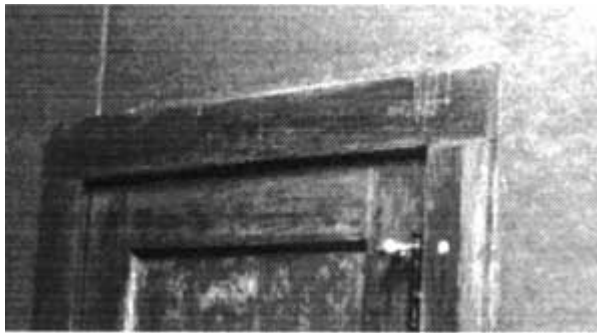
Glaze slopped onto door trim.

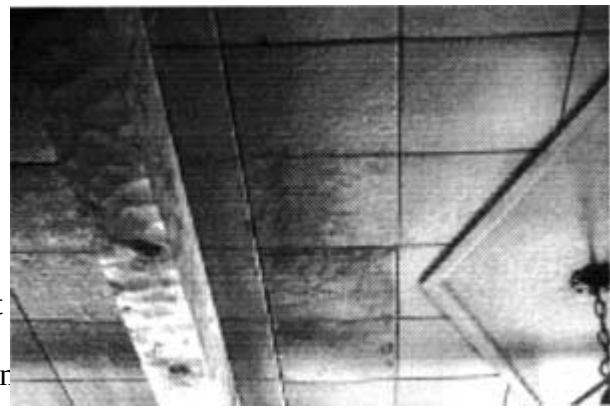
Water damage at the lobby ceiling.

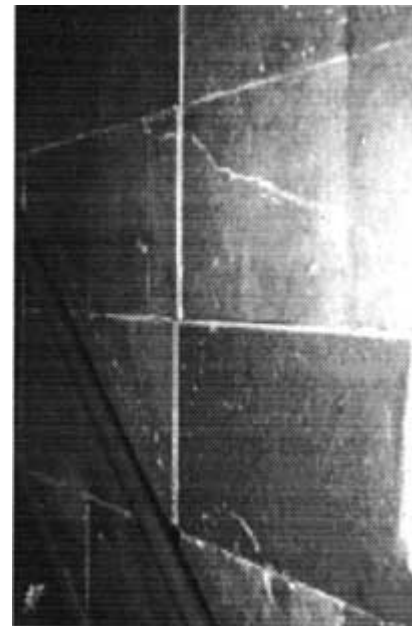
In addition to the problems with the fire retardant glaze, the fiberboard panels have suffered impact and abrasion damage. In the guest rooms, the impact damage can often be attributed to door knobs, as many of the stops are missing. In hallways and utility or linen closets, the damage is typically caused by housekeeping carts, rollaway beds, and other typical hotel equipment. Some of these areas have been patched with a replacement piece of Nu-Wood, either surrounded by small pieces of wood trim or left with the joints exposed. Many others, especially impact damage from door knobs, have been patched with wood putty. To make repairs in the public areas of the building, the concessionaire has removed panels from areas only open to employees, such as the office behind the front desk. The walk in freezer in the kitchen was placed in an opening historically used as an access to the coffee shop, and panels from the ceiling above the freezer have all been taken and placed in locations throughout the building to repair damage.

Abrasion damage at the stair.

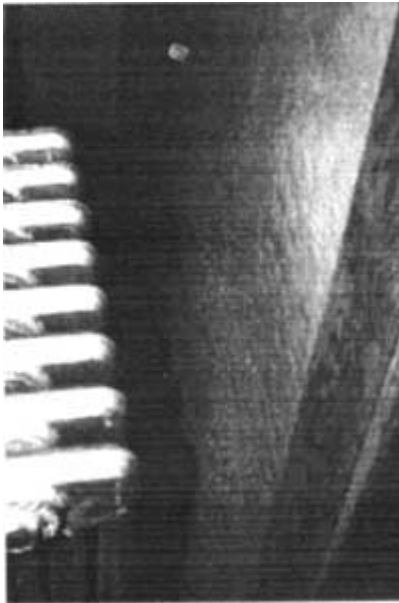
Glaze damage behind radiator.

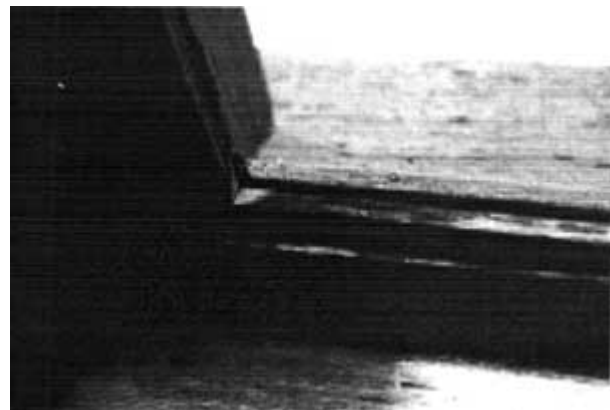
Finish deterioration and degradation at a fixed window.

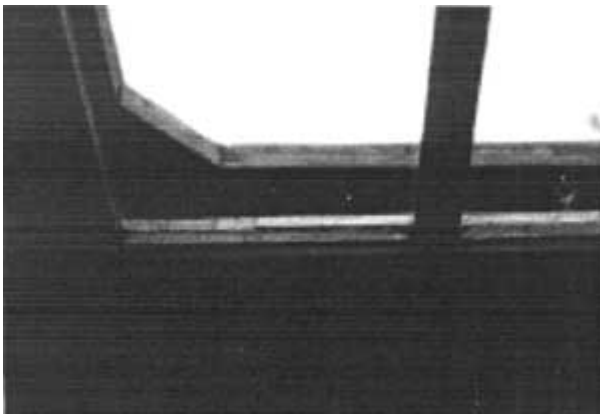
Missing glazing at a 6th floor fixed window.

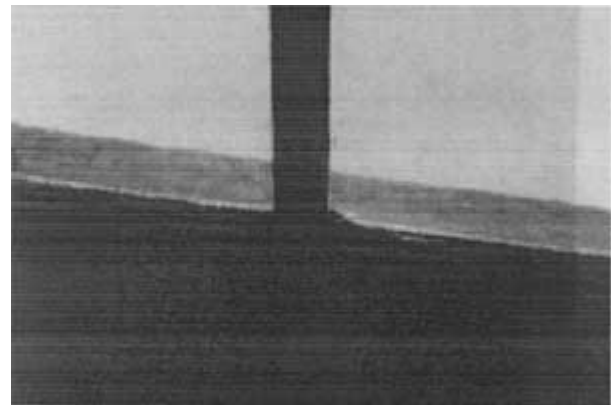
Fungal growth at a 6th floor casement.

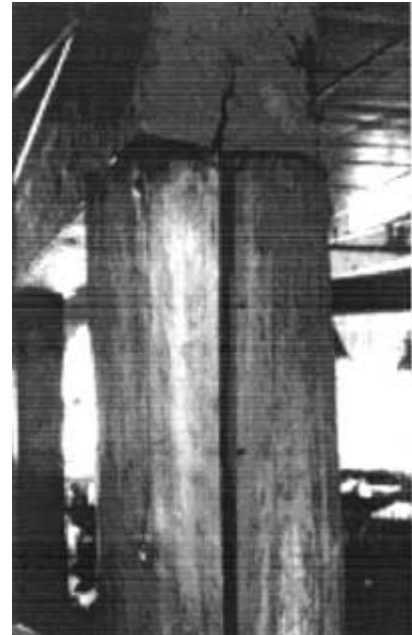
Check in dining room column.

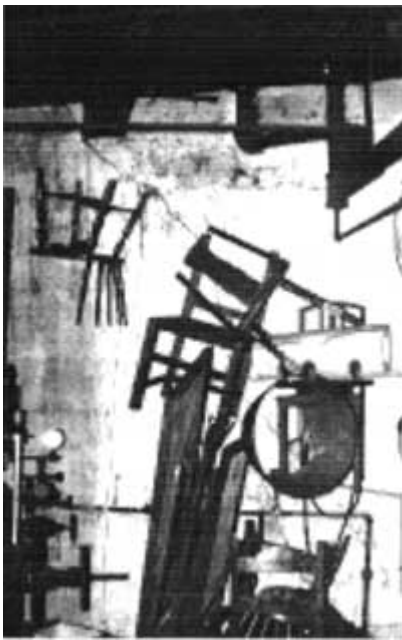
The Chateau's structural system is grounded with a reinforced concrete base spanning the gorge at the bottom two floors. With the exception of a crack in the west end of the north wall of the Boiler Room, this foundation appears to be in good order structurally. The main potential structural problem of the Chateau first appears intermittently on the third floor, where there is some lateral displacement of the exterior wall on the west side. The problem becomes much worse just one level up, especially in the north wing of the structure.

Crack in the boiler room, north wall.

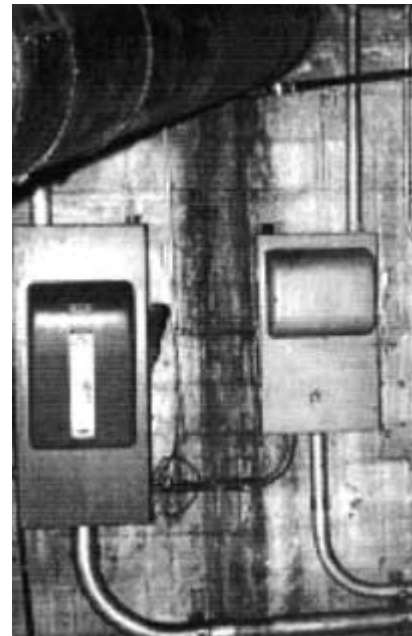
Water infiltration at the boiler vent pipe.
