## NATIONAL PARK SERVICE

December 12, 2019

Subject: Technical Assistance Report: Evaluation of Cub Lake Trail flooding, Rocky Mountain National Park

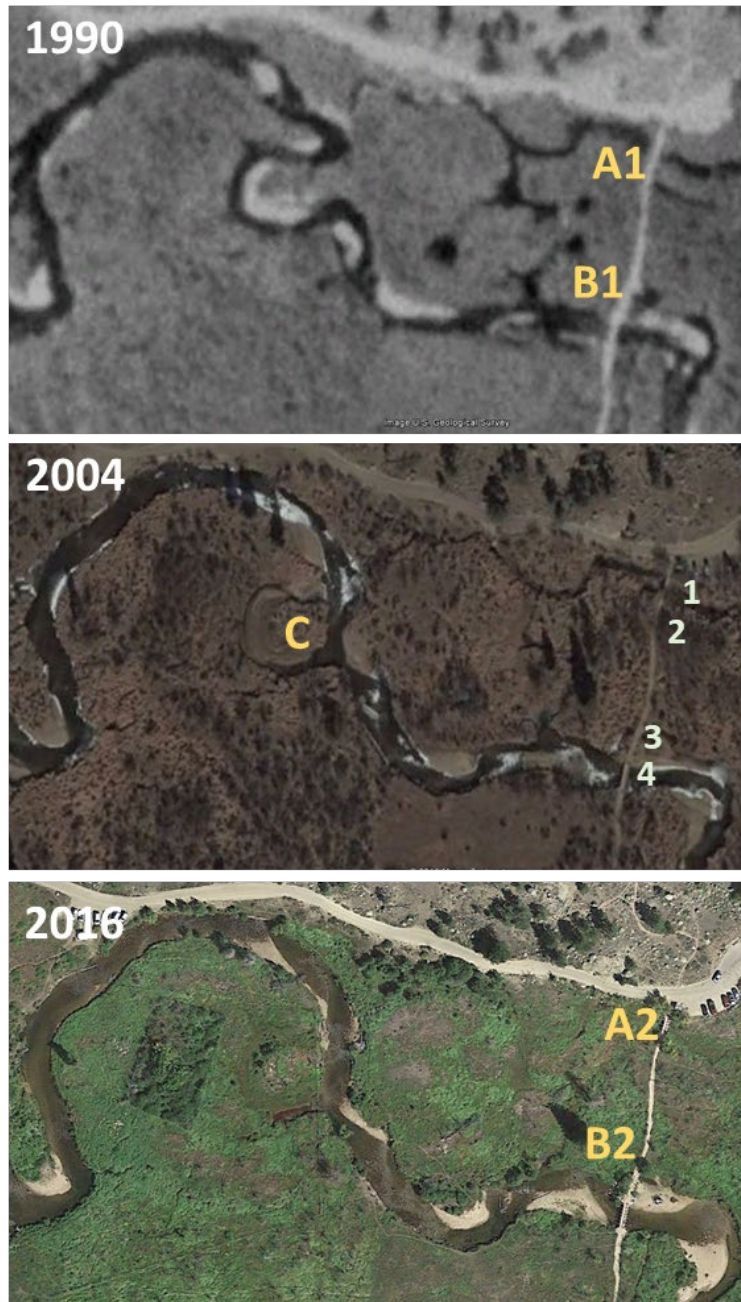
**Figure 1.** Evolution of the Big Thompson River near the Cub Lake Trail, 1990-2016. The water conveyance structures are labeled in the middle panel and are the small bridge, small culvert, main culvert, and main bridge (1,2,3, and 4). A side-channel that was possibly the former main channel supported surface flow in 1990 (A1) but was completely disconnected by 2016 (A2). The main channel had a relatively straight approach to the bridge in 1990 (B1), but increased sinuosity and a wider active channel developed by 2016 (B2). Increasing sinuosity near the bridge partially resulted from an upstream channel cutoff (C) that steepened the flow gradient and increased energy available downstream. The cut bank at B2 is likely to migrate downstream and compromise the north bridge approach in the future.

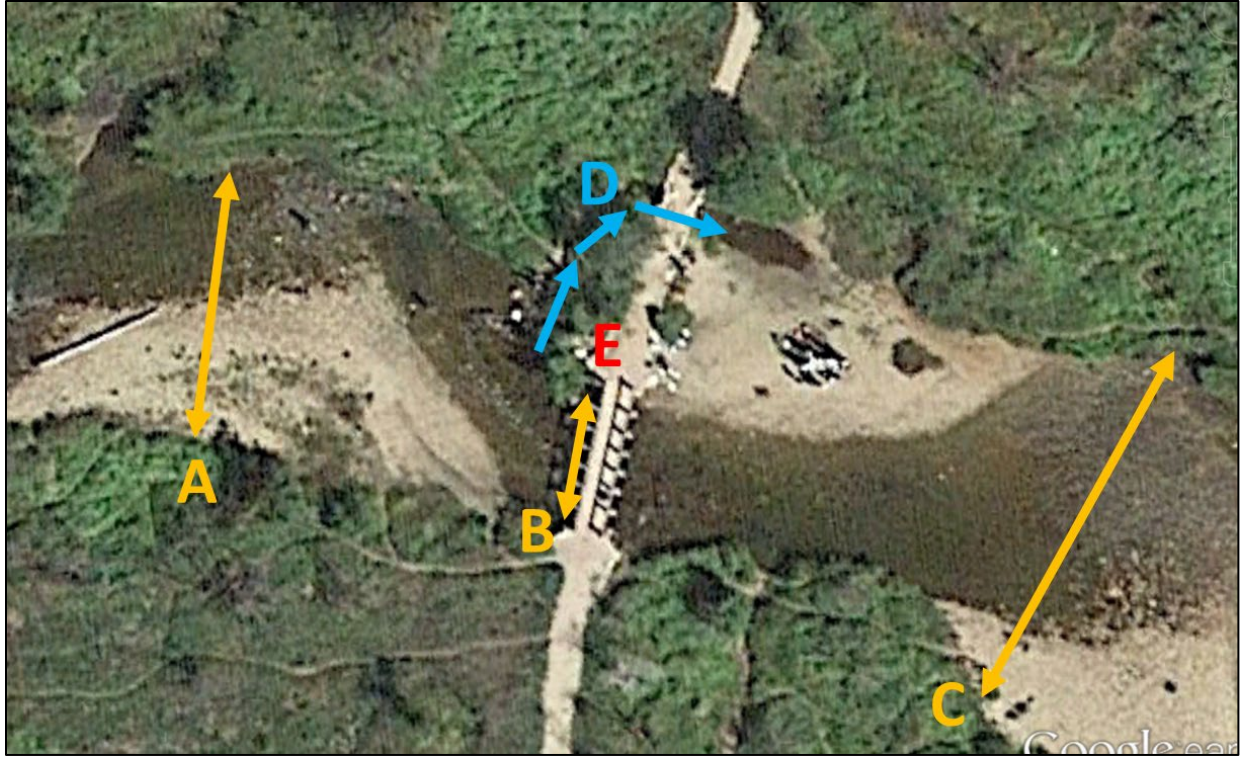
The bridge approach north of the crossing is about 50 ft. long and built on a prism of fill raised about 2 ft. above the active channel and surrounding floodplain. Conveyance is adequate at low and medium flows, but during high flows the trail fill restricts flow across the width of the active channel and overbank, acting as a semi-permeable dam/dike. This is because the bridge constricts the main channel to about 1/3 to 1/2 the width of the active channel upstream and downstream (Figures 2, 3, and 4). The resulting constricted channel creates backwater that spreads across the floodplain. Some of this water diverts into a side channel at river left and passes through the larger culvert in the north bridge approach of the trail. However, the culvert provides only a small amount of additional flow capacity and is functional over a narrow range of discharges. Higher discharges flood the trail, creating maintenance and visitor access issues.

A potentially greater concern identified during the field visit is a cut bank on the main channel immediately upstream that is eroding and threatening the north abutment of the main bridge (Figures 2 and 5). Eventually, this erosion is likely to circumvent the abutment and compromise the north trail approach of the bridge. The resultant new side channel would likely develop into the main channel because of its steeper gradient. This scenario would render the bridge largely dysfunctional and necessitate re-design of the crossing or a major trail reconfiguration. The time frame of this channel migration is flow dependent and not readily predictable.

**Figure 2.** Mainstem Big Thompson River near the main bridge of the Cub Lake trail. The active channel widths upstream and downstream of the bridge (A, C) are about 59 and 75 ft., respectively. This is 2-3 times wider than it is at the bridge (B), which is only about 30 ft. The constriction causes backwater that enters a secondary channel and flows through the culvert (D) or onto the trail. The bank loss that is threatening north bridge abutment is located at (E).

*Option 3 (preferred):* Replace the north bridge approach with a boardwalk structure. The boardwalk would complete the span over the active channel at about the same elevation as the bridge and extend a reasonable distance into the floodplain meeting natural grade at an ADA compliant slope. Its construction would enable removal of the prism of fill that supports the current trail and dams flows that occur during both normal annual runoff and extreme events. This option would allow the river to re-occupy most of its modern active channel. A boardwalk would alleviate most of the damming and an appreciable amount of backwater. The boardwalk will accommodate stock animals and be ADA compliant. Anti-scour measures must be taken to prevent undermining of the base of the boardwalk, whose piers would be subject to erosion. Current constriction from the cement bridge abutments will still affect hydraulics and create some backwater in the main channel, and its north abutment may necessitate anti-scour measures.

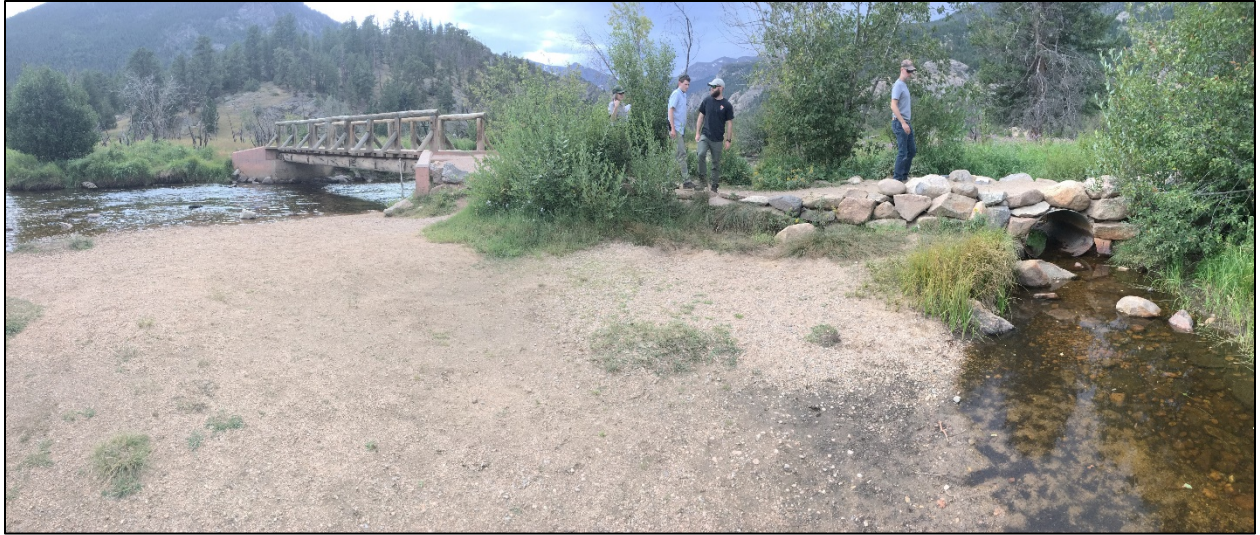
**Figure 3.** Upstream view of the Cub Lake trail, the bridge over the mainstem Big Thompson River, the prism of fill, and the culvert on the side-channel. The fill acts as a barrier to in-channel and overland flow at higher discharges. Note the large boulders that could serve as point protection riprap. NPS, 2019.

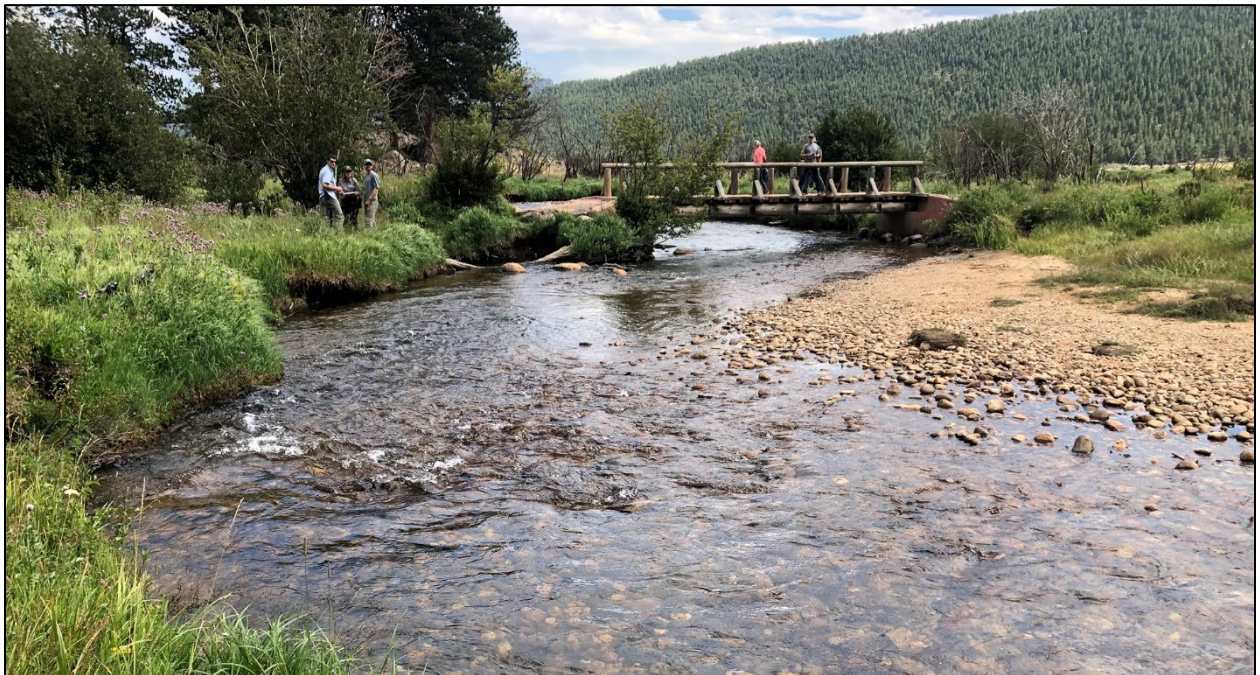
**Figure 4.** Downstream view of the Big Thompson River. The active channel width (i.e., bankfull width) is much wider than the bridge opening. The cut bank at left of the bridge will probably migrate downstream reclaiming the active channel width. This will surround the north bridge abutment and likely necessitate anti-scour measures. NPS, 2019.

Construction of a boardwalk that spans the northern section of the active channel (Option 3) is the preferred treatment for alleviating trail flooding, but it would exist in an environment vulnerable to future cutbank migration toward the boardwalk and bridge abutment. If the advancing cutbank is not artificially armored, it is likely to progress toward and circumvent the north bridge abutment. This process would represent the river reclaiming active channel on both sides of the north abutment, which is a natural result of dynamic fluvial processes. Despite the loss of some of the vegetated bank, this scenario would be a positive condition for the riparian system and hydraulic environment. However, the north bridge abutment and any boardwalk piers in the active channel will be subjected to substantial hydraulic pressure, and anti-scour measures such as boulders could be used to protect them.

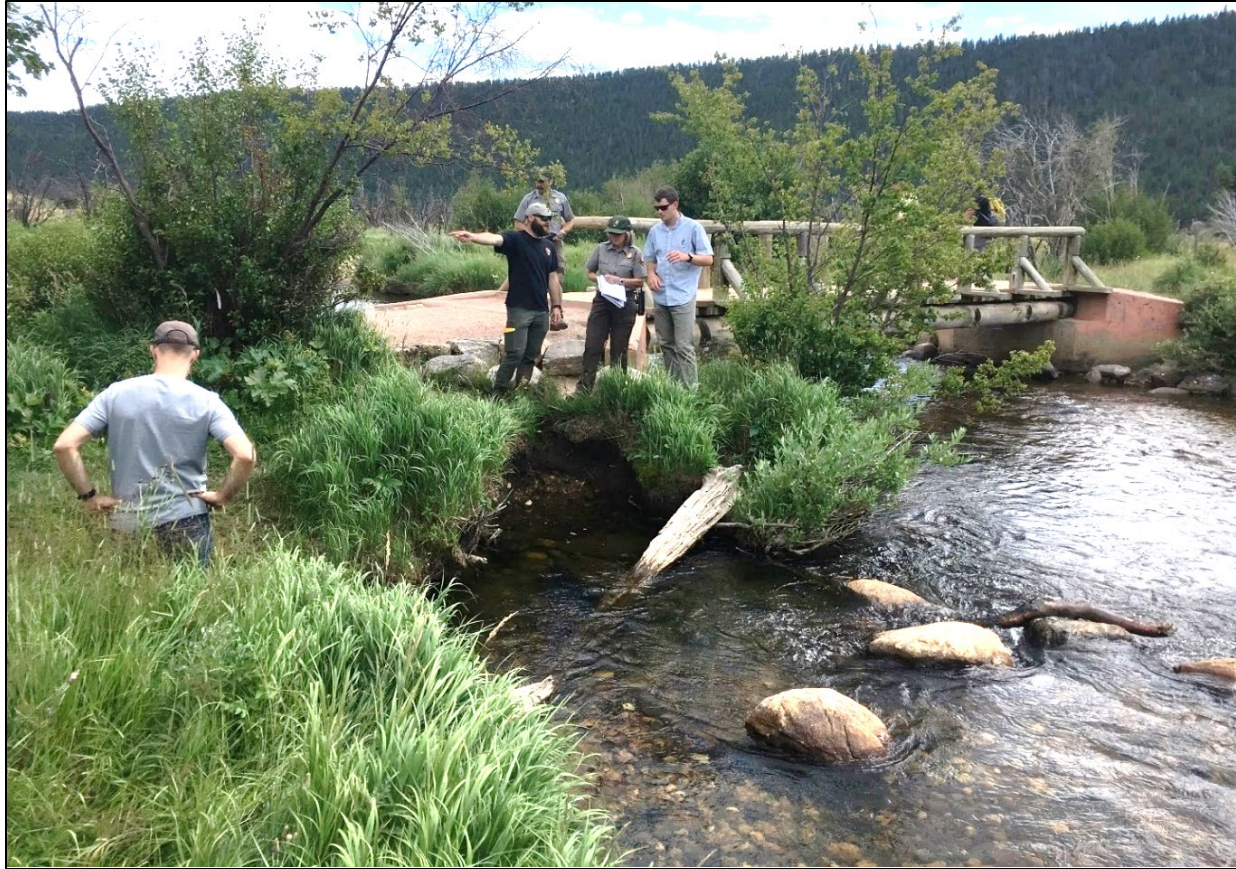
**Figure 5.** Downstream view of the main channel and its advancing cut bank that threatens the bridge abutment. The small side channel leading to the culvert extends to the left immediately below the researcher at left. This whole section of bank will likely become active channel and be spanned by the proposed boardwalk. NPS, 2019.
