United States Department of the Interior  
NATIONAL PARK SERVICE  
Water Resources Division  
1201 Oakridge Drive, Suite 250  
Fort Collins, Colorado 80525

Memorandum

Subject: Trip report of visit to Pinnacles National Monument, January, 2011,  
Evaluation of stream conditions and a potential pond restoration site

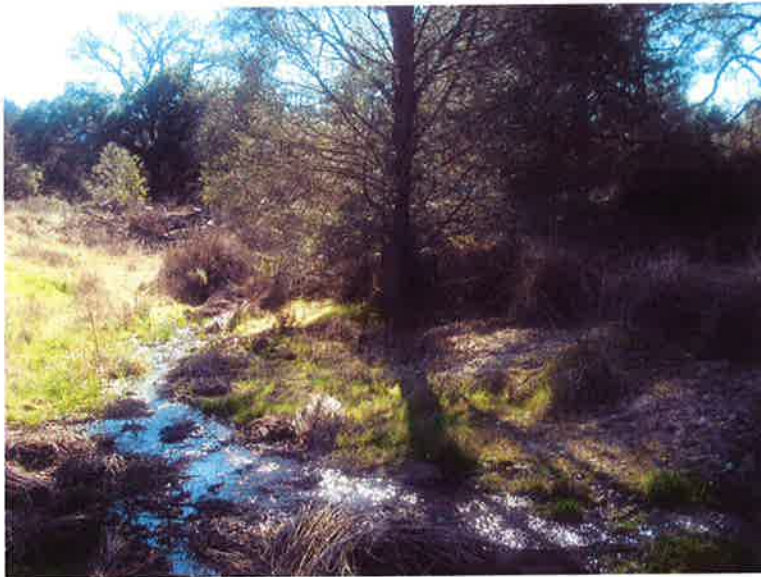
Our reconnaissance of the channel and floodplain began at the downstream reach of the drainage just above the road crossing and continued upstream to the wilderness area. Throughout the length of the drainage we observed alternating reaches where the channel was on grade (figure 2-a) and also where it was undergoing incision (figure 2-b).

Figure 2-a. One reach of McCabe Creek that was "on-grade"

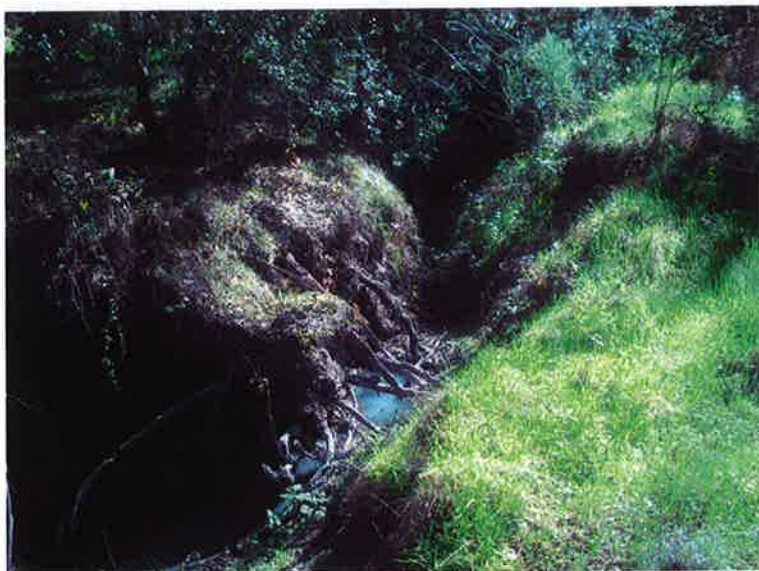
Figure 2-b. One of the incised reaches of McCabe Creek

Several lines of geomorphic evidence associated with McCabe Canyon drainage suggest that the observed incision is part of the natural valley evolution processes. The primary indicator is the fact that the observed headcuts are discontinuous, with the channel alternating between "on-grade" reaches and incised reaches along its length. If some major change in the fluvial system was responsible for channel incision, it would likely be manifested along the entire length of the stream. The discontinuous headcuts are more indicative of small scale and local adjustments in channel slope due to sediment moving through the system. In addition to the discontinuous headcuts, the previously mentioned observation of incision occurring on two different side channels along the same reach suggests that this particular reach is susceptible to incision due to valley conditions rather than channel conditions.

If specific areas of erosion, especially in the more upland zones exist in the watershed, then some type of treatment (likely revegetation) may be worthy of consideration. However, in-channel stabilization is much more problematic. Even if the observed channel incision present a severe resource threat, stabilization of the headcuts would be very difficult in this geologic setting. The local soils are very non-cohesive and easily eroded. Engineered structures have limited functionality in this setting, and stabilizing vegetation is not easily established in this relatively dry climate.

By all appearances, the discontinuous headcuts present in McCabe Canyon are part of the natural valley evolution, and therefore, stabilization measures are probably not appropriate. Furthermore, the soils of the watershed do not easily lend themselves to most types of stabilization.

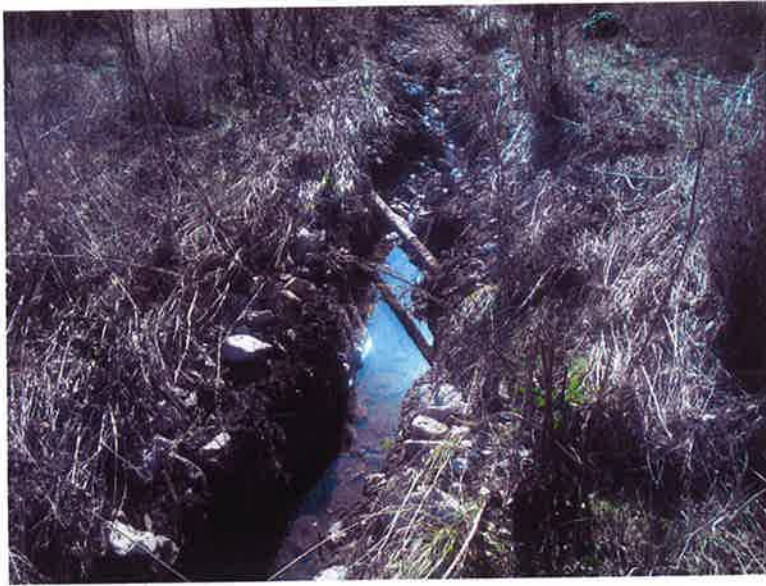
There is a small footbridge across the creek that basically marks the transition from an on-grade meandering channel to the incised portion of the channel. Specific areas of erosion are evident downstream from this transition, but all such areas that we observed were associated with cutbank/pointbar morphology common in a meandering channel. Upstream of the transition, however, the small channel has obviously undergone recent incision breaking through the protective armor layer and even exposing a buried utility pipe (figure 4).

Figure 4. Reach of Chalone Creek where it has undergone incision, exposing a previously buried utility line

At this time the incision is not severe (not deep) and therefore appears to be treatable at the headcut. Such treatments generally take the form of reducing the channel slope over the nickpoint(s) either by grading the vertical feature back or by filling it forward. Then some type of surface stabilization is placed over the new slope. In this particular case, replacement of the armor layer with locally derived stones could serve as reasonable surface treatment. One problem that often ensues is undermining of the base soil by flowing water. This condition may be alleviated by placement of some type of filter layer, either a graded layer of small gravel or geotextile fabric, under the new armor layer. An

additional hydraulic structure often used in incised channels is a check dam, which is designed to collect sediment and actually restore the level of the channel. While this type of treatment is relatively simple, inadequacies in the design often times lead to failure. WRD staff will be available for detailed consultation if park staff undertakes stabilization measures.

Conversely, in West Chalone Creek the observed incision is likely related to the footbridge crossing. Given the relatively small incision and the presence of an armored channel, stabilization through re-grading and hardening where appropriate, and the possible inclusion of a number of small, loose-rock check dams, could probably be effective in arresting the headcut.

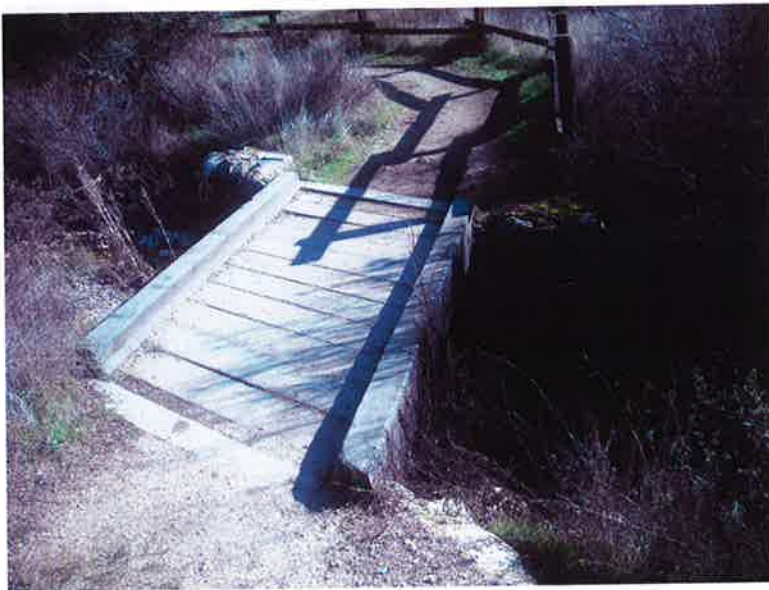
The point where the incision began appears to be associated with the small footbridge that spans the channel. This is not an unusual occurrence as constricting a channel by placing bridge abutments may increase depth of flow, increasing stream power, and lead to channel incision. This particular bridge configuration does not create a dramatic constriction encroaching only slightly on one side of the channel (figure 5). Nevertheless, the proximity of the bridge to the initial headcut strongly suggests a relationship between the two.

Figure 5. View of the small footbridge that could be the cause of the incision. Note the encroachment of the abutment on the far bank.

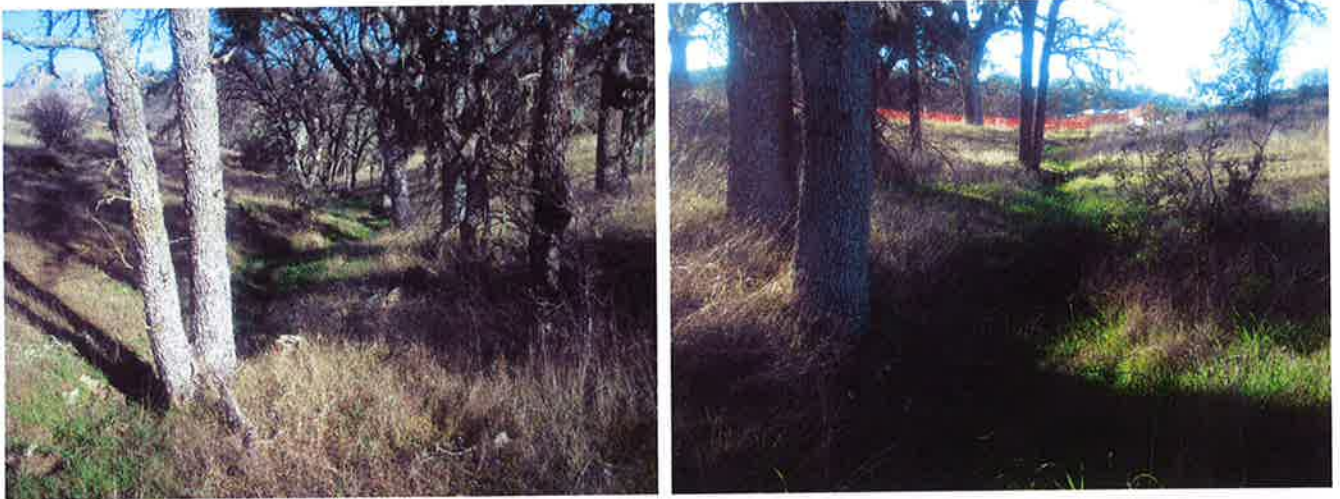
The site of concern within Jawbone Canyon is located in the headwaters of the drainage. Construction of a new Visitor Center (VC) just upstream from the channel raises the issue of stormwater delivery and possible channel alterations (figure 6). It certainly appears that once any substantial storm water is delivered to the headwaters of the canyon there is going to be significant erosion and geomorphic degradation of the natural channel. The boundary of the project is right at the transition between a grassy swale (sometimes referred to as a zero-order basin) and the beginning of a channel (first-order basin). According to park staff, overland flow is very rare if it occurs at all; nevertheless, the channel is showing signs of nickpoint formation at several locations immediately downstream of the project site. This indicates that the channel, with its present slope and soil type, is right at the threshold of stability with natural runoff conditions. The soils appear to be mostly sand and very non-cohesive at the surface, so there will likely be little resistance to hydraulic forces. We did not do a comprehensive soil analysis, but our simple assessment, coupled with numerous examples of mass wasting in the surrounding hills, supports this conclusion.

Figure 6-a. (Left) Jawbone Canyon headwater area. Looking downstream from below construction site.  
Figure 6-b. (Right) Jawbone Canyon headwater area. Looking upstream from below construction site.

Accepting that the soils are highly erodible and given the relatively steep slope of the drainage, if a substantial amount of water is delivered to the channel, the depth of the erosion could be dramatic, and the generated sediment could also be a resource issue downstream. Conversely, if the bedrock is fairly shallow underneath the channel, the conditions may not be so unacceptable. We looked around fairly carefully but could find no indication that there was shallow bedrock in the immediate area, although there are sizable boulders in the colluvium and obvious shallow bedrock exposed in the channel several hundred yards downstream.

Jawbone Canyon, or more specifically the headwaters of Jawbone Canyon, appears to be at risk of serious channel incision due to storm water delivery from a new VC site. A complete review of construction diagrams and a stormwater management plan during a subsequent visit failed to yield unequivocal conclusions regarding potential incision. Stormwater management strategies were incorporated into the engineering design and emplaced during construction. However, little or no consideration was given the “managed stormwater” after it leaves the construction site. As stated earlier, it is our opinion that an increase of flow to the headwaters of Jawbone Canyon will result in channel incision. The depth of this incision will likely be limited by the depth of bedrock under the channel. Fortunately, there is some evidence that the bedrock may be very shallow, although the true depth is unknown at this time.

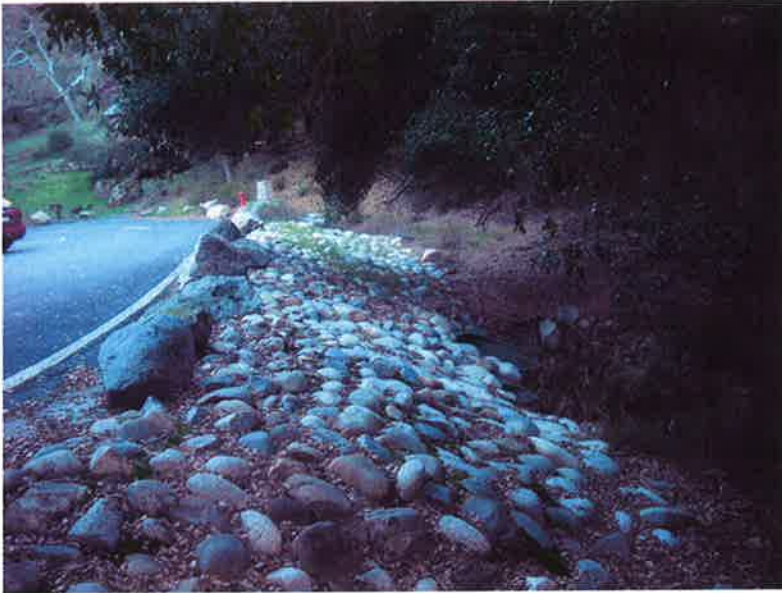
The Moses Spring parking lot and associated infrastructure is located several hundred yards upstream of the HQ area along Bear Creek (figures 7 and 8). The developed area includes an 11 vehicle parking lot, a comfort station, a water fountain, and fire hose as well as underground water and sewer lines. The parking lot, which measures about 0.25 acres, actually straddles the stream channel, providing flow conveyance through three corrugated metal pipes, one of which is plugged with sediment and is nonfunctional. The downstream face of the parking lot has a drop of about 8-10 feet to meet the grade of Bear Creek. The face of this drop is stabilized with grouted stone (figure 9).

Figure 9. Downstream face of parking lot at Moses Springs

However, we continued to evaluate the immediate area around Moses Spring for the potential of creating a pond environment. First of all, we evaluated the parking lot site itself for pond creation. At this location it would be physically possible to create a pond basically by removing all parking lot pavement, fill, and buried infrastructure and replacing it with a basin structure—essentially creating a contrived pond with an artificial impoundment. Such a feature may be roughly visualized in figures 8 and 9 by mentally substituting the pavement with open water.

In spite of the difficulties of creating a true pond environment in the area of Moses Spring, there may be a potential to enhance the desired habitat in this stream reach by restoring the buried stream segment with a step-pool-riffle morphology. This could be accomplished by breaking up the gradient of the stream channel with large boulders forming upstream pools and downstream steps. Whether this approach would really be effective in creating desired habitat is unclear, but it would certainly serve as a stream restoration.
