# United States Department of the Interior

## NATIONAL PARK SERVICE

November 4, 2013

Subject: Trip report detailing floodplain impact assessment of the Big Hole River

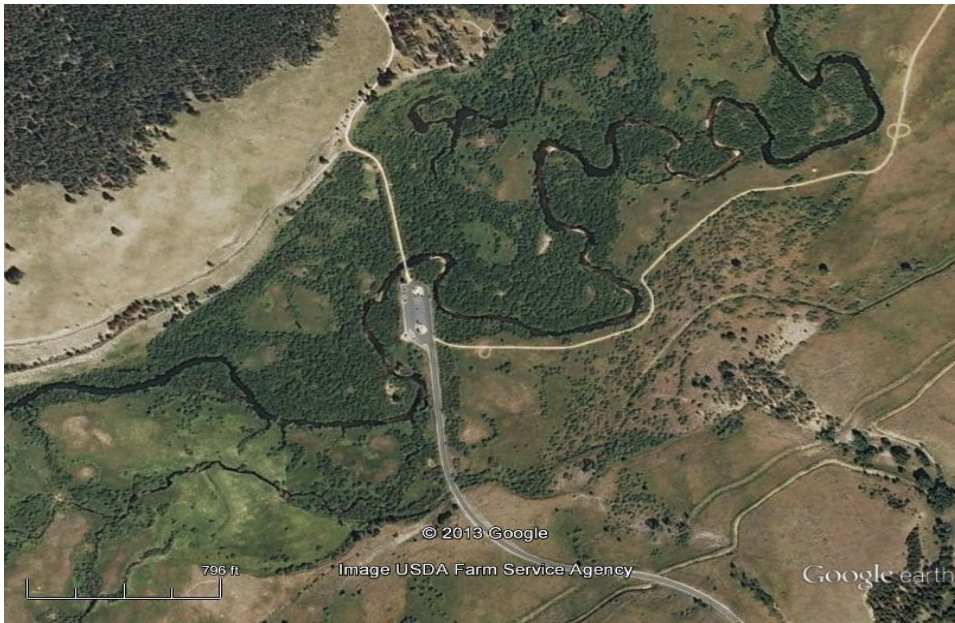
(Figure 1). Not only does this position place the structure in the immediate floodplain of the river but its proximity to the active channel will likely disrupt channel migration processes at some time in the future. This near one-acre, asphalt parking lot was placed on about 5 feet of imported fill, and its footprint takes up near half of the floodplain area within the meander. The northeast corner of the pad is only a few feet from an outside meander bend of the active channel. To add to the impact, the asphalt paving of the parking only provides minimal infiltration and recharge to the alluvial aquifer, if any.

**Figure 1** - Google Earth image of Big Hole National Battlefield. Note the position of the parking lot adjacent to the active channel.

Another consideration associated with the location of the parking lot is the likelihood that natural channel migration will eventually overtake the footprint of the structure. Given the proximity to the active channel to the parking lot pad, it is almost a certainty that the channel will eventually migrate into the parking lot location. This is especially true at the outside of two meander bends near the northeast and southwest corners of the parking lot (Figure 1). The common reaction to such a scenario is usually to treat the “eroding” channel with rip-rap, essentially forestalling natural river processes in favor of protecting threatened infrastructure.

Consequently, we recommend Park Staff consider steps and opportunities to relocate the parking lot to a non-floodplain location. This can be done at the convenience of other management goals as there does not appear to be any urgency related to any of the resource effects. However, at some time in the future, it may become more of an emergency action and negative consequences will likely occur.

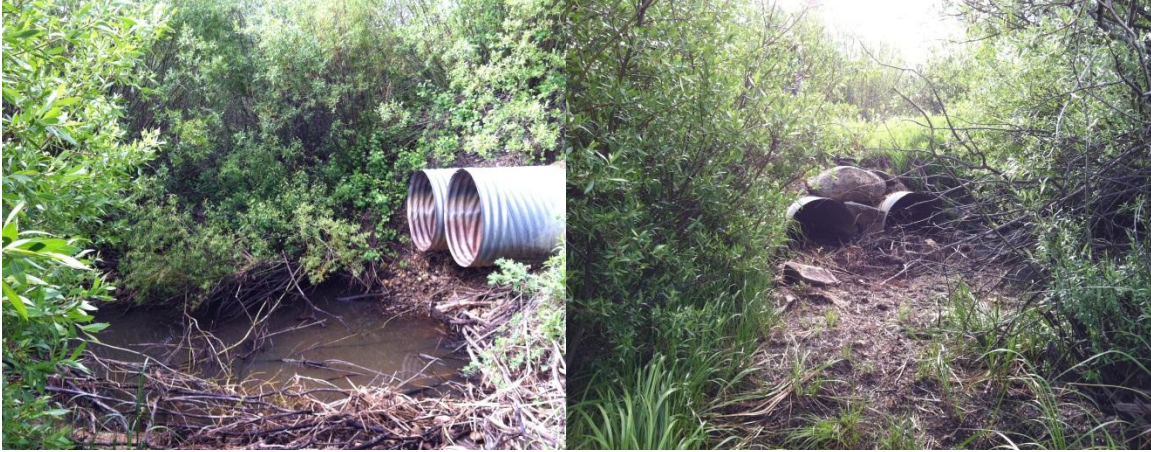
**Figure 2** – culvert crossing that passes through the road fill. The left image is the downstream side (note the plunge pool. On the right image, the upstream side, note the accumulation of sediment.

More significantly, both the inlet and the outlet to the two pipes are set several feet above the natural grade of the floodplain.

The culvert crossing is basically non-functional in relation to natural floodplain processes. With all overbank flows restricted to a single hydraulic crossing point, the current road – culvert configuration represents a dramatic reduction of overbank flow conveyance during periods of high water. Adding to this problem, the above grade elevation of the culvert intake requires a substantial overbank flow to even reach the pipe. Likewise, the high elevation of the culvert outlet creates conditions of excessive flow energy. This type of configuration almost always leads to ponding and/or deposition of sediment on the upstream side, with the downstream side experiencing scour and channelization, sometimes severe. In addition to the geomorphic impacts, this culvert configuration compromises passage of fish and other aquatic species, as well as transfer of any sediment, organic matter, or nutrients to the downstream floodplain.

On the upstream side of the road grade, the near complete blockage of overbank flows by the road fill has produced obvious upstream ponding and some degree of sedimentation in the vicinity of the culvert. On the downstream side of the culvert, there are definite signs of scour with the formation of an approximate 200 square foot plunge pool at the culvert outlet (Figure 2). While such channel incision can be a serious concern, the erosion at this crossing has not propagated for a very great distance. The gentle slope of the floodplain and the prolific vegetation, especially the willow stands, serve to limit the erosive effects of the concentrated flows that periodically leave the culvert pipes. Nevertheless, the current configuration does result in unnatural erosion for a distance and the generation of sediment.

The most obvious improvement would be to replace the current culvert crossing with an on-grade structure that provides greater flow conveyance at all stage levels, especially the lower stage levels. Additionally, multiple crossing points could be added to the road grade to allow greater flow conveyance over a wider floodplain area. However, even with several conveyance points, flow would still be unnaturally concentrated to some degree and wetland riparian habitat would be covered by the road fill.

The most functional restoration that could be achieved while still maintaining the road alignment would require a raised causeway or boardwalk type of structure with a near completely open span. Or, for complete restoration, total removal of the road grade and fill. We recognize the difficulty and cost associated any type of reconfiguration of this historic road grade. Considering that the resource impacts of this flow obstruction do not appear to be widespread, park staff may want to consider only minor treatment, if any. Nevertheless, the option of a complete restoration of this floodplain and wetland disturbance may be available to park staff and is worthy of consideration. Funding may be available through mitigation compensation resulting from local projects.
