# United States Department of the Interior

## NATIONAL PARK SERVICE

November 4, 2013

Subject: Trip report detailing assessment of a hydraulic drop structure at the confluence of the Paria River and Water Canyon

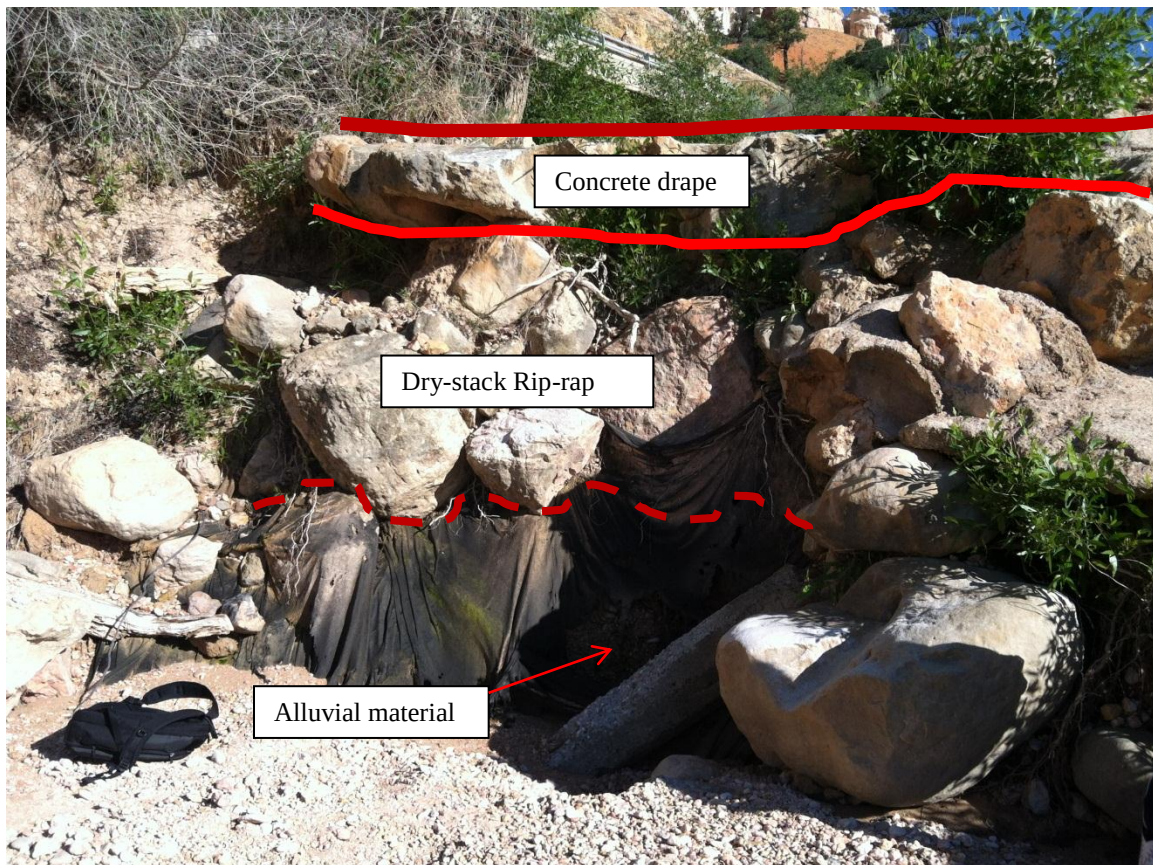
grouted rip-rap overlying the base, and several layers of re-enforced concrete drapes overlying most of the structure. The overall vertical drop is about 35 feet and it appears that the complete structure provided a stable transition from the upper Paria River channel to the lower, until recently. Currently, the lower end of the drop structure has been undercut by downstream channel incision and the entire structure could be on the brink of failure (Figure 2).

Most of the remaining, re-enforced concrete drape, which probably capped the entire structure, is still in good condition, both above and immediately below the confluence, and the portion of the structure that is still intact shows no obvious sign of structural failure. However, an unknown length, maybe as much as 40 feet, of the lower end of the structure has been completely lost. This loss includes the large rip-rap base material and the overlying re-enforced concrete drape. Additionally 3 – 4 feet of the river alluvium that was underneath the structure has also been eroded. At the point of failure of the structure there is about an 8-10 feet scarp of exposed river alluvium, base material, and overlying rip-rap and concrete (Figure 2).

Figure 2 - Area where the structure has failed. Note the exposed geo-fabric marking the elevation of the channel bottom at the time of emplacement, directly below the large boulders (dashed red line). Also note the “upper bench” bracketed by a solid red line marking the level of the concrete drape. NPS-2013.

Since most of the upper part of the drop structure appears to be functioning well, treatment and repair of the lower section, where the structure has failed, may be the most cost effective measure. As mentioned, development of specific engineering designs for treatment was beyond the scope of this field reconnaissance, however, after our assessment, we have noted a number of important design elements that need to be considered.

One crucial design element would be to make sure the repaired drop structure extends beyond any reasonably possible level of future incision, i.e. keyed fairly deep into the bed of the river. The depth of potential incision is not predictable, so the keyed depth of the structure should be at a low enough level to forestall any future incision. A geotechnical study might provide the depth of the bedrock, which would be a desirable feature to key into, however, its depth may make it cost prohibitive. Additionally, solid keys into the banks will need to be re-established.

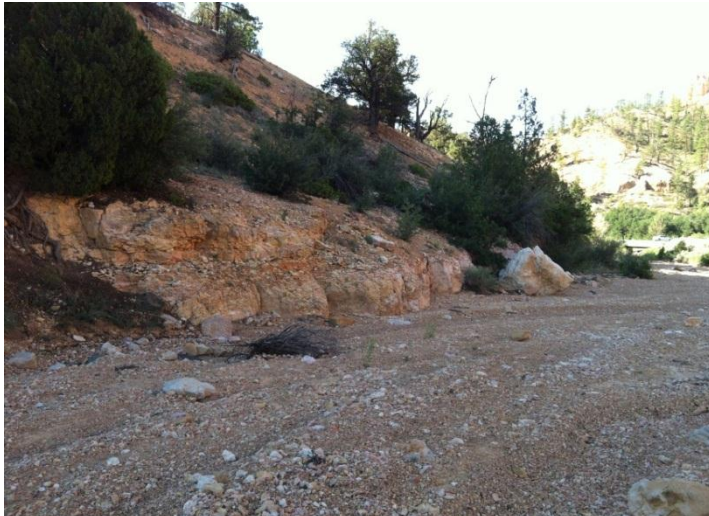
**Figure 3 - Bedrock out crop about 100 yards upstream from drop structure. NPS 2013.**

The channel in the reach of interest is primarily alluvial, although, there are some bedrock outcrops both up and downstream of the structure. The bedrock outcrop about 100 yards upstream of the structure is a well indurated sandstone on the left bank (Figure 3). If this bedrock outcrop extends under the river bed at a reasonably shallow depth, it could provide very good grade control for the upstream reach. However, we were unable to locate any other outcrops here in the channel or the opposite bank

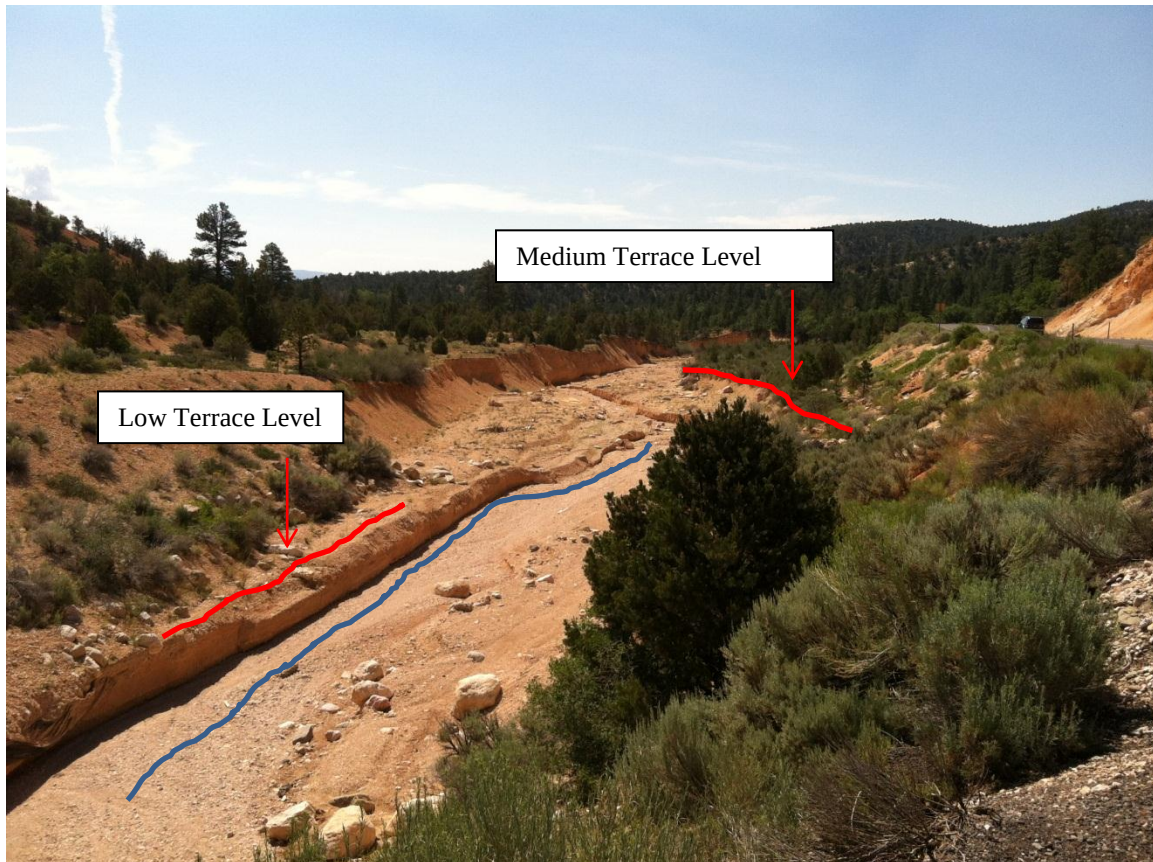
Currently, the upstream channel is mostly on-grade with active floodplains and no signs of incision. The downstream reach, however has obvious signs of multiple episodes of incision with two distinct terrace levels as well as an inner, active channel (Figure 4).

**Figure 4 - View of the channel downstream of the drop structure taken from the highway. Note the terrace levels (red lines) and the inner channel (blue line). NPS - 2013.**

Park staff reports that these two terrace levels are remnants of river bed elevations from the last few decades. The medium terrace level is from about 50 years ago and the low terrace level from about 10 years ago. So, the inner channel, which is currently about 3 to 4 feet below the lower terrace, likely began downcutting about 10 years ago, and it was sometime after this period of recent incision began that the failure of the structure base occurred.

In addition to repair of the drop structure, we would recommend including additional downstream protection such as one or more loose rock check dams, or similar structures, to provide both early warning of channel incision and add to overall grade control. Well-constructed, downstream protection could not only help to maintain the current grade but could possibly trap sediment and restore the channel elevation to some degree.

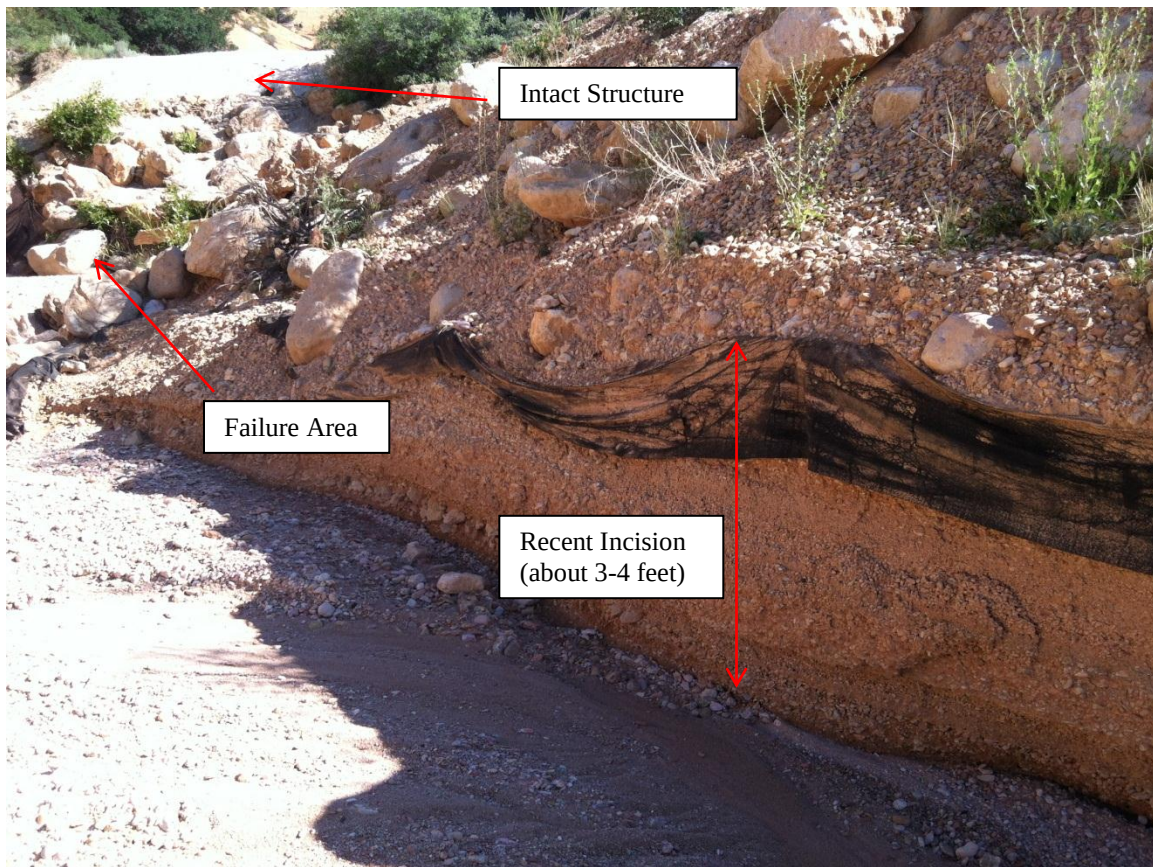
Careful inspection of the river channel and both the failed and intact portions of the drop structure indicate that it was channel incision and the formation of the inner channel that led to the structural failure. Apparently, a headcut migrated upstream and undermined the alluvium that supported the lower structure. This led to failure of the large, dry-stacked rip-rap and the overlying grouted rip-rap and re-enforced concrete blanket. The former level of the stream channel is well defined by the remaining geofabric that was underneath the structure (Figure 5).

**Figure 5 - Left bank of channel about 50 yards downstream of structure. Geo-fabric marks the streambed elevation prior to the recent incision. Note the structure visible in the upper left corner. NPS - 2013.**

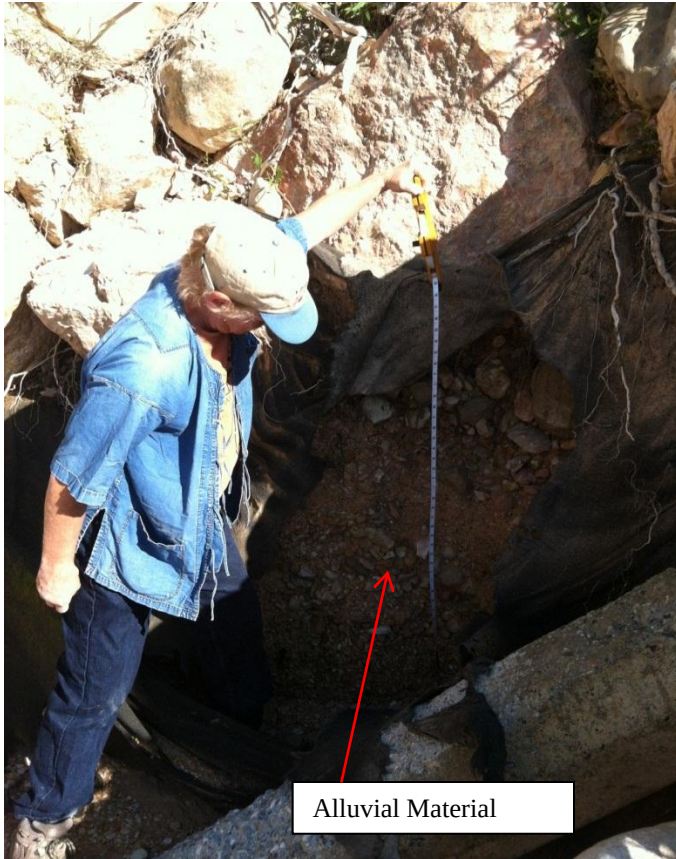
Regardless of the cause of downcutting, the relatively recent evolution, and the current state of the channel, severely threatens the future of the drop structure. At the very base of the structure, where erosive energy is the greatest, there is about three to four feet of exposed alluvium (Figure 6). While this alluvium appears well compacted, it is not at all cemented and therefore, will probably erode somewhat during all sizable flow events. During a large, sustained flow event, there could be substantial loss of this material, which will further undermine the base of the structure.

**Figure 6 -- About 3.5 feet of alluvial material at the base of the headcut. The dry-stack rip-rap that serves as the base for the concrete drop structure is visible in the upper portion of the picture. Also note the remaining geo fabric that was at the base of the structure. NPS – 2013.**
