## NATIONAL PARK SERVICE

November 21, 2017

Subject: Evaluation of Erosion Issues along Ike Smith Stream.

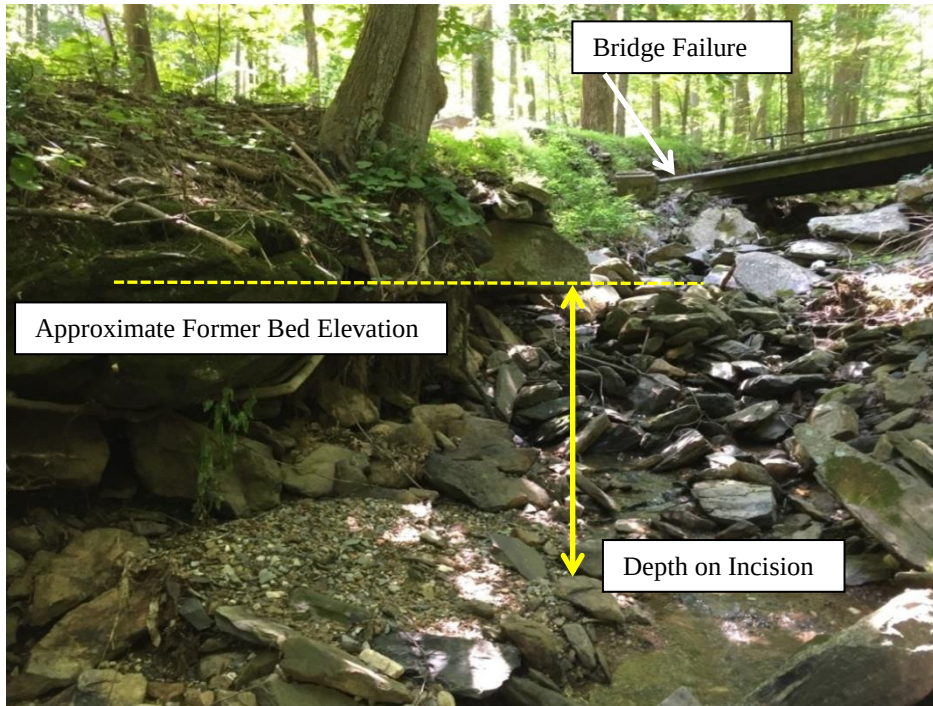
A vehicle access bridge to the pump house has already been compromised by bank erosion at this location (Figure 2), and much of the terrace material, some of it possibly cultural, has been destabilized. The remaining pieces of this bridge, especially the deck and the right bank abutment, are contributing to bank scour and accelerating erosion at this location. The gravel service road that parallels the creek not only affects floodplain hydraulics and adds to the stream related impacts, but with the road base in its current state of disrepair, out-of-

Immediately below the crossing, the channel has incised up to 2 ft. (0.6 m) and noticeably undermined the masonry structure that supports the culvert. Farther downstream, the

depth of incision increases to 3 ft. (0.9 m) or more, and has destabilized the bank material causing undercutting of mature riparian trees and failure of the vehicle bridge (Figure 2). Loss of such trees removes large sections of the bank, and reduces the natural cohesion of the remaining bank material (Figure 3).

**Figure 2** – Reach of Ike Smith Stream adjacent to the pump house (looking upstream) where the channel has incised about 3 ft. (0.9 m). Note the undercut tree and the failed vehicle access bridge. The dashed yellow line marks level of the former channel bottom. The solid yellow line illustrates the degree of incision. (NPS-2017)

The pump house itself is not immediately threatened because there is about 25 feet (7.6m) of setback from the top of the right bank, and channel widening in this type of system is relatively slow. However, it is not clear how much of the historic structure, the cultural landscape and the water distribution system will ultimately be compromised through continued channel evolution. The failed access bridge (Figures 2 and 4) will continue to create bank scour and accelerate bank retreat, especially on the right bank terrace. To forestall this loss of resources, the remaining pieces of the bridge should be removed under an emergency action.

- 2) Re-establish the natural cross-section of Ike Smith Stream by rebuilding the channel grade over the length of the incised reach, using appropriate natural-channel restoration techniques. The affected reach is about 300 ft. (91 m) long. The depth of incision varies from about 2 ft. (0.6 m) at the culvert to around 3 ft. (0.9 m) near the pump house. With an average bottom width of about 10 ft. (3 m), the volume of material required to rebuild the grade is in the range of about 350 cubic yds. (265 cubic m) of fill. This is not an excessive amount of fill, but given the steepness of this reach, the hydraulics associated with high flows will necessitate large material, robust design, and careful implementation to successfully restore a functional channel.

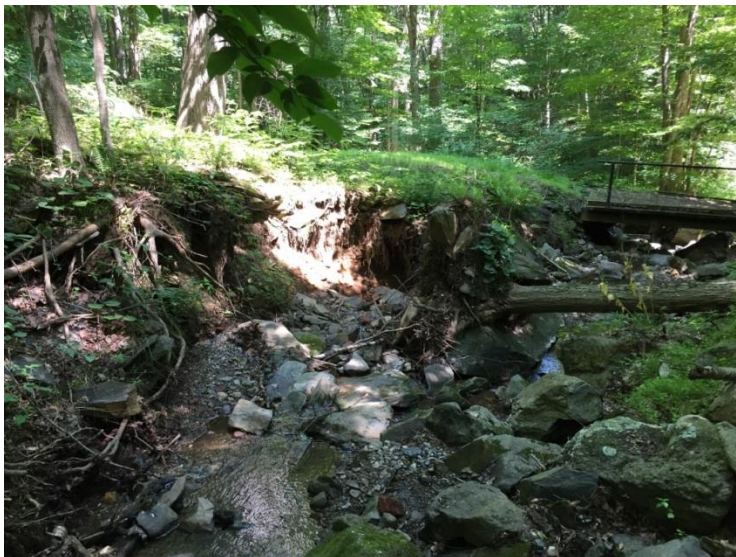
**Figure 3** – Incised reach of Ike Smith Stream looking downstream from near the culvert crossing. Note the undercut and fallen trees on the left bank. The vehicle access bridge to the pump house is visible on right side of the image. (NPS-2017)

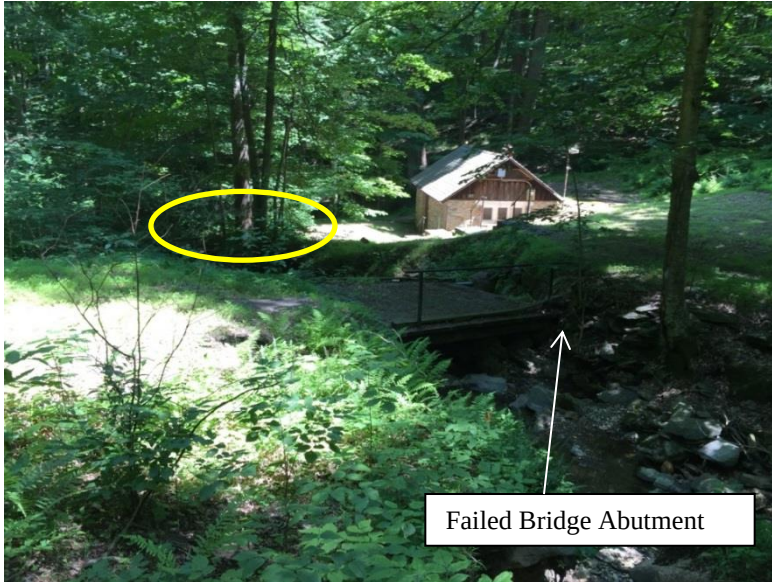
There are still a number of mature riparian trees present on the tops of the banks, but these will undoubtedly fail at some time in the future under current conditions. Of special concern are the dozen or so large trees on the right bank terrace adjacent to the pump house. This thin layer of trees is the last line of riparian protection for this section of bank and when they are lost, bank retreat may be expected to accelerate (Figure 4).

**Figure 4** - The historic Ike Smith Pump House (1936) that serves as water distribution for Park facilities. The yellow ellipse marks several riparian trees that will probably be lost relatively soon without treatment. Note the vehicle access bridge that has failed on the right bank side. (NPS-2017)
