## **Technical Assistance Report**

Subject: Evaluating channel condition and risks associated with Rock Creek after recent floods and a tornado, Chickasaw National Recreation Area

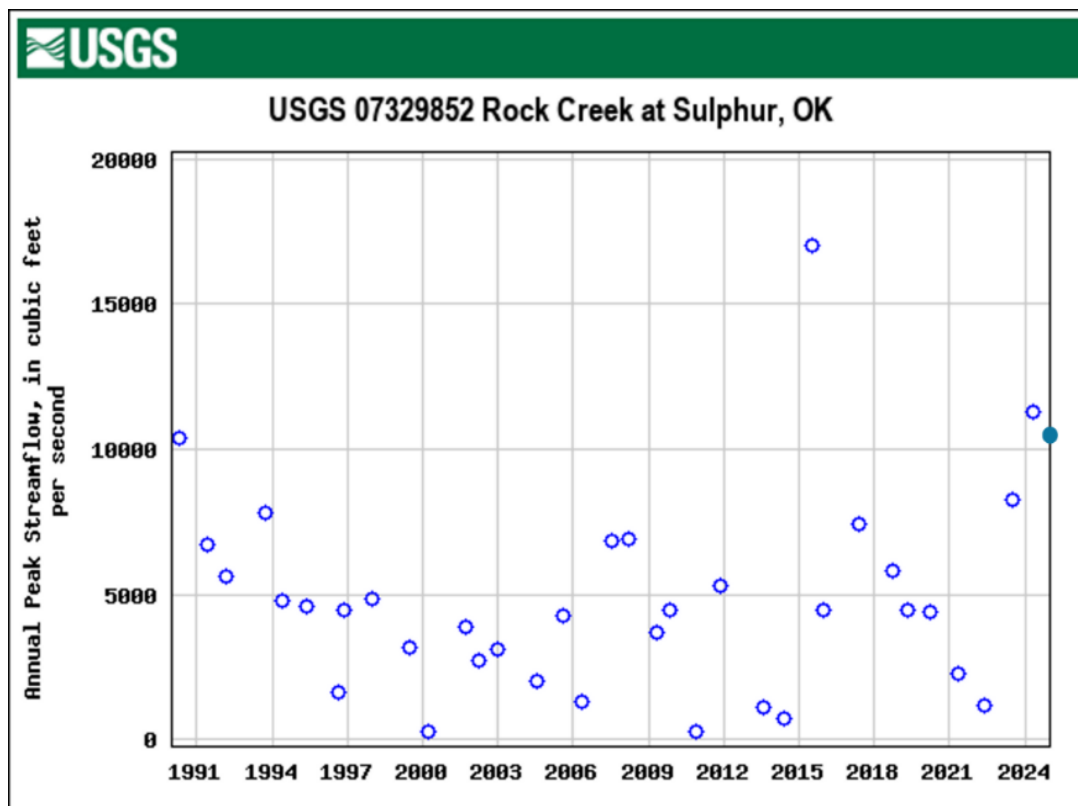
annual flow have occurred since 2015, including each of the last two years (2024 and 2025, preliminary data; Figure 1). Park staff expressed concern that large floods are becoming more frequent.

**Figure 1.** Rock Creek peak annual flows for 1990-2025. The highest flow was in 2015, a year in which there were approximately four events above 7,000 cfs. The 2025 flood peak is preliminarily estimated at 10,400 cfs (filled circle), making the past two annual peaks two of the top three in the 36-year record.

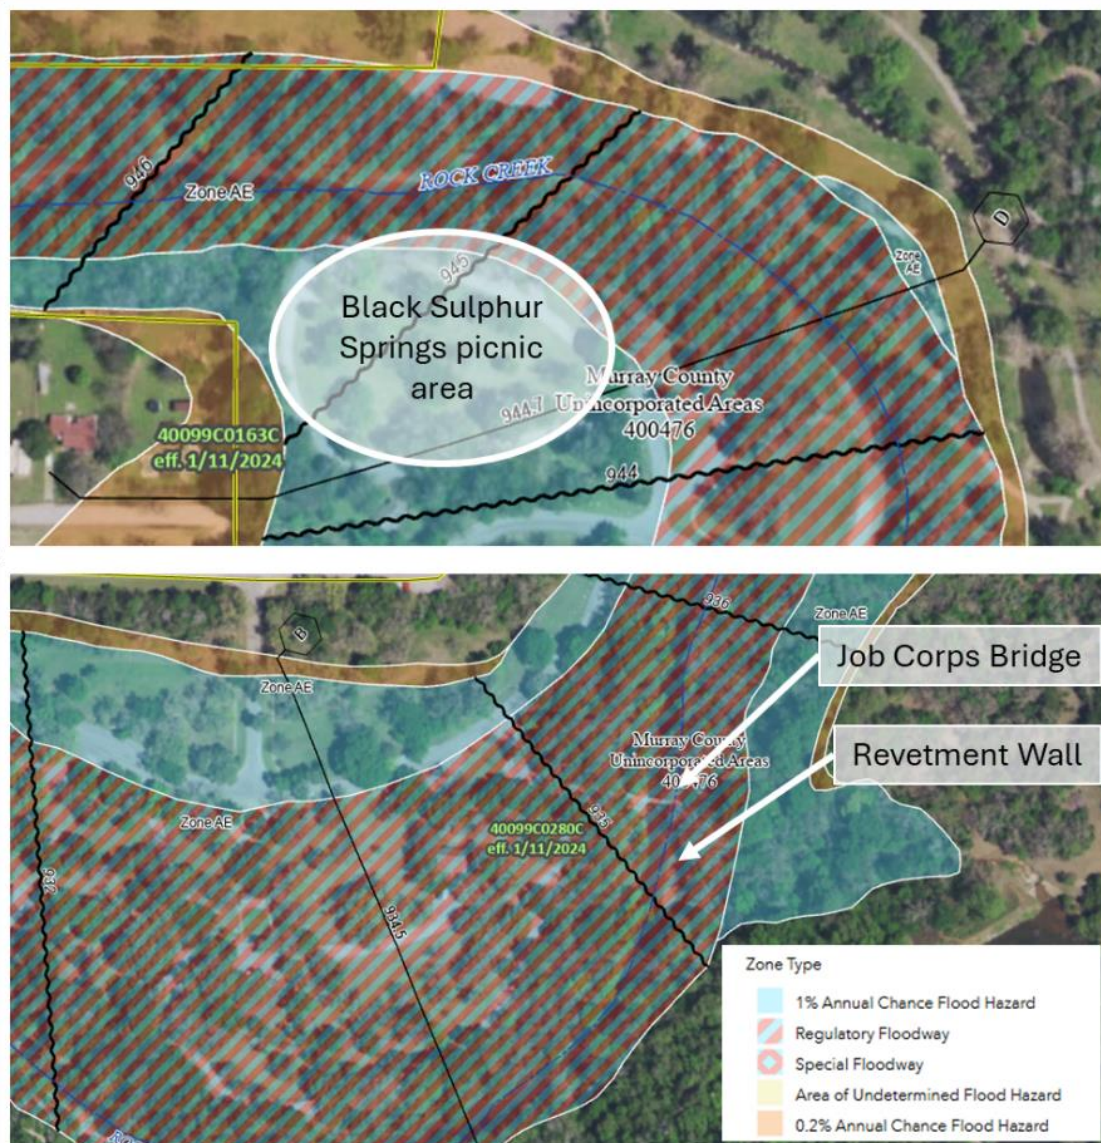
Central Oklahoma is prone to fast and large-magnitude flooding, with its flood hazard index being in the 88<sup>th</sup> percentile for sub-regions across the continental United States (Flood Potential Portal 2026). Rock Creek’s FEMA flood hazard map, updated in January 2024, shows that most infrastructure and visitor use areas along Perimeter Road in CHIC lie within the 1% annual chance flood hazard zone (i.e., 100-year floodplain; Figure 2; FEMA 2026). Therefore, flood concerns are especially poignant in CHIC because of visitor exposure and the speed and depth at which water rises.

**Figure 2.** FEMA flood hazard zones along Rock Creek at Black Sulphur Springs (top panel) and Bromide Springs (bottom panel). Flow is from top to bottom in each. Note the abundance of park use areas within these flood hazard zones, including the labeled Black Sulphur Springs picnic area, Job Corps Bridge, and rock revetment wall.

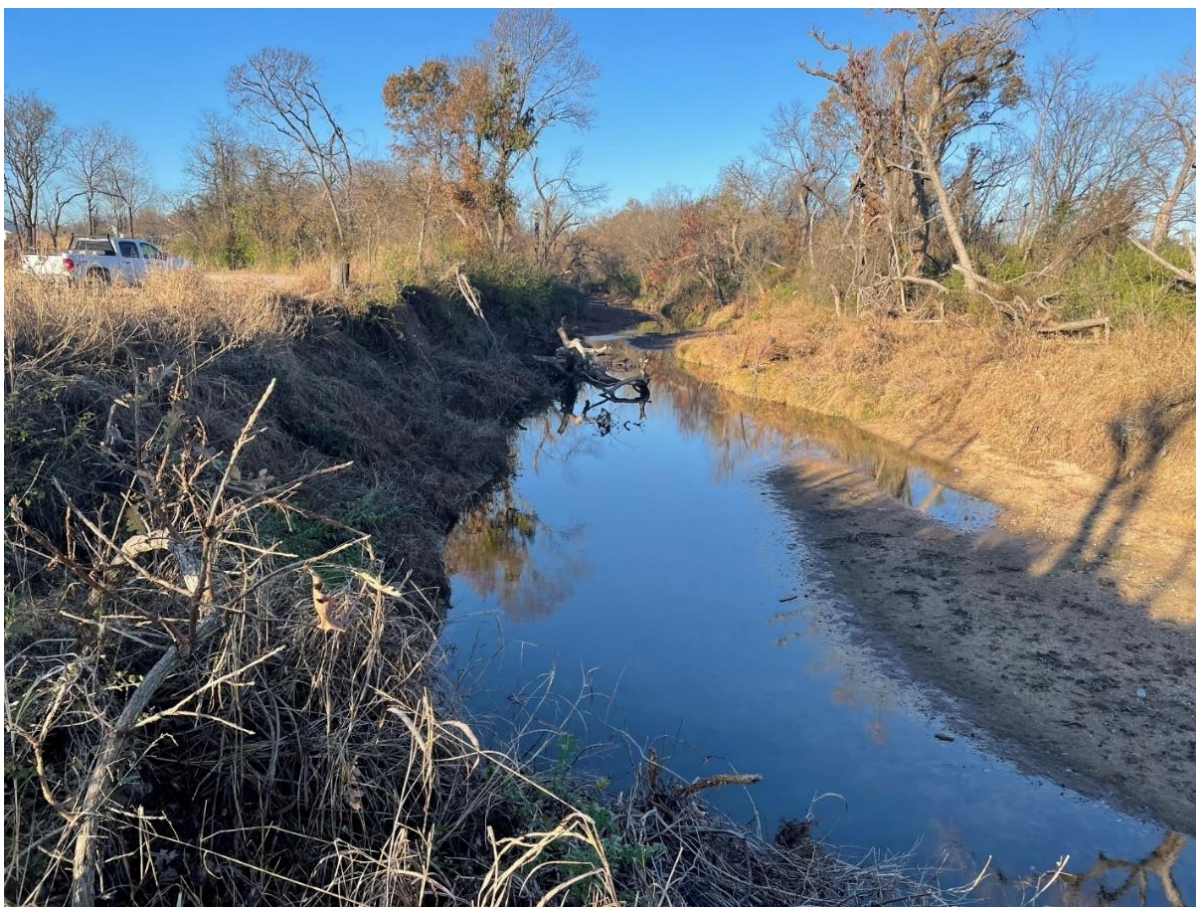
The channel has an inset sinuosity, where relatively straight stretches of channel contain small-scale meandering that has deposited sediment in alternating bars (e.g., Black Sulphur Springs area; Figure 3). These bars provide a beneficial array of in- and near-channel habitats, with some being unvegetated and others dominated by horsetail, sedges, or saplings. Although there is a lot of downed wood in the riparian forest post-tornado, the in-channel wood load did not appear to be especially high. Overall, the channel does not appear to be on a trajectory toward instability or other conditions that would warrant large-scale intervention.

**Figure 3.** Upstream view of Rock Creek near Black Sulphur Springs picnic area. The channel bank at left has recently eroded, but the straight reach, the non-vertical bank, and quick revegetation suggest that further bank erosion will not extend significantly into the picnic area.

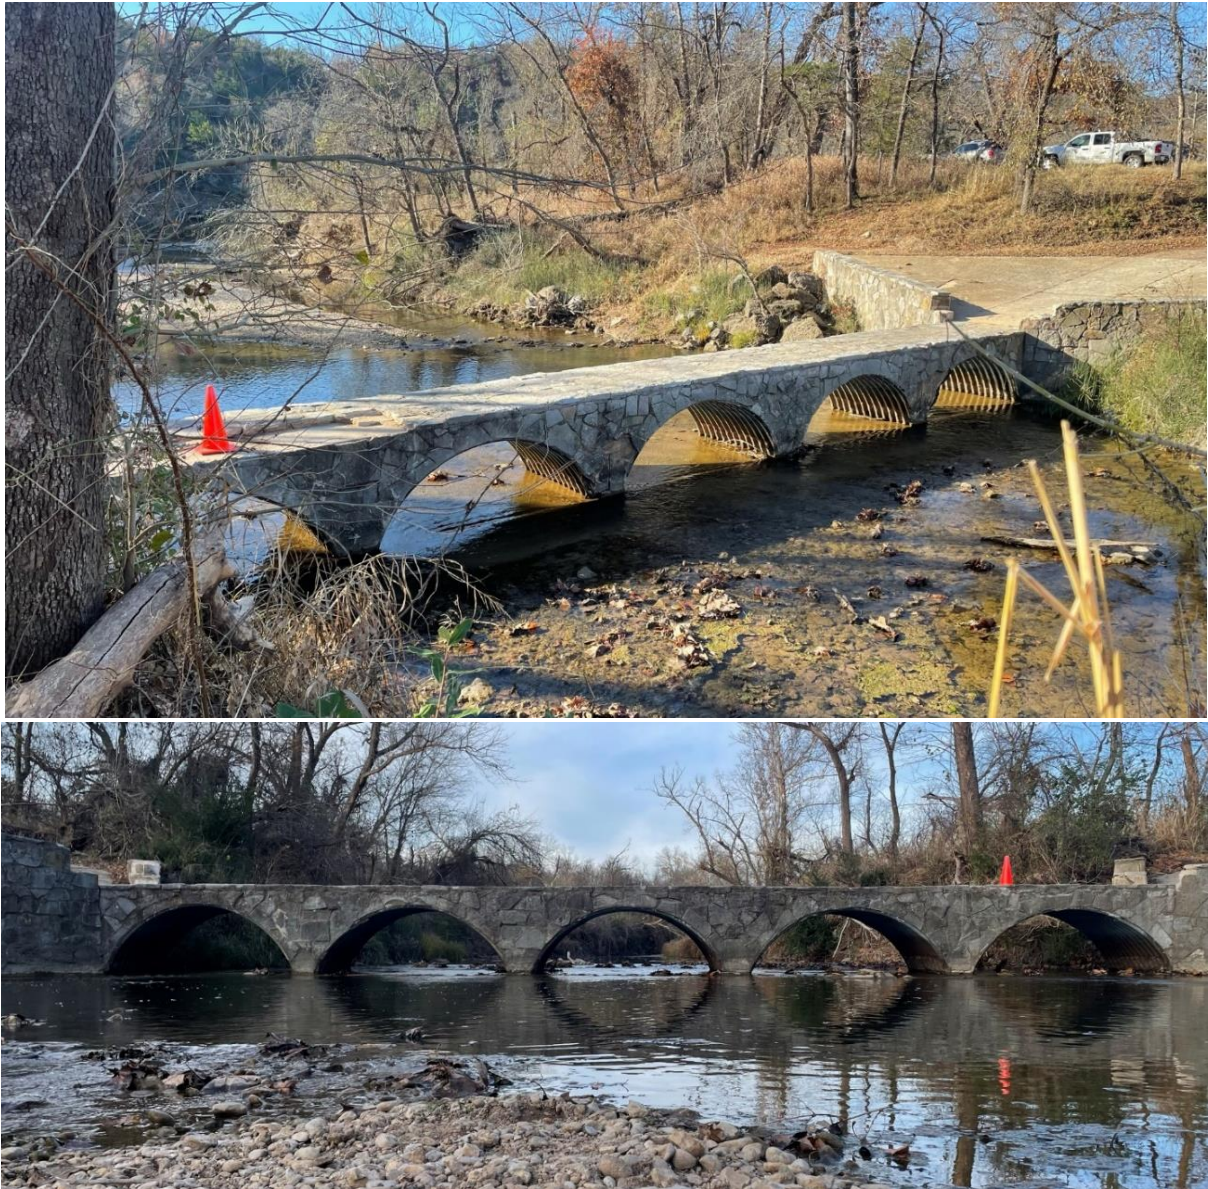
The Job Corps Bridge (JCB) is a pedestrian walkway over Rock Creek that provides access to hiking trails across from its Bromide Springs parking area (Figure 4). Its stone walkway is about 5.1 feet above a hardened concrete channel bed. It has five adjacent archways with openings measured at 3.9 feet high and 9.2 feet wide. Low flows successfully pass through the bridge archways. The JCB was built in 1967 as part of the park's Mission 66 improvements and is considered a non-contributing feature to CHIC's historic landscape, which dates to the Civilian Conservation Corps period in 1933-1940. Ominously, the JCB was washed out three times during construction (Hohmann and Grala 2004), foreshadowing a troubled design and future.

**Figure 4.** Photos looking downstream (top) and upstream (bottom) at the Job Corps Bridge. High flows frequently overtop the bridge and pose a threat to visitors.

The JCB fails to serve what could be considered its primary purpose, to provide safe transport across Rock Creek. Flows frequently overtop the bridge, endangering bridge integrity and people in the vicinity. For example, hikers caught in the rain may be tempted to unsafely cross a flooded JCB to return to the safety of their vehicle. The bridge obstructs water, wood, and sediment transport downstream, with jams forming that exacerbate flood impacts. Some recent flows have undermined the bridge base, and repeated excavation of the sediment bar downstream of the bridge is a recurring maintenance demand on park staff. This bridge reduces channel conveyance of flow downstream and likely increases flood stages within the regulatory floodway.

We recommend considering the JCB as the top management concern for Rock Creek in CHIC. The bridge invites visitors into the river corridor, but doing so comes with appreciable risk. In the short term, installing warning signage (e.g., “Caution: Do not use bridge during floods”) with a break-away rebuilt handrail could mitigate some of the danger, but bridge removal or replacement is the full solution.

Further downstream in the park, the Inkana Bridge provides an example of what an ideal replacement bridge could look like. It is a suspension bridge spanning 190 feet, even though active channel width here is closer to 90 feet. This bridge removes piers from areas affected by common floods, thereby largely removing prime locations where wood could become lodged. Its artistic foundational arches maintain the built aesthetic of CHIC's Historic District. Additionally, JCB replacement would also obviate its associated recurring gravel bar maintenance needs.

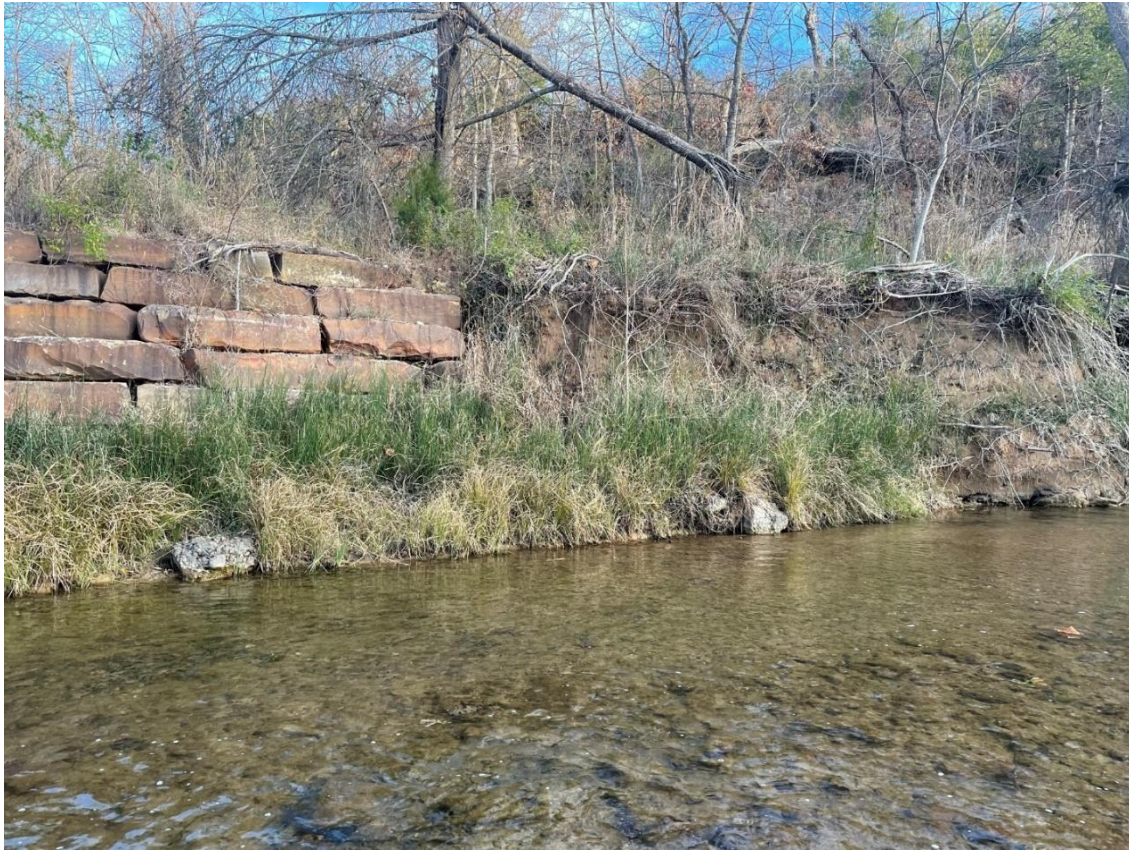
After the 2015 floods, a 160-foot-long rock revetment wall was installed just downstream of the JCB to prevent erosion of the left bank toward the Bison Pasture Trail. This wall remains fully functional, with no immediate threats to its integrity. There is no appreciable flanking on its downstream end, and a vegetated gravel bar has formed at its base providing further stability (Figure 5).

**Figure 5.** The rock revetment wall on Rock Creek just downstream from Job Corps Bridge. Note 1) sedimentation with subsequent plant growth now stabilizes its base, 2) no flanking or excessive erosion on its downstream (right) end, and 3) living and downed vegetation are present to protect the bank and overbank areas during floods.

We do not recommend extending the rock revetment wall downstream of the JCB because it is functioning as designed and bank erosion downstream of it is not abnormally high compared to the rest of Rock Creek in CHIC. If extension were to occur, the most sensible length would be 250 feet to tie into the Vanoss conglomerate bedrock downstream. However, the Bison Pasture Trail is not currently threatened by channel widening or bank erosion, and there is abundant riparian vegetation and downed wood that will protect the bank during future floods. Any future bank erosion here is expected to occur slowly with or without the JCB in place, providing time to monitor future erosion and re-evaluate concerns. Additionally, the revetment wall will no longer be needed as a counter measure to erosive flows if the JCB is replaced. WRD recommends re-evaluating the role and necessity of the wall as part of a JCB replacement project.

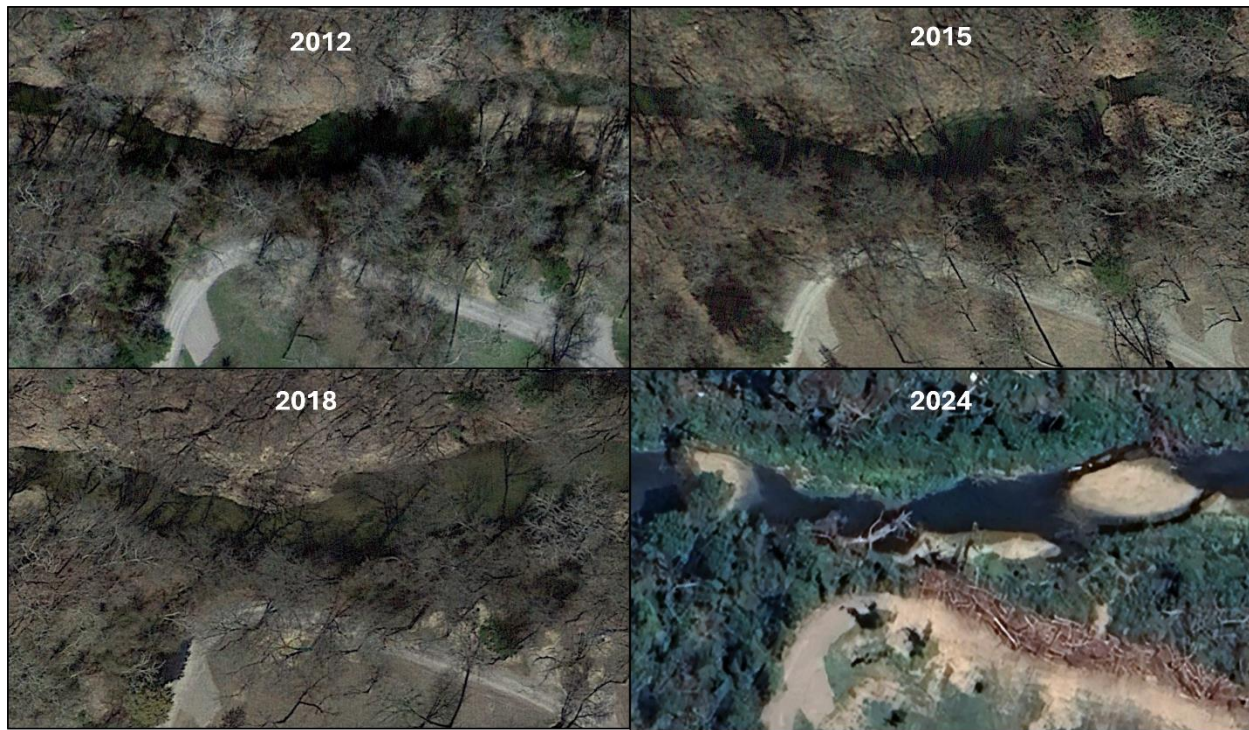
We visited the Black Sulphur Springs picnic area to evaluate its relation to Rock Creek prior to planned redevelopment of this highly tornado-impacted site. The area currently contains a dirt loop road, but there are plans for potential picnic tables and a pavilion to serve visitors. The area lies within Rock Creek's floodplain (Figure 2). Rock Creek runs perpendicular to the site, occupying nearly the same location as it did in the 1936 historical aerial photo. The channel has inset bars that come and go through time (Figure 6). The right bank of the river channel has recently eroded a small portion of floodplain and proposed picnic area (Figure 3).

**Figure 6.** Aerial photo time series of Rock Creek near Black Sulphur Springs for 2012, 2015 (post-floods), 2018, and 2024 (post-tornado, with stockpiled debris visible) (Google Earth imagery). Instream bars come and go, but the eastward orientation has remained. Note that the channel has not moved substantially toward the road, a trend that goes back through the 1936 photo (not shown).

We recommend allowing the channel to naturally recover and adjust here instead of intervening to stabilize the bank or redirect flow. Any full bank stabilization would be hundreds of feet long, so accommodating channel adjustments is likely the easier option. This recommendation is consistent with NPS best management practices that advise avoiding bank stabilization when possible (Field et al. 2025). Furthermore, avoiding in-channel intervention also has the benefit of not transferring extra flow energy downstream. Instead, this is a timely opportunity to redevelop the site with an understanding of this relation to the river. Several-to-tens of feet of additional bank erosion and floodplain loss could occur as the bank lays back into a more stable angle, but bank erosion is not anticipated to proceed significantly into the picnic area, as evidenced by the 90-year air photo record. Flood inundation of the picnic area is likely to continue.

We recommend placing new infrastructure well away from the riverbank. This could include realigning the dirt road a few tens of feet further from the bank and ensuring that any new capital investments (e.g., pavilion) are placed away from the river and comply with Director’s Order #77-2: Floodplain Management (DO 77-2; NPS 2003). Near-channel locations can be preserved as open space or day-use picnicking, with low-value infrastructure (e.g., picnic tables) and safe

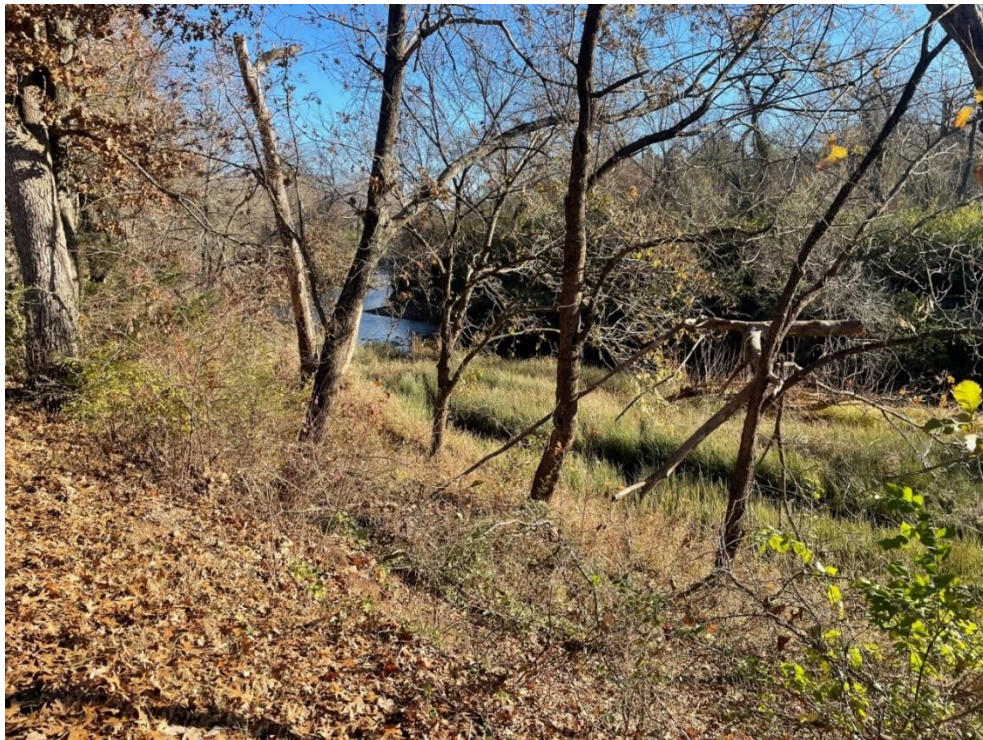
For the areas observed, an estimated ten feet or more of upland floodplain remains between the riverbank and roadway, with dense riparian vegetation and organic debris protecting the cohesive soils beneath (Figure 7). Downed wood and living vegetation are present to redirect and absorb flow energy to partly protect the bank from erosion.

**Figure 7.** Rock Creek and its riparian vegetation near Walnut Grove. The photo shows an upstream view as seen from the roadway edge, with vegetation and downed wood providing natural bank and road protection.

Although bank scour and localized erosion have recently occurred, the river does not appear to be threatening Perimeter Drive. Additionally, riparian vegetation and downed wood in the overbanks serve positive roles by reducing flow velocity and protecting the underlying soil from erosion. Therefore, leaving the wood and vegetation in place serves as natural bank and road protection. Restoration of native riparian vegetation could facilitate a healthier and more resilient riparian corridor, including the removal of invasive honeysuckle to facilitate the restoration of a more biodiverse understory. We do not see a need to introduce engineered bank protection.

Although we did not observe imminent threats to the road, continued evaluation and monitoring could be undertaken by initiating a simple protocol. For example, staff could measure the distance from road edge to top of riverbank every 20 feet throughout the area of concern, repeating the survey annually or after each flood.
