EMERALD CREEK LANDSLIDE REHABILITATION (Site 81-6)  
Summary of Heavy Equipment and Labor Intensive Costs

## STATUS OF THE EMERALD CREEK LANDSLIDE, REDWOOD NATIONAL PARK

REHABILITATION SITE 78-2  
HARRY WIER (EMERALD) CREEK, 1981-6

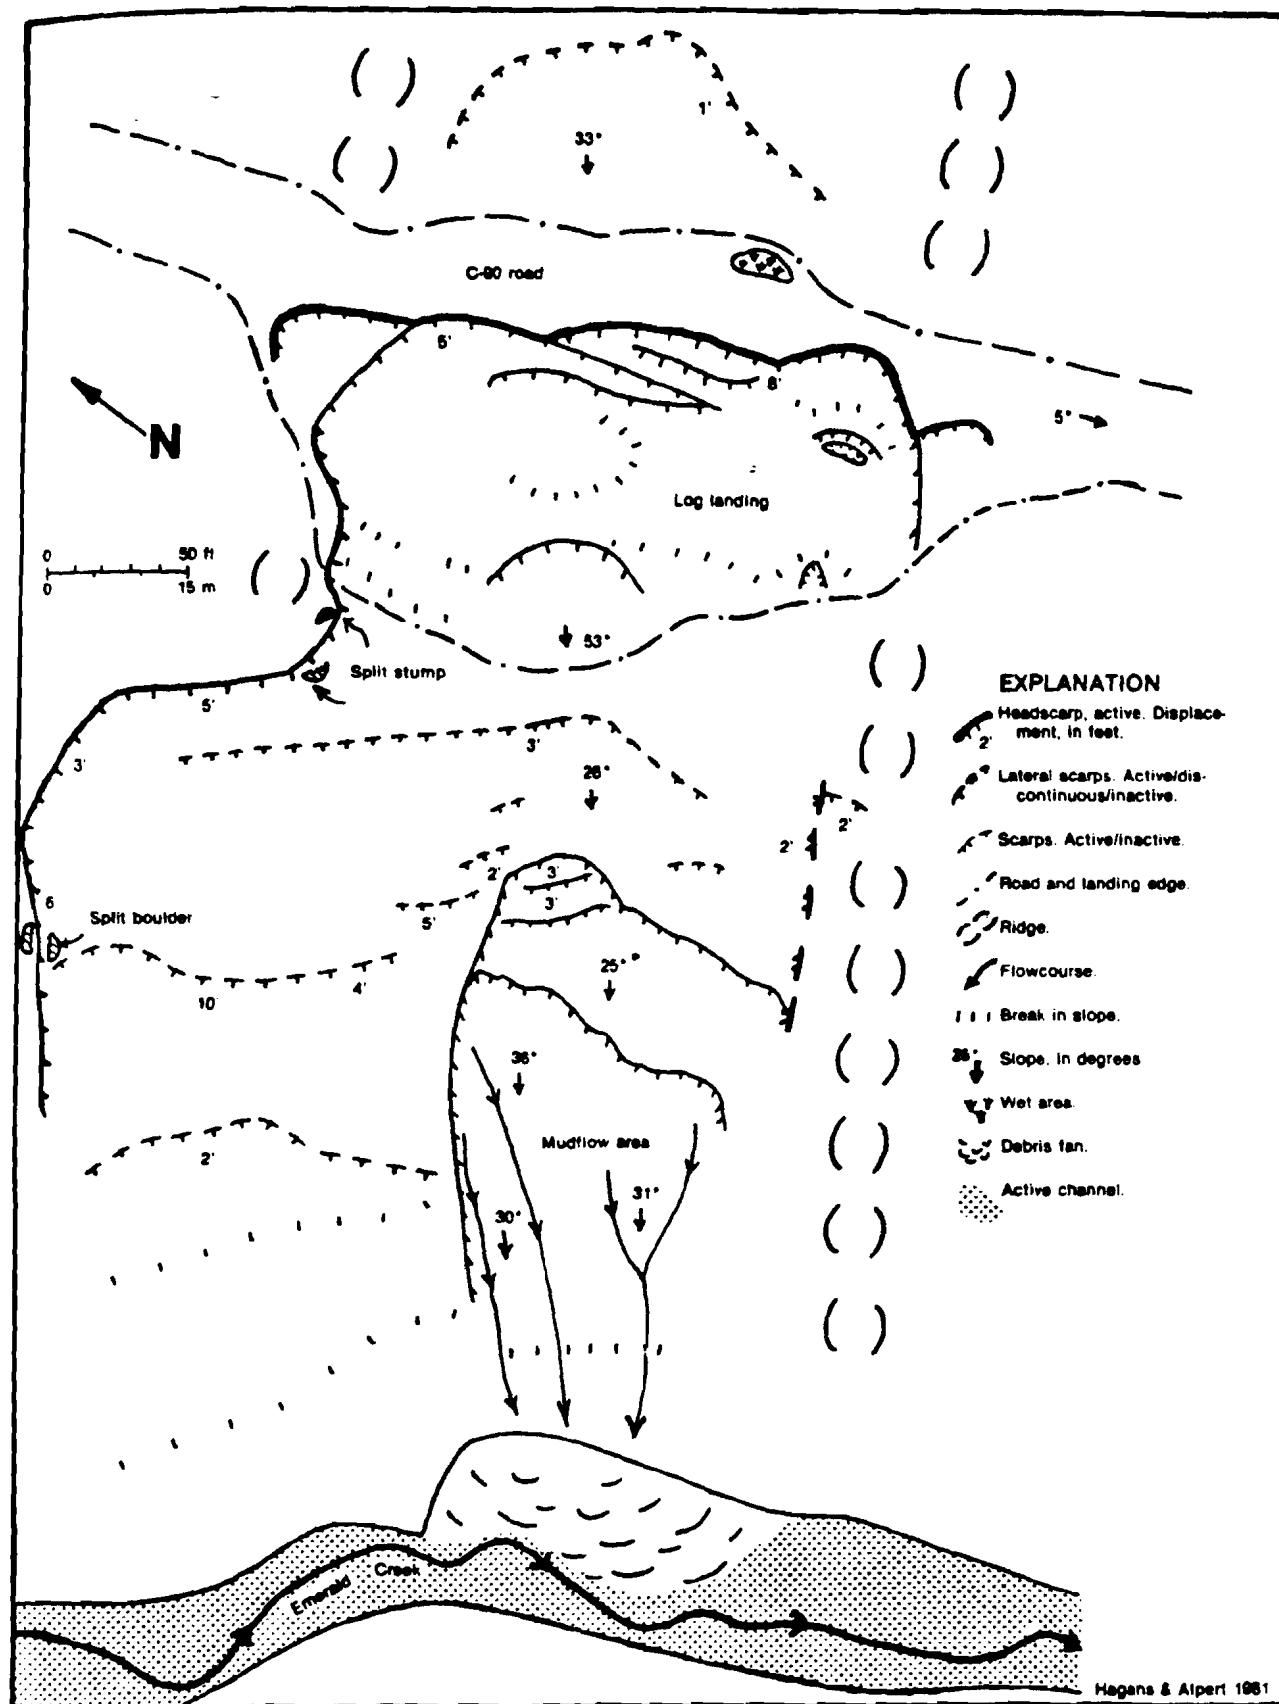
Figure 2

By 1981 (Fig. 2) the headscarp was 5 to 8 ft high, and the landing edge had dropped a total of 17 ft since construction. Downslope of the road several old growth redwoods had fallen and the soil mantle was further destabilized by root upheaval. The north lateral scarp was continuous with the headscarp and showed evidence of recent activity. From the headscarp down to the 100-ft-wide mudflow, the south lateral scarp was discontinuous and defined by enechelon ground tears. From the top of the mudflow the creek, the south margin was a well-defined 3-ft lateral scarp.

Plan Map Before Treatment, Summer 1981, Emerald Creek Landslide, R.N.P.

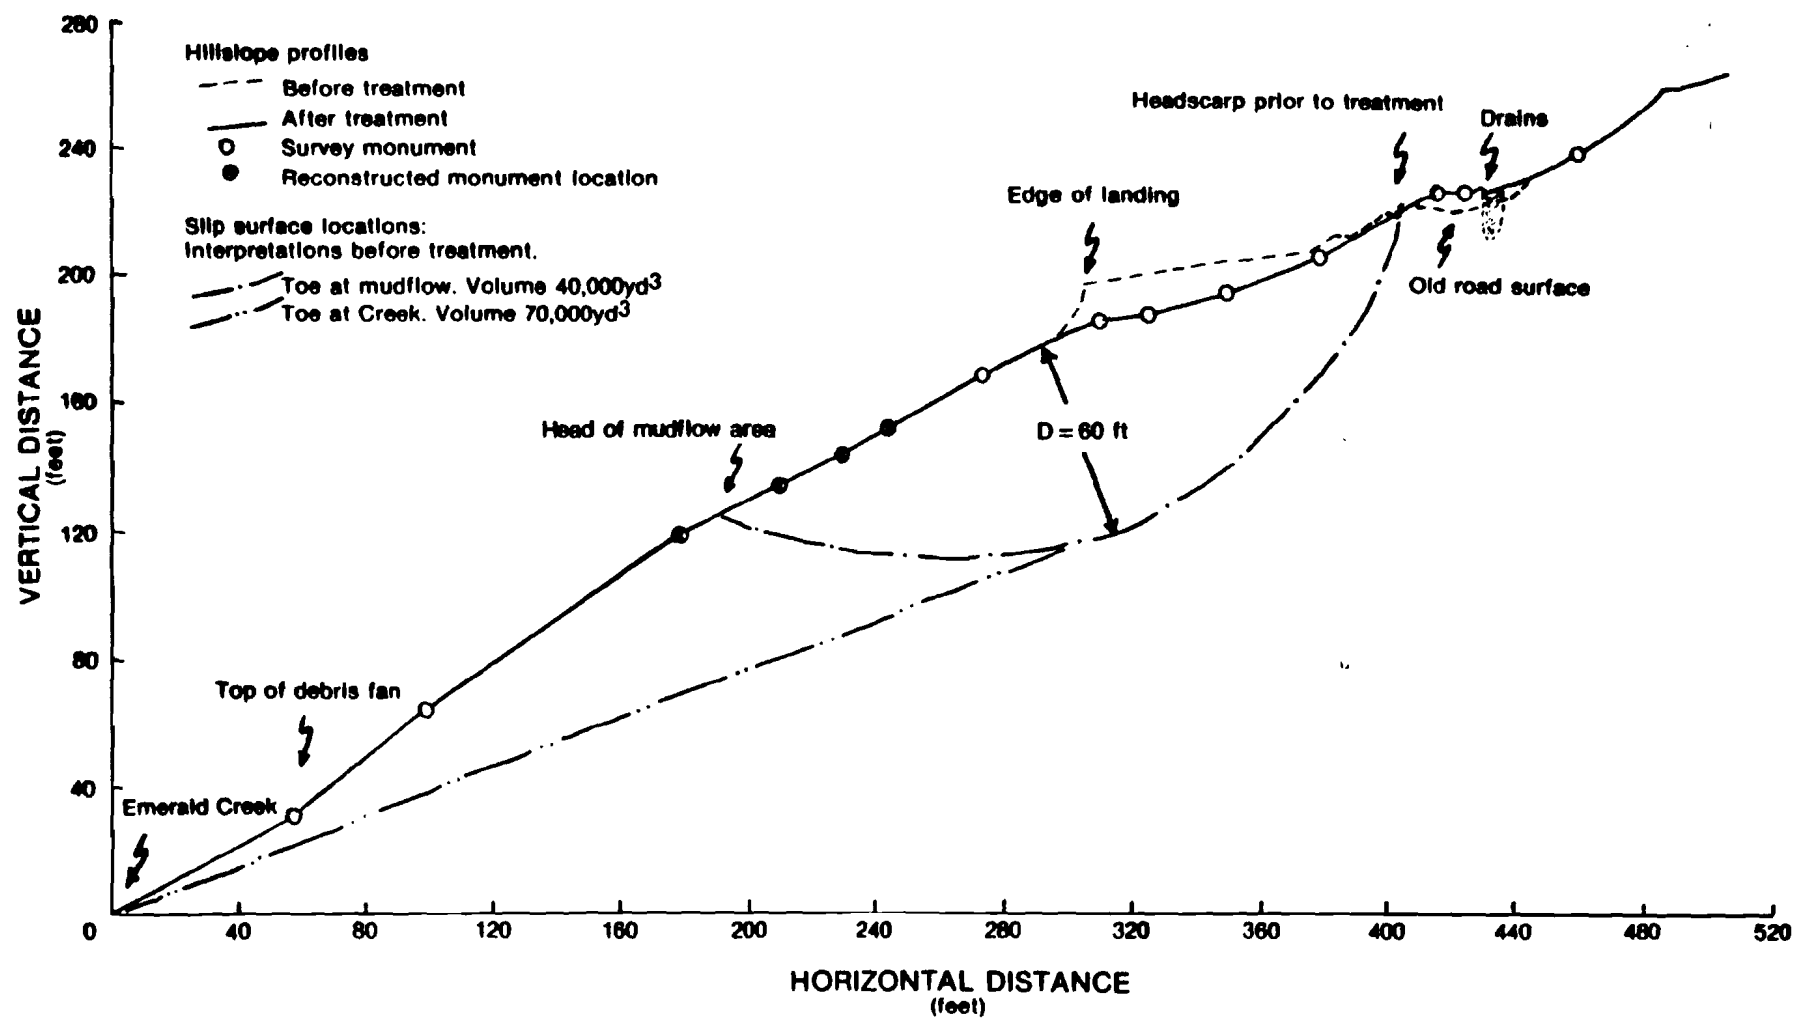
**Figure 3**  
**Profile Before and After Treatment, Summer 1981, Emerald Creek Landslide, R.N.P.**

The depth of failure appears to be shallower than previous interpretation suggested. Evidence is not clear whether a deep-seated slip surface ever existed (Fig. 3) or what its downslope extent may be. If it is present, the lack of measurable movement on the mudflow and old headscarp system (Fig. 2) show it was inactive in 1981-82. The shallow failures observed possibly could represent the adjustment of surface blocks on a deeper failure. Evidence of a shallow slip surface include the initiation of movement early in the wet season, the observed depth of the bent piezometers, and the observed translational gliding of blocks which Fig. 9 also illustrates. The toe of this failure plane is probably at the break in slope at the top of the mudflow.

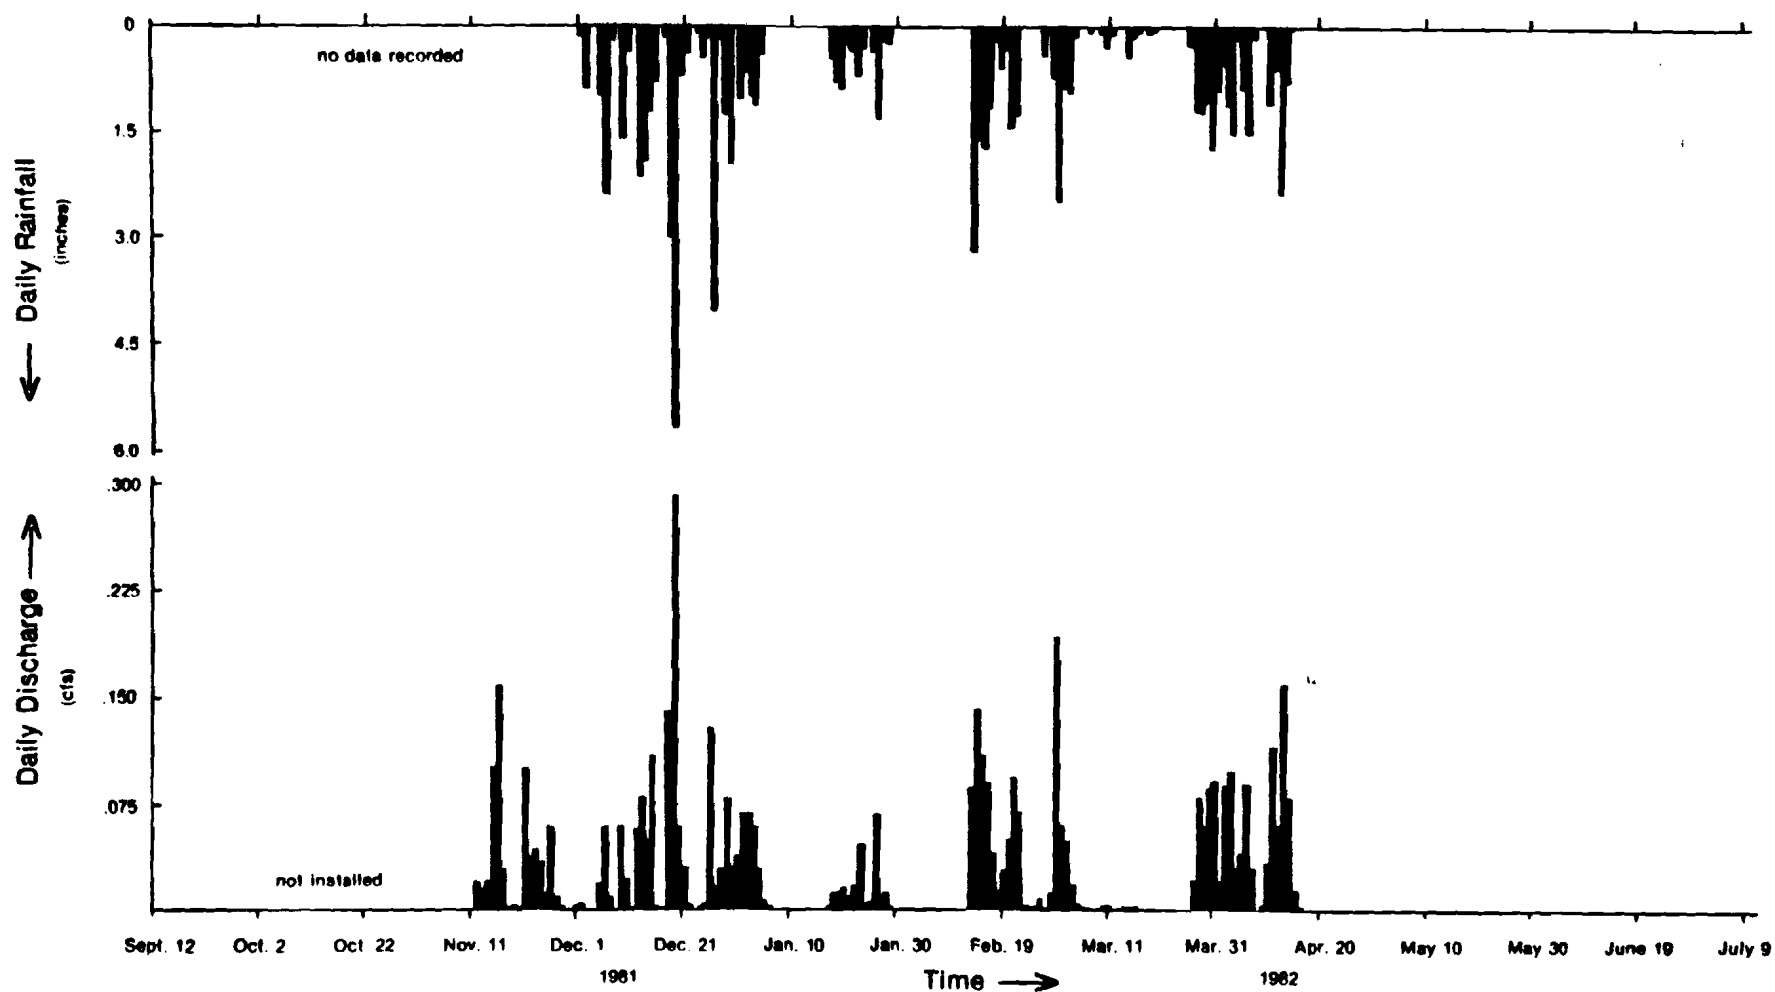
Figure 4  
Daily Rainfall Totals and Average Daily Discharge of Surface Water Drain  
During Winter 1981-82, Emerald Creek Landslide, R.N.P.

All surface water which would have entered the slide from upslope was intercepted. Surface water removed by the drains between 12 November and 14 April was approximately 406,000 ft<sup>3</sup> ( $3 \times 10^6$  or 9.3 ac/ft) or 40% of the rain that fell with the 3 ac contributing watershed uphill of the landslide during that period (Fig. 4). The drainage area effectively contributing runoff is difficult to determine due to a dense network of tractor trails which may divert some surface flow. The runoff/rainfall ratio seems to be somewhat low compared to published data for nearby large streams (Nolan and Janda 1981) and Redwood Creek (Lee et al. 1975). The slide area itself generated an unmeasured amount of runoff which was observed to flow into and along internal and lateral scarps.

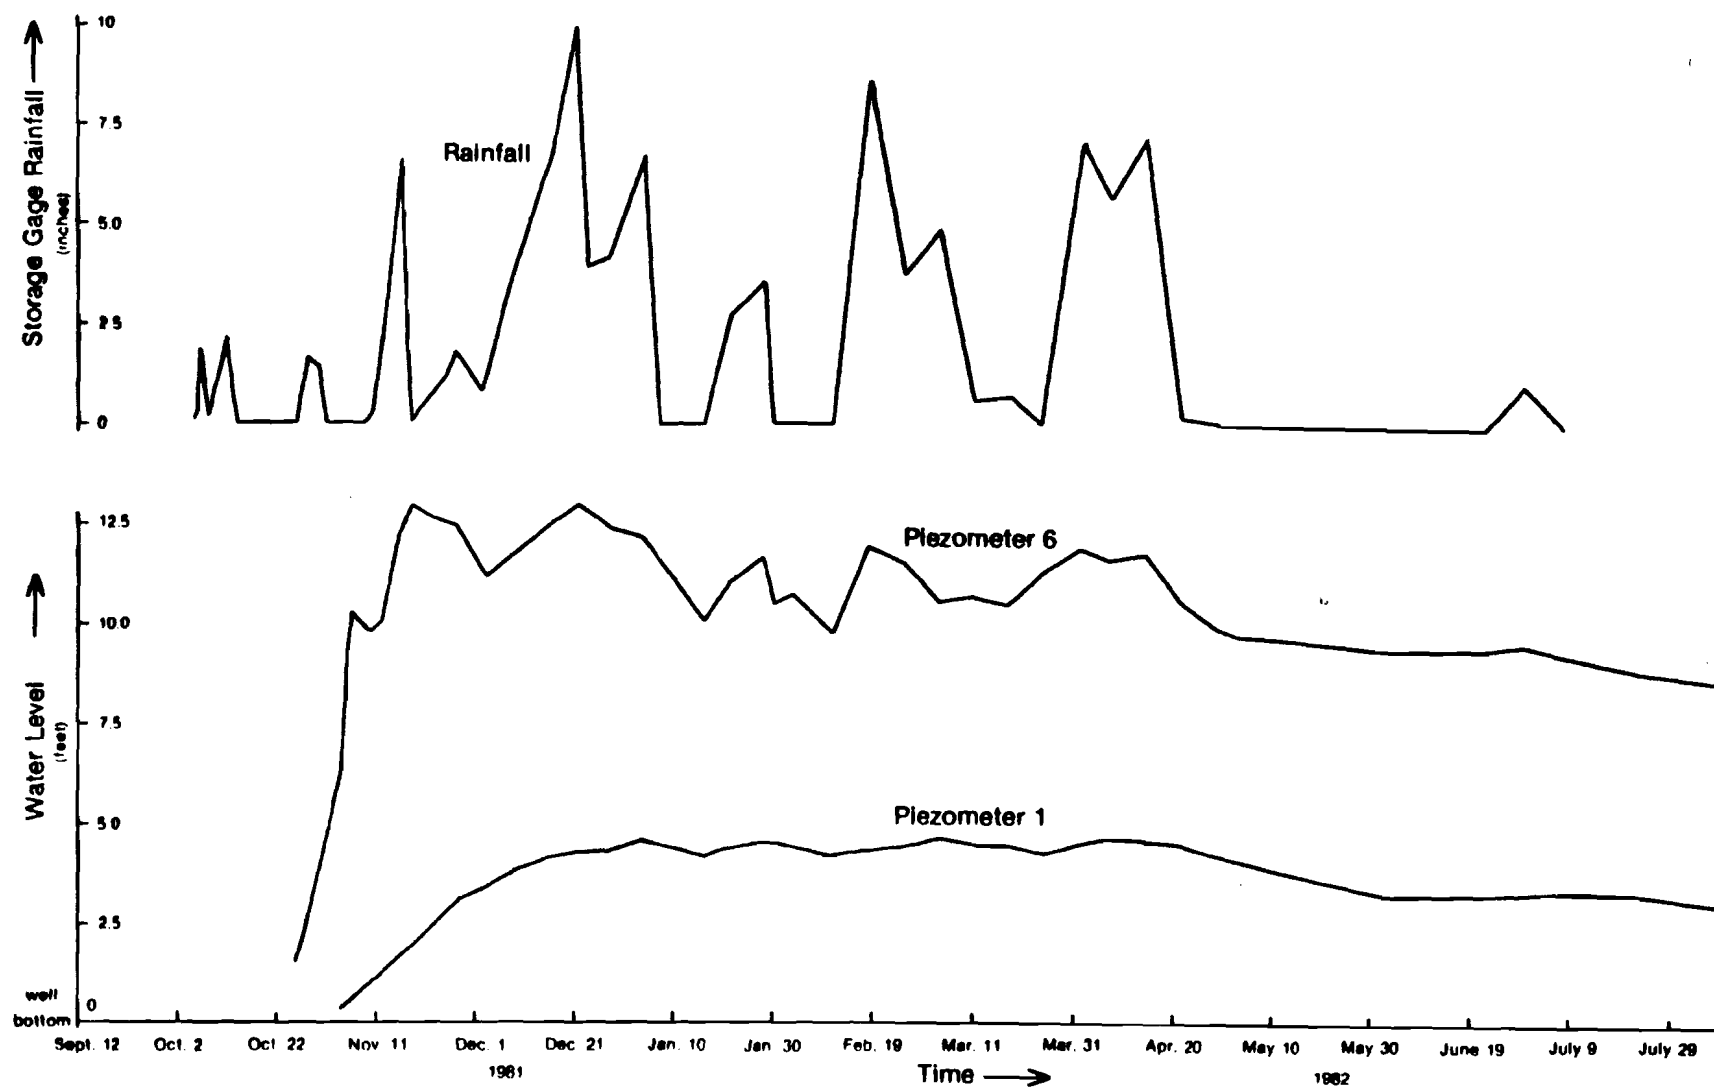
Figure 5

Many peak water levels in the piezometers were missed due to the periodic measurements (Fig. 4, 5). Continuous data would have allowed some correlation with rainfall and mass movement rates. Most piezometers were dry except during periods of high rainfall. Only two showed measurable water throughout the winter. P-6, located in a wet clayey area on the excavated landing area (Fig. 6), was artesian with water levels 2 - 4 ft above ground most of the winter and responded strongly to rainfall (Fig. 5). P-1 is in a clayey seep on the road cut bank 50 ft higher in elevation than P-6 (Fig. 6), and responded more to the overall wet season than specific storms. P-1 may tap an unconfined aquifer and reflect the groundwater table, whereas P-6 is in a confined aquifer which is probably a perched water zone.

Periodic Measurements of Rainfall and Water Levels During Winter 1981-1982,  
Emerald Creek Landslide, R.N.P.

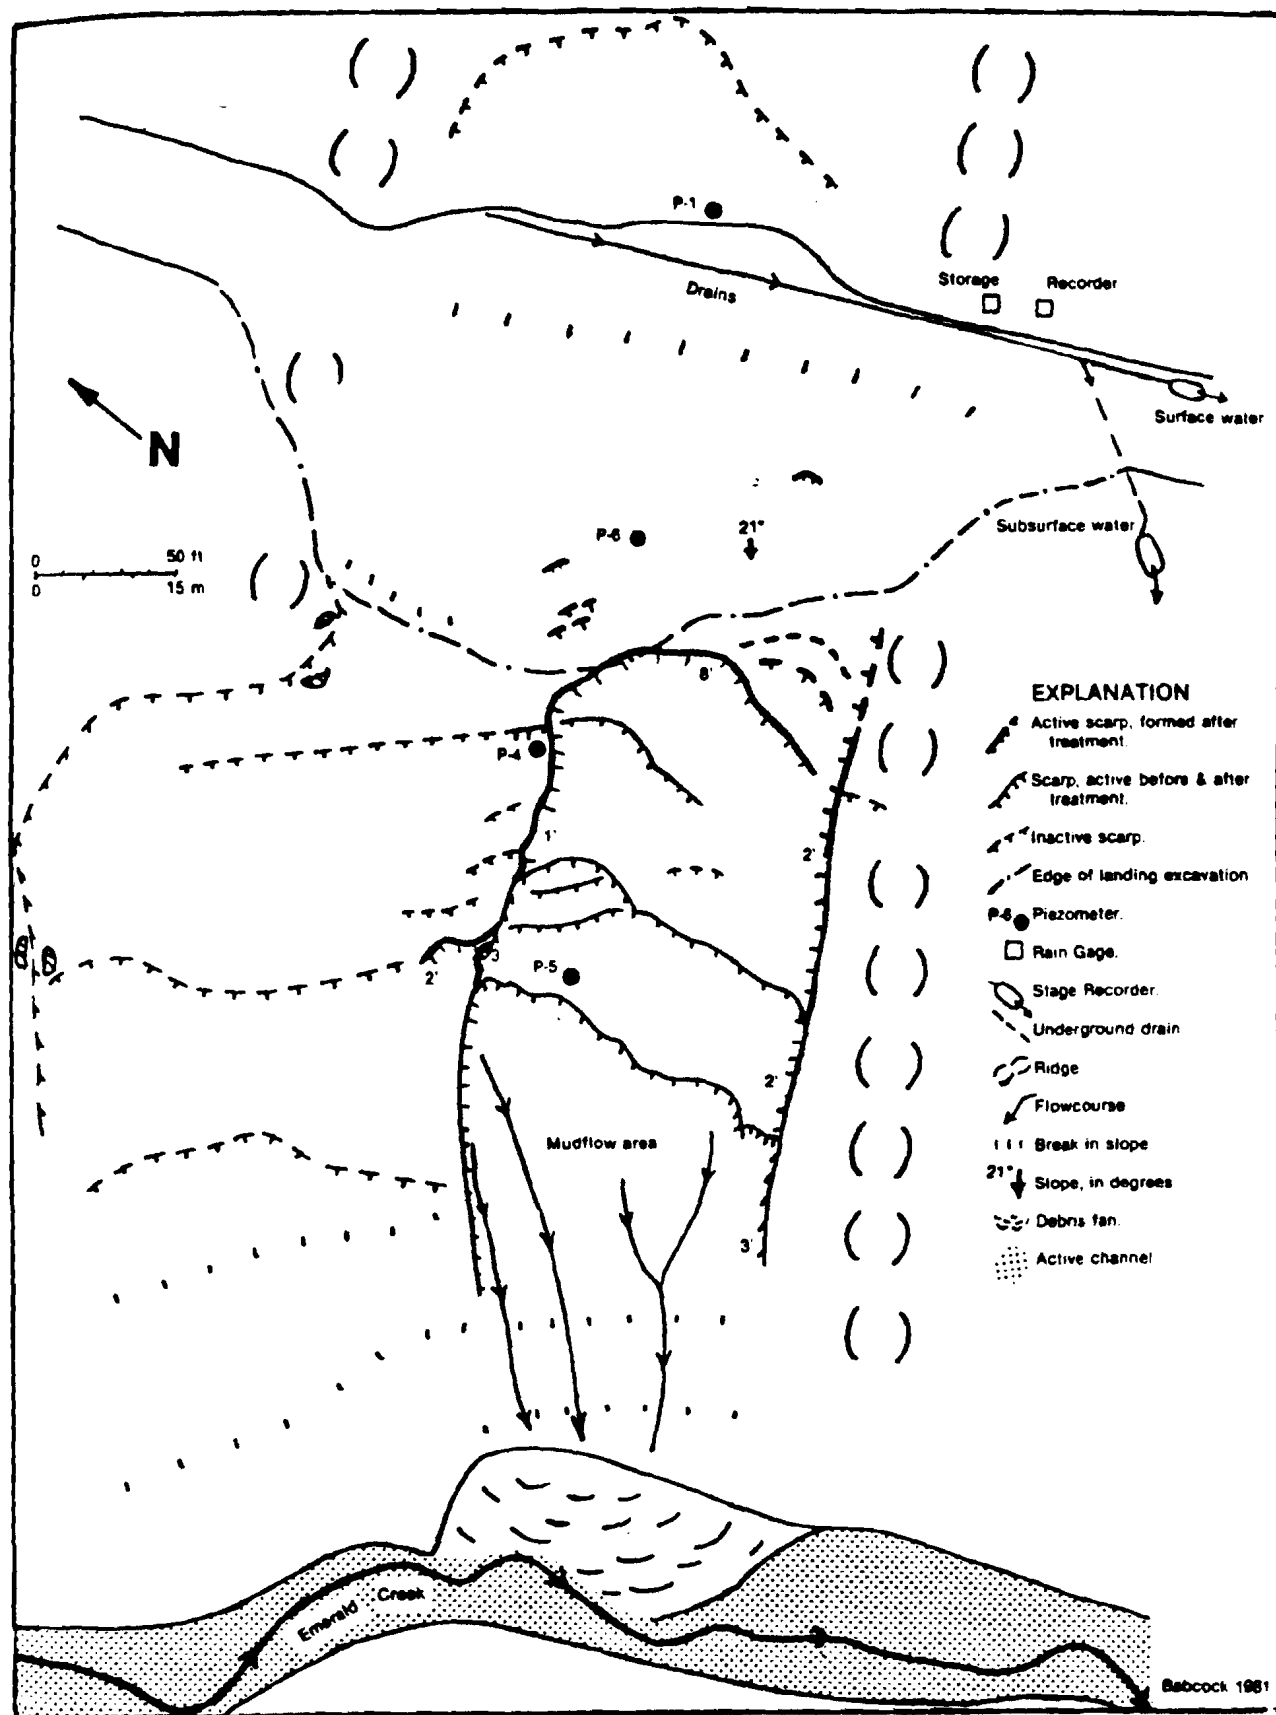
Figure 6

Two piezometers acted inadvertently as inclinometers. On 12 November, after 12.9 in of rain to date, the 717.7-ft deep hole of P-5 (Fig. 6) was pinched at 12 ft deep. Four days later it was 6 ft deep. At this time an 8 to 10 ft headscarp formed at the edge of the excavated area, downhill of the original headscarp and uphill of the "inclinometers" (Fig. 6). The south lateral scarp had extended uphill to the new headscarp. By 16 December, after 27.6 of rain, P-4, the 15-ft deep piezometer 77 ft uphill of P-5 (Fig. 6), was pinched at 6 ft deep.

Plan Map Showing Change of Scarps, November 1981, Emerald Creek Landslide, R.N.P.  
Rain-to-date 22 in. Average Movement 3.5 ft.

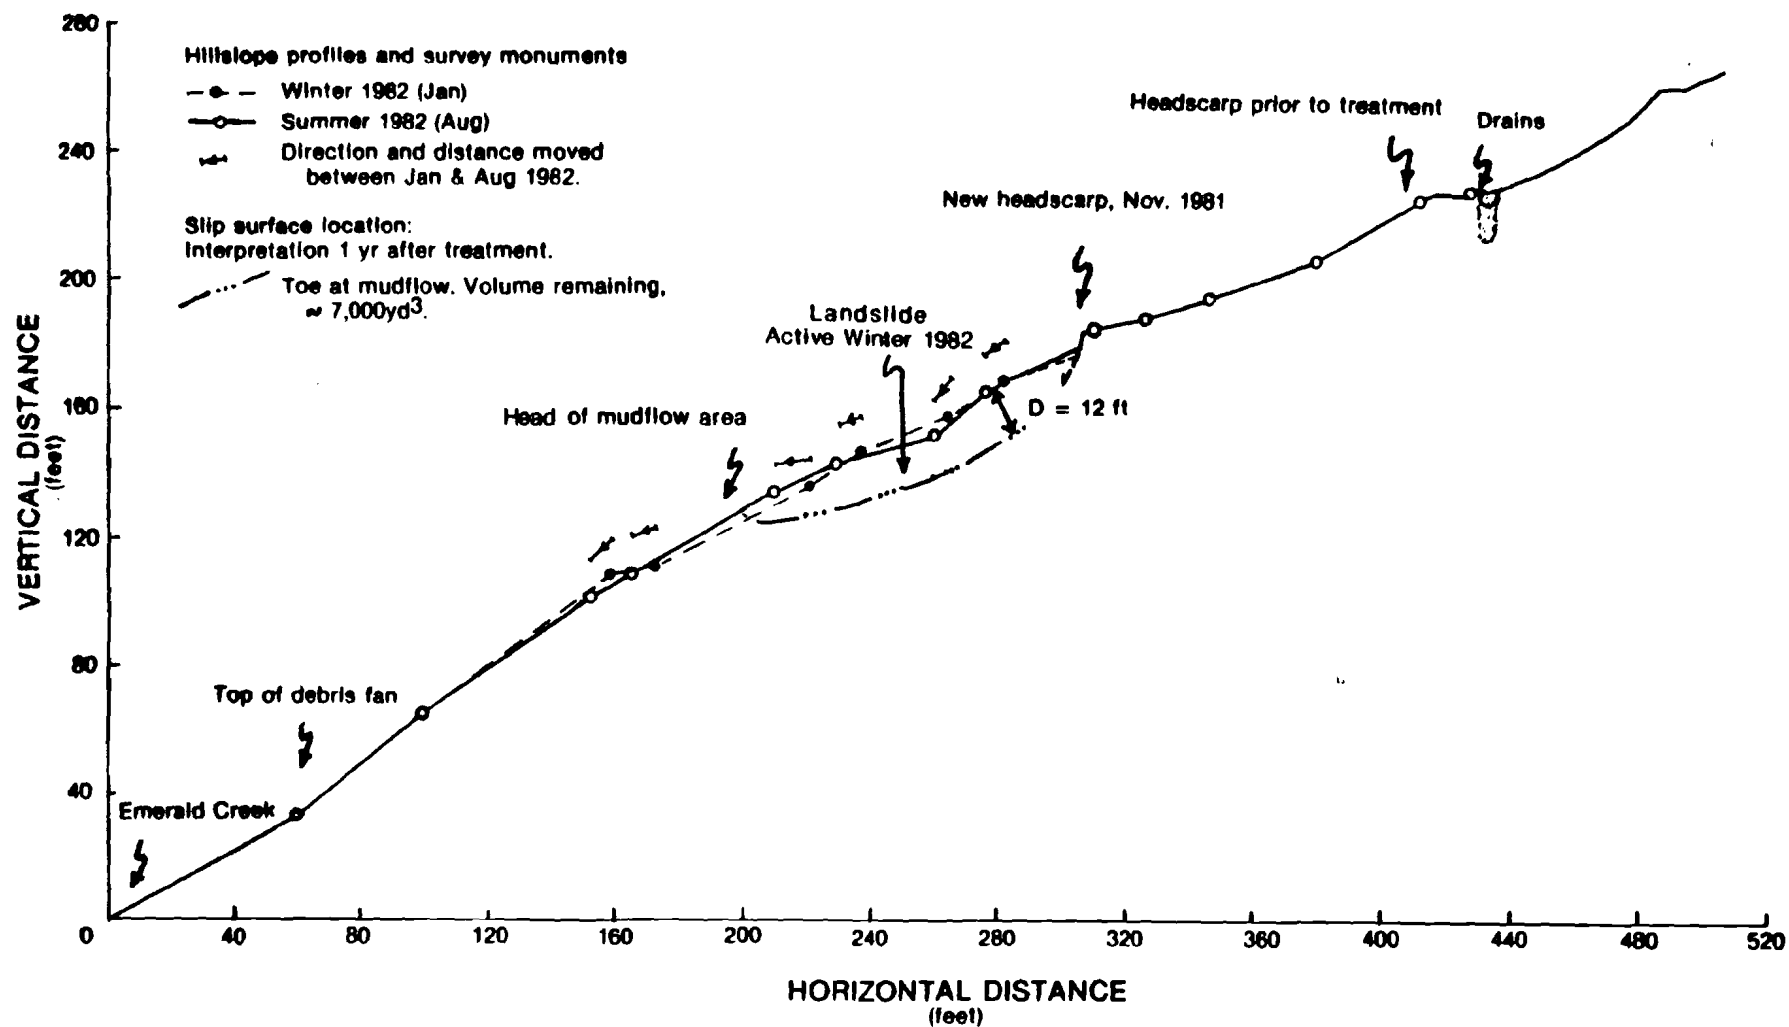
Figure 8

Monument Movement and Slope Profiles in January and August, 1982, Emerald Creek Landslide, R.N.P., With Present Interpretation of Failure Plane

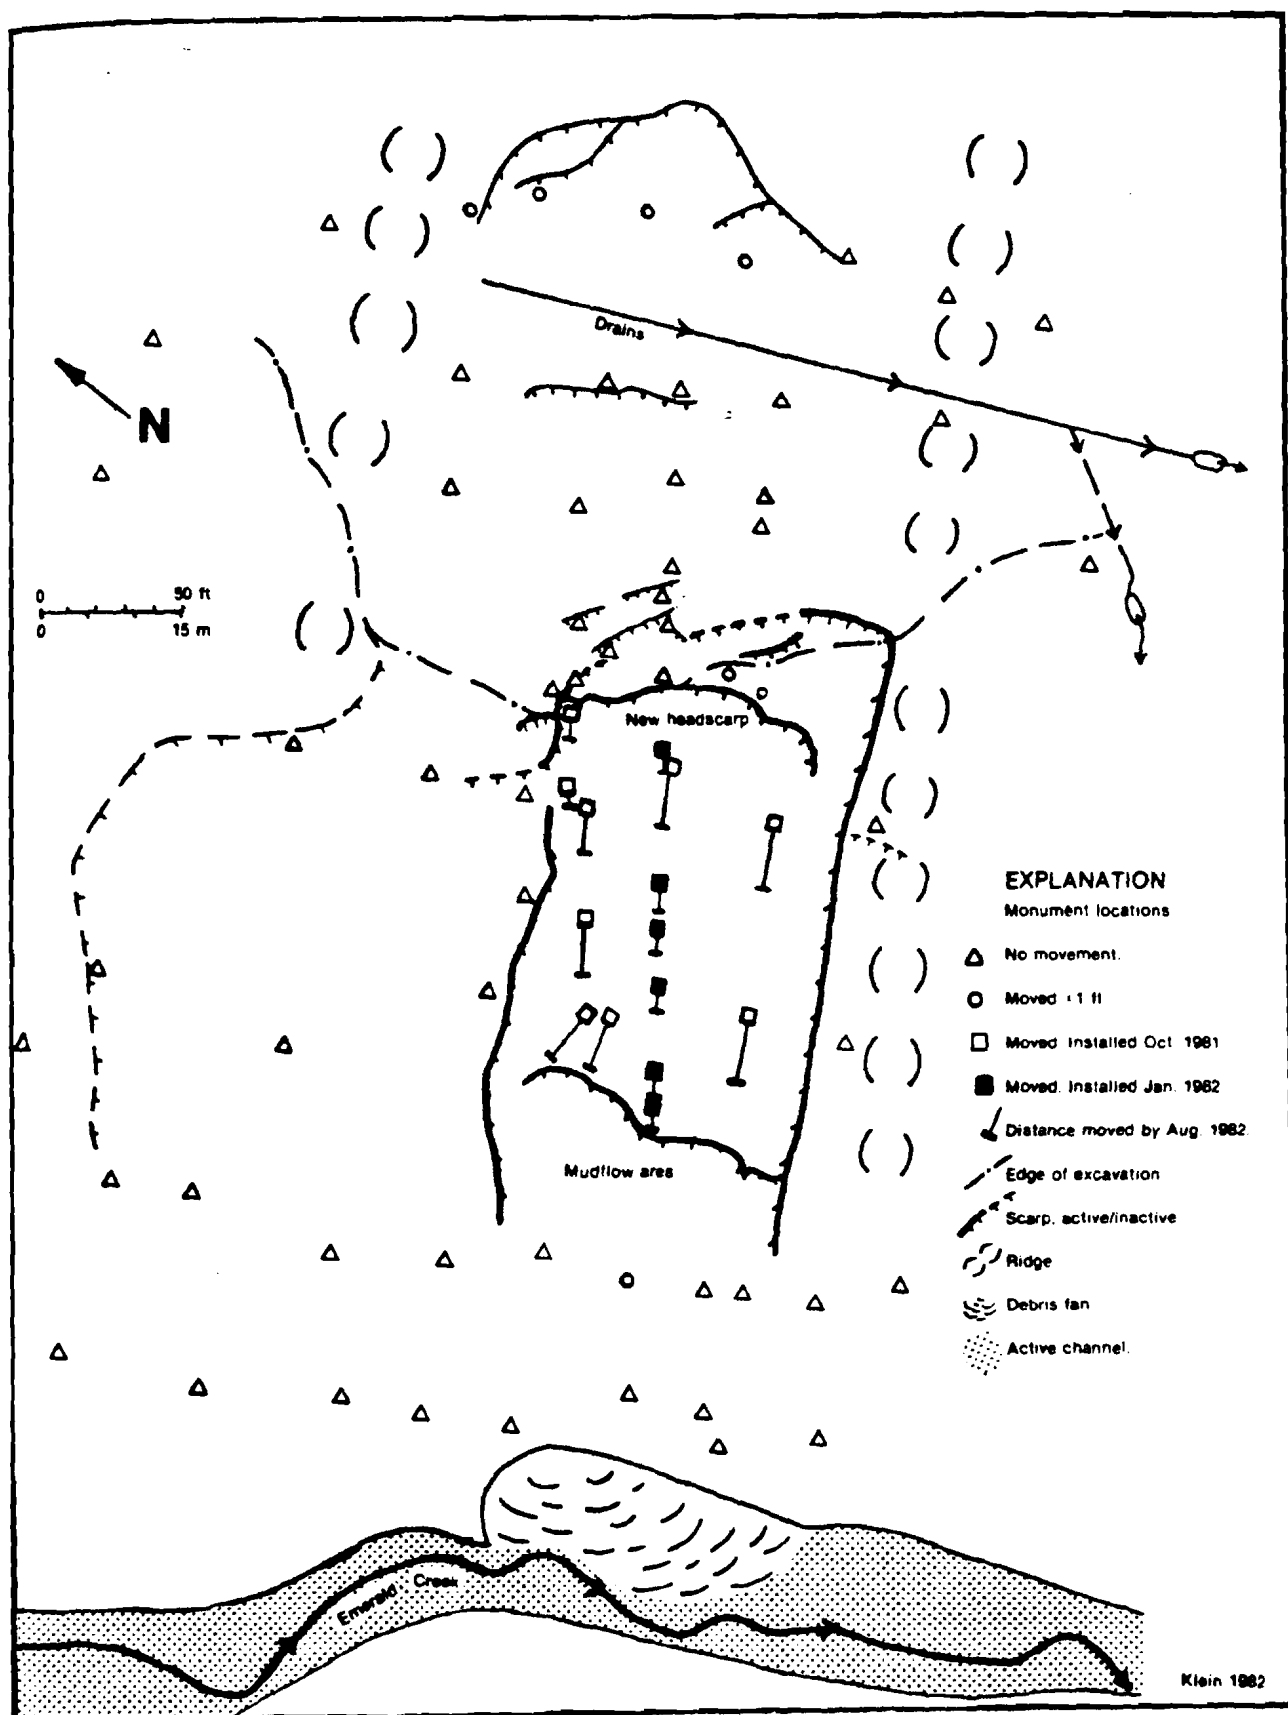
Figure 9

By February, 1982, after 75 in of rain, blocks of material downslope of the new headscarp and above the mudflow area moved 13 ft or more according to surveyed monuments. The final scarp map (Fig. 7) and the map of monument movement after the winter (Fig. 8) illustrate overall slide changes. No measurable displacement occurred at the old headscarp. A new headscarp had formed and migrated slightly uphill. The south lateral scarp became continuous and well-defined up to the new headscarp. No change occurred on the north lateral scarp. The major movement was translational, downhill sliding of blocks (Fig. 9) in part defined by pre-existing scarps (Fig. 2). Maximum total movement was 21.2 ft horizontally and 10.6 ft vertically. The magnitude of distance moved was probably influenced by the relatively wet winter (25 in above the basinwide average). The mudflow area was altered by fluvial processes, but showed no mass movement. In 1981, the slide mass seems to include a smaller area than before treatment.

Plan Map Showing Total Monument Movement After Winter 1981-1982,  
Emerald Creek Landslide, R.N.P.

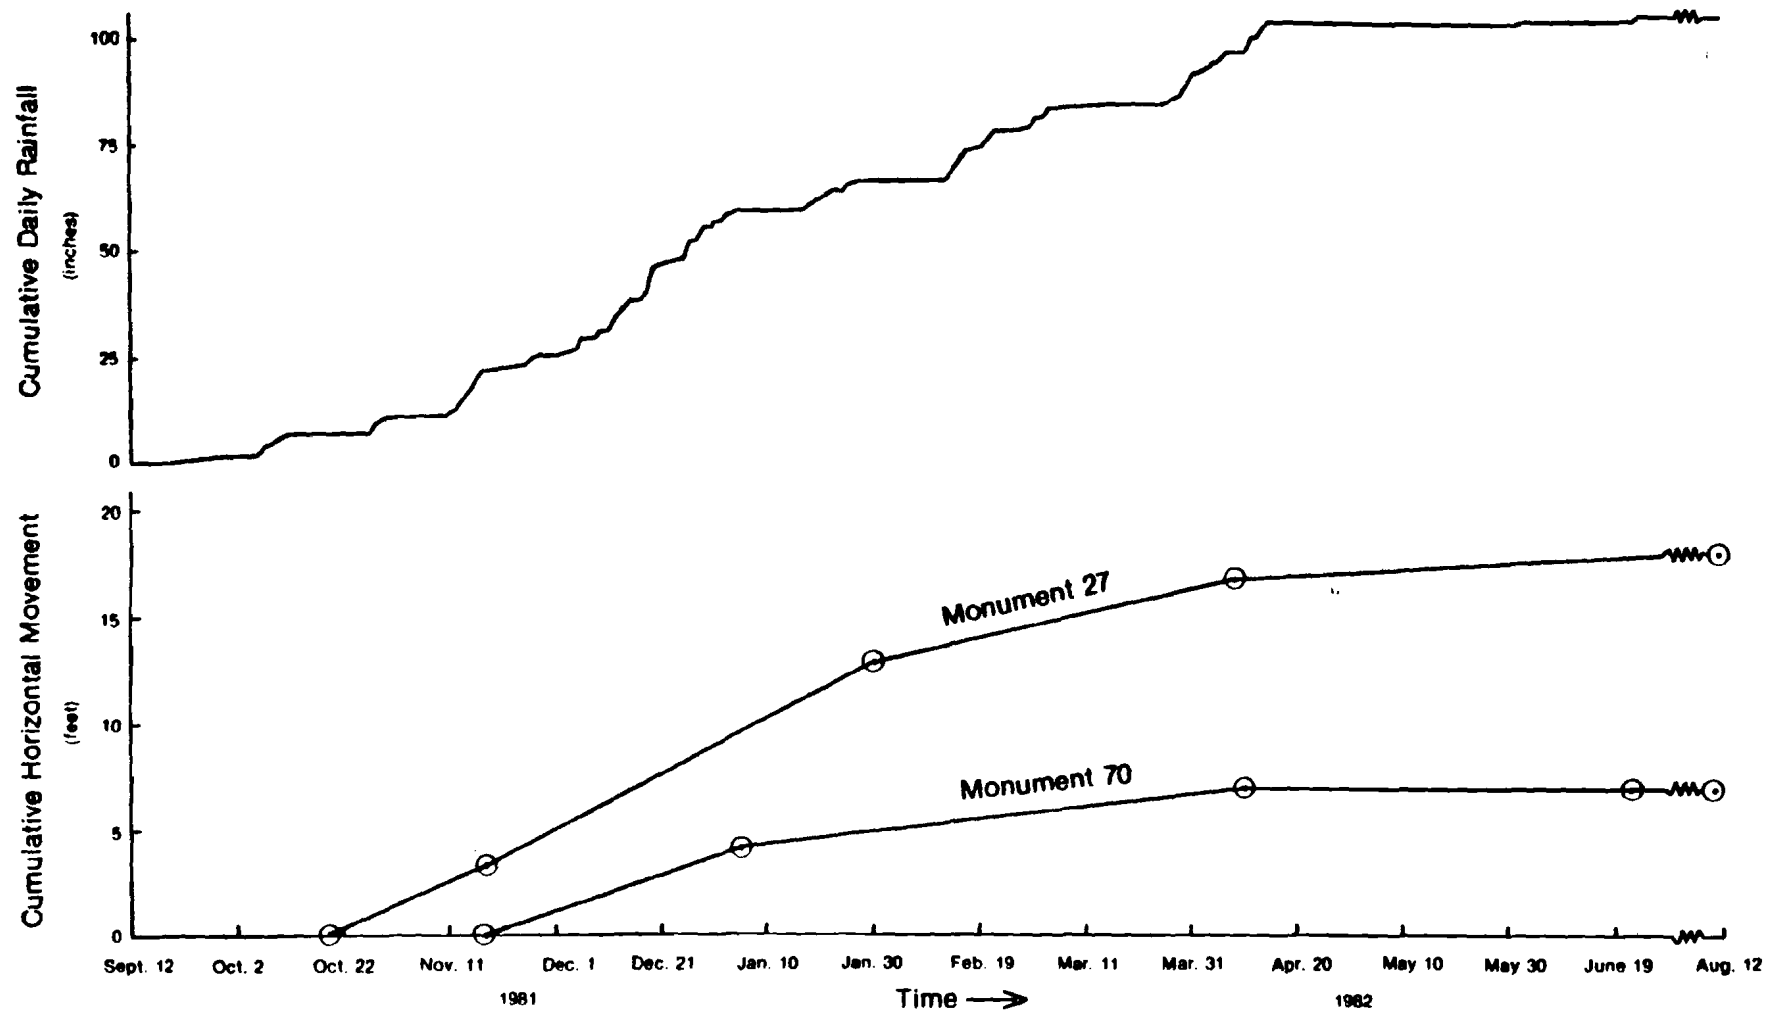
Figure 10

Fig. 10 shows time plotted against cumulative rainfall and the cumulative horizontal movement of two monuments. The slopes of the line segments drawn between monument distances do not indicate actual rates of movement, since movement was observed to be dependent upon individual rainfall events. The slopes of the line segments are partly dependent on when measurements occurred before and after a major storm. The slopes could be called "averaged movement rates". Representative distances of monument movement were 12.8 ft, 2.5 ft, and 0.5 ft, respectively, for the three rainfall periods. The "averaged movement rates" mimic the seasonal rainfall distribution (e.g., the averaged rate of rainfall within a period of time). Although surveyed infrequently, movement correlates strongly with rainfall. The effect of antecedent soil moisture on slide movement has not been evaluated.

Cumulative Rainfall and Horizontal Movement of Two Monuments During Winter  
1981-1982, Emerald Creek Landslide, R.N.P.
