**SUMMARY REPORT**

**EROSION CONTROL WORK PERFORMED ON  
UPPER DEVILS CREEK REHABILITATION UNIT**

**85-1**

**December 1985**

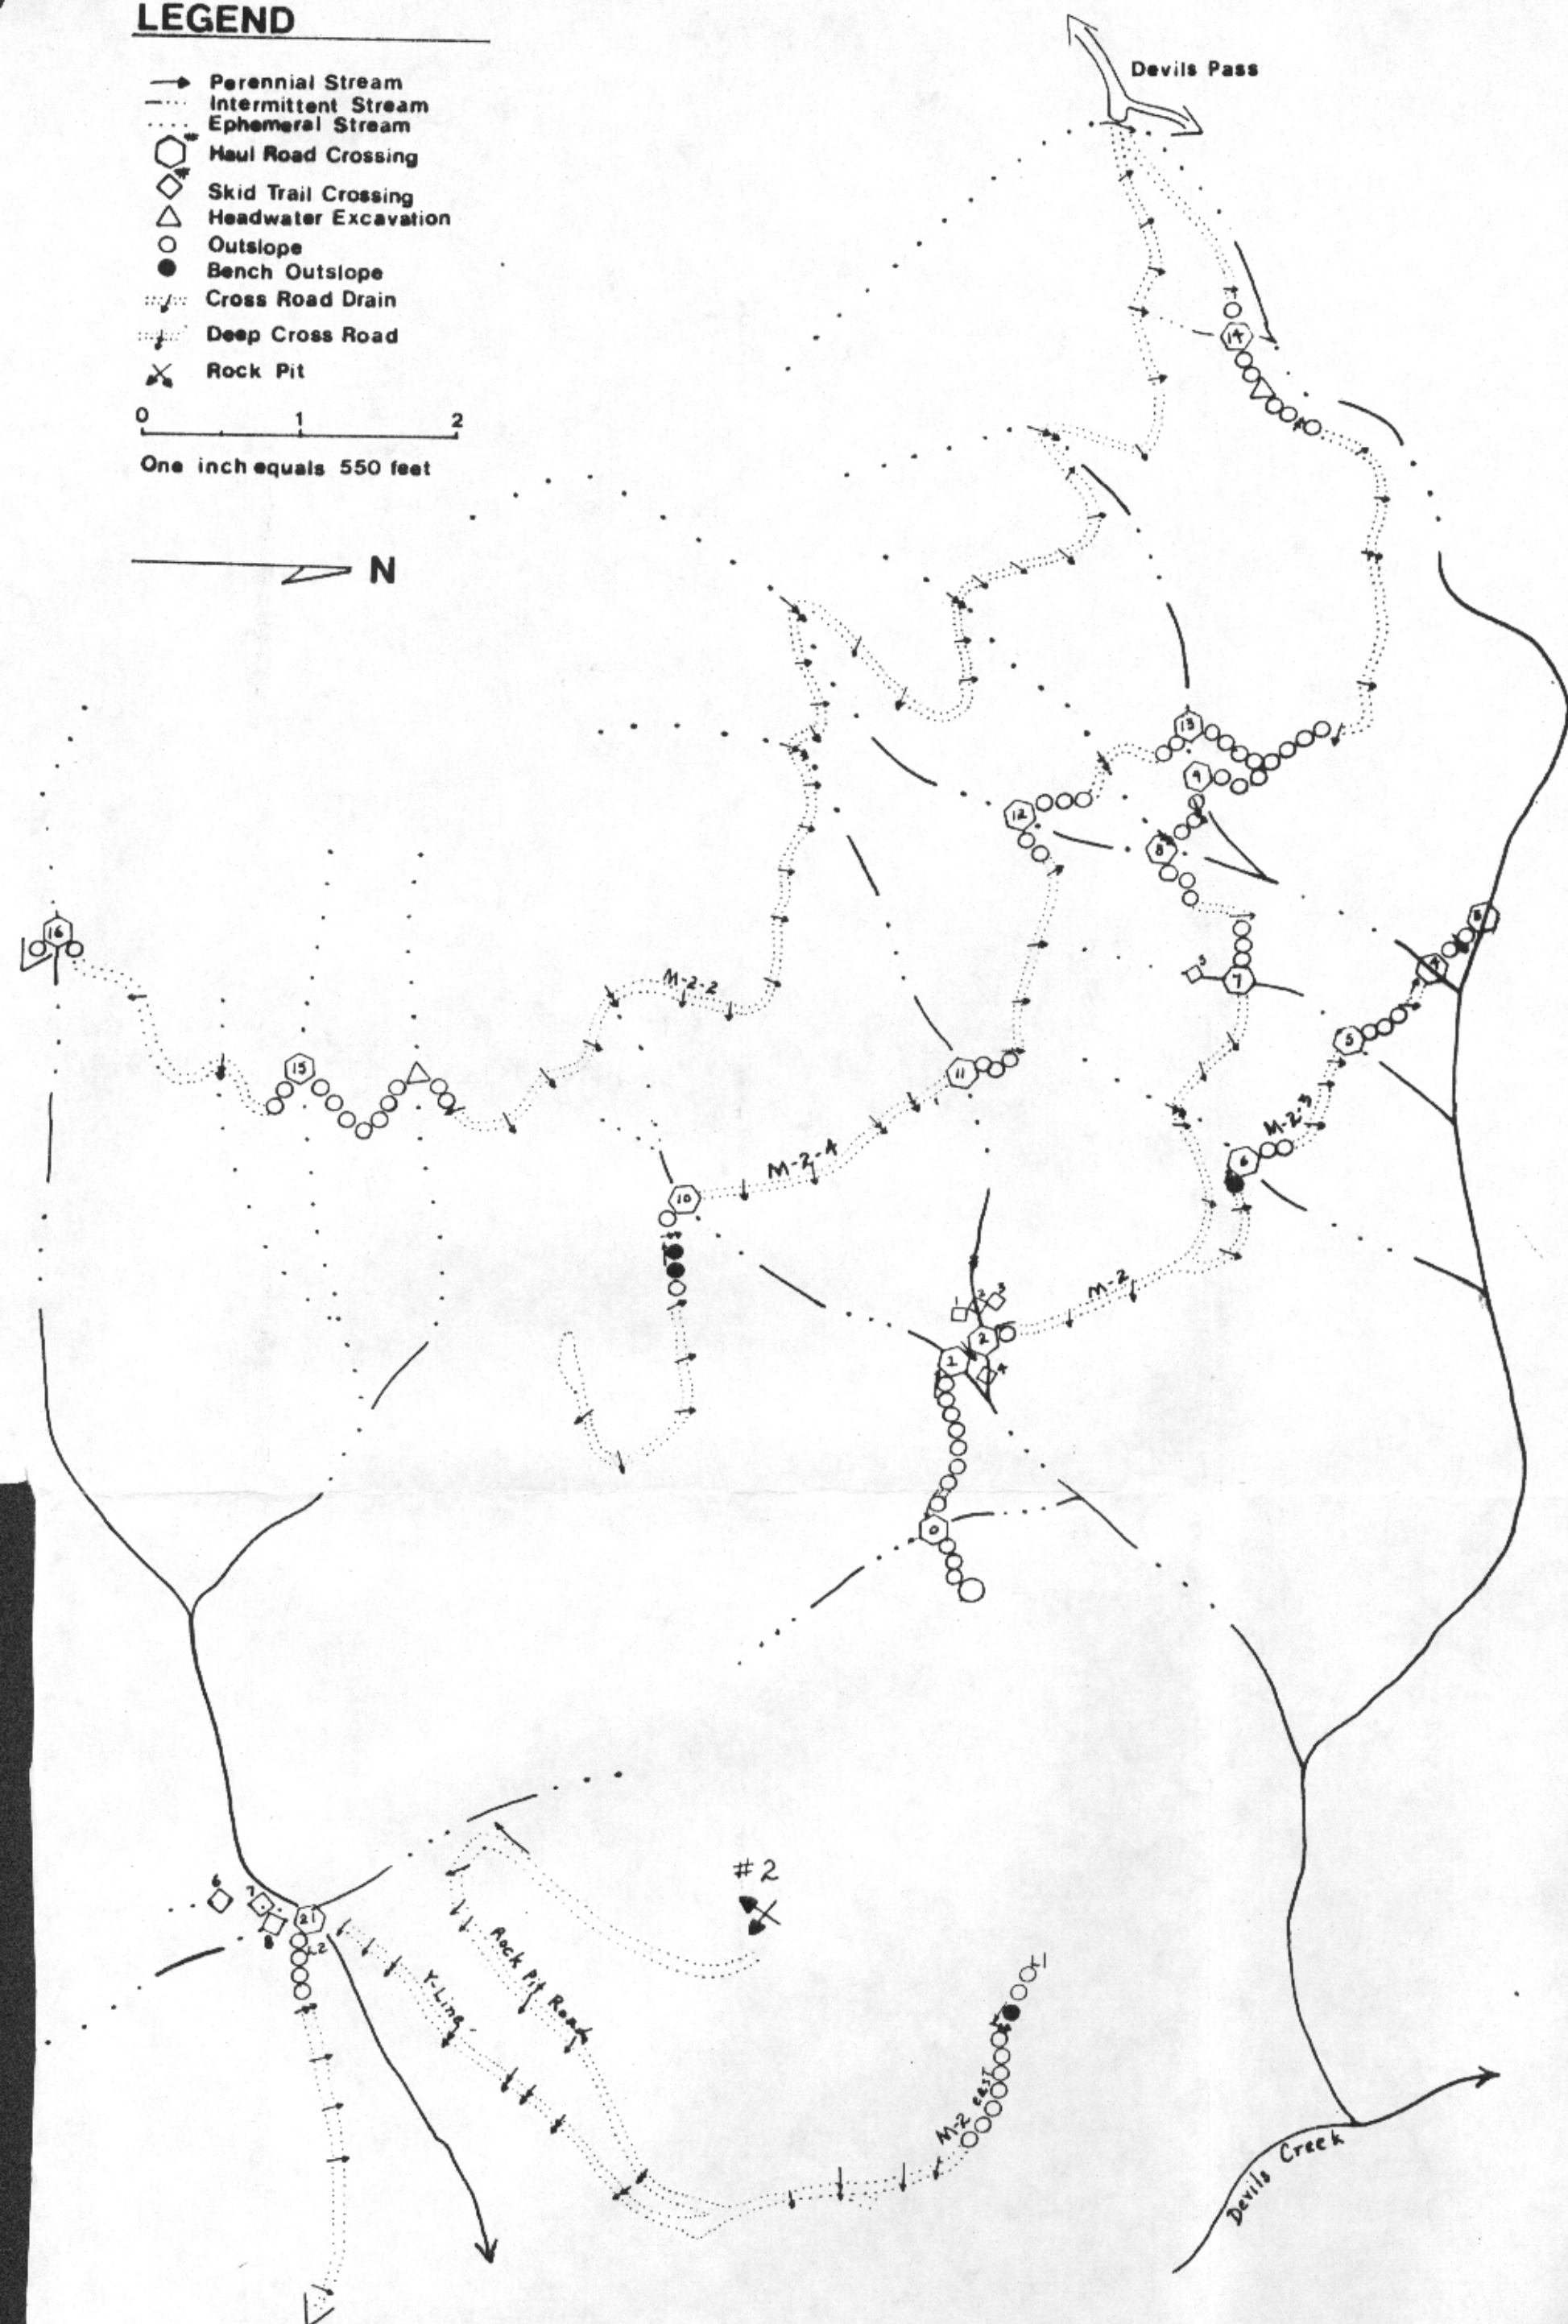
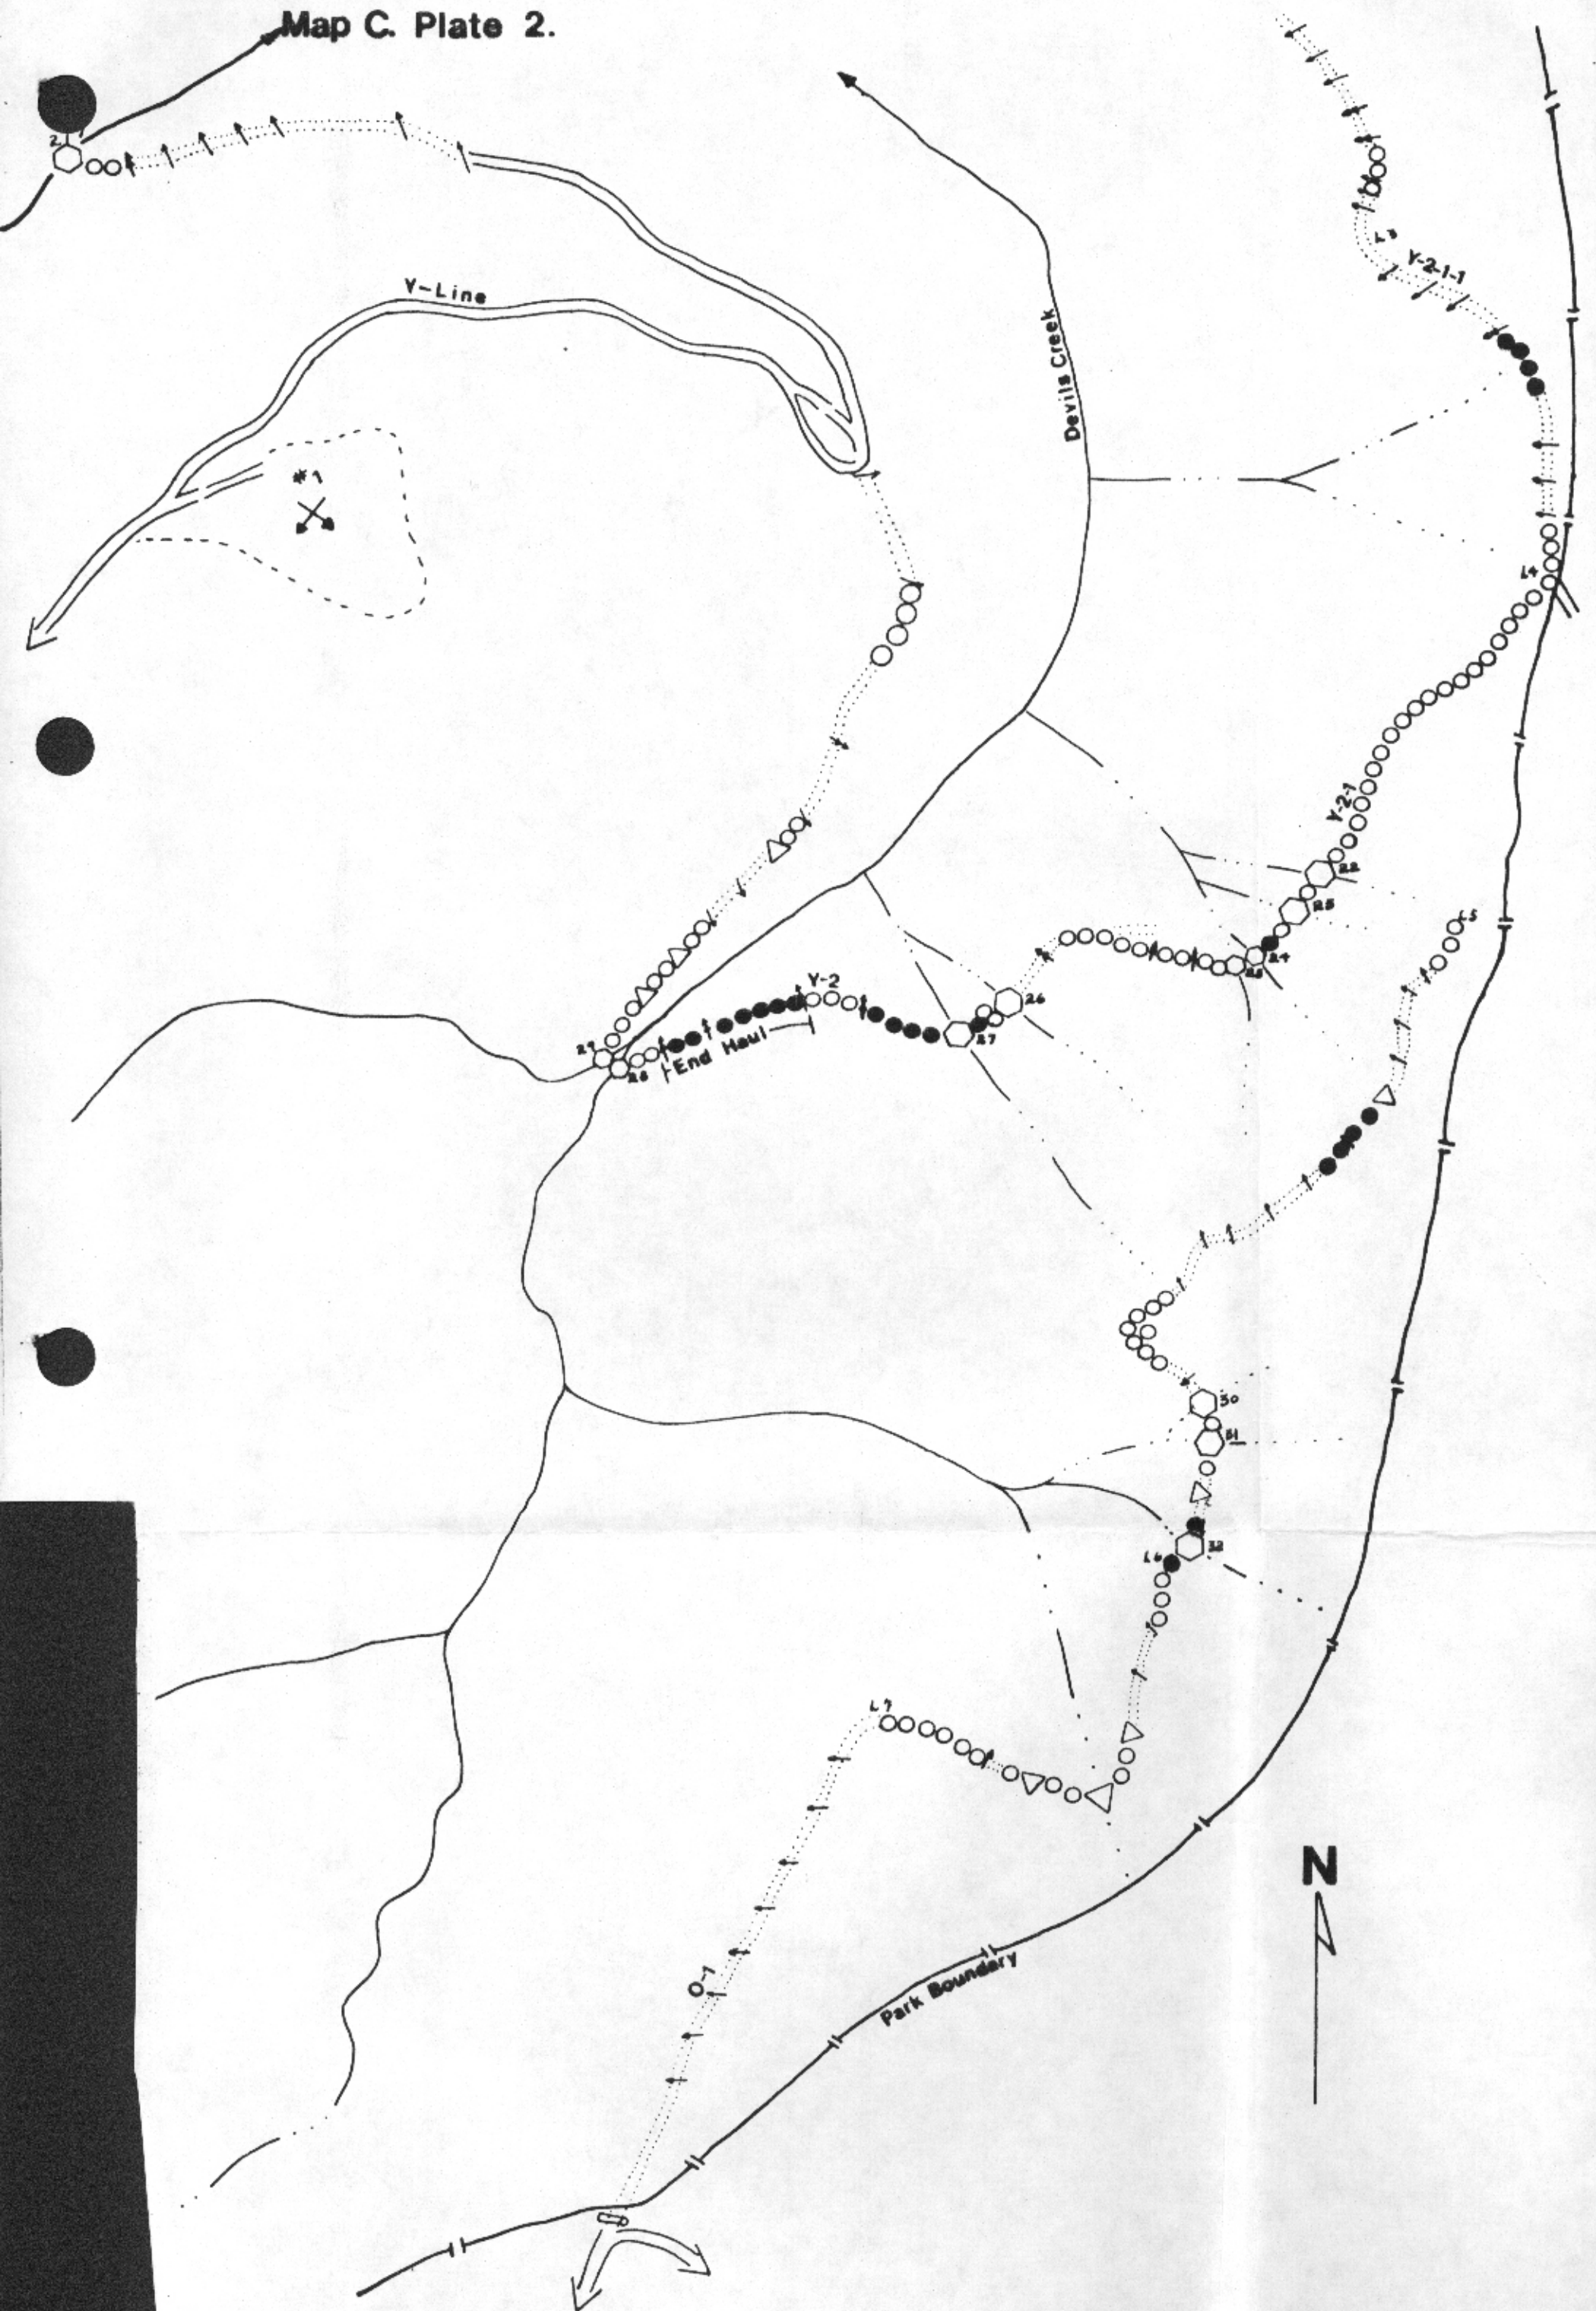
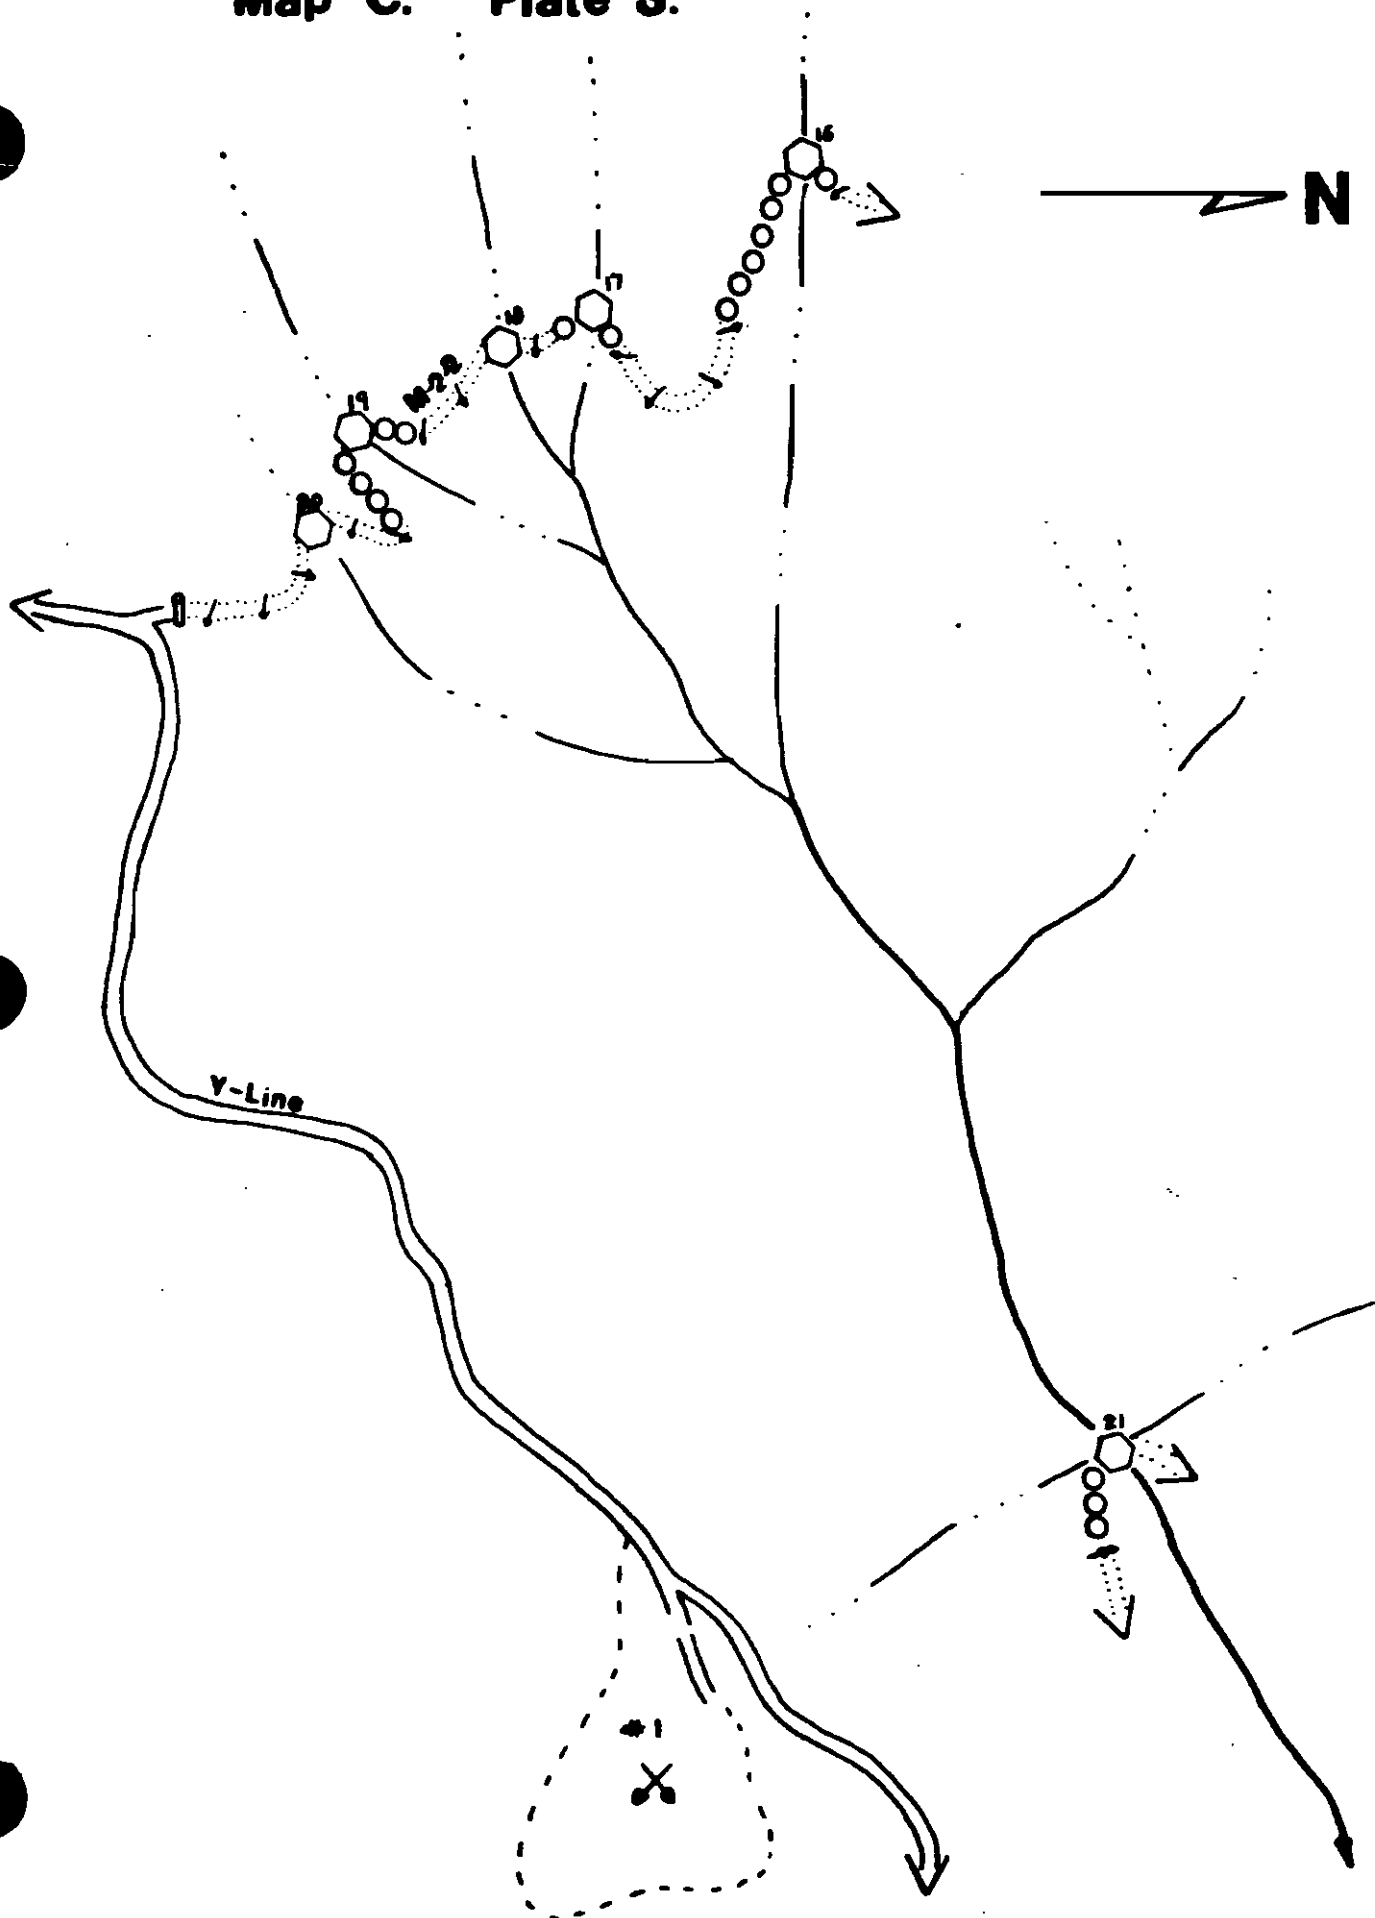
# MAP C. EROSION TREATMENT

Erosion control treatments were performed on erosion features capable of delivering sediment directly to streams, and, in some cases, on potential debris avalanche features which threatened stands of old growth redwoods. Examples of these treatments included: 1) excavating road and skid trail stream crossings; 2) outsloping unstable roads and landings; and 3) excavating road fill from headwater depressions. A summary of average heavy equipment costs for all treatments is presented in Table 2. All worksites and treatments are located on Map C.
