**Cuyahoga Riverbank  
Erosion Study  
in the Cuyahoga Valley  
National Recreation Area**

**March 1997**

**prepared for:  
The Cuyahoga Valley National  
Recreation Area**

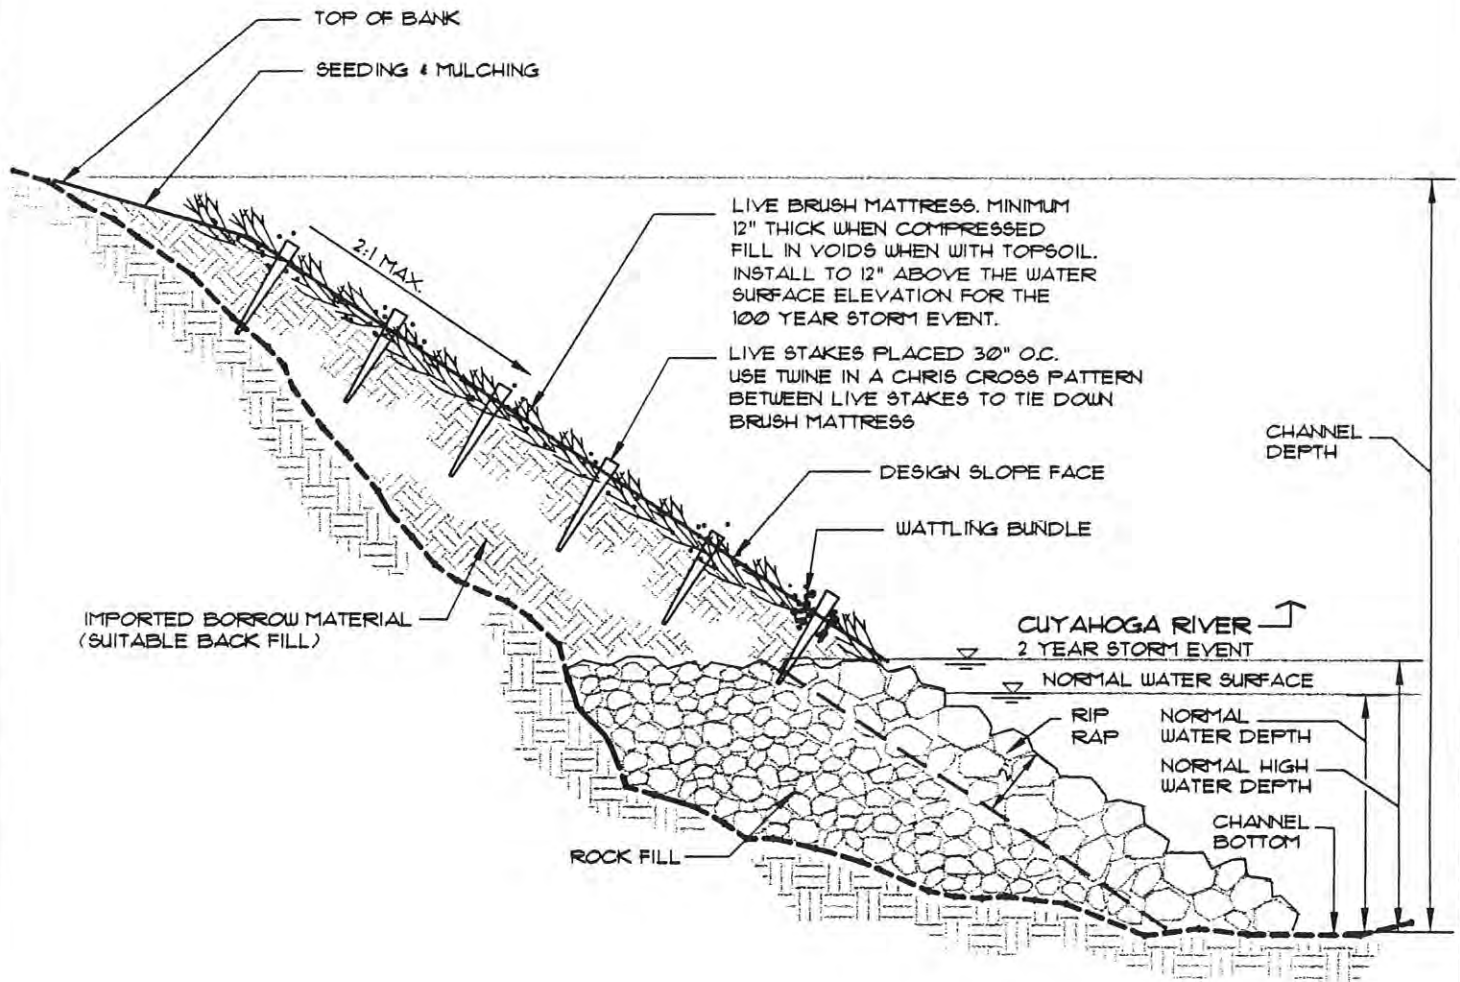
FIG. 1

## LIVE BRUSH MATTRESS WITH RIP-RAP SLOPE STABILIZATION

As the velocity decreases, the erosive forces also decrease. This allows for stabilizing the bank (above the rip-rap) using vegetation. Figures 1 through 3 illustrate these repair techniques. On slopes that are 2:1 or less, the bank is revegetated using a live brush mattress (Figure 1). On slopes between 2:1 and 1.5:1, the banks are revegetated using live plant cuttings. (Figure 2). Appendix "B" notes that shrubs and trees and/or live plugs may also be used to revegetate the banks. In areas

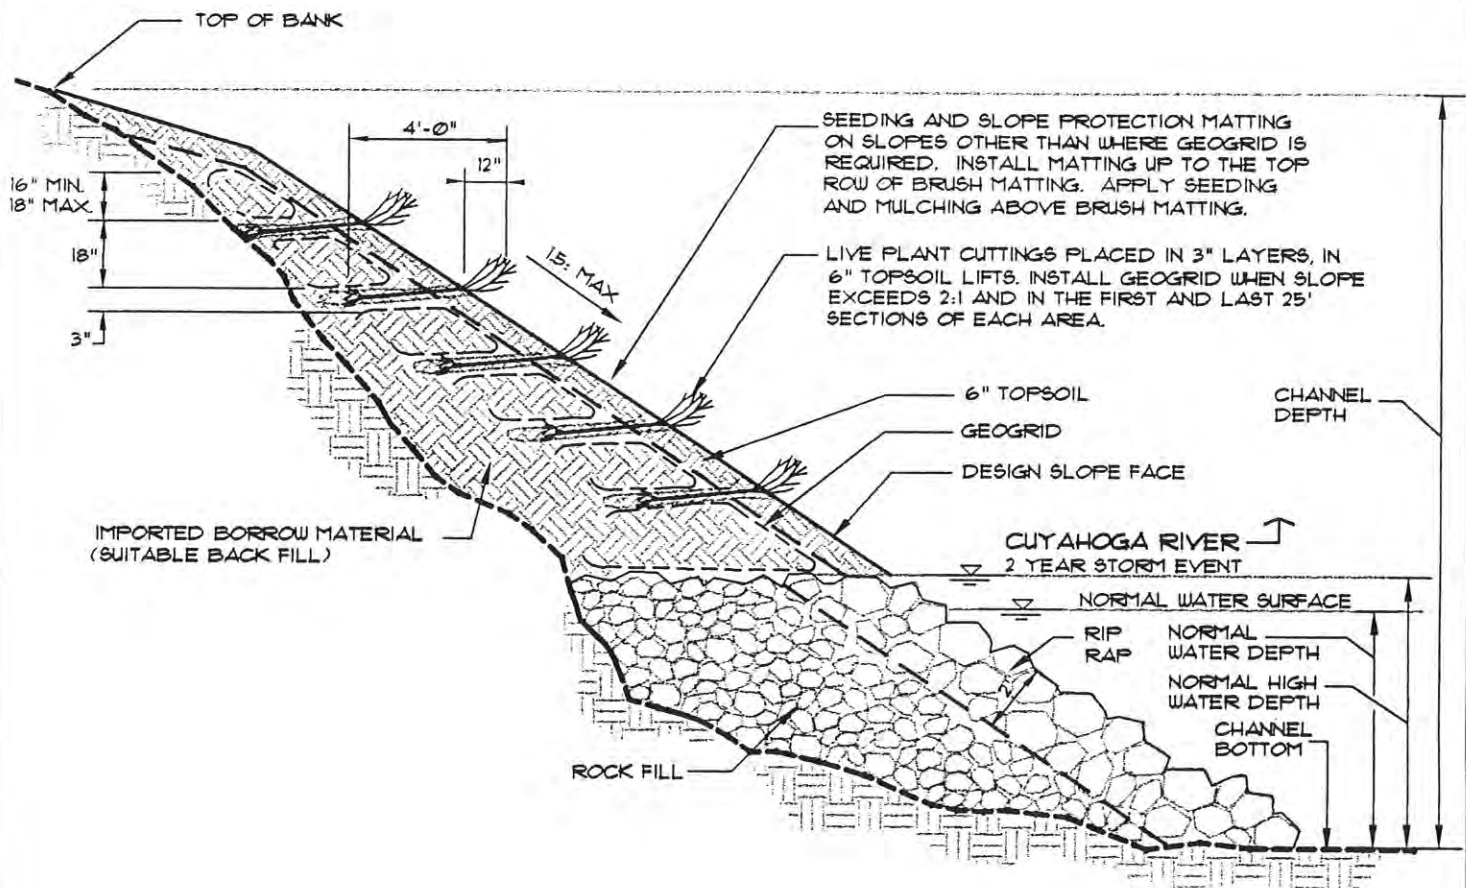
**FIG. 2**

## BRANCH LAYERING WITH RIP-RAP SLOPE STABILIZATION

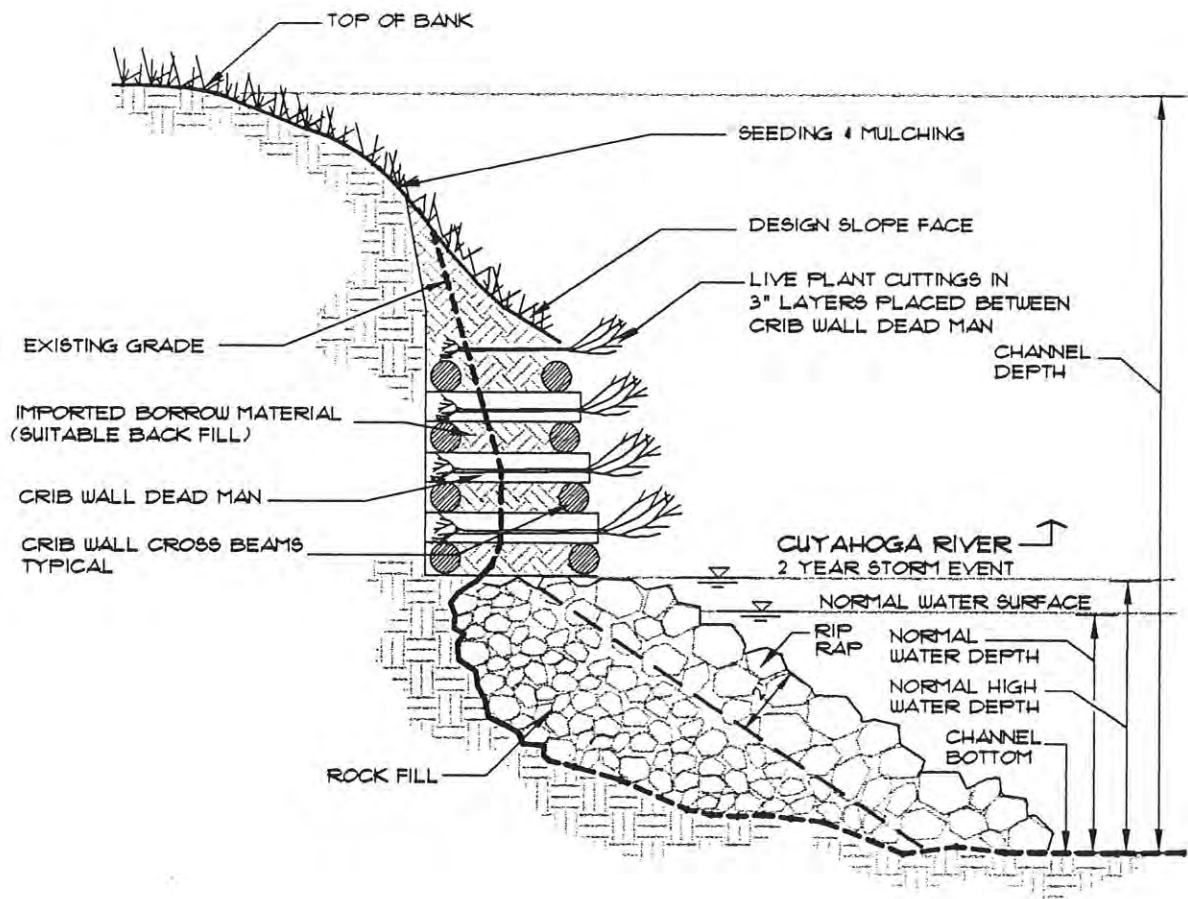
**FIG. 3**

### LIVE CRIB WALL WITH RIP-RAP SLOPE STABILIZATION

where the river channel is narrow and the river bank is in close proximity to the resource, a live crib wall would be constructed. This allows for vertical construction which results in less fill (rock) in the river channel, thus minimizing the effects of the repair on the hydraulics of the river. Note that the above is provided as a general guide. It is recommended that each area is studied prior to initiating permanent repairs to determine the most prudent repair alternative.

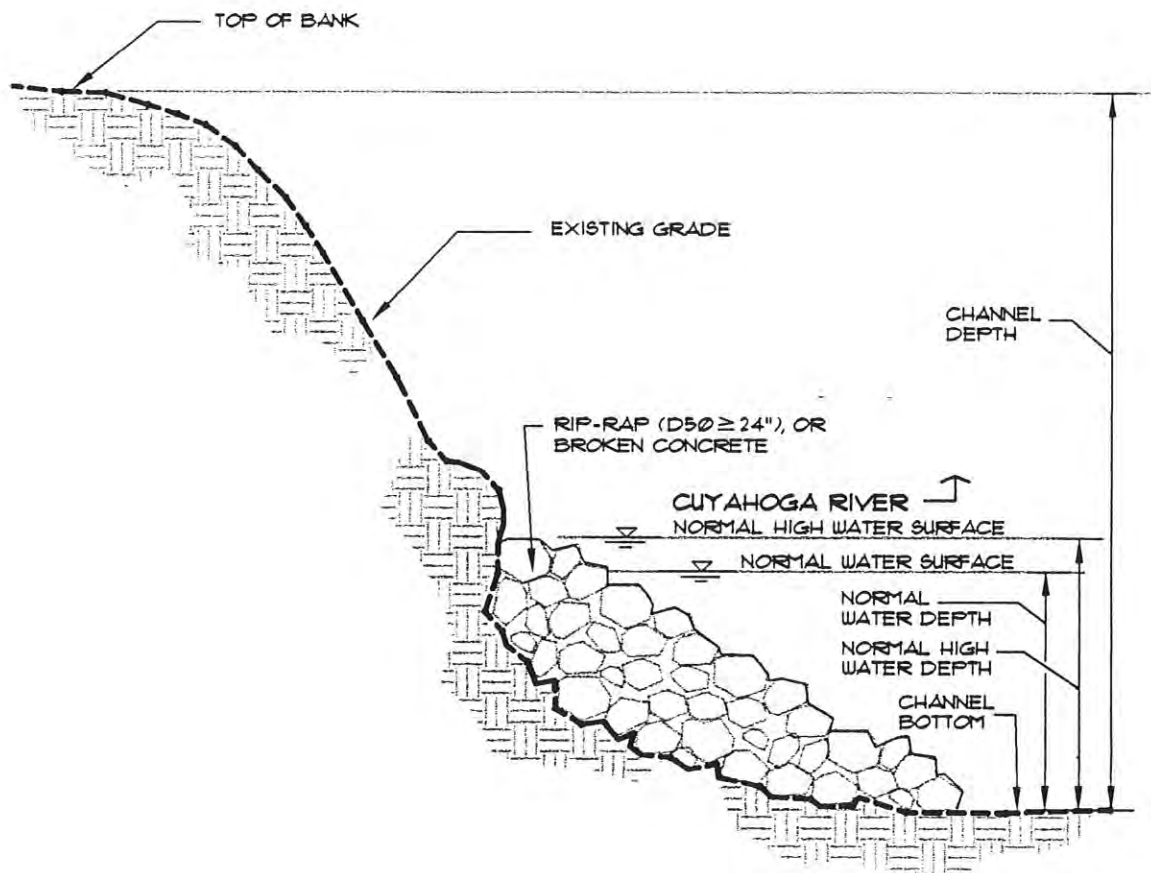
**FIG. 4**

## TEMPORARY / EMERGENCY SLOPE STABILIZATION

A typical section is also included for temporary or emergency repairs. Typically rip-rap or broken concrete is installed along the bank up to the normal high water level in the river channel (Figure 4).
