GEOTECHNICAL REPORT  
PHASE II STUDY AND  
EVALUATION OF  
TSAILE DAM, APACHE CO.,  
ARIZONA

20 July 1981

ENGINEERS TESTING  
LABORATORIES, INC.

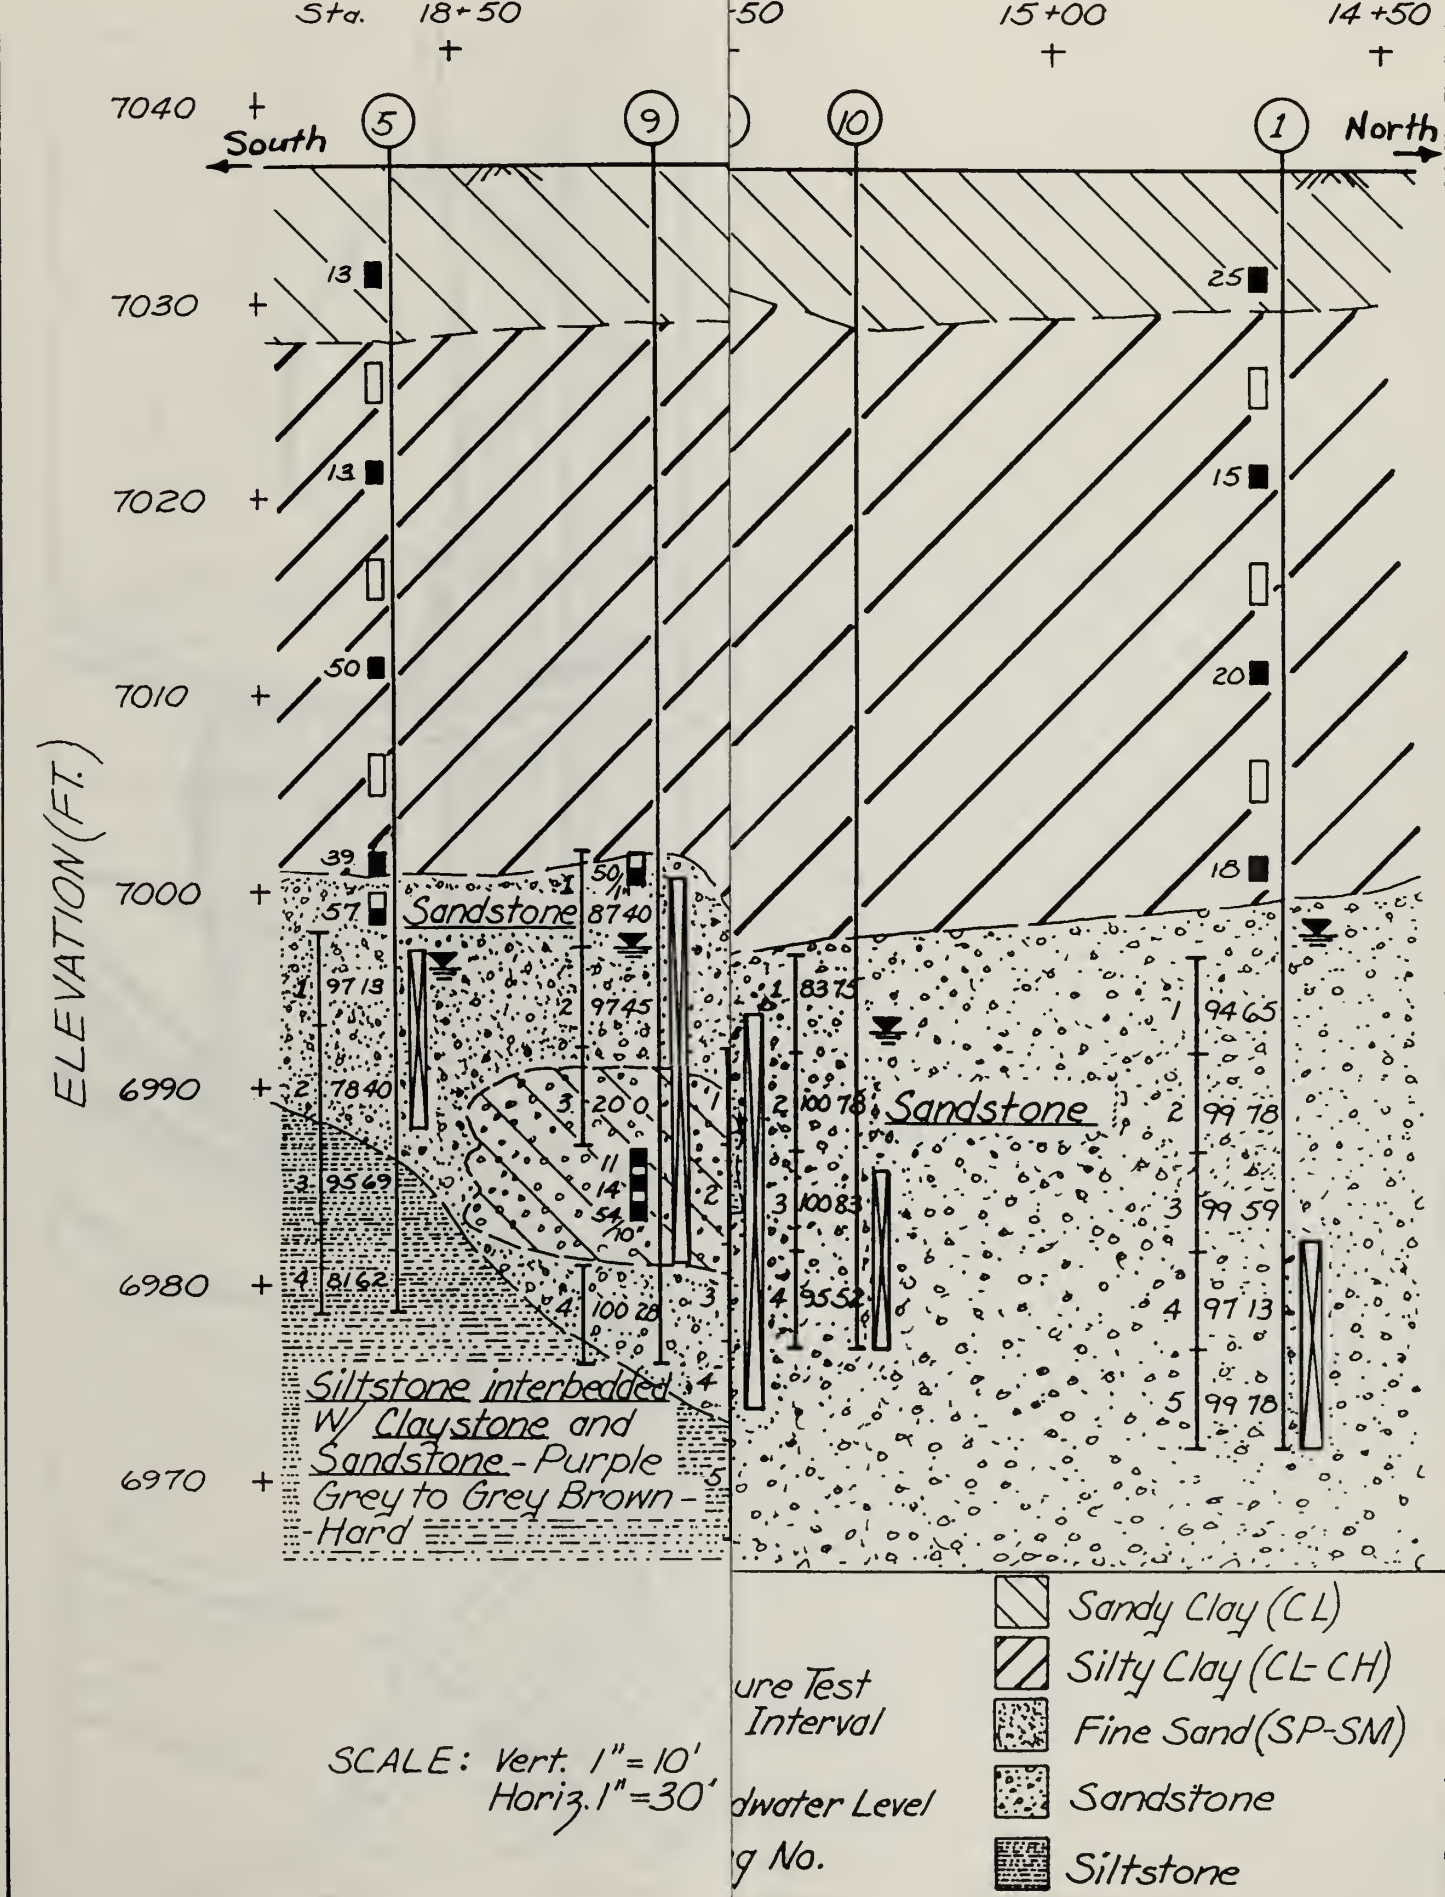
FIGURE 3

D. Groundwater Conditions: Groundwater level measurements recorded during and after completion of the borings are shown on the respective borings logs and also on Figure 3. These readings indicate that the groundwater level at the time of exploration was situated at Elevation 6992 to 6998 within the abutment areas, while the groundwater level within the stream channel was situated at approximately Elevation 6988. It should be noted that the reservoir was virtually empty at the time the field exploration was performed. Fluctuations in the location of the long-term groundwater level should be anticipated depending on variations in precipitation, evaporation, surface runoff and the reservoir level.

GEOLOGICAL PROFILE A-A'

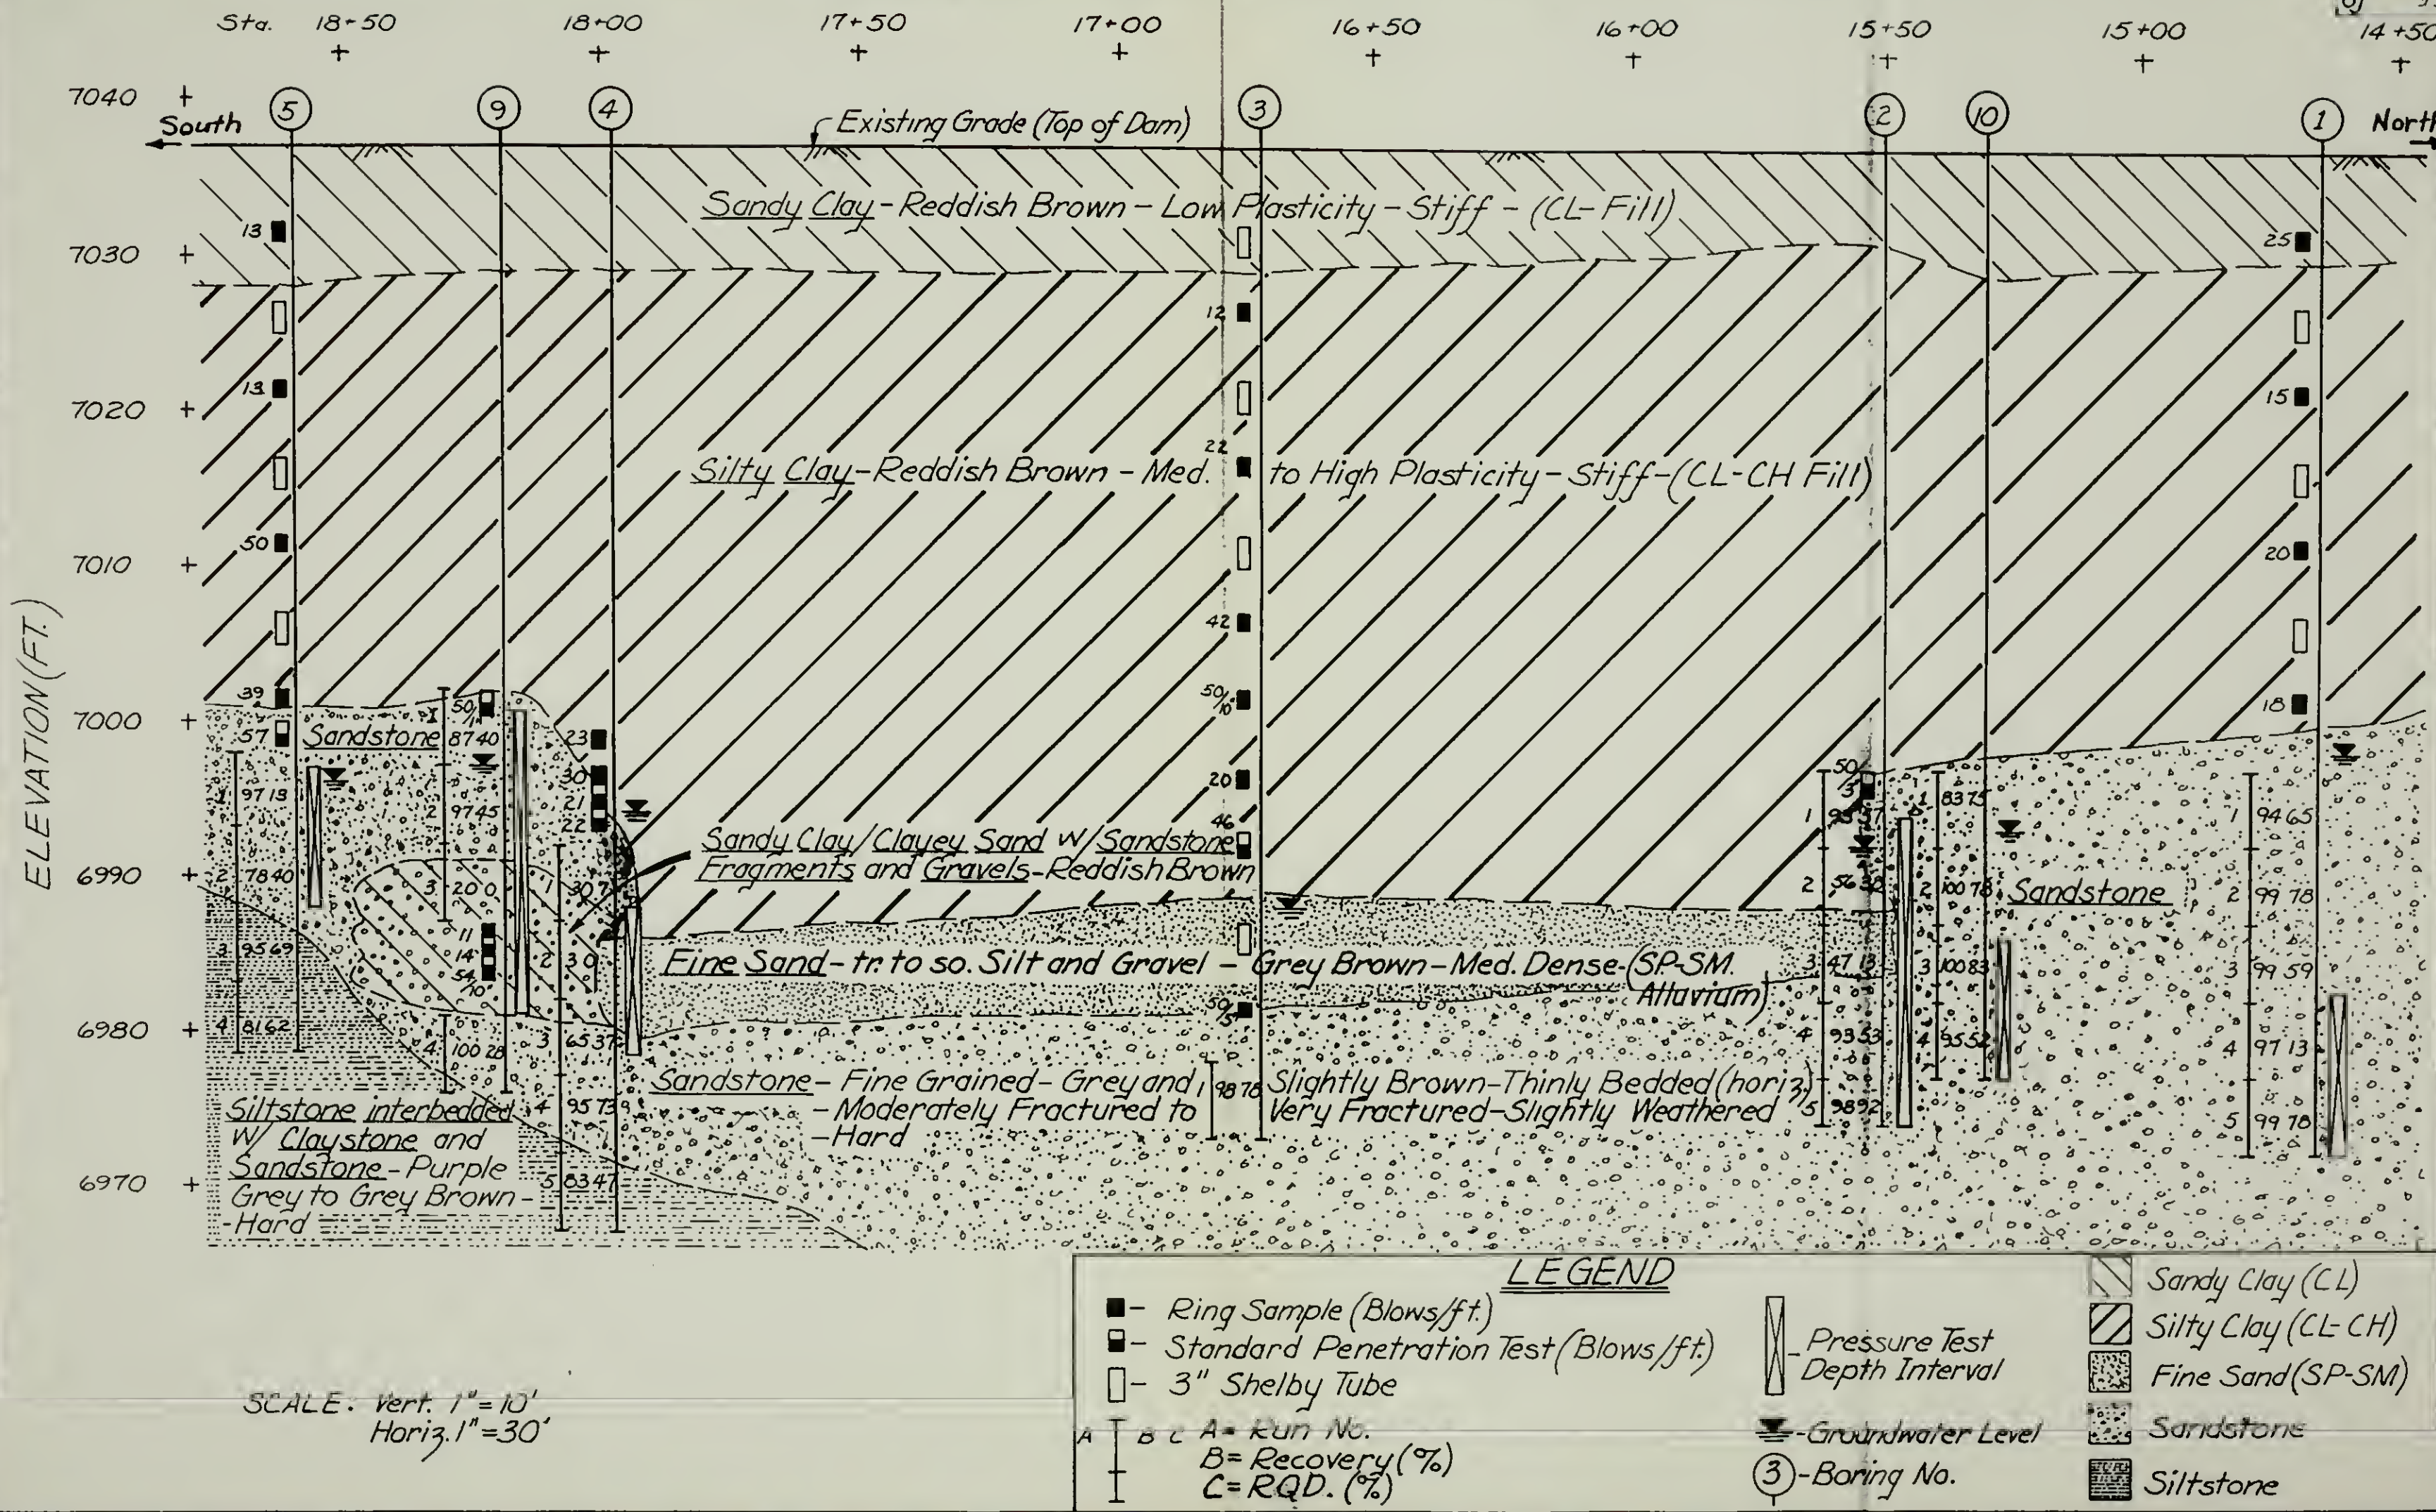
FIGURE 4

Plan for Proposed Grouting Program

A line of grout holes (combination compaction and curtain grouting) is recommended along each abutment contact area. A five foot horizontal spacing is recommended for these grout holes. The estimated total number of holes along each contact abutment is 31 with an average depth of 40 feet. It is anticipated that the zone between Elevation 6995 to 7000 and Elevation 6980 will require grouting, approximately 15 to 20 feet in each grout hole. The overhang zone will require compaction grouting in order to densify the soft clay fill. The fractured sandstone formation will require curtain grouting to seal the fractures and joints to reduce the seepage against the adjacent embankment materials. A line of curtain grout holes is recommended extending along the longitudinal centerline of the dam away from each abutment contact for a

distance of approximately 100 feet. The recommended curtain grout hole spacing is 10 foot on center for the south abutment and 10 to 20 foot on center for the north abutment. These curtain grout holes are expected to have an average depth of 60 feet with a grouted zone from approximately Elevation 7000 to 6980 or an average grouted length of approximately 20 feet per grout hole.

For all grout holes, it is recommended that alternate holes be performed initially. Once these alternate holes are completed, the intermediate holes should be grouted. Where high grout takes occur within the secondary phase of the grouting operations, additional holes may be necessary and should be performed by the split-spacing method.

Figure 4 presents the plan for the recommended grouting program. Comments on the grouting program along with estimates for the drilling footage and grout takes are provided in Appendix D. Guide specifications for the grouting contract are also included in Appendix D.
