**Demonstration Enhancement of Pueblo Colorado Wash**

**Hubbell Trading Post National Historic Site**

**Grant No. 97-029WPF**

**FINAL REPORT**

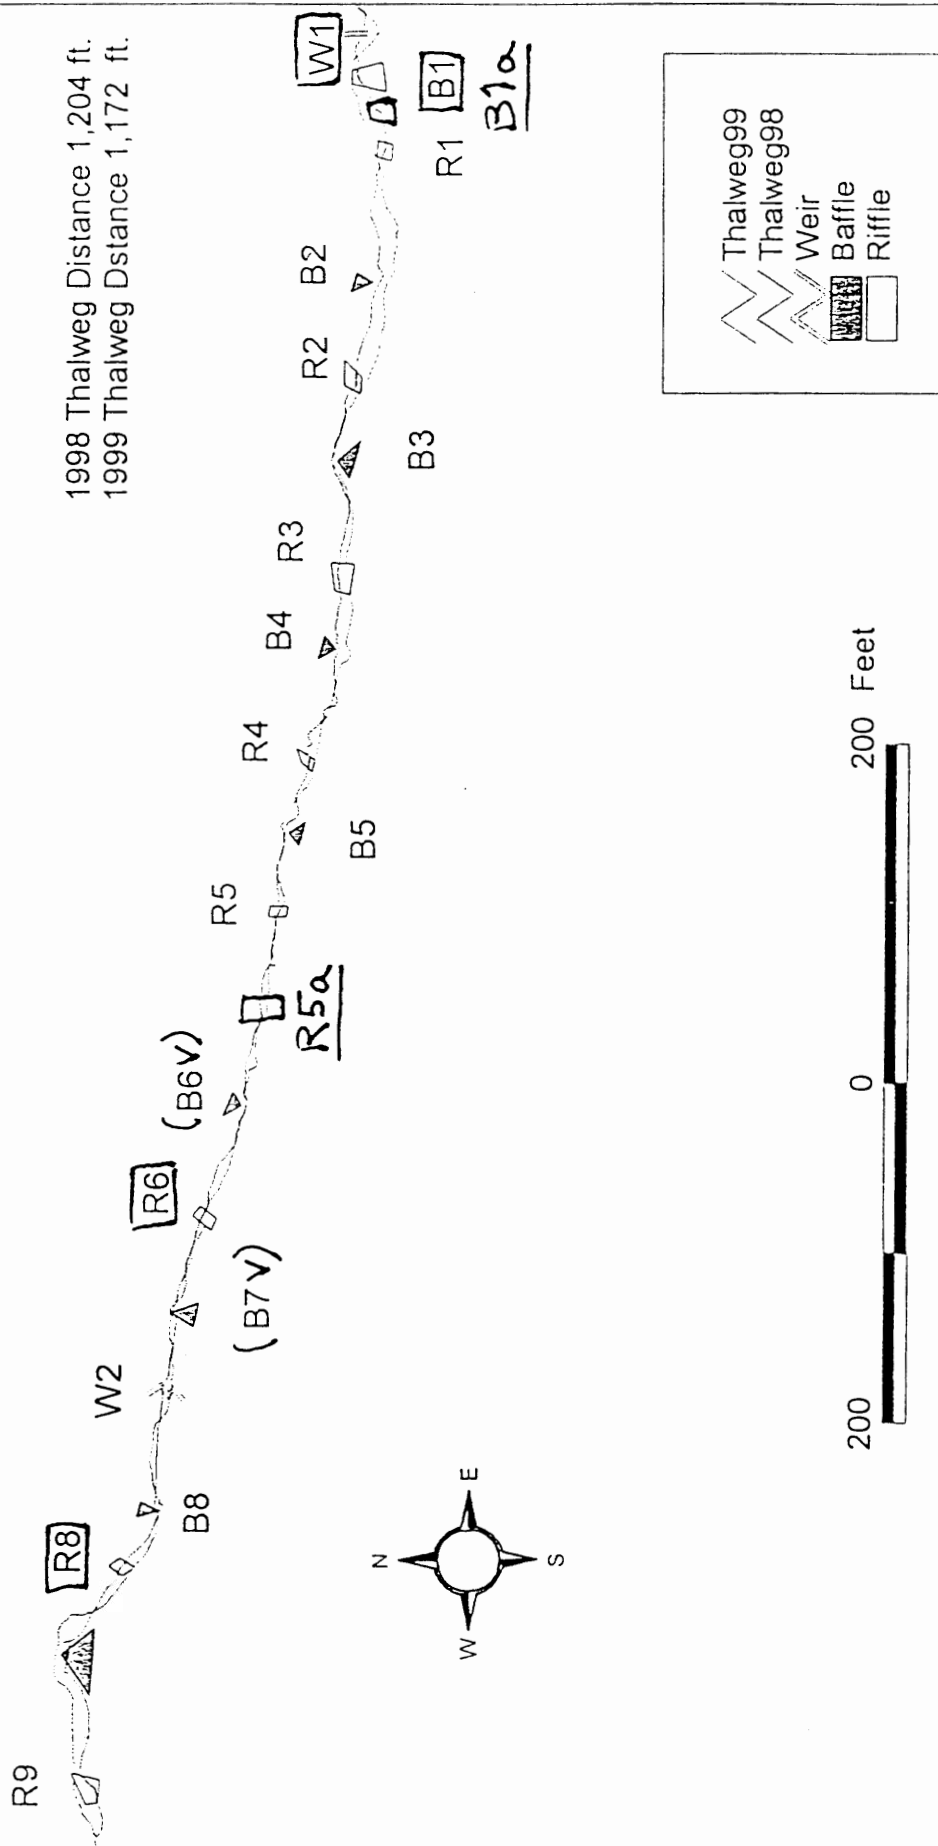
**Figure 2:     Structure Locations and Status, Phase 1, November 1, 2000**

Significant bank sloughing occurred opposite Baffles 2, 4 and 9, widening the channel from 1 to 2 feet but root wads within the slumped materials blocked the channel thereby reducing beneficial results and damaging Baffles 2, 3, 4, 5 and 7. It was not possible to remove root wads until snowmelt runoff subsided. Shear forces associated with these floods and eddying around root wads damaged some structures by plucking rocks and rubble from the outer 1-3 feet of the tips of the baffles and scouring channels through some riffles.

Maintenance and modification of Phase 1 structures began in May 1998 and were completed in June. All structures were modified using rock and concrete rubble from on-site sources. To increase erosion resistance, structures were edged with sod plugs of rooted aquatic herbaceous vegetation, mainly American three square (*Scirpus americana*), which was readily available from the streambank and floodplain. Upon project completion, all structures were photographed and measured to document dimensions. On July 29, 1998, overbank flooding occurred, with a discharge of 800 cfs (5 times bankfull). Although most structures were damaged, channel response was significant.

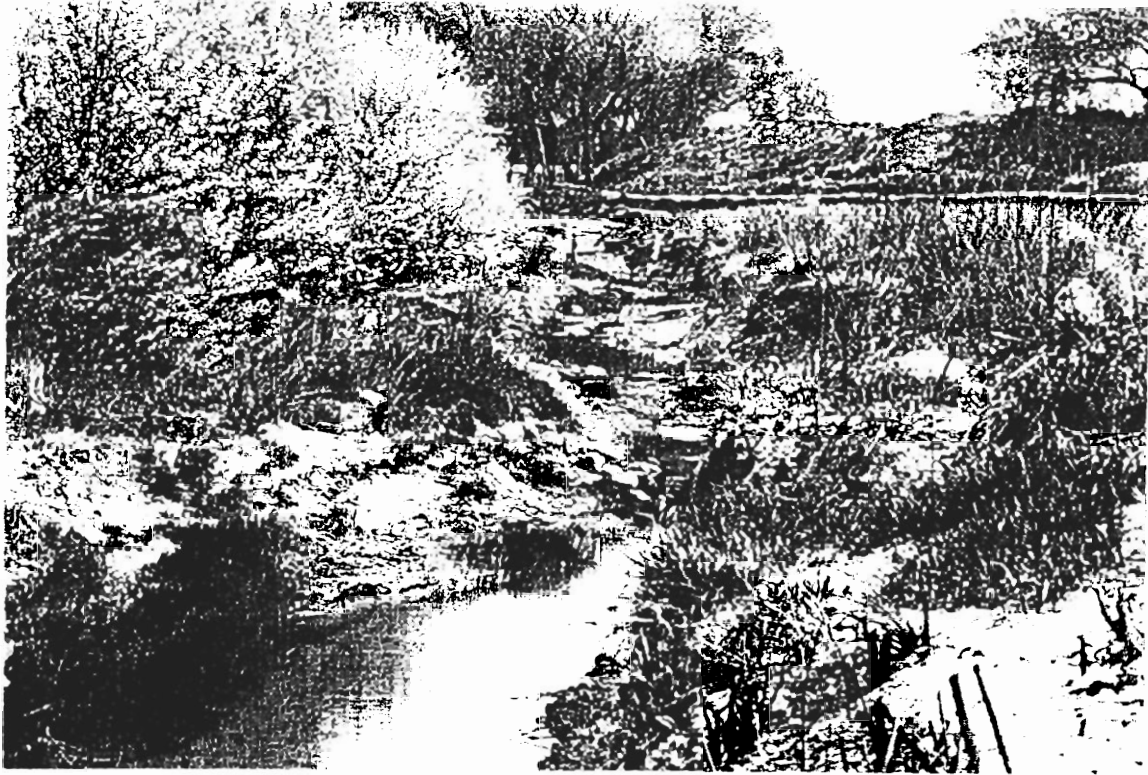
Permanent Photo Point 3x2, view east from top of south bank. Baffle 4, foreground, initially installed by volunteers in June 1997, prior to AWPL Grant 97-029. Note narrow, steep channel, low sinuosity, some early point bar development and bank collapse, May 29, 1998.

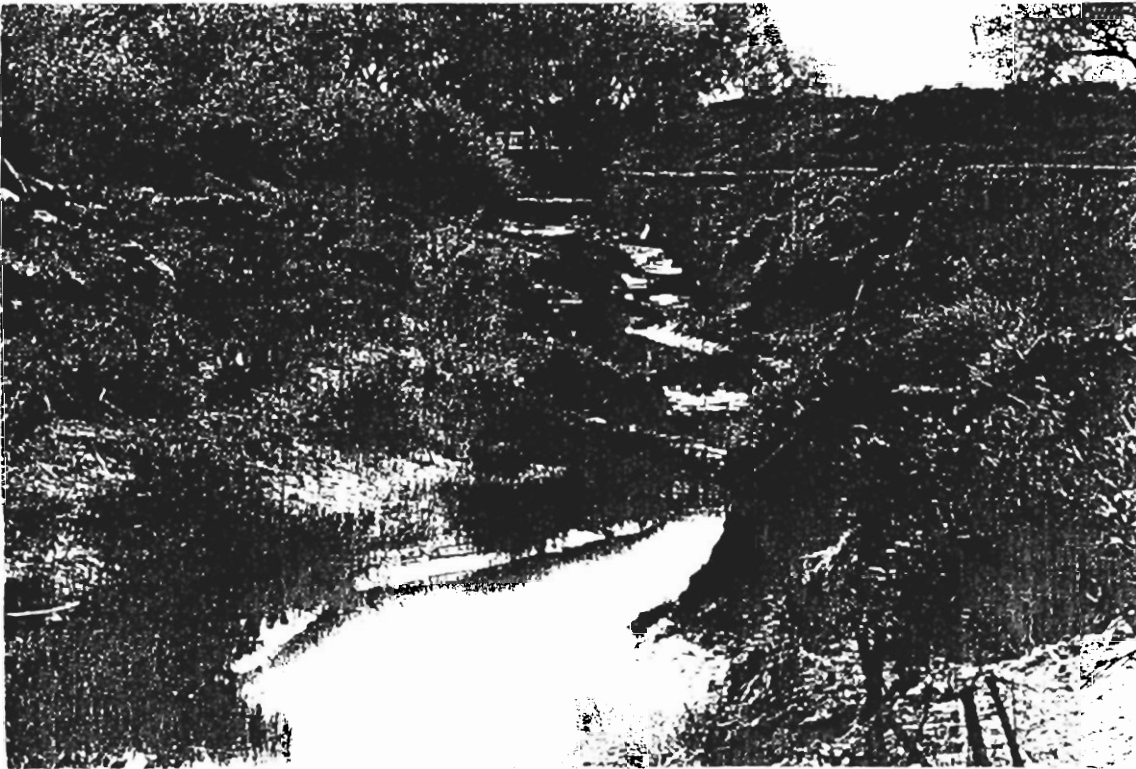
Same view, May 28, 1999. Note expanding point bar at Baffle 4, foreground. Point bar now at Baffle 3 in distance, and bank collapse in right foreground.

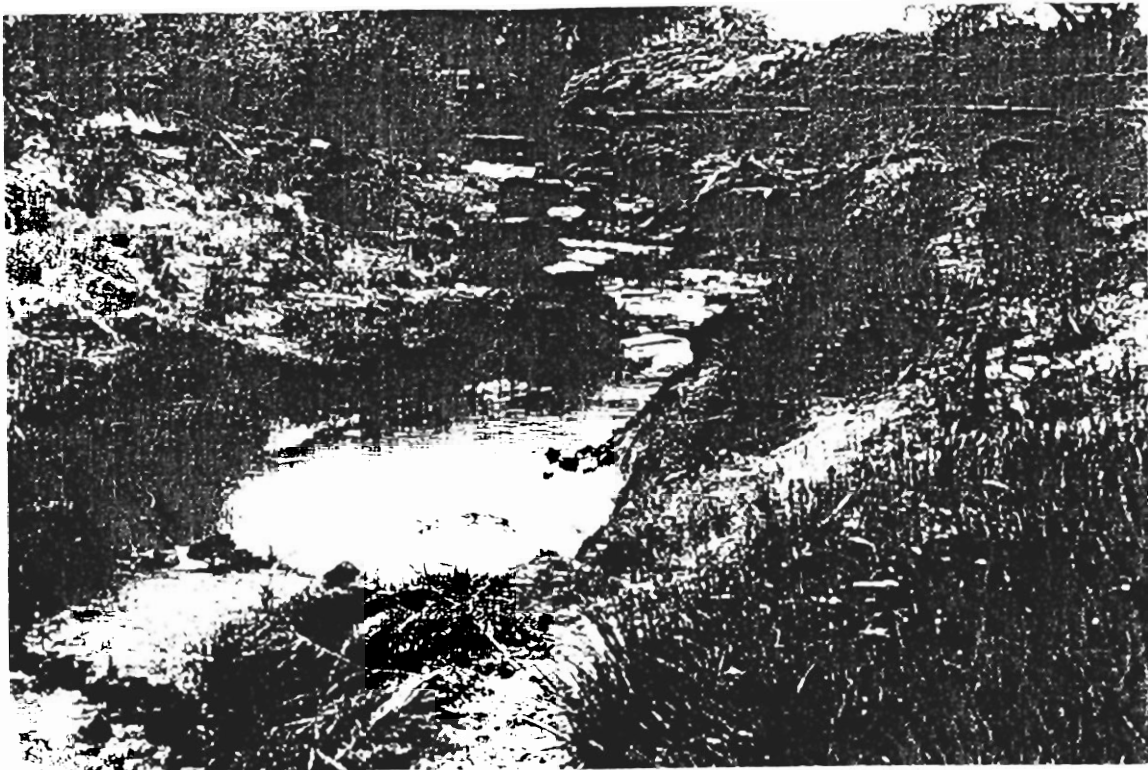
Same view, May 25, 2000. Slight change of camera angle (two feet south, four west) due to bank collapse following 1999 flood. Riffle 4 foreground (Wicker Weir). Battle 4 pickets added, midground. Note point bar expansion and developing flood plain as south bank recedes.

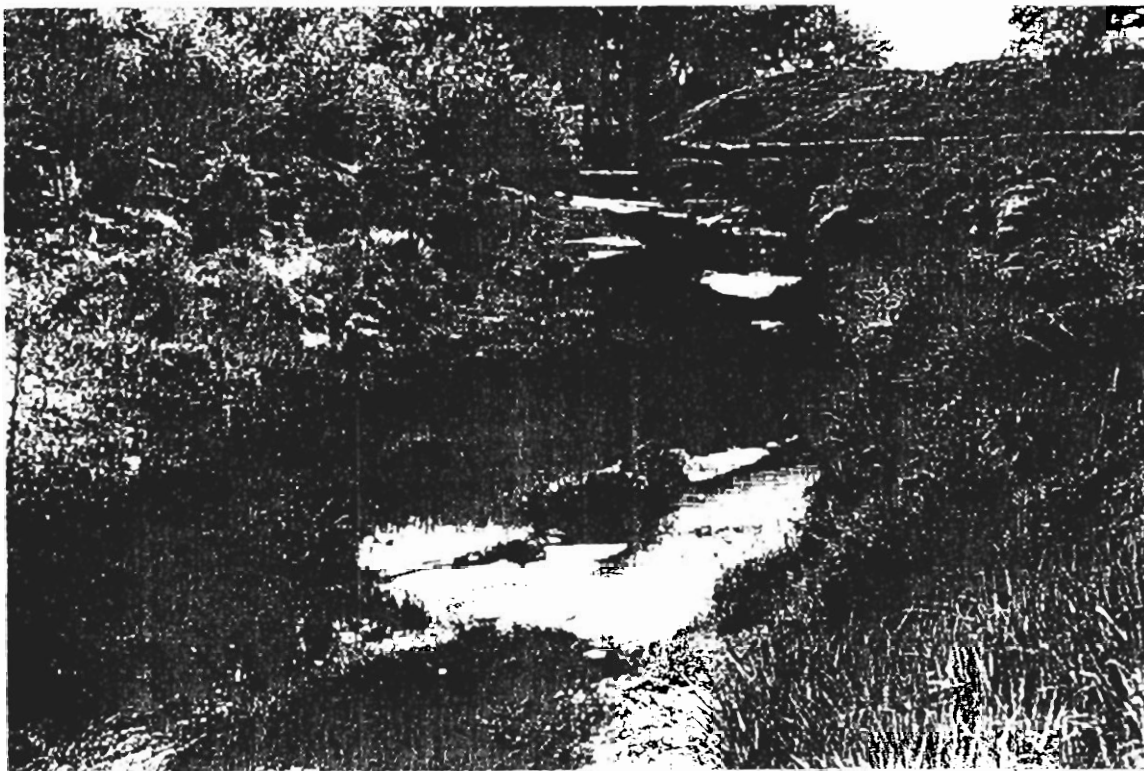
Same view, May 25, 2000. Note more pronounced meander right of riffle. Battle 4. Riffles have shifted right, south bank continues to collapse and flood plain is well developed and expanding.

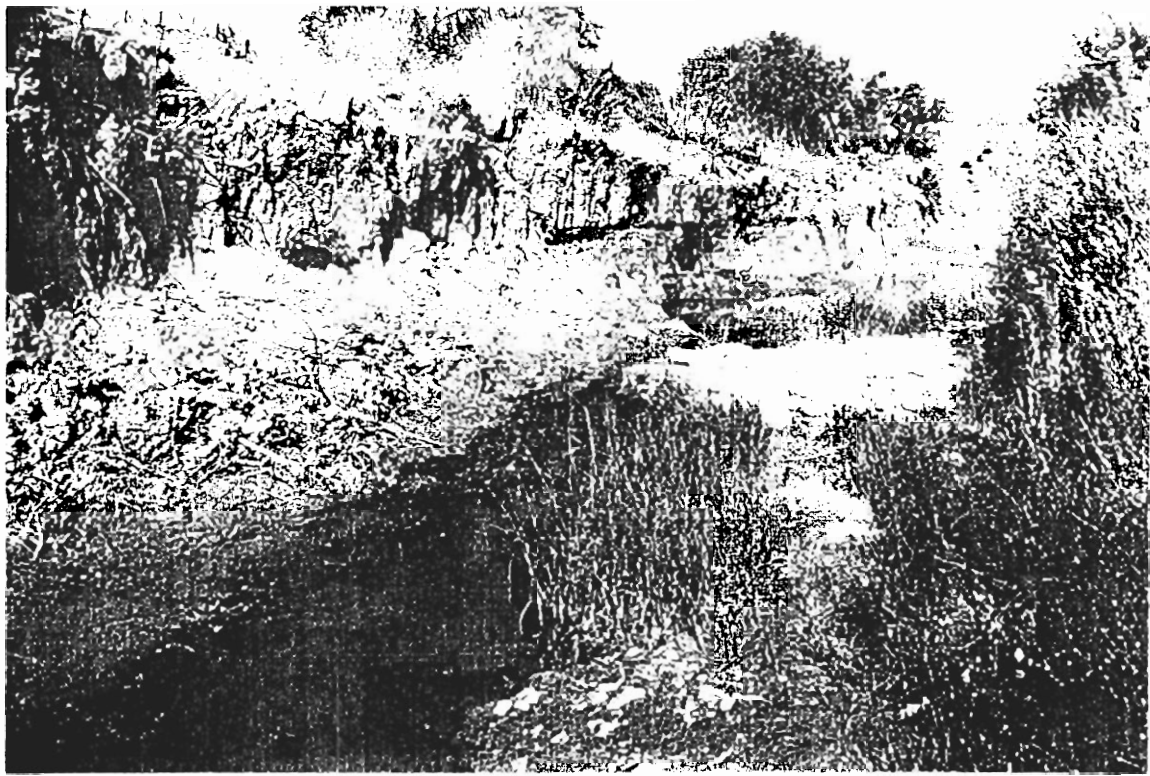
Phase 1, Baffle 4 - A rock only Baffle, June 1998

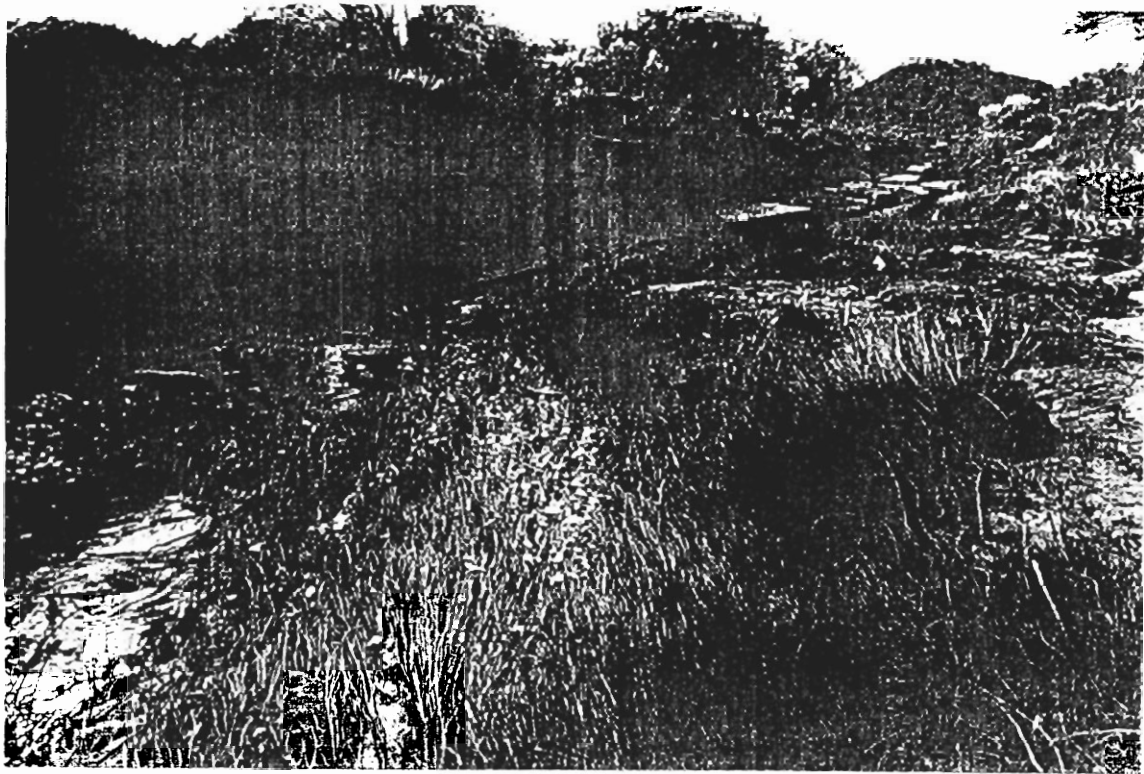
Same location as in photo 1 with pickers. 30" of soil has since been added to the face of the embankment.

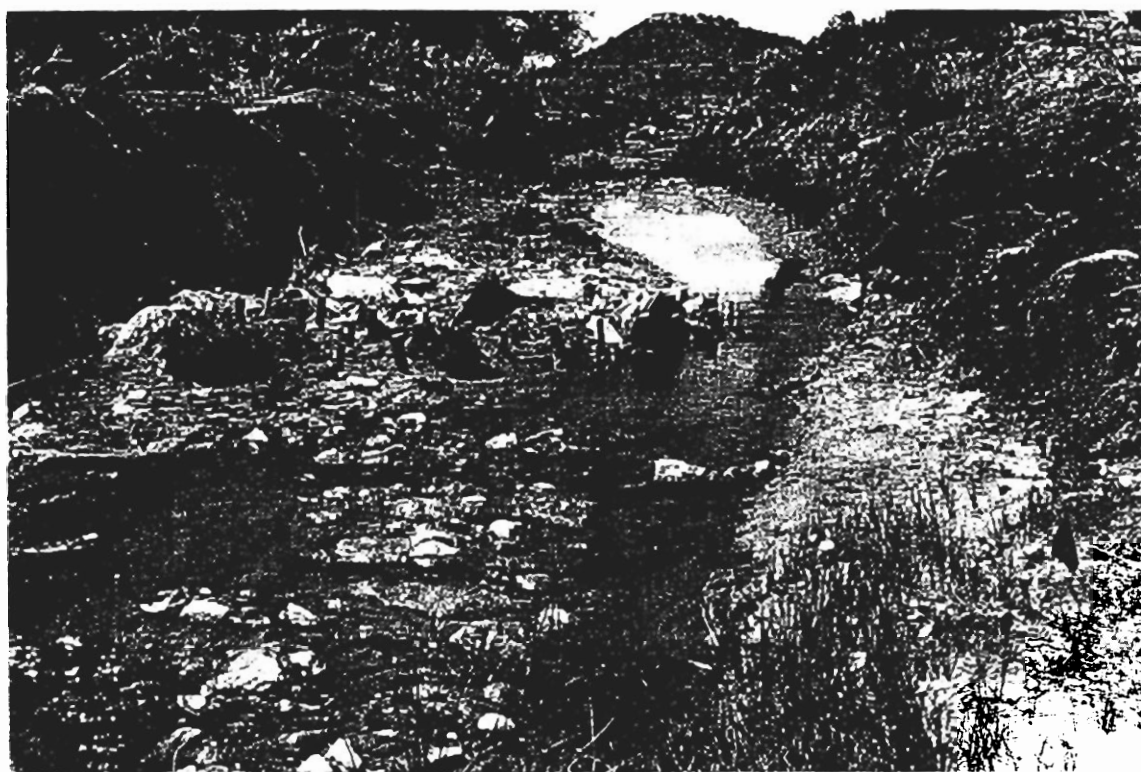
Same site from opposite bank. pickets added to Baffle 5. May 25, 2000

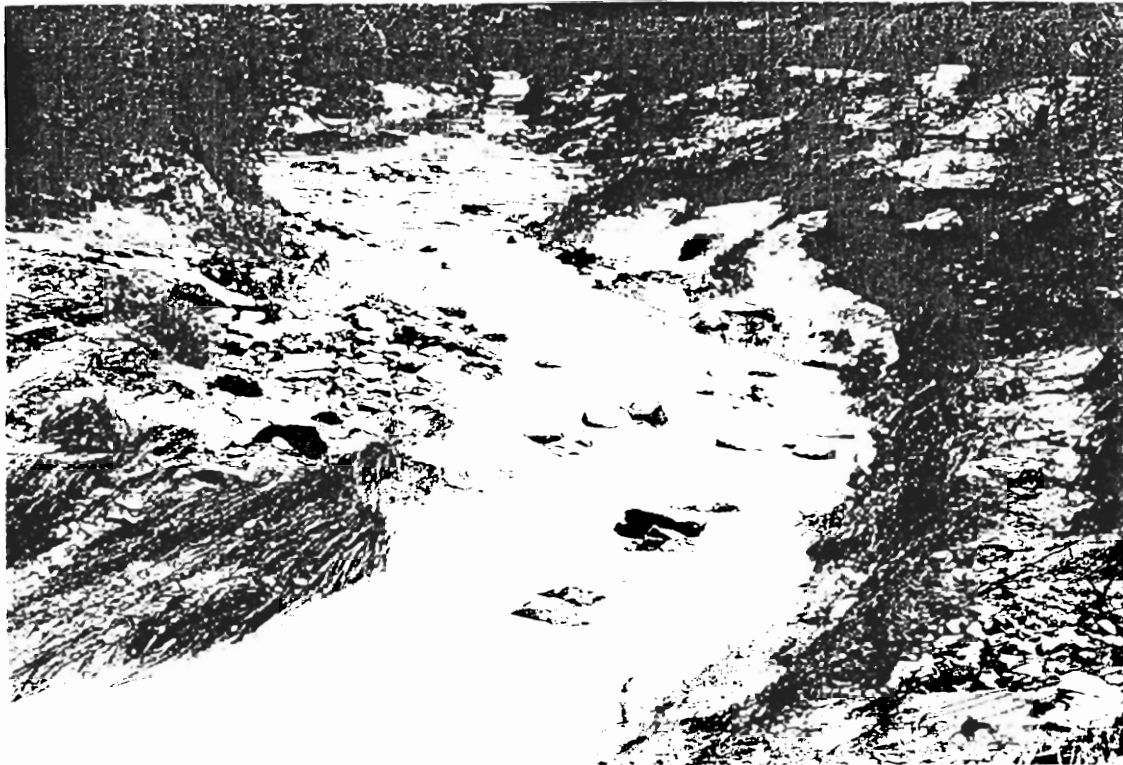
Permanent Photo Point 4 - View east, July 29, 1998 - channel at bankfull stage, 10 cfs, receding from maximum stage of 800 cfs

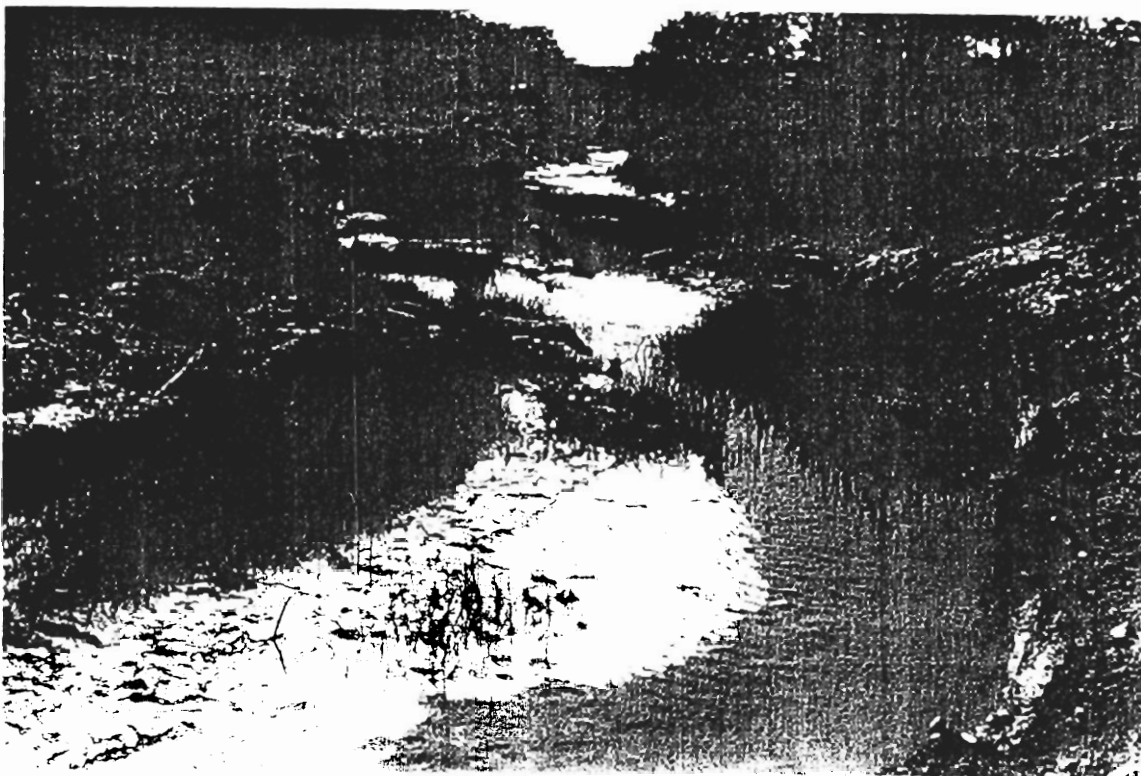
Permanent Photo Point 4 after July 29, 1998 flood. Baffle 8 (left foreground), Weir 2 (midground). Scattered rocks are from damaged structures.

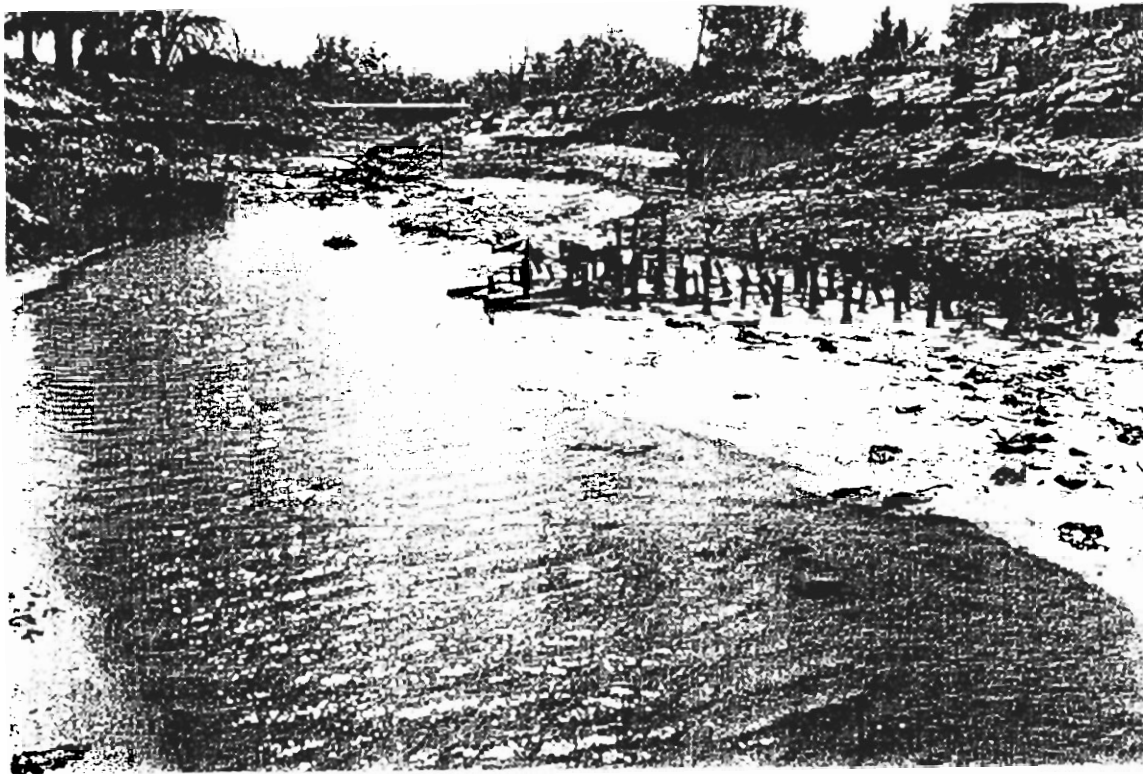
Same view. Following spring runoff 1999. June 23, 1999.

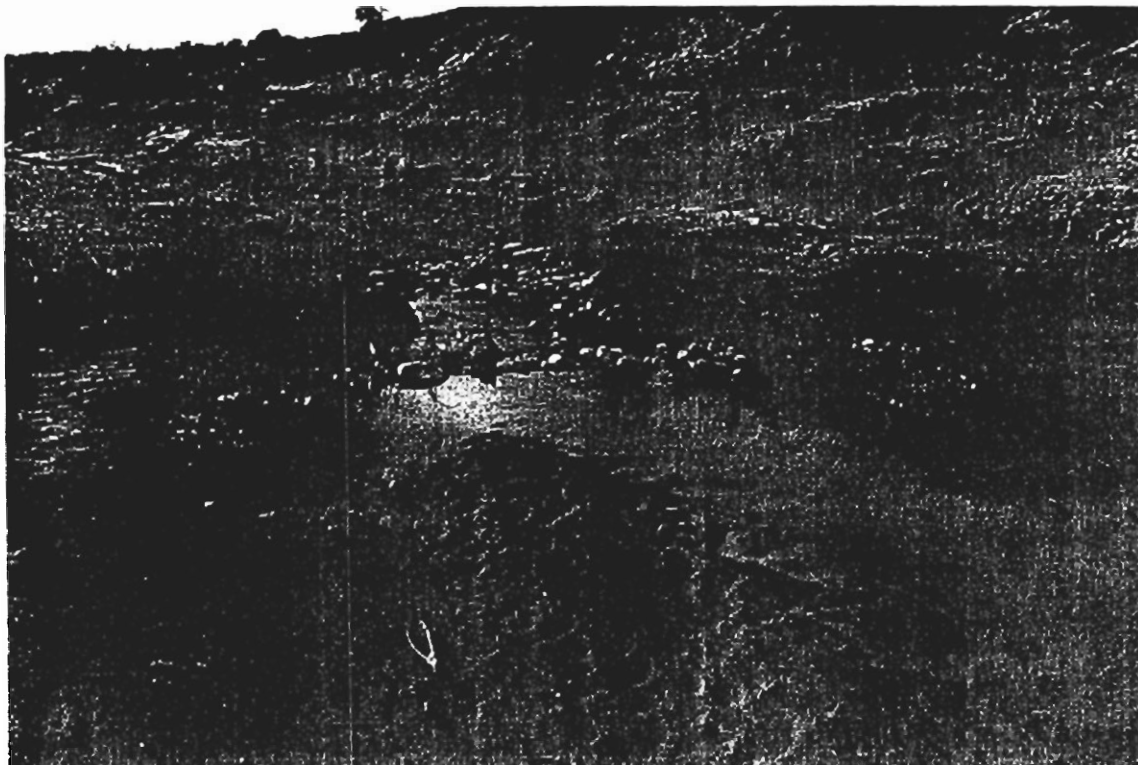
Phase 2 - Baffle 5 site. Rock baffle replaced by a picket only Baffle following August 28, 1999 flood.

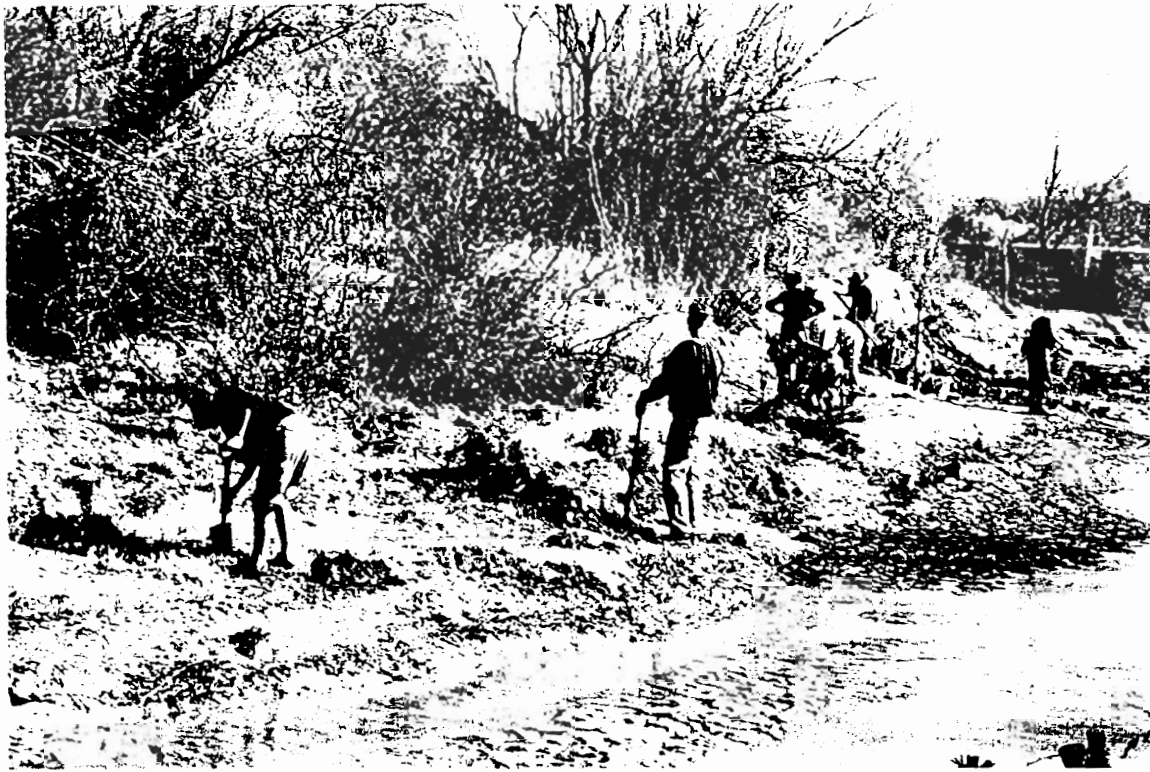
Phase 2 - site NR4 - A Wicker Weir with cobble added - Structure installed to control flow during incising Kogon G channel generated by July 28, 1999 flood (photo taken Aug 2, 2000)
