## INTRODUCTION

Watershed Restoration Unit 99-1 constitutes the third phase of a three-year strategy to remove the C-Line South. This project removed 0.5 mile of the C-Line South that included one stream crossing. This project involved the excavation of a total of 44,000 yds<sup>3</sup> of fill material, including 17,000 yds<sup>3</sup> associated with one stream crossing.

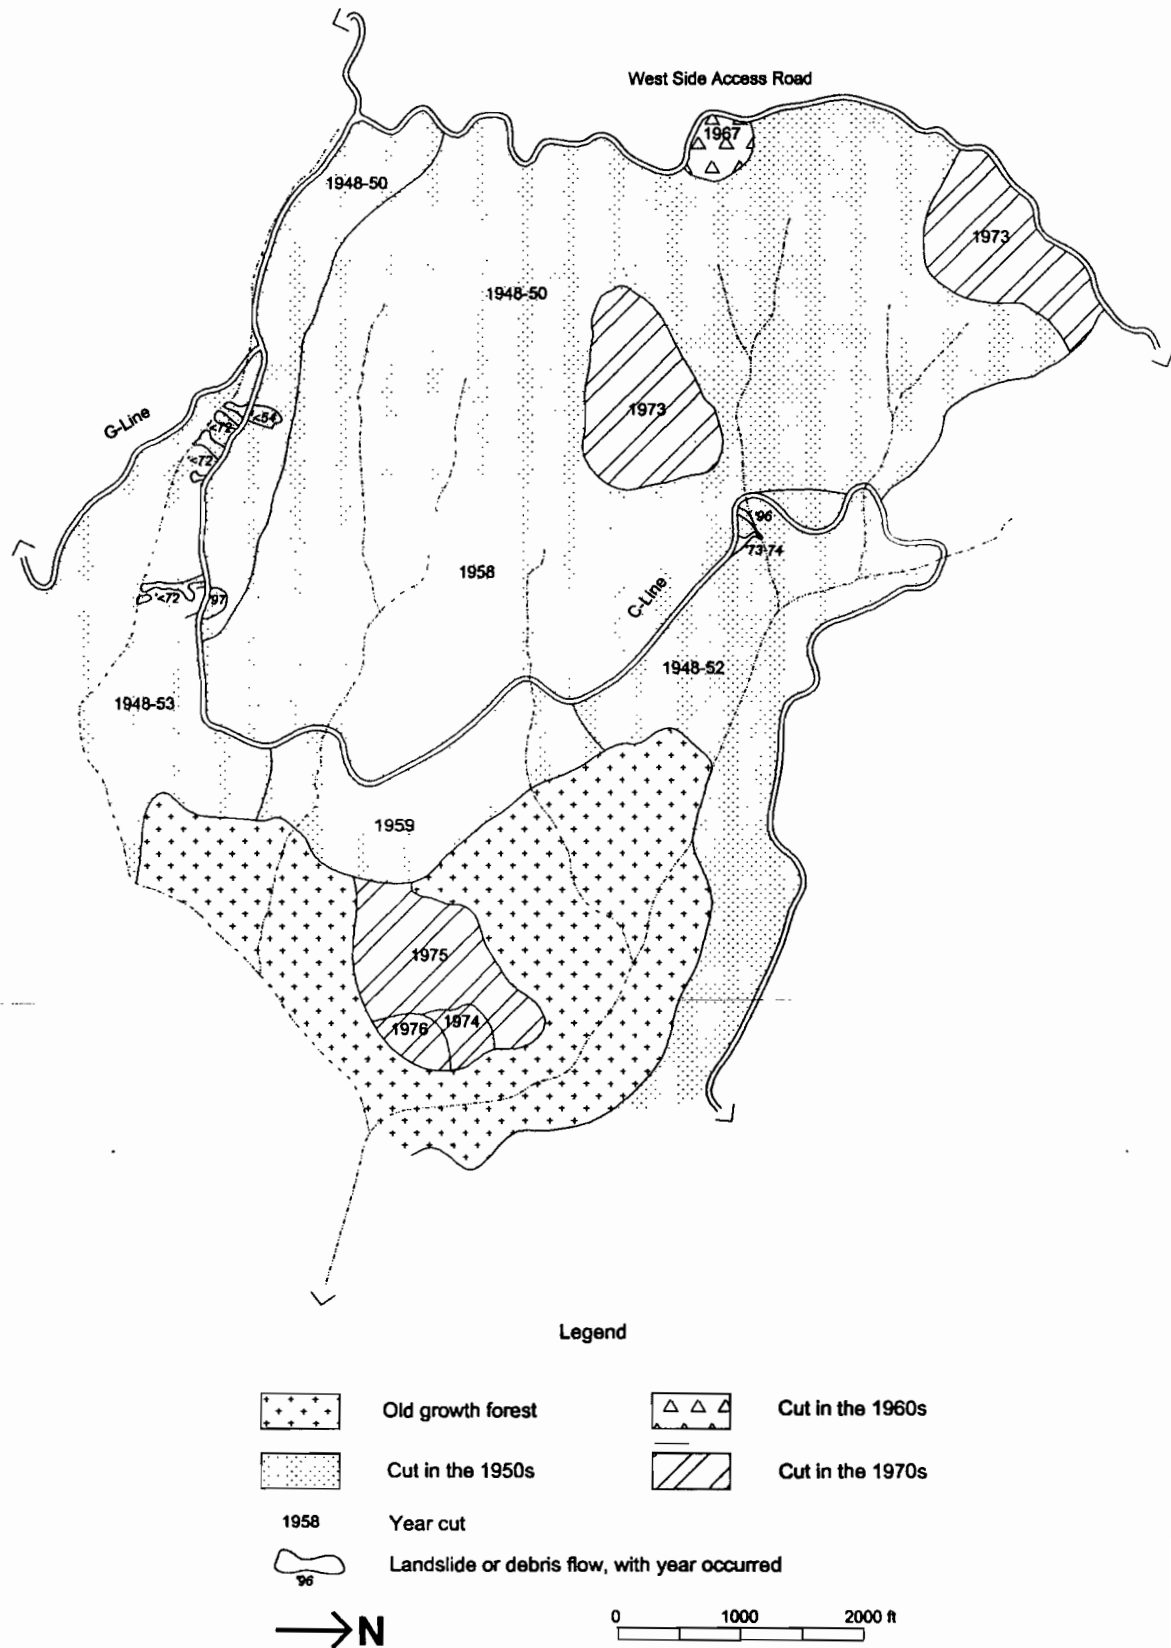
Figure 2. Timber Harvest History and Recent Mass Movement Features

The most dominant erosional features are landslides and debris flows (Figure 2). The 1954 air photos show one recent slide originating above the C-Line in a cable yarded unit just east of the intersection of the G-Line. The 1972 photos show four recent land slides/debris flows that originated on the outboard edge of the C-Line and terminated at the creek, east of the intersection with the G-Line. Between 1972 and 1973, immediately following clearcutting of an old-growth patch and construction of very large skid roads above the C-Line, a debris flow occurred originating on the outboard edge of the C-Line and terminated in the creek below RX-1 and RX-2. Between December 5 and 9, 1996, the outboard edge of the road at RX-2 failed and debris flowed

into the creek. During the New Year's storm on January 1, 1997, a section of the C-Line east of the G-Line intersection slumped, dropping the roadbed approximately five feet. In addition, the soils below the C-Line are very prone to gullyng. A ditch relief pipe at station 73+80 discharged water onto the hillslope at a ridge. This water created a gully with dimensions up to 5' wide by 3' deep running all the way down to the creek.
