Summary Report  
WATERSHED RESTORATION UNIT 99-2  
A120 and A100 Road Reconstruction

Becca Smith  
Redwood National Park  
November, 2000

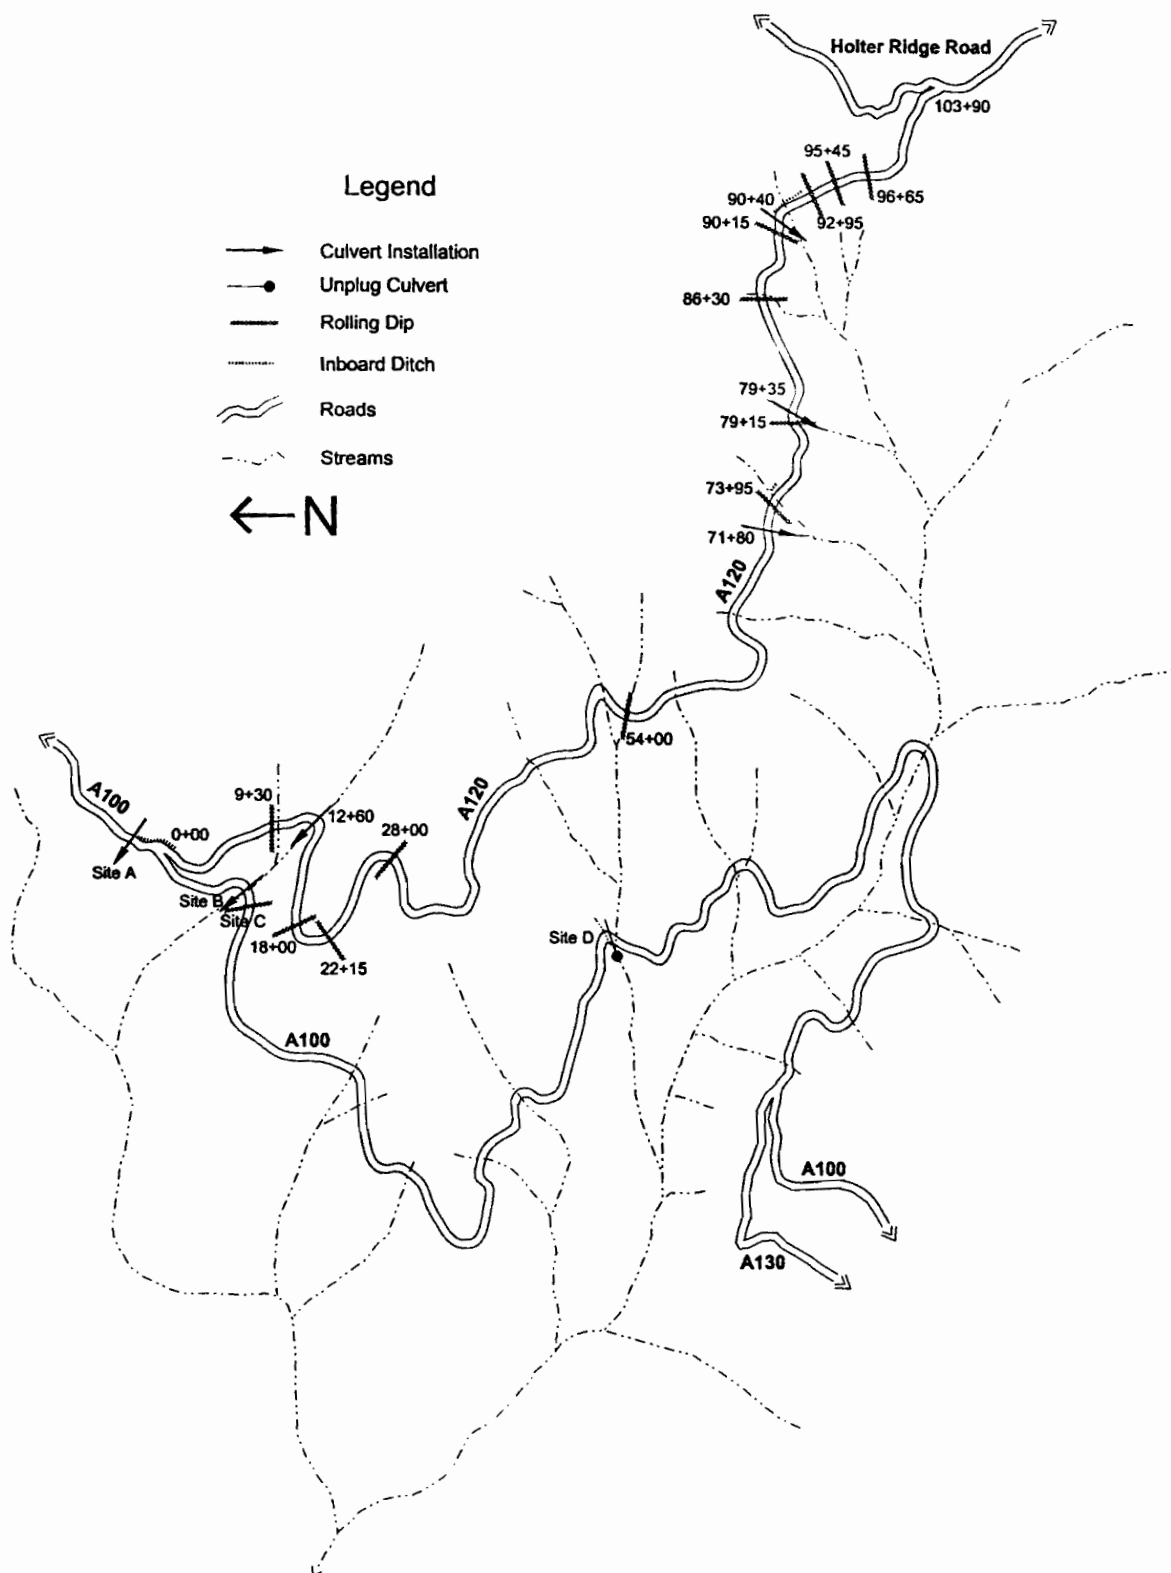
Figure 2. Site Locations and Site Specific Treatments

The most dominant erosional features are partially failed stream crossings. Only one stream crossing had a culvert in it. All the other stream crossings were Humboldt or fill crossings. The stream crossings on the A120 at stations 12+60 and 71+80 and on the A100 at Site B and Site D were partially blown out.

Reconstruction work focused on repairing the roads to a drivable condition to permit access to future road removal sites. During installation of two culverts, the upper portions of these stream crossings were restored to natural conditions and a smaller scale road reconstructed over the culverts. Reconstruction work included culvert installation, rolling dip construction, inboard ditch cleaning, and road blading (Figure 2).
