Redwood National and State Parks

**NRPP Watershed Restoration Project:  
Removal of the B530/B560 Roads  
Lost Man Creek**

Michael B. Sanders  
February 17, 2004

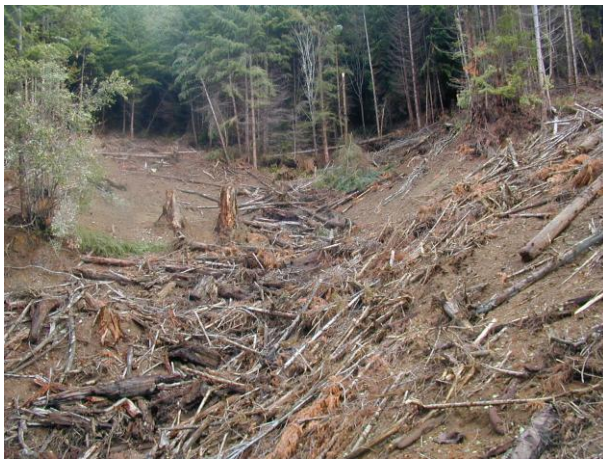
Post-excavation observations of these two sites indicated adjustments to fillsites owing to loosely placed fill material. Both sites required use of excavators for final fill excavations and this material was typically placed in proximal fillsite locations. It seems likely that the lack of compaction from having a bulldozer track the material into the fillsite may have contributed to the instability of the fill placement and lead up to the failures observed during the winter rains. Much of the mobilized material appeared to have been arrested and retained by the ample amount of large woody debris located in and adjacent to the excavated channel. Post-excavation volume measurements were not taken but visual observations estimated volume evacuated during winter rains to be approximately 50 yd<sup>3</sup>.

Photo 1: View of completed work on USX. Prominent landing and crossing were constructed at level with two exposed stumps located to the left of the wooded excavated draw. Fillsite for this excavation lies to the right of the photo.

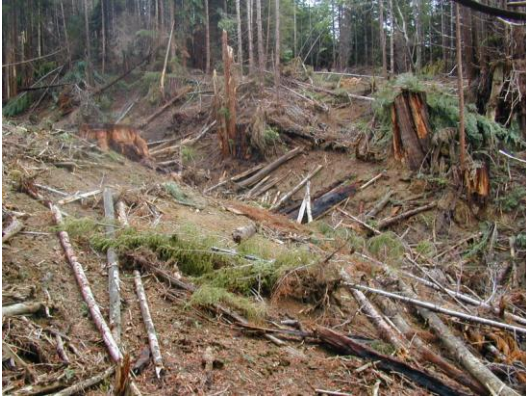
Photo 2: Post-excitation view of RX1 from right side of excavation. Fillsite for both RX1 and RX2 located to the left of the photo, above the confluence of the two stream crossings.

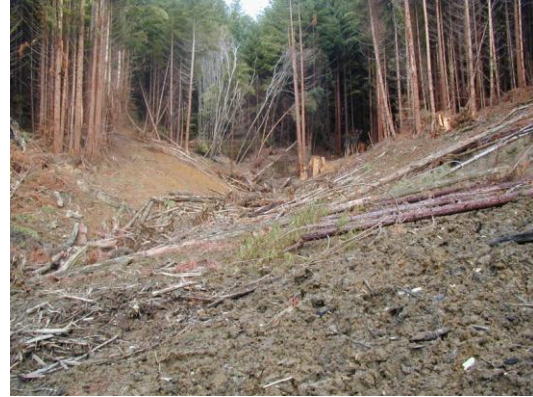
Photo 3: Post-excitation view of RX2 looking upstream. Fillsite for both RX1 and RX2 located to the right of the photo.

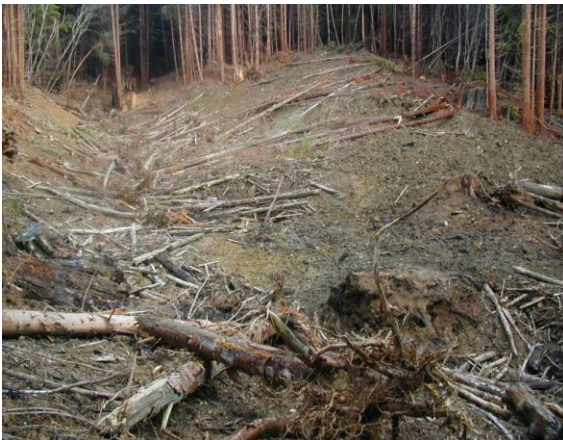
Post-excitation observations of this worksite identified significant adjustment to the prominent fillsite located between the two excavated channels. This adjustment was analogous to deep-seated hillslope creep and resulted the movement of several 1000 yd<sup>3</sup>. While there was considerable movement, there was very little evidence that indicated any delivery of material to either of the excavated channels. Instead of failing as a fluid mass with high velocity, this material seemed to have oozed down slope and arrest itself when slope gradient fell below a movement threshold. Overall, the fillsite and the excavations were shallow gradient, but the likely scenario is the burial of seeps and/or springs, causing saturation of fill and eventual failure. Repeated visits over the winter, did not identify additional material or movement of the original failure. Contrary to the previous sites (UX1 and US1), all fill placed in the fillsite between RX1 and RX2 was walked in using bulldozers. Thus it is assumed that this material achieved a higher level of compaction and this may be observed failure was more cohesive and not fluid and rapid. Additionally, it also appears that the failure was more deep-seated, likely the result of buried seeps and/or springs, so the mechanism for the failure was different than UX1 and US1. Pre-excitation investigation of this site was seriously hampered due to the thick regrowth of vegetation on the road and landing.

Photo 4: Fillsite for RX1 and RX2. Post-excitation adjustment of fillsite evident from scarp developing along the middle portion of the fillsite. Scarp height at time of photo is approximately 6'. Fill material appears to have been laterally displaced as a relatively cohesive mass and remained on the hillslope above both channels.

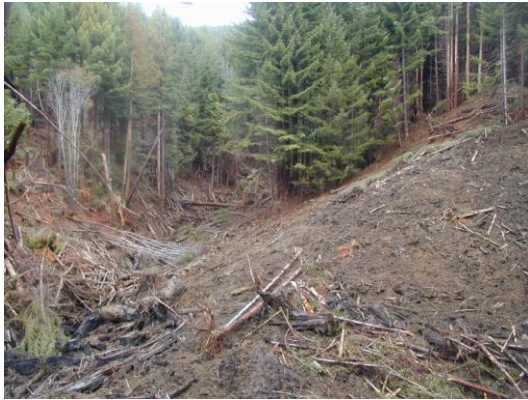
Photo 5: Post-excavation view of RX3, looking upstream. Photo taken from a mid-point between the two excavations of RX3 and RX4. Prominent fillsite for this and RX4 excavations is located along the right portion of the photo.

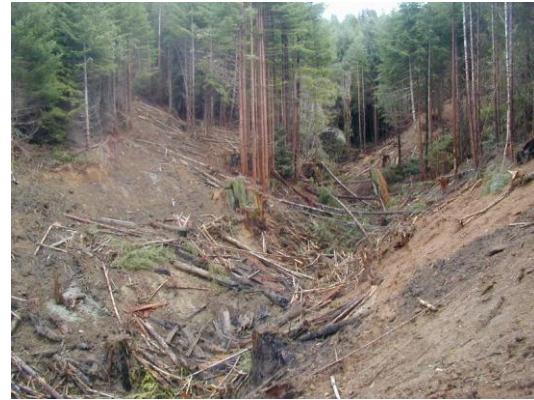
Photo 6: Post-excavation view of RX4, looking upstream. Exposed slope along right side of photo is referenced in narrative on excavation and is the location where post-excavation adjustment was most pronounced.

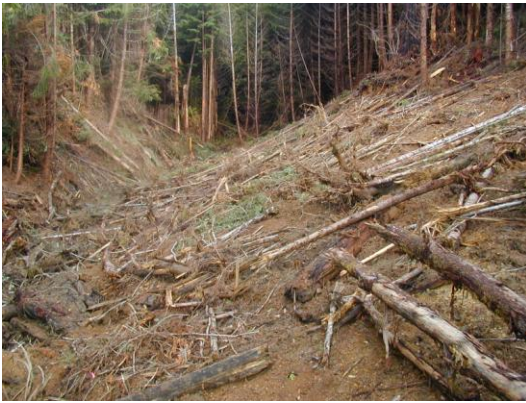
Photo 7: Post-excavation view of RX3, looking from bottom of excavation towards the top.

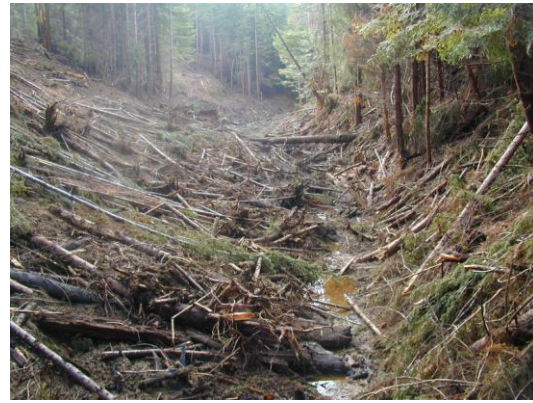
Photo 8: Post-excavation view of RX3, looking from top towards the bottom of the excavation. Pooling water are sections where large woody debris was used to arrest material left in the channel.

were modified to remove the bulk of the material and then fabricate a large woody mass to help moderate eventual channel adjustments. This LWD helped to capture material contributed during fillsite adjustments.

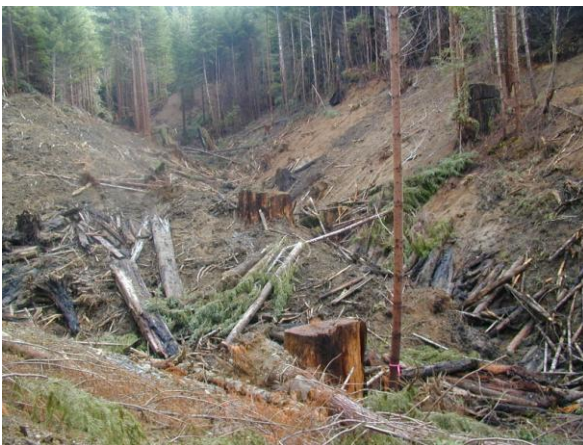
Additional adjustments occurred on the left bank of RX4. Again, as with previous sites, the likely mechanism for this was poorly compacted fill placed by an excavator. This location was the final portion of the worksite and all work was completed with excavator. In addition, the access to the worksite was eliminated by the use of the available road bench for fill placement. Consequently, the last sections of the worksite were not completely mulched in accordance with the guidelines due to the inability to deliver hog fuel to the worksite. The most prominent failure along this section of the worksite was associated with a fill wedge placed on the remaining road bench, immediately adjacent to the excavated stream crossing. The original amount of material excavated from the hillslope during road construction was much greater than

Photo 9: Post-excavation view of RX4, taken from the left side of RX3. View of excavated confluence of both crossings. Post-excavation adjustments experienced during the winter rains are visible in the background of photo.

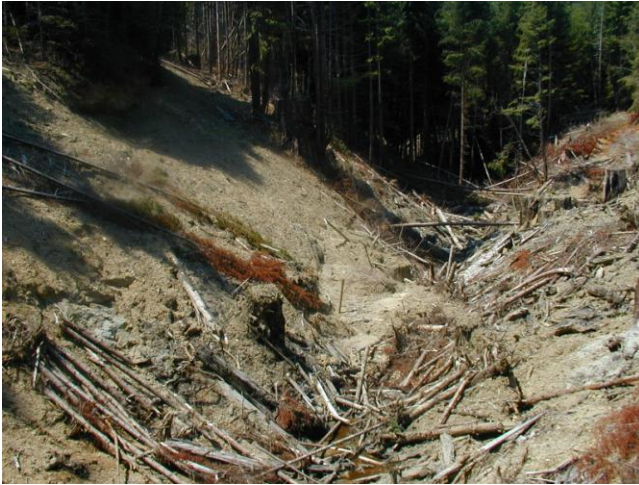
Photo 10: View of post-adjustment stream channel of RX4. Failure of approximately 50 yd<sup>3</sup> originated along lower left bank of excavation. Material covers large woody debris left in excavated channel. Lack of surface erosion of debris lobe indicates suitable avenues for channel flow beneath and within large woody debris.

was replaced during road removal, mainly due to the inability to place the material in a stable configuration. Instead, material was placed to both provide positive drainage and to utilize a proximal fillsite to the excavation site. Unfortunately, this strategy, while benefiting production and completion of the worksite, proved to be detrimental to the objectives of the project. Approximately 50 yd<sup>3</sup> of material were mobilized and transported to the channel, however, the majority of this material was arrested by the large woody debris placed in the channel during the excavation. It is likely that this material will eventually be metered into the stream system.

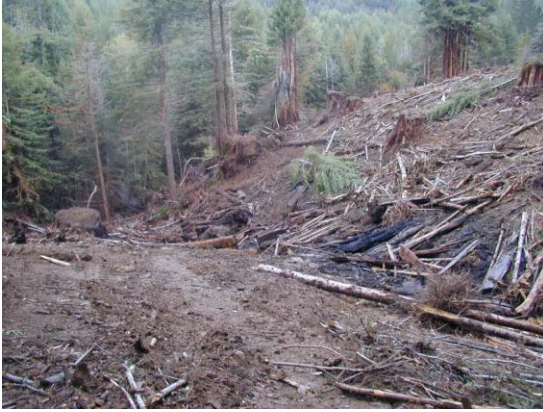
Photo 14: Post-excitation, early winter view of RX W2, taken from the upper right bank of excavation looking downstream.

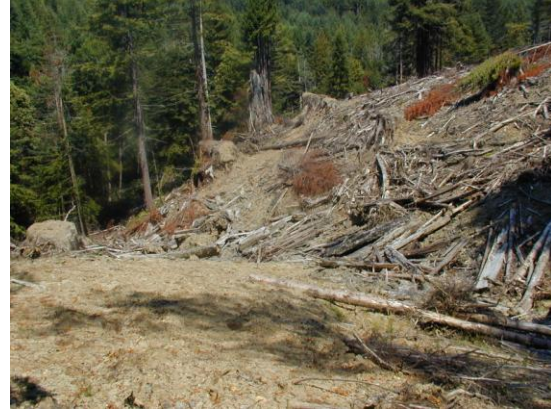
Photo 15: Same perspective of RX W2, post-excitation, late spring view, after the first year's winter rains.

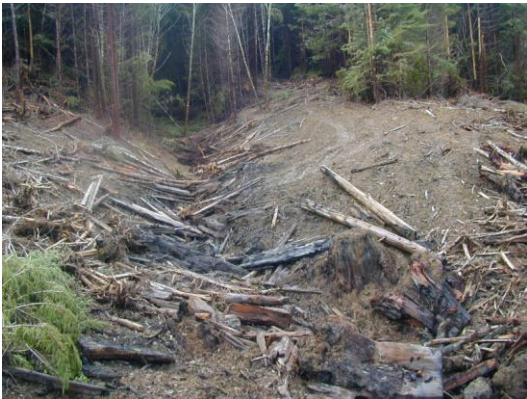
Photo 16: Post-excitation, early winter view of RX W2, taken from the lower right bank of excavation looking upstream.

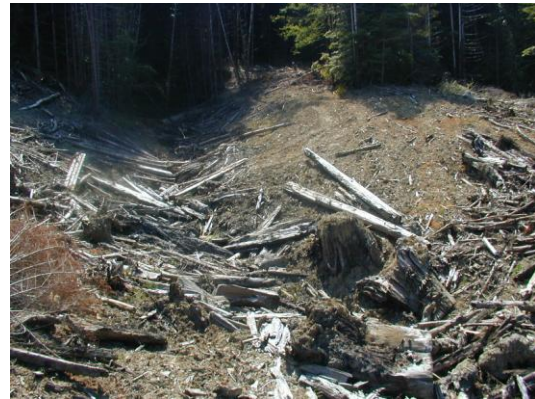
Photo 17: Post-excitation, late spring view of RX W2, after the first year's winter rains.

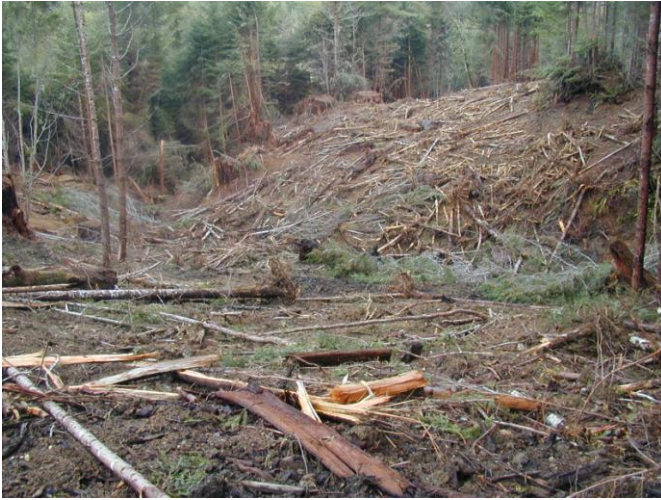
Photo 18: Post-excitation view of RX W3, looking downstream from upper left bank of excavation and left fillsite.

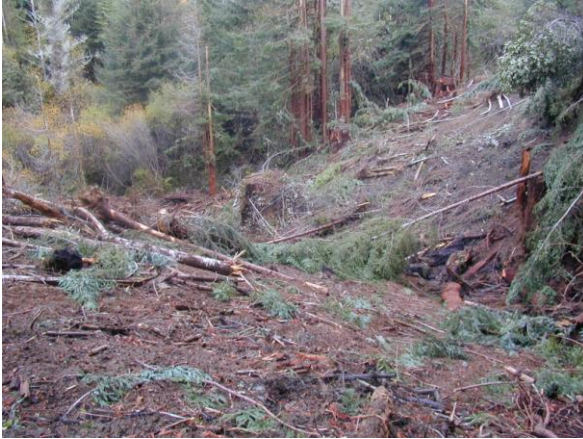
The final configuration of this site was very sympathetic towards stability. This configuration included shallow gradient sideslopes, modest channel gradient, and fillsites located away from the excavated channel. As with RX W3, negligible post-excitation erosion was observed at this site.

Photo 19: Post-excitation view of RX W4, looking downstream from upper left bank of excavation and left fillsite.

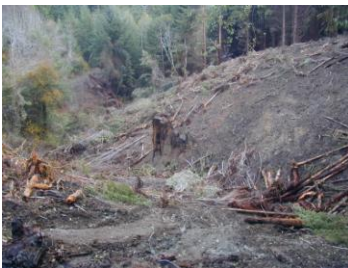
Photo 20: Post-excitation of RX W5, taken in the early winter. View is from the upper left side of the excavation, looking downstream.

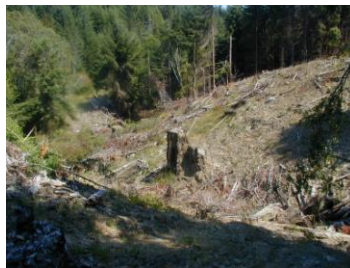
Photo 21: Post-excitation of RX W5, taken in the late spring, after first year's rains.

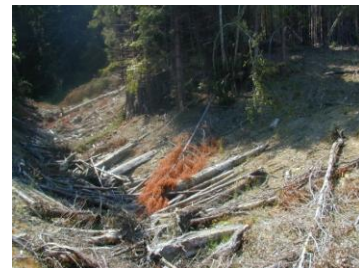
Photo 22: View of RX W5 looking upstream, taken from the prominent stump visible in the center of photos 20 and 21.

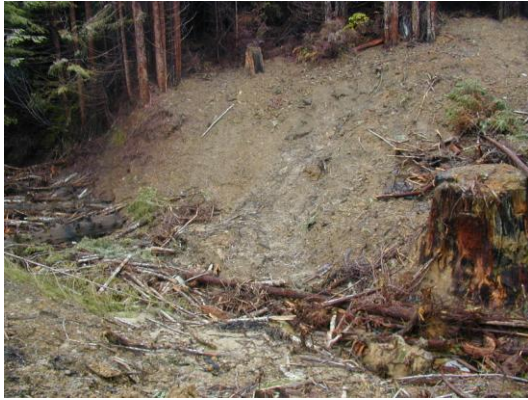
Photo 23: Post-excitation, early winter view of RX E3, after first set of heavy rains. View shows the fillsite failure along the left bank of the excavation.

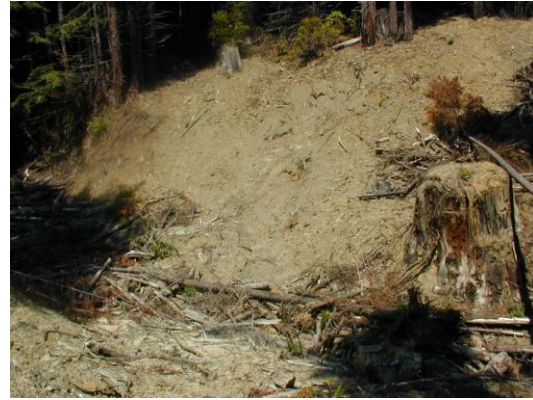
Photo 24: Same view of RX E3, but taken in early summer after first year's rains.

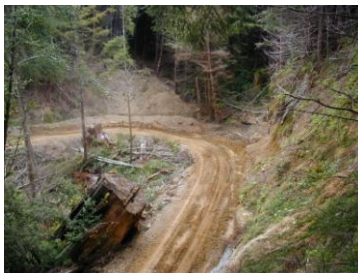
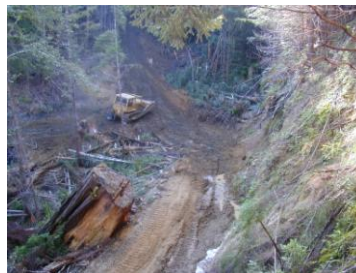
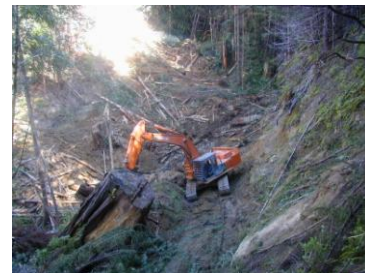
Initial excavation on the crossing was undertaken by bulldozer which pushed fill to fillsites located on both sides of the channel. The fillsite located on the right side of the channel utilized the bench of the access road as well as a skid road immediately upslope of the crossing. Additional material was pushed beyond the 1997 slide and to a stable fillsite located approximately 300 feet away upstation of the crossing. Once the majority of the fill had been removed, the excavator finished the worksite by squirreling fill into available fillsite pockets adjacent to the crossing. (See photo sequence above.)

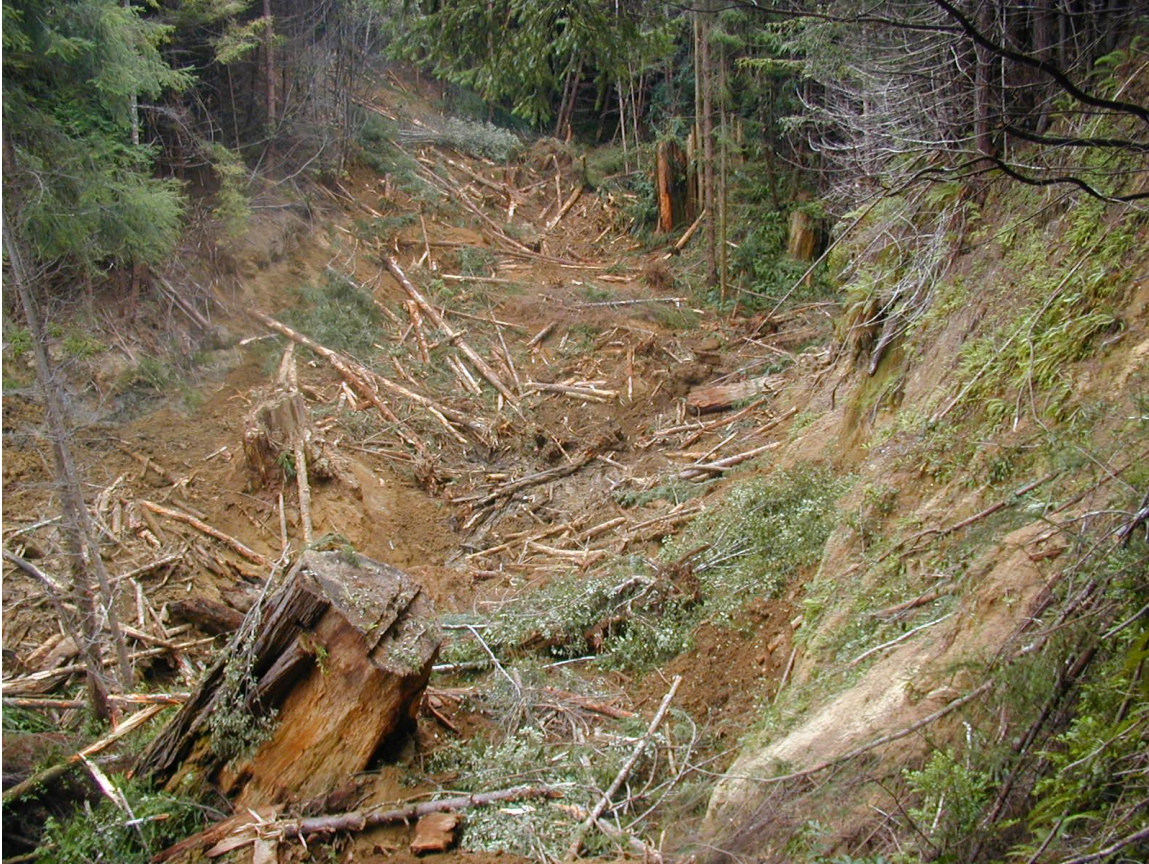
The completed crossing excavation was vegetated with material removed during the treatment of both the crossing and the road reached on both side of the crossing. In addition, the access road through the slide was partially outloped and vegetated. (See photo above.)

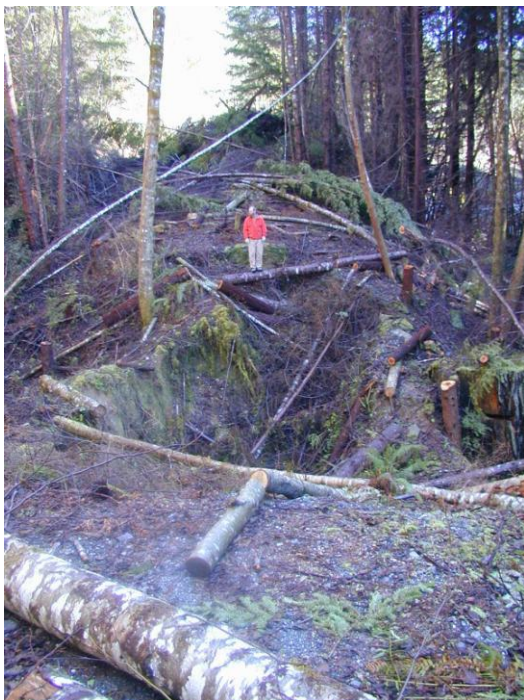
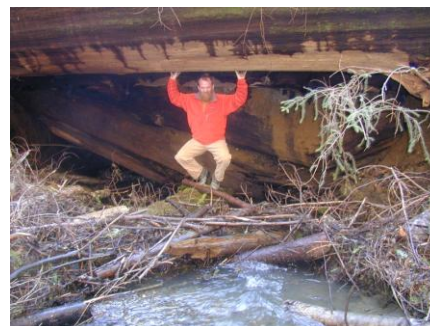
Photos XX and XX:

The 530E Bridge excavation was the removal of the failing log stringer bridge across Larry Damm Creek which provided original access to the 530 Road. This bridge had already failed when originally inventoried during the 1992 Road Inventory conducted throughout the Redwood Creek basin. Rendered inaccessible by the collapse of the center log stringers and the partial slumping of the buttresses on both sides of the crossing, this failing crossing also posed a formidable barrier to fish passage along Larry Damm Creek.

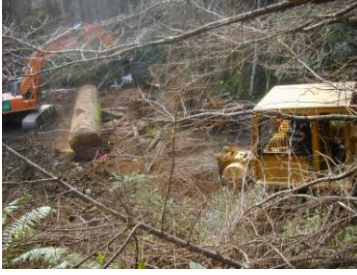
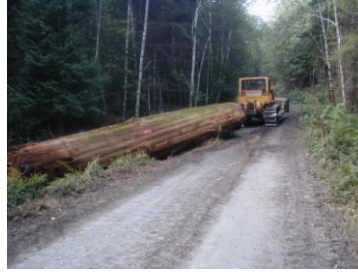
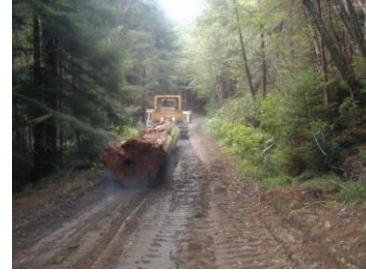
The above photo sequence captures the skidding of the salvaged log stringer from the 530 Bridge. This log was skidded down the Lower B500 road to await being retrieved by park staff.

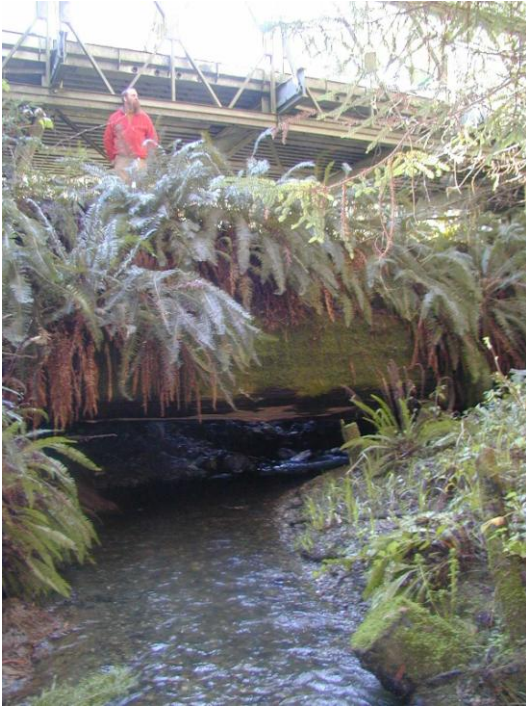
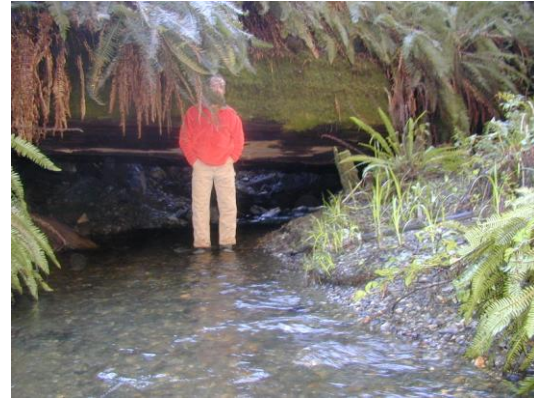
Photo at left shows the installed Bailey bridge and one of the original log stringers.

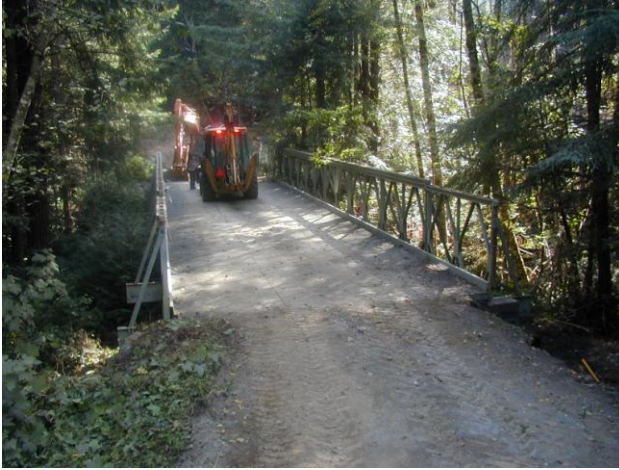
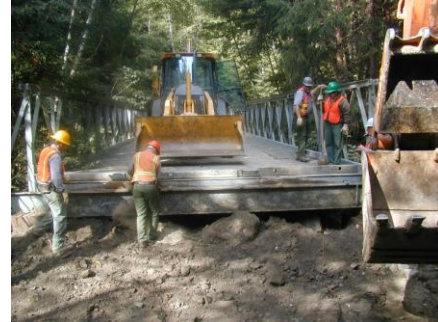
Photos show the Bailey bridge, at right, and the work crew beginning to prepare for removal and disassembling the bridge.

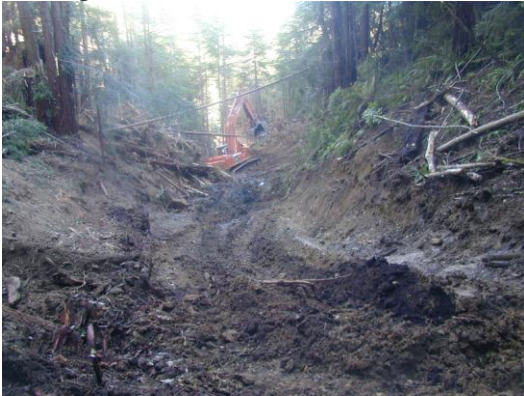
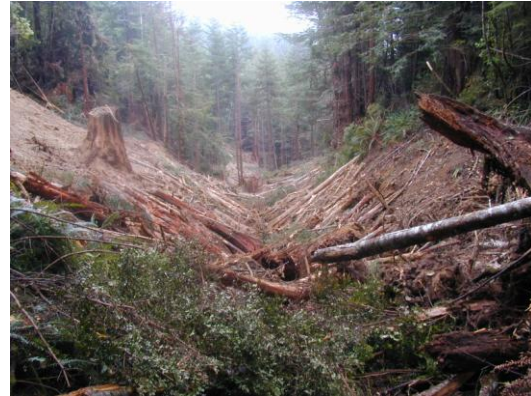
The above photos are looking downstream from the top of the excavation. In the first photo, the spur has been deflated using the bulldozer and the excavator is presently feeding additional material to the bulldozer. The material is being pushed to a fillsite, located to the right of the photo. The second photo, from the same location as the first, shows the final conditions of the site. Most of the material that was in the channel in the first photo, was deposited above the left bank of the channel. Here a skid road bench provided a stable location for spoils from the excavation.

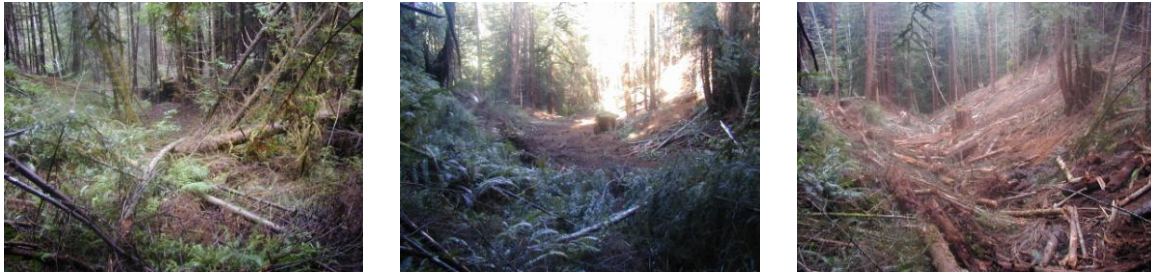
The photo sequence above documents the excavation from the top of the draw. The southeast spur crossed the draw just below the prominent stump in the middle of the view. Another skid road came right up the center of the draw and another skid road was constructed above the redwood stump cluster left standing in the third photo.

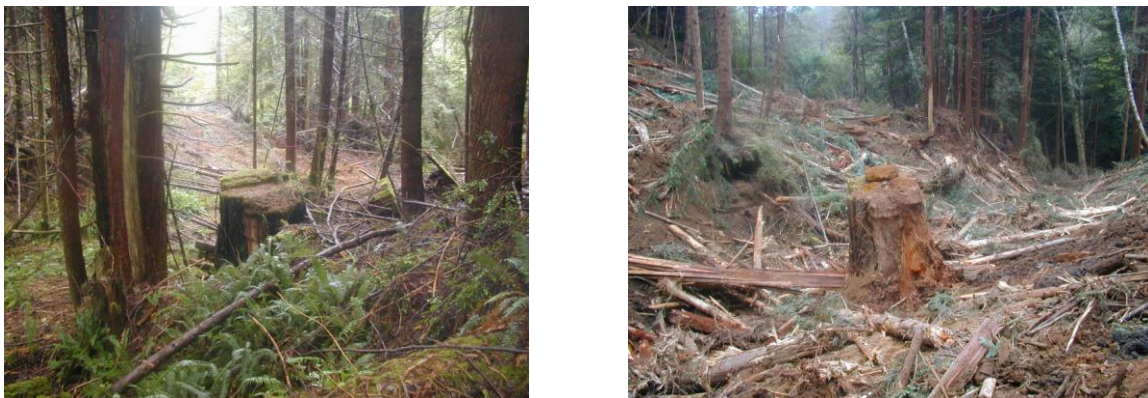
The above two photos document the excavated site from above the right bank of the channel and above the right most skid road, outlined in the proceeding photo sequence. The prominent stump was located on the outboard edge of the skid road and the southeast spur is visible in the background of the first photo.

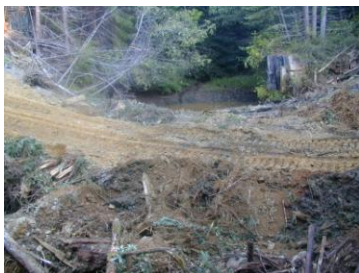
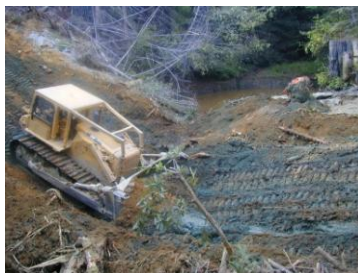
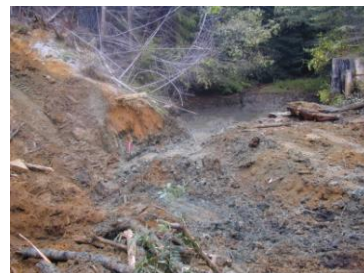
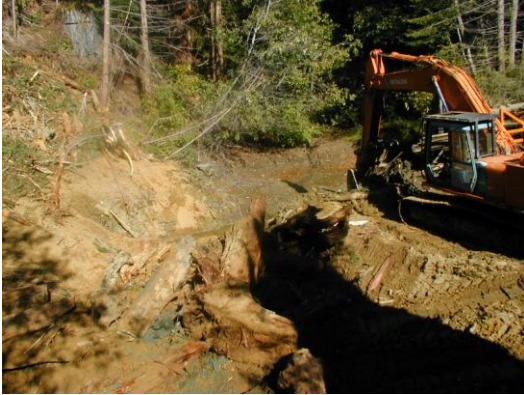
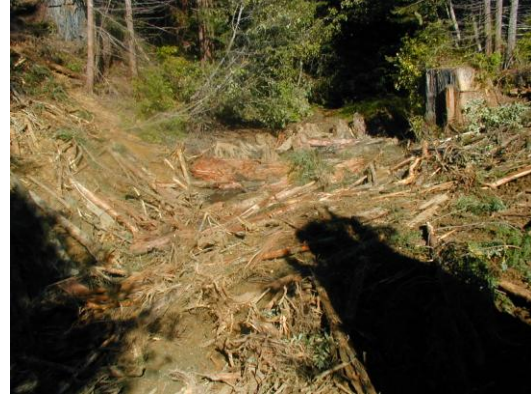
The preceding photo sequence documents the excavation of POND RX. The top left photo is of the rebuilt crossing. Top middle photo captures the bulldozer dishing out the crossing. The top right photo is how the latter part of the excavation proceeded. Here the crossing is being left to dry out a bit between periods of excavation. The bottom two photos were taken near completion of the crossing. The bottom left photo captures the excavator nearing completion of the crossing. The bottom right photo is the completed crossing. The large old growth stump on the right side of the photo was used to key large woody debris in the channel.
