Summary Report  
Watershed Rehabilitation Unit 03-03  
Y zone and B540 Roads

Portion of road removal work in the Larry Damm Creek watershed  
(Lost Man Creek)  
Completed with Line Item Construction Funds  
Package #277

Neal Youngblood  
Redwood National and State Parks  
December 2003

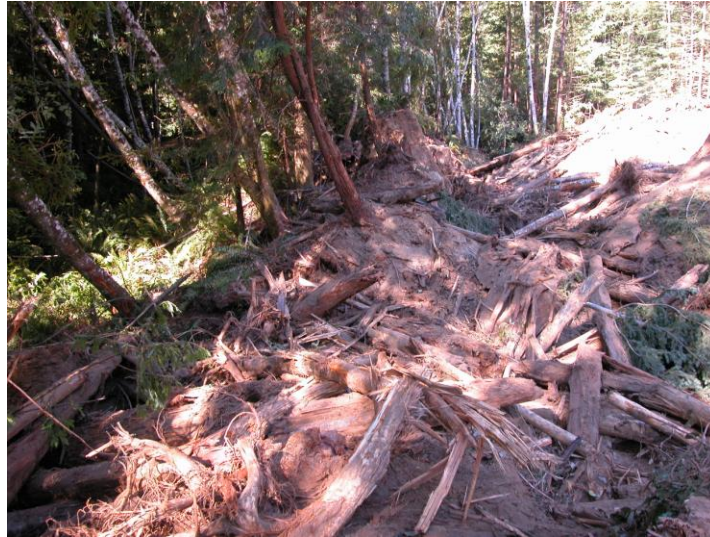
Figure 3. Riparian trees left in large woody fills on the flood plain of Larry Damm Creek.

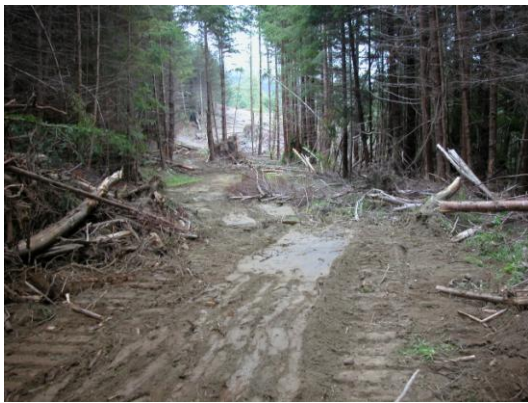
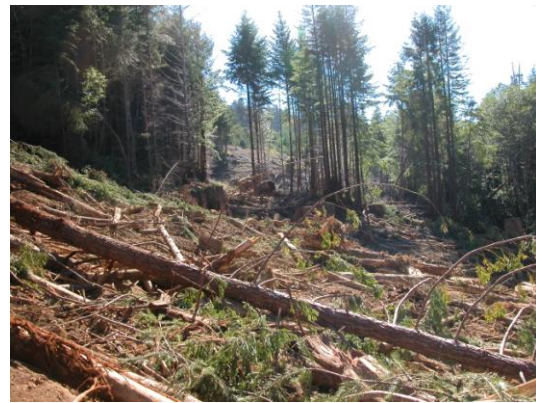
Photo point 0303072a\_8\_21\_03, before.

Photo point 03030702a\_9\_17\_03, after.

Figure 4. Photo point 0303072a showing before and after photos on the B551, looking downstream or south along road alignment.

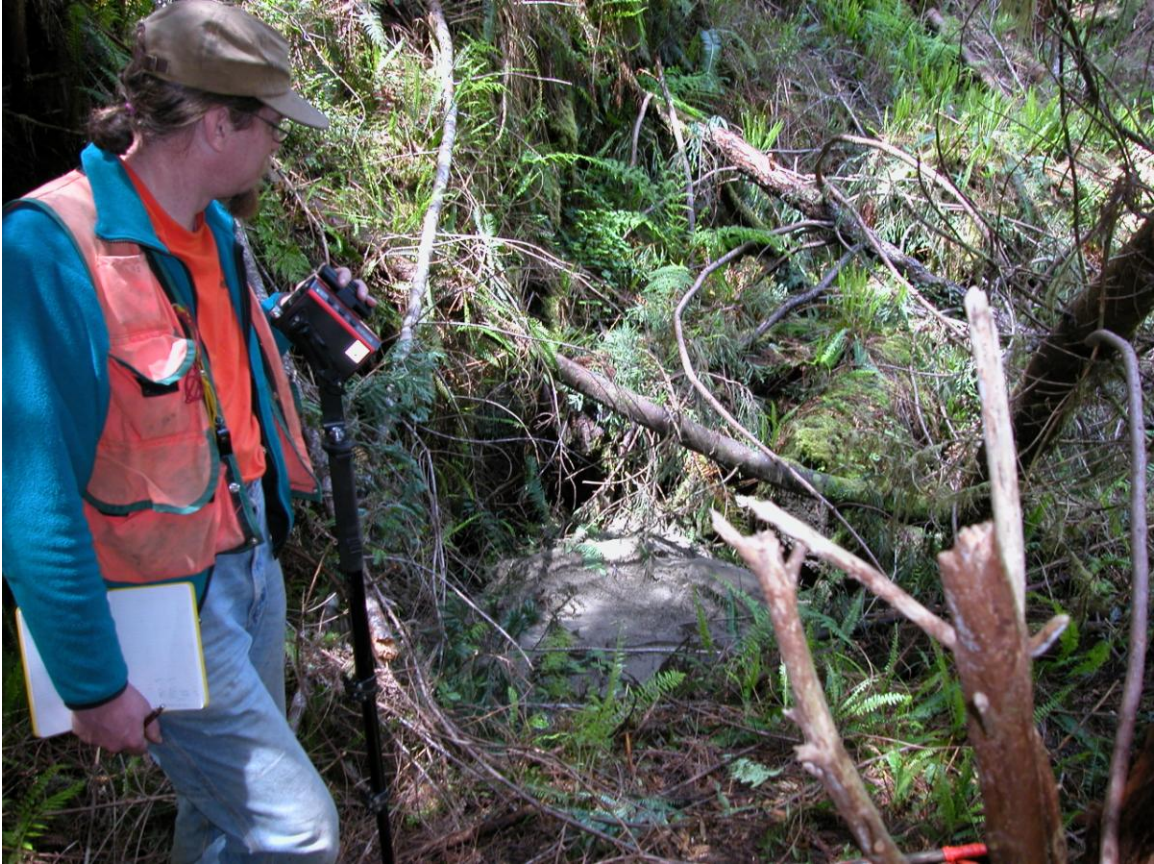
The crossing was actively eroding through internal decay, or “metering” as can be seen in figure 9. Large holes had collapsed as buried organic debris decomposed and settled following construction. The holes, or voids, were on the order of 5 to 50 yd<sup>3</sup> of where fill material had eroded.

Figure 9. Sediment deposit in a hole at Upper Y derived from internal decay of crossing fill (field book for scale). Deposition is located approximately 3 feet above active flow at time of photo.

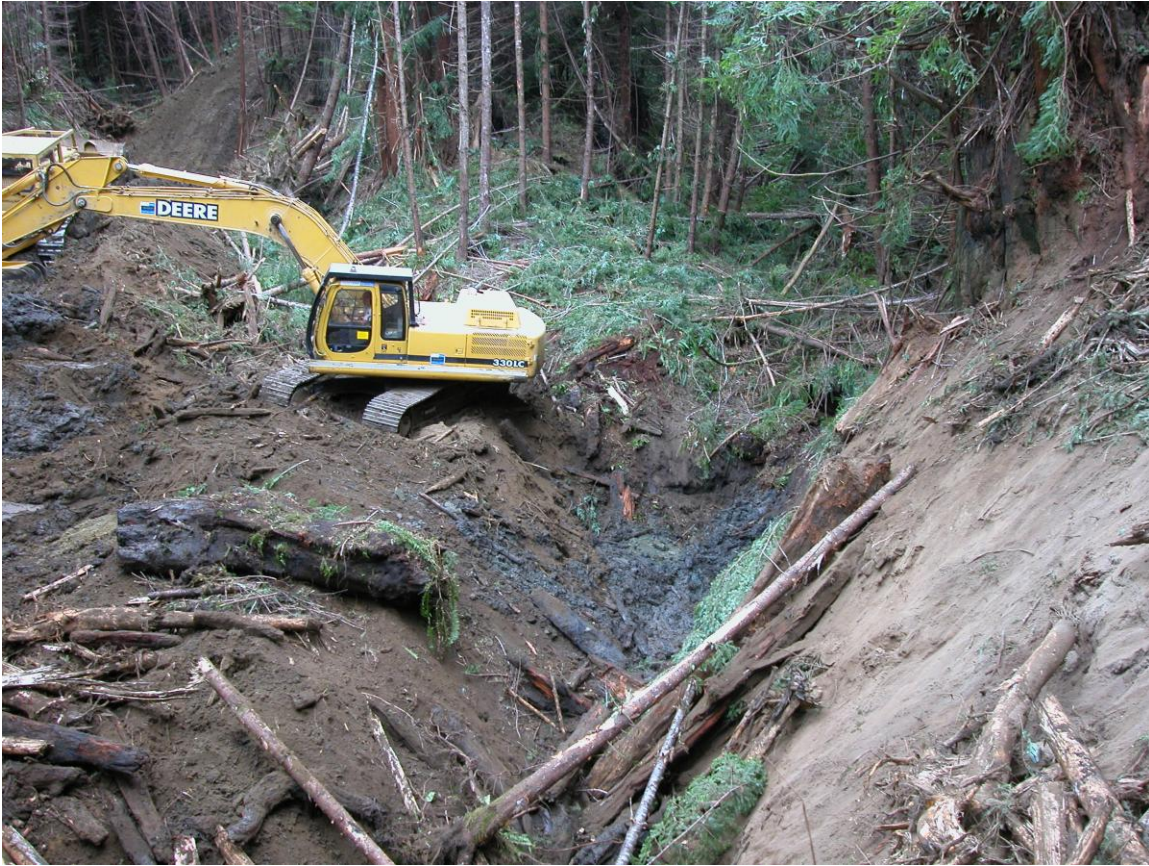
Figure 10, Looking upstream at the confluence of east and south forks at Upper Y crossing. Minimal fill in the south fork (to the right of the excavator) reduced the cost benefit ratio resulting in leaving the fill to adjust through runoff processes.

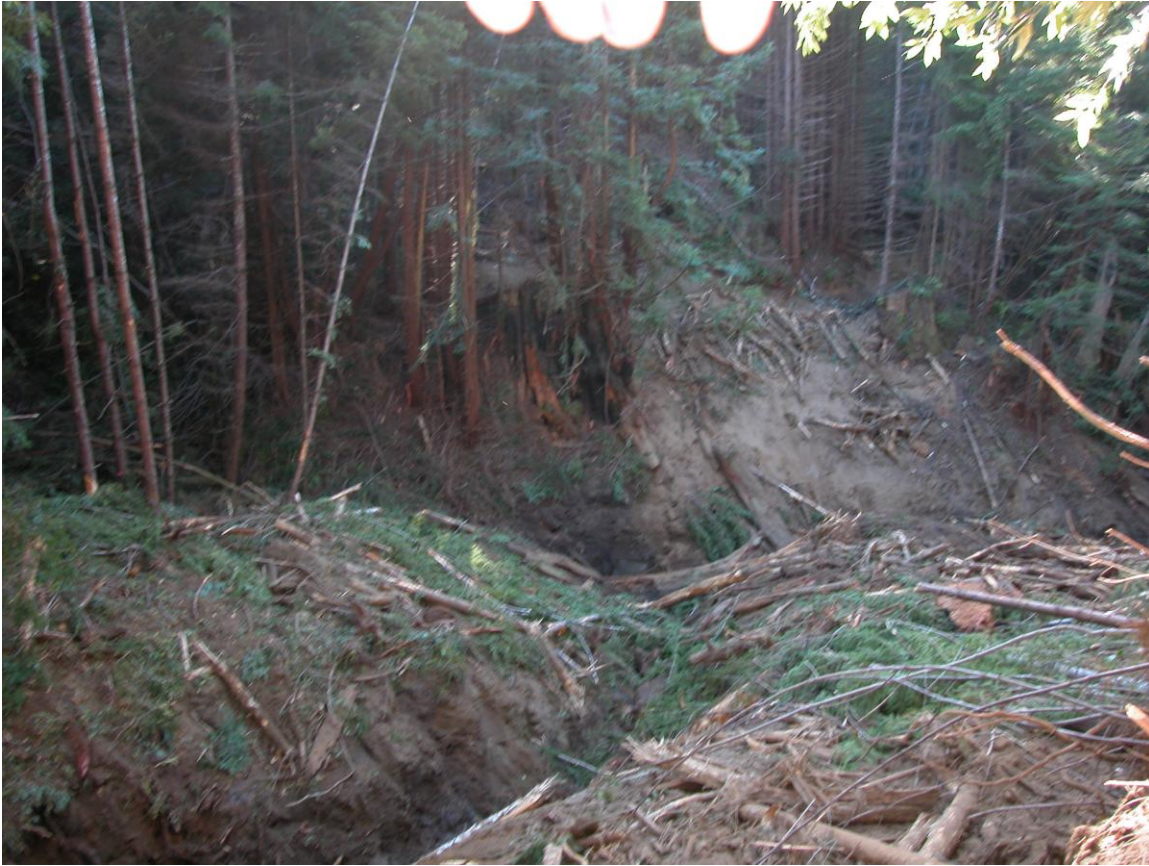
Figure 11. Looking down stream at the west bank (left bank of Upper Y) where a portion of the B551b was removed during the Upper Y excavation. Additional brush mulch was applied during the removal of the remaining B551b, covering the bare slope seen in this photograph. Photo location PP0303031b.

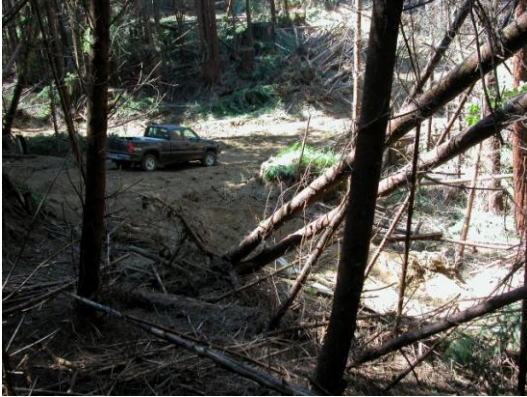
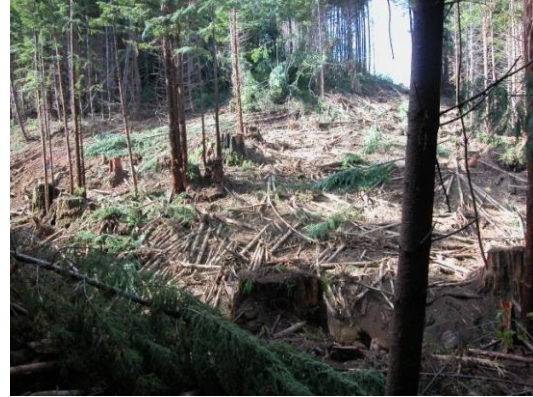
The stream crossing at Lower Y may have been a small landing or major intersection of numerous skid roads constructed in a narrow stream channel. The crossing was failing by internal decay as subsurface or piping flows carried away eroded material. Large holes were present during initial reconnaissance.

Figure 12a, Photo point 030305-1 as the lower Y crossing (Work Item 5) was being cleared prior to excavation.

Figure 12b. Photo point 030305-1 following restoration of the channel through Work Item 5.

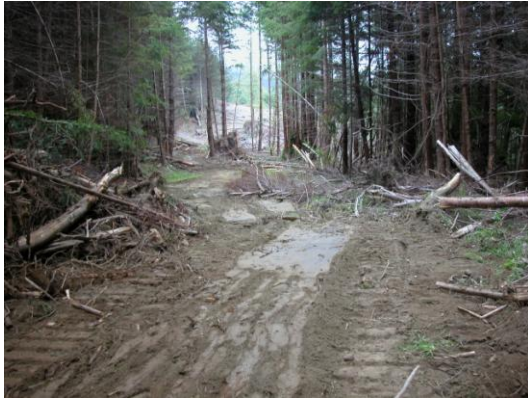
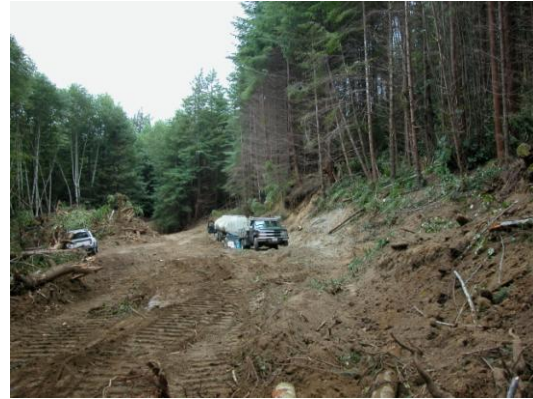
Figure 13a. Photo point 0303072a, looking back towards swale.

Figure 13b. Photo point 0303072b, looking up road towards the B550.

Targeted fill for excavation focused on road fill in the swale at station 12+45 and perched fill along Larry Damm Creek. Some slumping was noted along the outboard edge of the B551. The swale location showed subsidence and developing holes, typical of the North Fork Lost Man and Larry Damm Creek erosion processes seen throughout associated road networks.

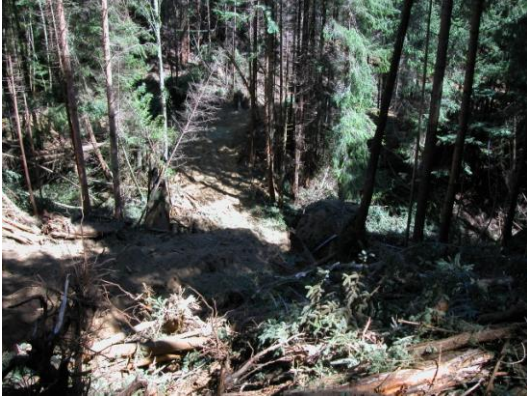
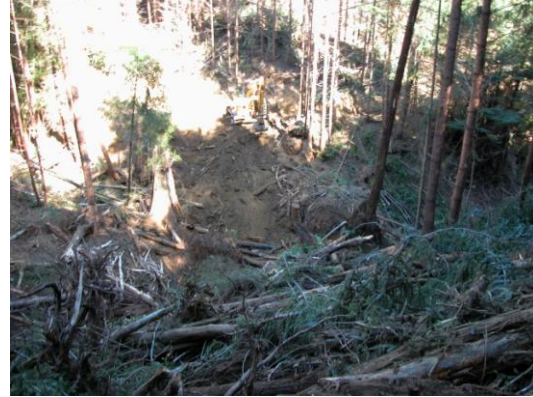
Fill had been slowly failing in the form of internal collapse within the channel. General subsidence and voids were present throughout the buried tributary. A large wad of perched fill existed above the road on the right bank. This fill was also included in the excavation due to its potential failure in to live flow following the crossing removal.

Figure 15a. Push road that was rebuilt to transport fill across mainstem, through RX4.

Figure 15b. Excavation of last portion of fill from mainstem channel at RX4.

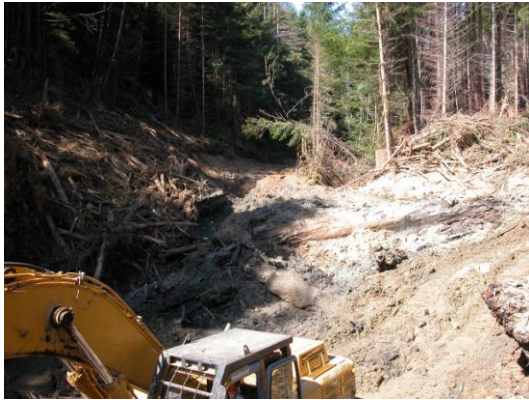
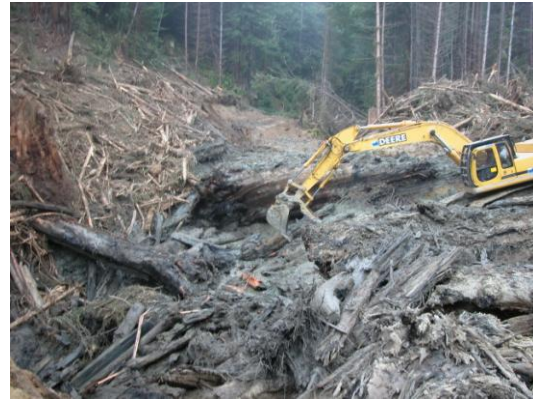
As with most landings constructed by filling in stream channels in the North Fork and Larry Damm drainages, subsidence was occurring on an annual basis. No drainage structures were used in construction of the landing unless you define large chunks of wood randomly buried in fill as “structure”. The down stream portion of the landing had already failed into the creek. Numerous holes and depressions were evident prior to brushing of the landing surface.

Figure 16a. Uncovering large ‘jackpot’ of woody debris in lower portion of B540

Figure 16b. Windthrow (14' BDH) exhumed in mid portion of B540 landing.

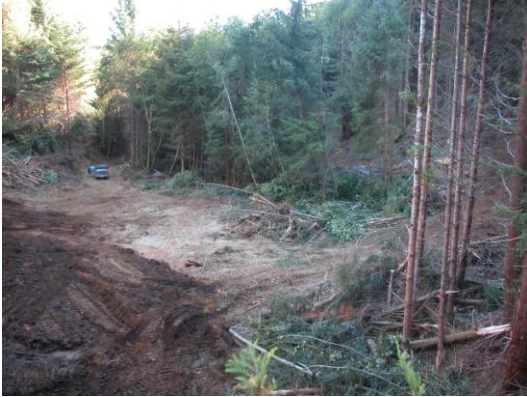
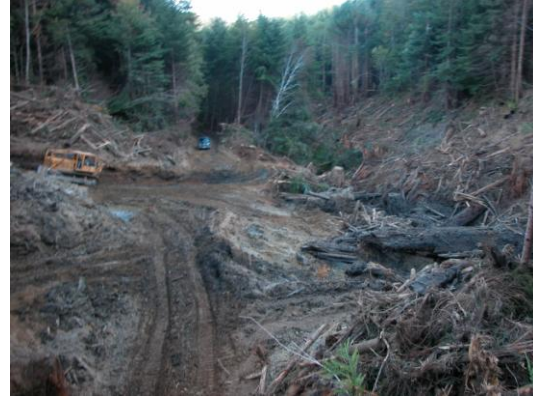
Figure 17a. B540 Landing during early excavation.

Figure 17b. B540 Landing with main channel excavated.

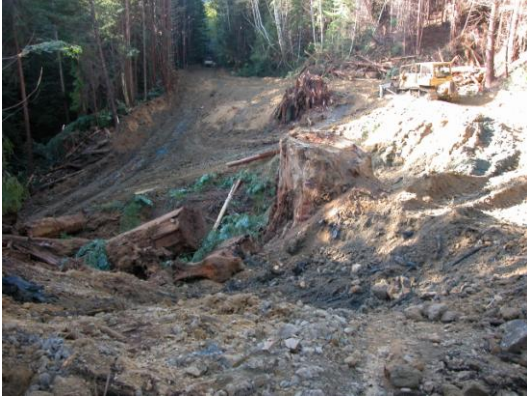
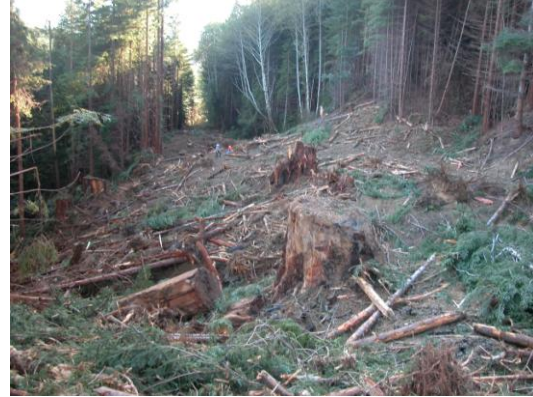
Hollywood Bowl consisted of the Lower B500 skirting around the upper portion of a bowl morphology for the confluence of three small channel forms. The road bench was comprised of predominantly clean fill. The lower portion of the bowl had been filled in with large wood and earthen material, possibly used as a staging area or disposal site.

Figure 19a. Hollywood Bowl, partially excavated, dozer on B500 road elevation.

Figure 19b. Final excavated surface of southern portion of Hollywood Bowl.
