Watershed Restoration Unit 02-04  
Summary Report  
AA1/AA2

Ingrid Corson  
Redwood National and State Parks  
July 2003

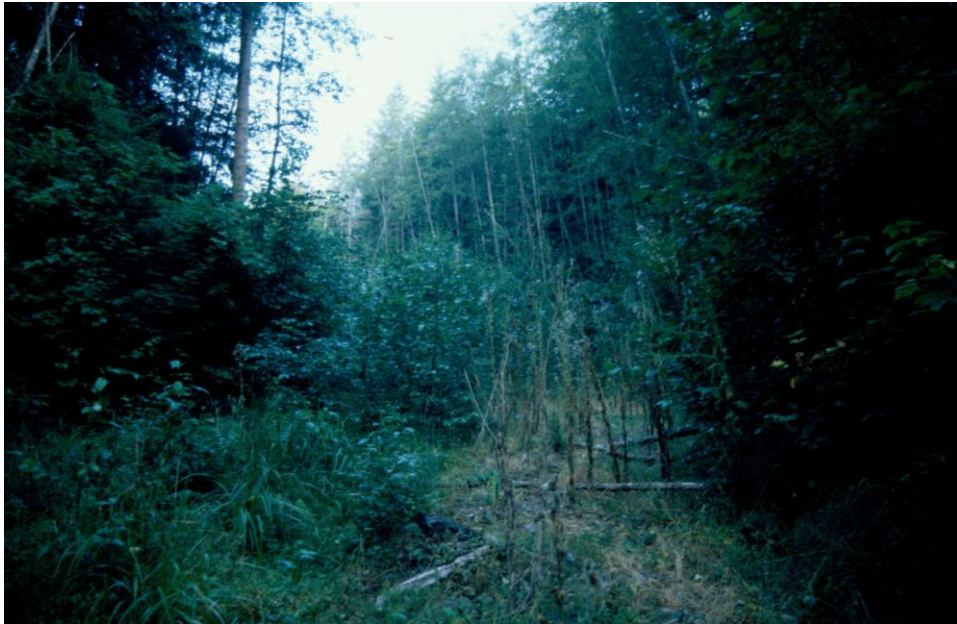
RX-1 was created by filling the lower reaches of a steep stream that enters Larry Damm Creek at almost a right angle. Prior to excavation there was an approximately 150 ft. long, 20 ft. tall wall of fill perched alongside Larry Damm Creek. Numerous active gullies riddled this fill, some as deep as 12 ft. There were also tension cracks and buried large woody debris (LWD) evident in the wall of fill.

**Figure 4.** Pre-excavation view of RX1, Work Item 3, looking downstream from the middle of the Larry Damm Creek debris deposit just upstream its the confluence with Rx-1's creek. The right side of the image is a 20 foot high wall of fill covered in vegetation.

RX-1 was a 7,864 yd<sup>3</sup> crossing and the first crossing of the contract. It took 95.5 equipment hours to complete using the D8K, D8L, and 330 excavator, and yielded an average production rate of 82 yds<sup>3</sup>/hr. From top to bottom, RX-1 was approximately 300 ft. long, widening from top towards the bottom, and the excavation was approximately 180 ft. wide and 20 ft. deep at the confluence with Larry Damm. Most of the fill from RX-1 was returned to the hillside just west of the crossing. RX-1 was mostly dry during excavation; the only wet areas coincided with trapped subsurface water associated with buried stumps and buried LWD. During the early December rain storm event, RX-1 had surface flow in the channel.

The excavation of RX-1 was fairly straightforward and began with bulldozer work at the downstream end of the excavation. The fill was dry and easily pushed uphill to local fillsites. There were many buried wood chunks in the lower third of the crossing and most of these were placed along the banks of RX-1 and along its channel to help trap any excess sediment that might be carried down the channel after excavation. As this tributary is a headwater stream and not a fish bearing stream there were no concerns that the LWD placed in the channel would create barriers to anadromous fish passage.

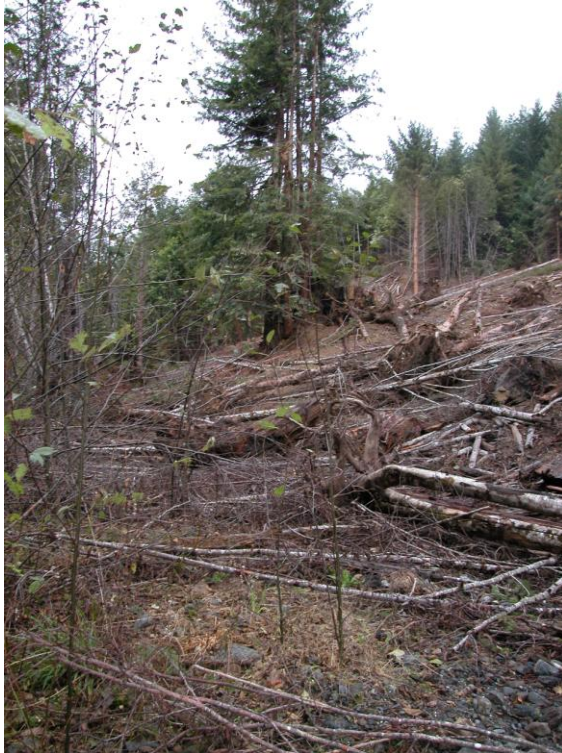
**Figure 5.** The finished slope of RX1, Work Item 3, looking downstream from the middle of the Larry Damm Creek debris deposit just upstream its the confluence with RX-1's creek. The wall of fill has been removed and the finished surface covered with vegetation.

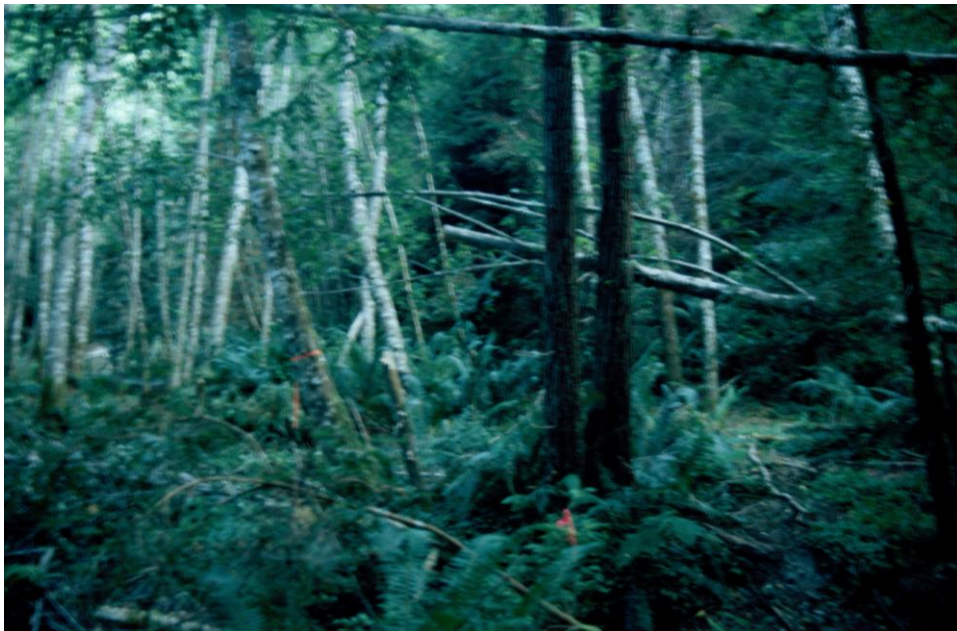
Prior to excavation, there was a large swampy area coinciding with the confluence of the two smaller tributaries and that extended to the banks above Larry Damm Creek. The swampy area had standing water, surface and subsurface flow, sink holes and a 3 ft. deep gully that down-cut to a large buried log running parallel to Larry Damm Creek. In the upper reach of the excavation on the left fork, where the channel sides steepen, there were large sinkholes, and large buried stumps and logs. The upper reach of the right fork contained a pond flowing into a short but well-defined meandering channel incising through a large layout. The channel sides were steep on both creeks (60%) but especially steep on the right fork.

**Figure 6.** RX3, Work Item 7, prior to excavation viewed from across Larry Damm Creek. The view is up towards the confluence of the two tributaries.

RX3 was an 8,694 yd<sup>3</sup> crossing and took 211.5 equipment hours to complete using the D8K, D8L, and 330 excavator. The average production rate was 41 yds<sup>3</sup>/hr. This is a low production rate and reflects the difficulty of this excavation. Production was slow for a few reasons, including long push distances, steep pushes, and a tight and steep working environment. While the lower portion of the excavation was wide and flat from downstream of the confluence of the two forks to the confluence with Larry Damm Creek, the upper reaches of both forks were very steep (>60%) and quite narrow. The 330 excavator was unable to swing in the upper sections of the right fork and had to constantly drag excavated

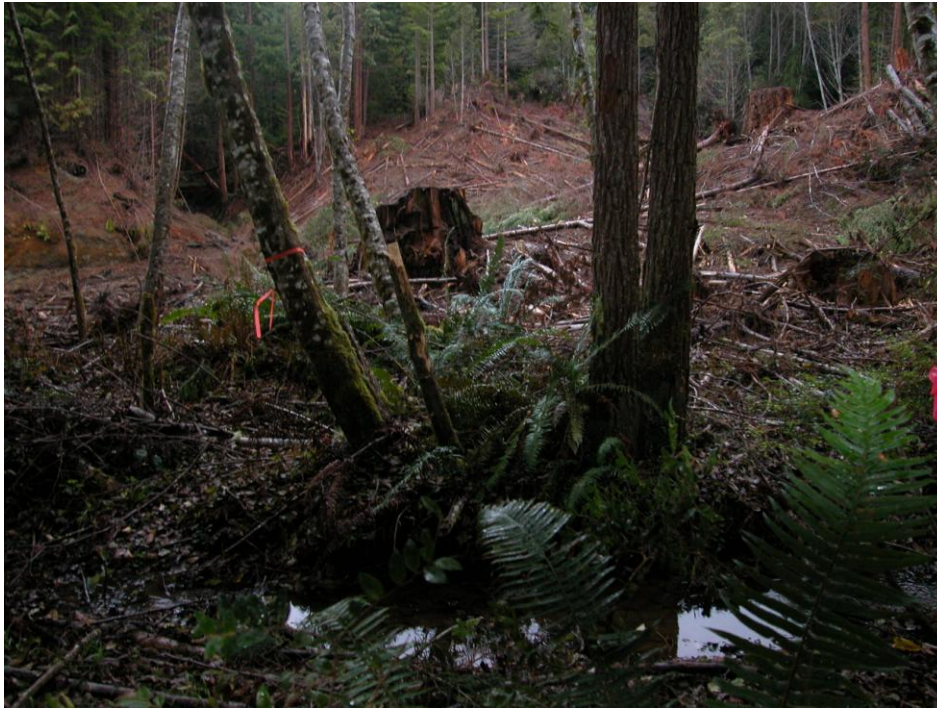
**Figure 7.** RX3, Work Item 7, after excavation viewed from across Larry Damm Creek. The view is up towards the confluence of the two tributaries. Notice the twin second growth redwoods in Figures 6 and 7.

A shallow adjustment originating mid-slope on the left bank of RX-3 (monitoring site 2) occurred during the first big December storm. The upper slope is a fillsite and the slide is in the same location as a steep push road used to access the fillsite. The push road was removed and the hillslope shaped by the excavator. The finishing fill was not compacted by the bulldozer. The scarp was 1.5 feet tall on March 27, 2003, and there was no delivery to Larry Damm Creek as of April 24, 2003.

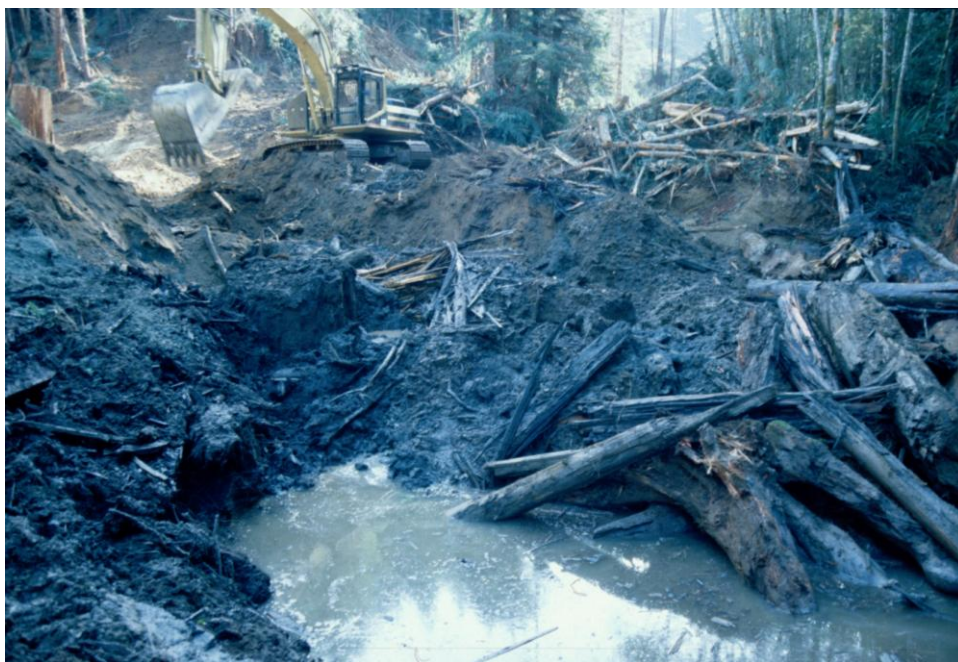
that the contemporary Larry Damm Creek elevation was actually higher than the pre-logging tributary elevation. There was a unique layer of blue unconsolidated gravel that may be an old alluvial or landslide deposit in the confluence area. This blue layer comprised some of the material burying the large snag and didn't hold together well when disturbed or wet. Instead of completely excavating this blue layer near the confluence, we created a large settling pond in the middle of the tributary. This pond acts to trap sediment before it enters Larry Damm Creek and also allowed us to blend the two actively flowing channels without rerouting either one. Because of this elevation difference we also left some fill and buried LWD on the right bank of the tributary just downstream of the confluence with Larry Damm Creek. This area seems to be part of an old logjam and to excavate it would have required disturbing the flowing Larry Damm Creek and completely eliminating the existing riparian buffer. Farther up the channel we exposed a similar dry blue gravel layer, and excavated it to reveal old top soil and root mats below. As there was evidence of pre-logging top soil, we fully excavated the blue layer in this area. One thing we learned here was that if you are following a wet channel and hit a dry gravel layer, that dry layer is most likely fill in the channel and should be excavated.

**Figure 8.** RX3, Work Item 7, during excavation viewed from the lower left bank. The bluish unconsolidated gravel can be seen above water level and

around the partially buried stump just left of center.

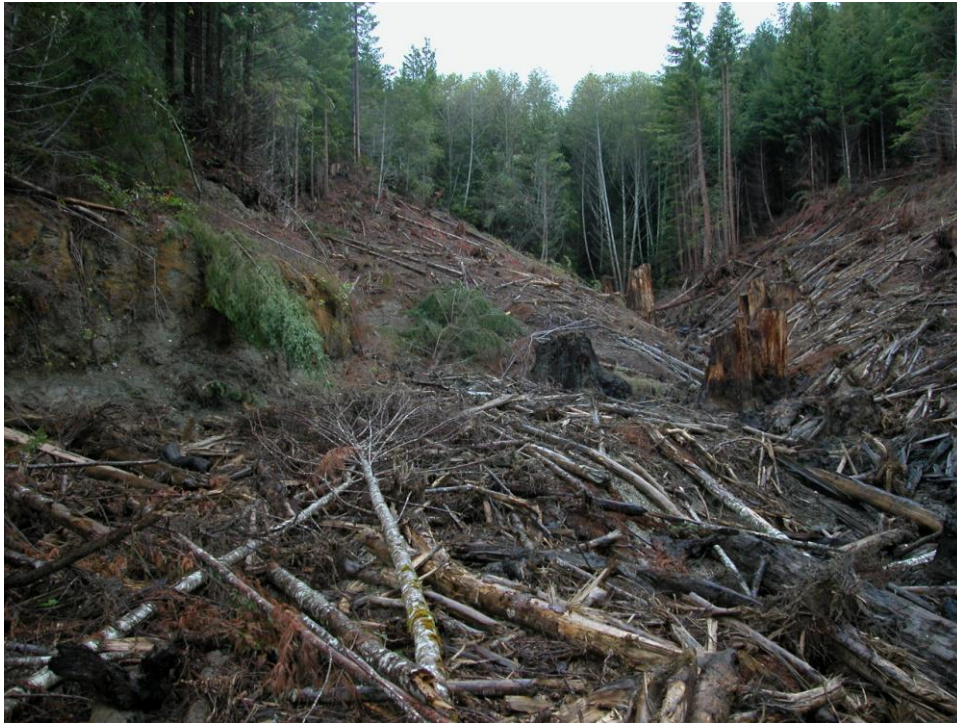
The second site-specific challenge was how to treat a spring at the base of a 12 ft. tall cutbank on the lower right bank of RX-3. It is current operating procedure to leave all springs in the Prairie Creek Formation uncovered, so we left this cutbank unfilled.

**Figure 9.** RX3, Work Item 7, finished slopes viewed from the lower left bank up to the top of RX3. The springy cutbank is on the center left edge of the photo and the settling pond is just out of view in the bottom right corner.

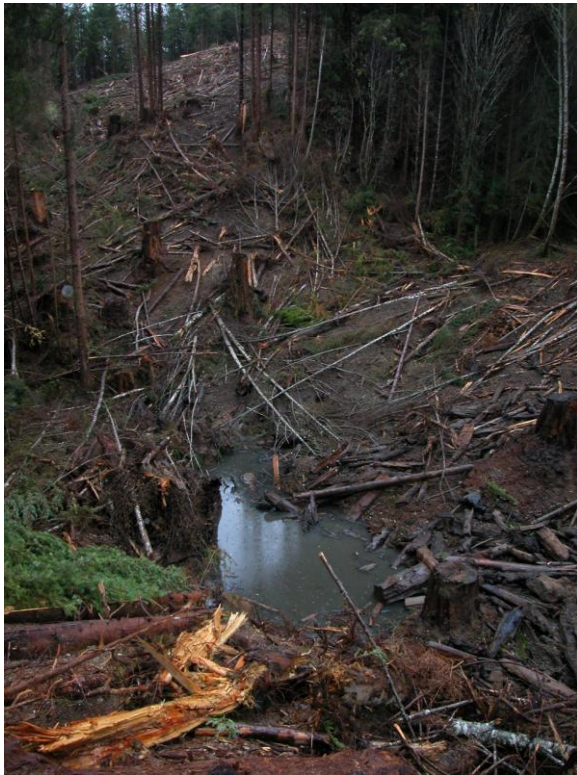
The scarcity of fillsites in the area is due mostly to the steep topography. The fillsite was on a long and steeply sloping ridge. All that remained of the ridge after logging were numerous one-blade-wide through-cuts into the gravely bedrock. Some of these through-cuts were over 10 ft. deep and separated by less than 15 ft. of less disturbed ground. Many of these through-cuts were created as layouts or as source sites for material needed to build layouts, and, according to Paul Johnson and Jim Anderson, contractors who logged in the area in their youth, it was easier to bring fill down the hill with every skidded log rather than pick up the skidder blade and leave the material in place. The blade was also used as a brake on steep slopes. The near complete disturbance of the fillsite area, caused by logging practices and combined with the unconsolidated nature of the underlying bedrock, is similar to the disturbance level elsewhere in the AA1/AA2 road complex area.

**Figure 10.** Fillsite to southwest of RX16. Finished slopes viewed from the lower left bank looking downstream. Settling pond is in the lower center and the unexcavated right fork is in the middle right of the photo.

RX16 was an approximately 19,500 yd<sup>3</sup> crossing; this volume was estimated based on equipment excavation hours and estimated production rates (timing of the work precluded surveying). It took 513.75 hours to complete using the D8K, D8L, D6H winch, D6H grapple, and 330 excavator. Production rates were estimated to be low, at 38 yd<sup>3</sup>/hr, due to the steep, long (800 ft. average) push to the fillsite on the ridge to the south. The steep, long push required the fill to be passed from the excavator, to three bulldozers before arriving at its end destination. No other local fillsites were available, the alternative being trucking fill, which would have been more expensive.

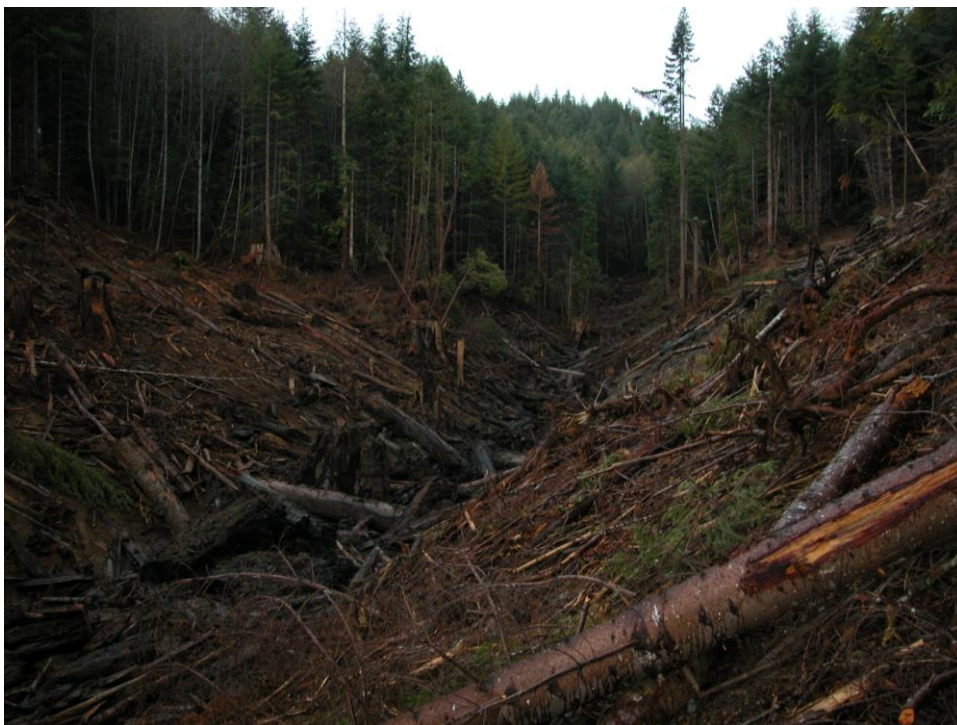
There were two notable adjustments in RX-16 (monitoring site 1), both occurring during the December 14, 2002 storm. The shallow adjustment in the push road below the fillsite occurred in fill placed by the excavator as it was working out of a site. This steep fill was not compacted by a bulldozer. There is also a small depression at the top of the slope where the excavator placed fill blindly. This depression collects and holds water and may contribute to the saturation of uncompacted soils. The other notable adjustment also occurred in excavator-placed fill at the bottom of a through-cut. There was also a small depression left by the excavator working blindly out and off this steep slope that may have contributed to the shallow failure by ponding water and causing the fill to saturate. During the December 14, 2002 storm while walking to the upstream grab sample site in saturated soils I actually caused a small (< 1 cubic yard) slide off the steep left bank with some delivery to tributary channel above the settling pond. There were no noticeable changes to the adjustments as of April 24, 2002.

**Figure 11.** RX16 (Work item 16) finished slopes viewed from the lower left bank looking upstream to the top of excavation. The enormous in-place stump is in the left center of the photo.

The excavation of RX-16 went relatively smoothly despite being slow. Prior to excavation the stream ran completely subsurface from the upstream end of the landing to the culvert on the Lower B500 but there were wet areas evident. Excavation began at the downstream end of the landing where we dug a settling pond to trap sediment from the excavated area. The pond did not fill despite the inflow of water, indicating a subsurface conduit. Once the settling pond was complete and most of the lower reach of RX16 was dished down to damp fill, excavation resumed at the upstream end of the landing. The contractors chose to proceed with excavation at the top of the crossing out of necessity. Due to the narrow and steep nature of the valley walls there was no other practical solution. Proceeding from the top of a flowing crossing does have its drawbacks and in this case the contractors did have to push wet fill up to the fillsite. This was usually only an issue in the morning, and by mid-day the excavator was able to catch-up with the water and able to provide the bulldozers with drier fill.

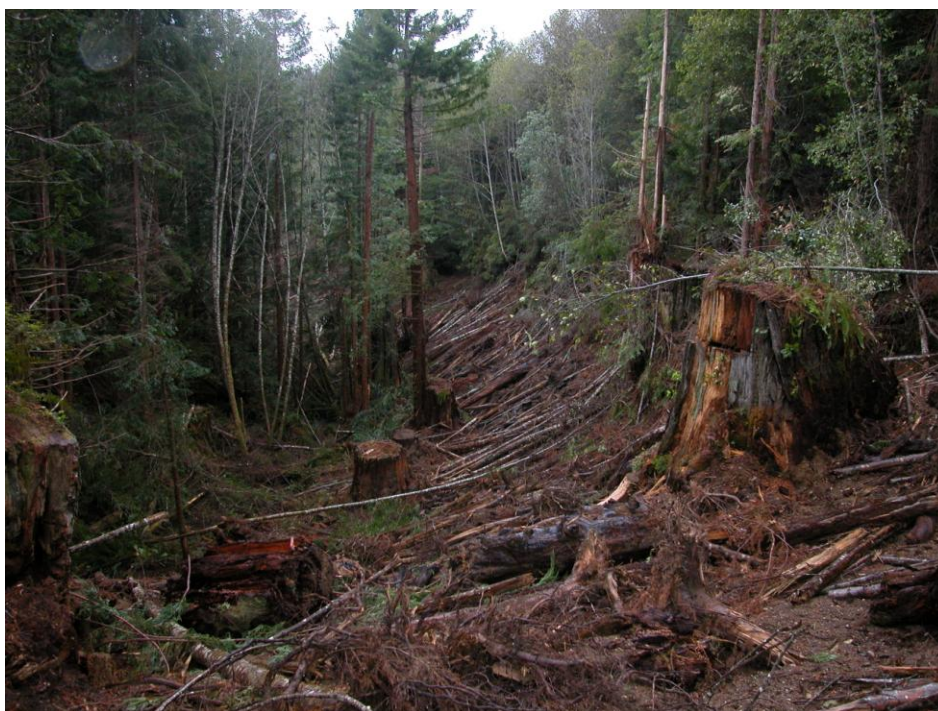
pre-logging surface to be much deeper than originally estimated. In fact, in this area the pre-logging ground surface was lower than the contemporary Larry Damm Creek; similar to the area at the bottom of RX3. The extra fill was perched on a steep slope along the Larry Damm Creek and needed to be removed. However, we could not excavate to original all the way to Larry Damm Creek as this would have re-routed Larry Damm Creek. Instead, we shaped a stable low berm between Larry Damm Creek and the completely excavated WI6 section and created an outlet at the downstream end. The resulting topography included an area that will be wet during the rainy season. This change in design allowed the existing Larry Damm Creek riparian buffer to remain intact. Also, the final shape of the bank along Larry Damm Creek is natural in appearance and is geomorphologically stable.

**Figure 12.** Export outslope work items 9 and 10 from work item 8. Larry Damm Creek flows from the bottom left towards the upper center left.

Work Item nine involved outslowing a narrow section of the AA1 perched above Larry Damm Creek on a steep slope and exporting the fill down the road through WI10. Approximately 1,750 yds<sup>3</sup> were moved in 24.25 equipment hours using the D8K, D8L, and the 330 excavator (Table 3). The production rate for this work item was 72 yds<sup>3</sup>/hr; slightly higher than the other export outslows because the contractors had an efficient system in place and the excavation was fairly straight forward (Figure 12). This excavation became larger than designed when a stump with a large alder growing out the top that was thought to be in-place turned out to be a cut wind-throw buried in the perched fill along Larry Damm Creek. What was thought to be a 5 ft. tall stump became a 20 ft. cut section and what was thought to be the root swell was actually part of the upper section of the tree. I learned that any stump with a flat cut is not an in-place stump and instead, must be a buried log or the stump of a cut wind-throw that is no longer in place.

Work item ten was similar to WI9: it was narrow, along Larry Damm Creek, and became larger than design for similar reasons as those mentioned above. Approximately 2,950 yds<sup>3</sup> were moved in 52.25 equipment hours using the D8K, D8L, and the 330 excavator (Table 3).
