HISTORIC STRUCTURES REPORT

JEDEDIAH HIGGINS HOUSE

(Bldg. No. 13-13)

Truro, Massachusetts

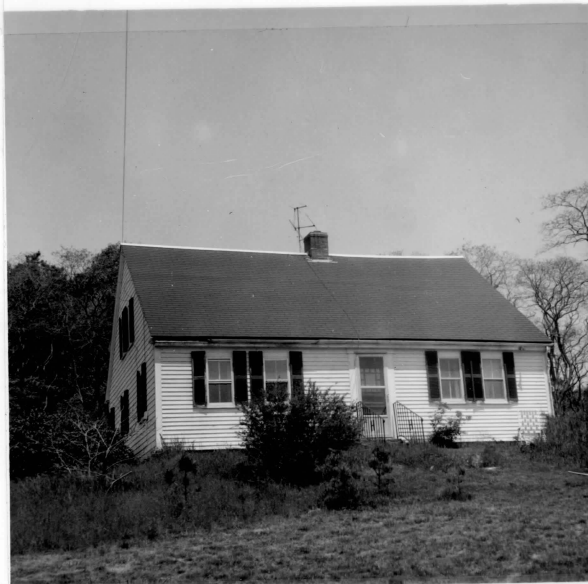
- (3) In general, except for the sloping floors as above in paragraph (2), the interior of the house is in fairly good condition and requires only papering and painting all presently papered and painted surfaces to preserve the interior of the house.
5. Cost of repairs, preliminary estimate: This house can hardly be brought up to good condition for \$20,000, yet to fail to spend this amount, and very soon, will certainly make rehabilitation impossible. The next step, then, would inevitably be a restoration job.
6. Photograph, exterior of house.
