Blankenship Ranch - Gachado Well Line Camp

Organ Pipe Cactus National Monument

Stabilization Report - 1972

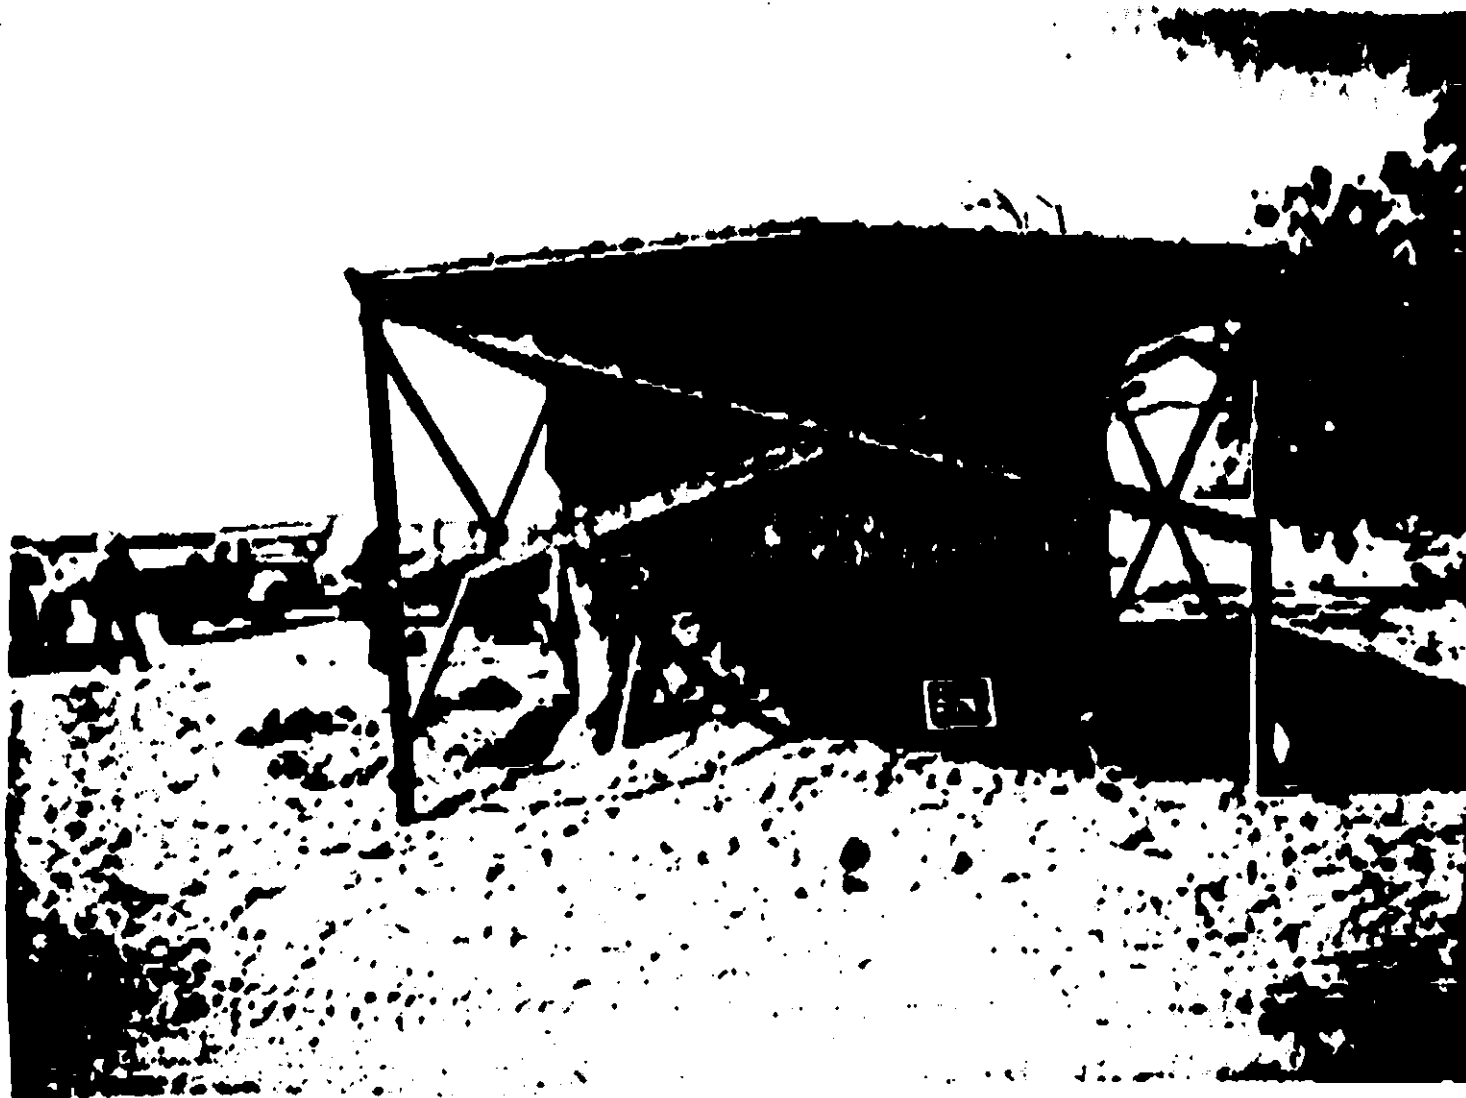
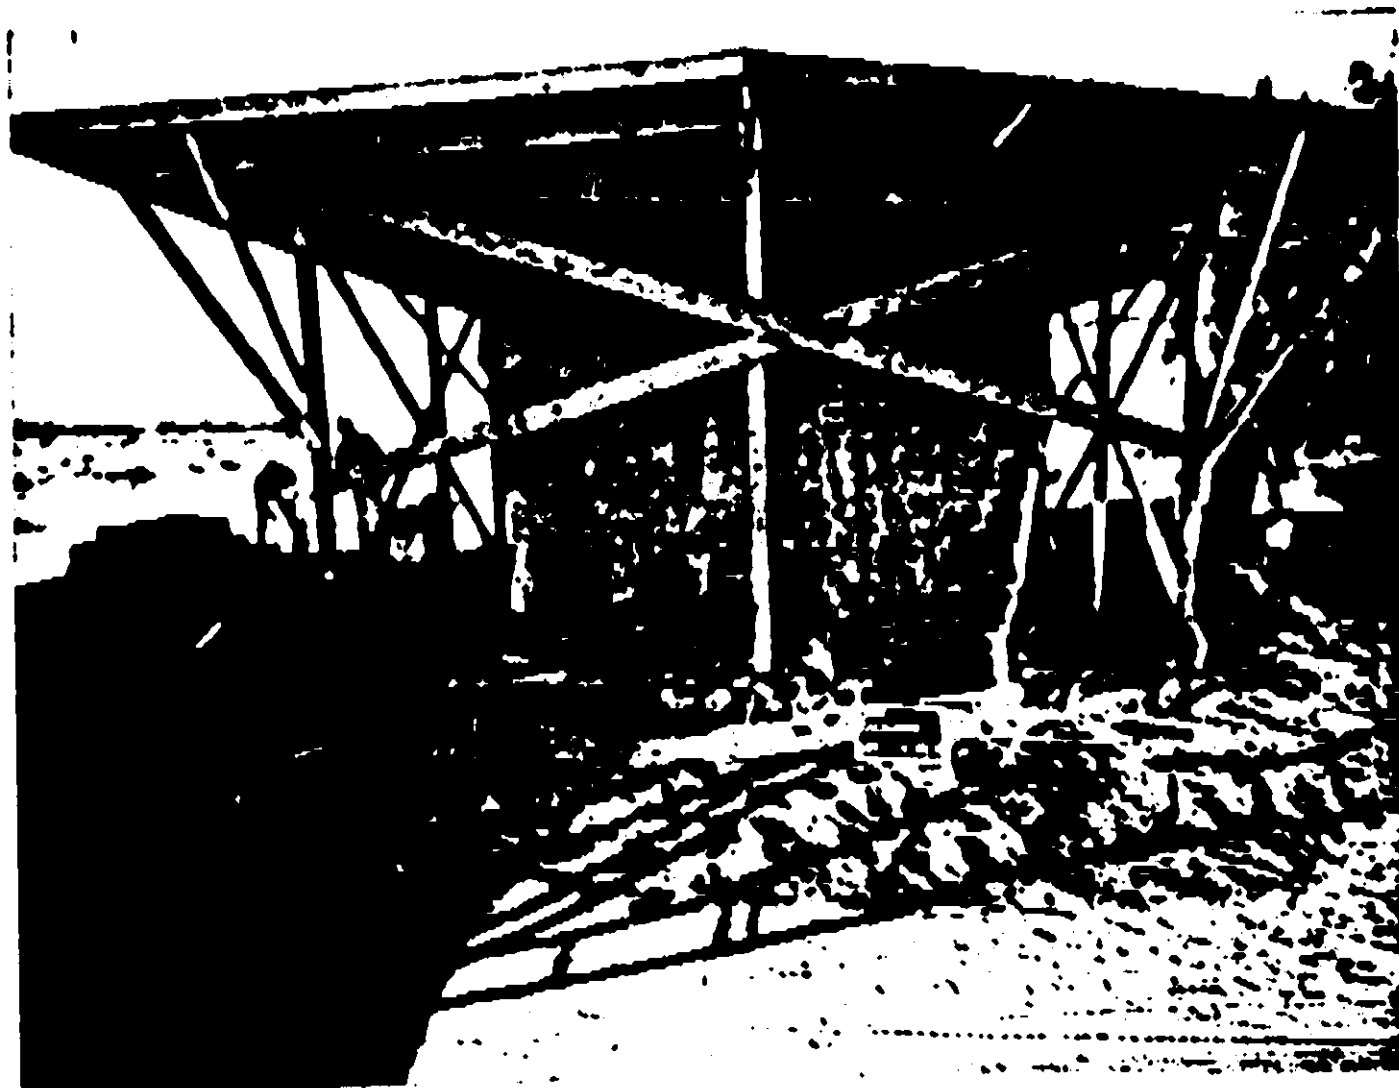
The exterior north wall suffered moderate to heavy basal erosion. The chimney which had abutted the north wall had melted into a pile of adobe (top photograph.) The stones by the lower central portion of the wall served as the chimney foundation.

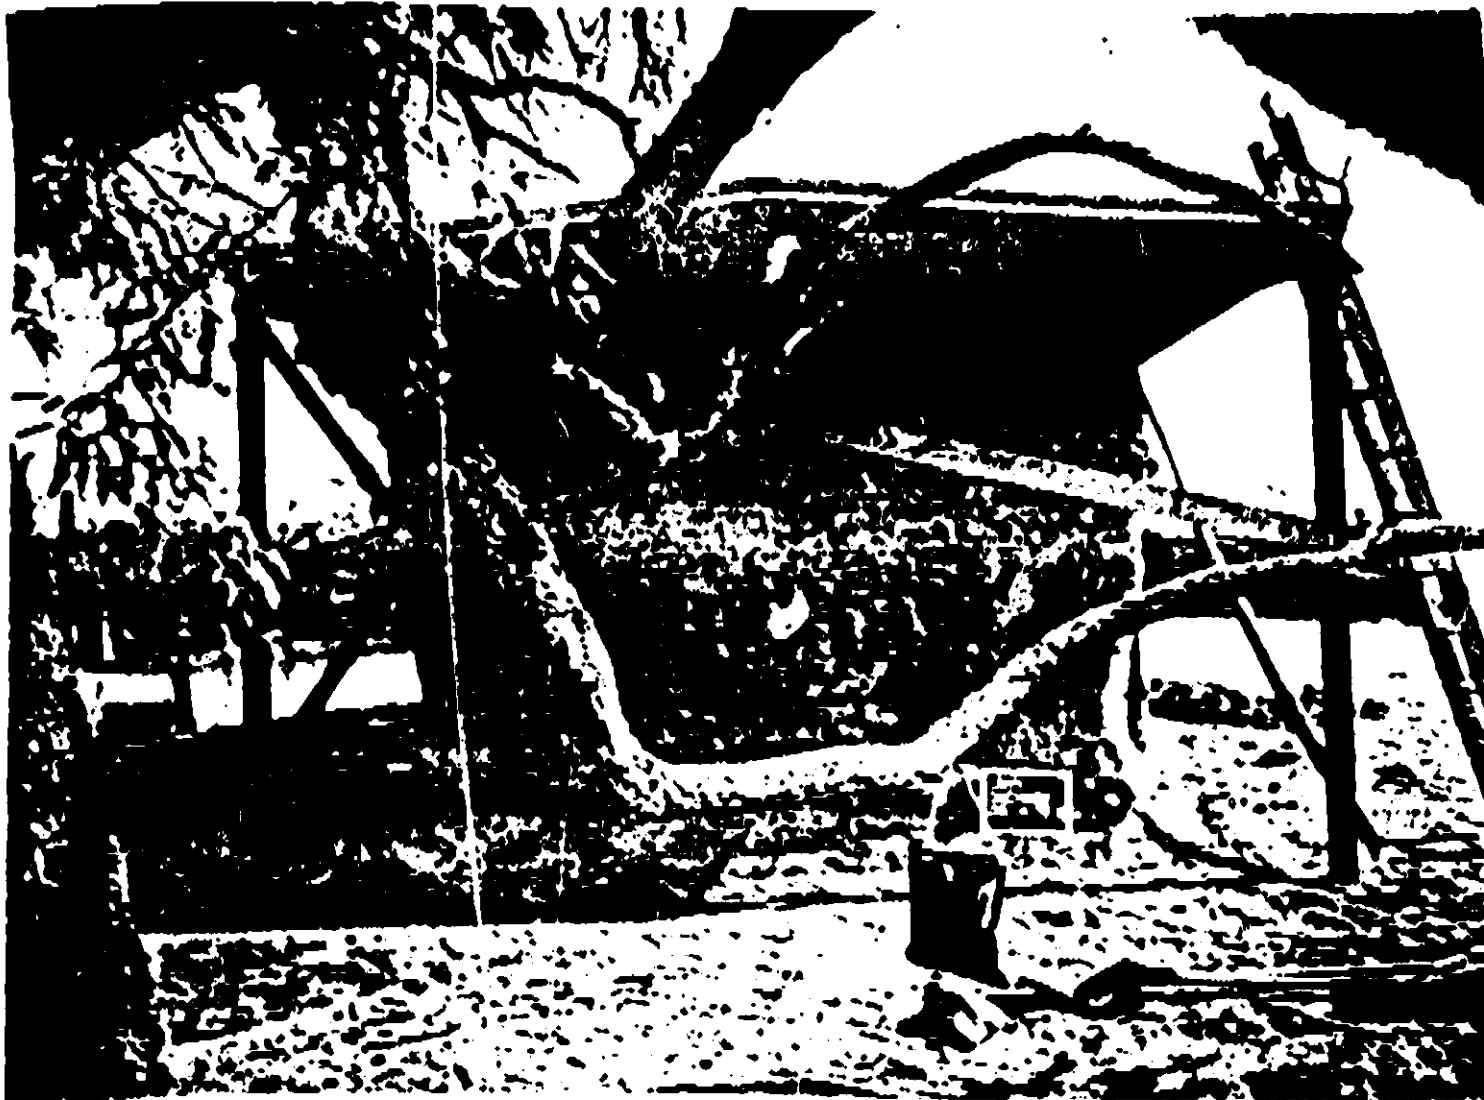
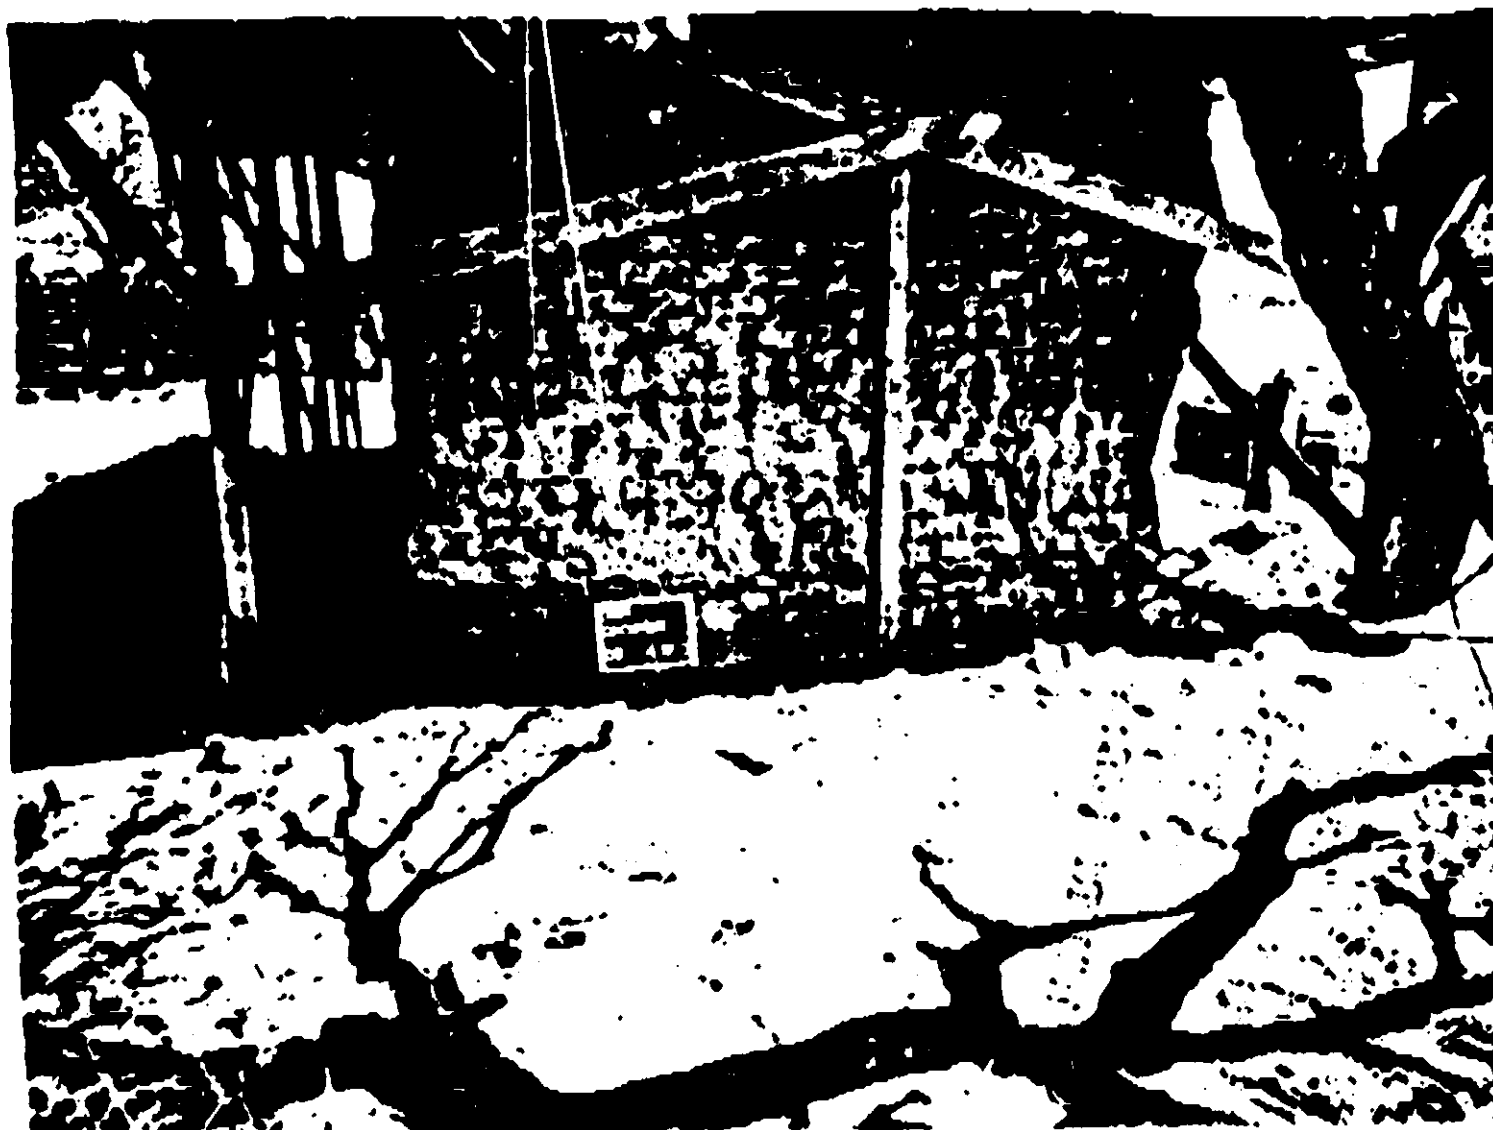
The outside south wall had moderate to severe basal erosion. The adobe bricks were made of a softer material than the mortar and had receded leaving the mortar lines in bold relief.

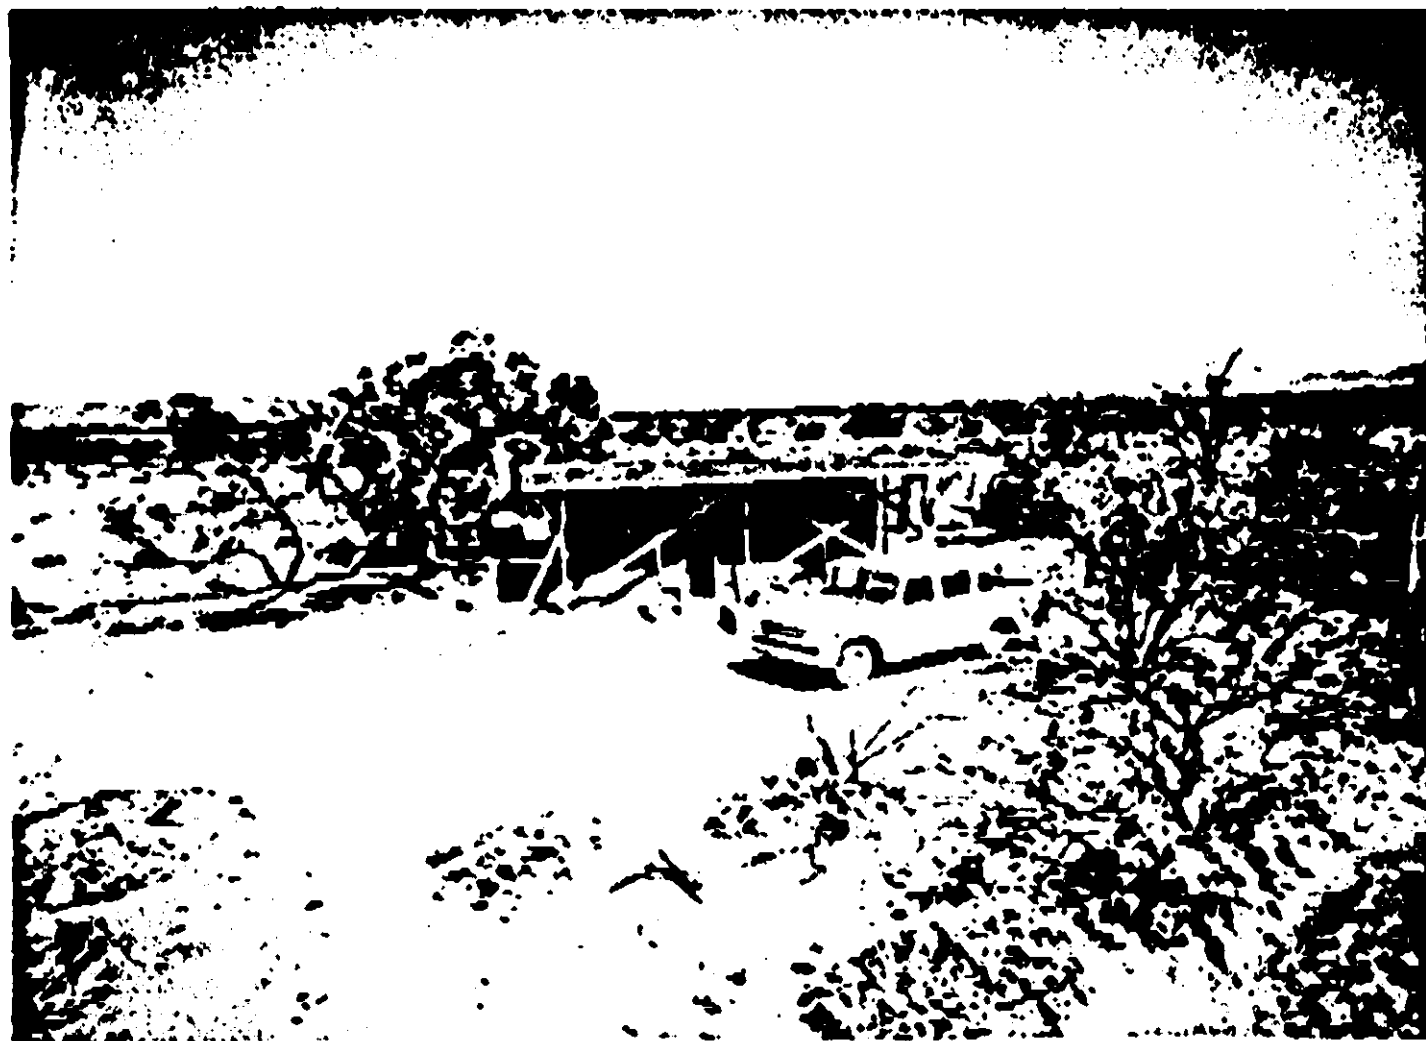
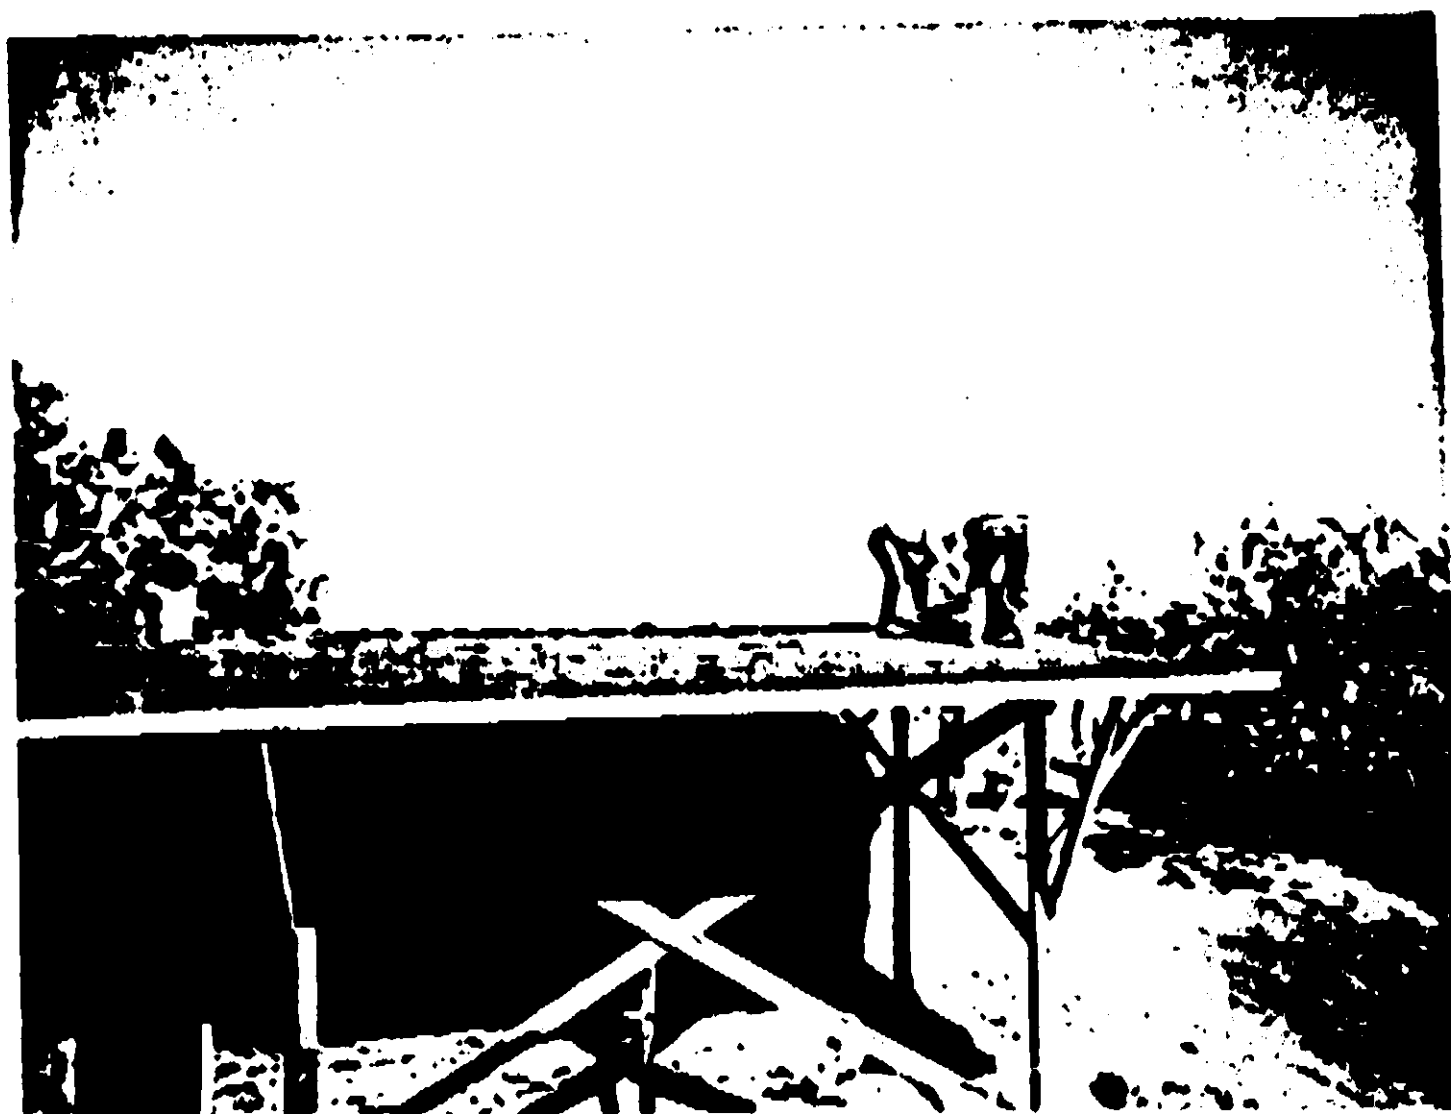
The shelter had lost much of its effectiveness after wind carried away the surface. After the extension was built, the roof was resurfaced using gold. mineral paper.

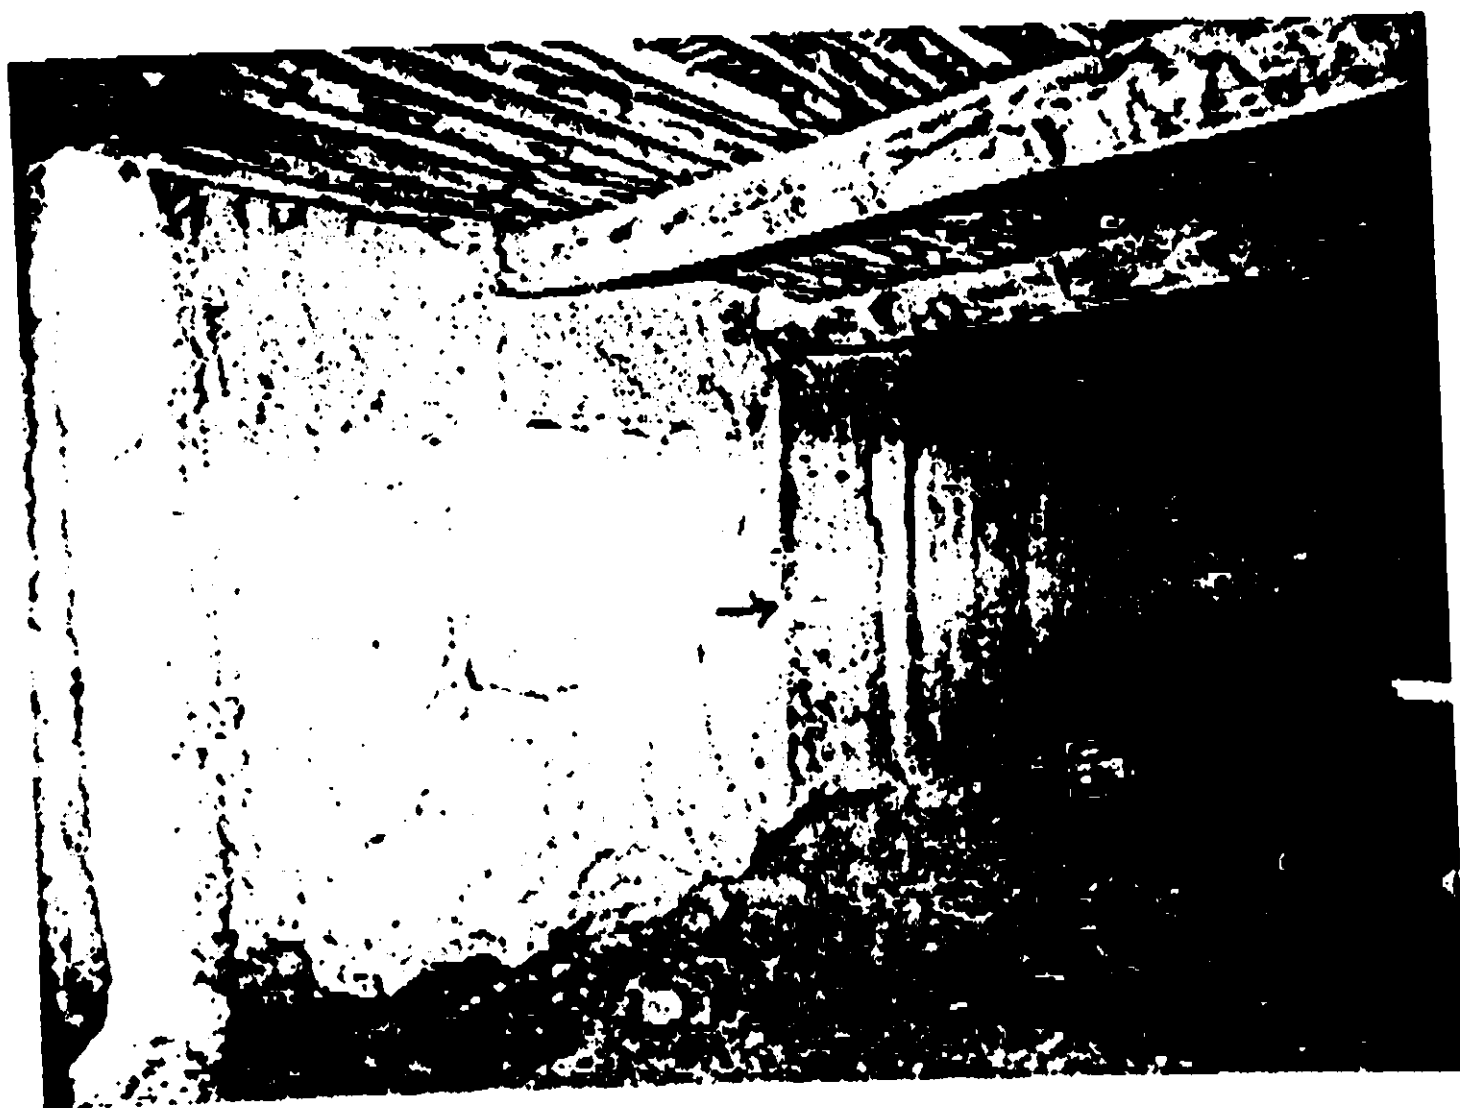
The west wall had extensive basal erosion and a dripline on the southern portion which had eroded through ceiling to floor. Another dripline on the north portion of the wall had eroded to a depth of about four inches. See arrows.
