# ***Bandelier National Monument***

## **Archeological Site Hazardous Fuel Assessment Report**

Subject: Hazardous Fuels Assessment Report for Bandelier National Monument

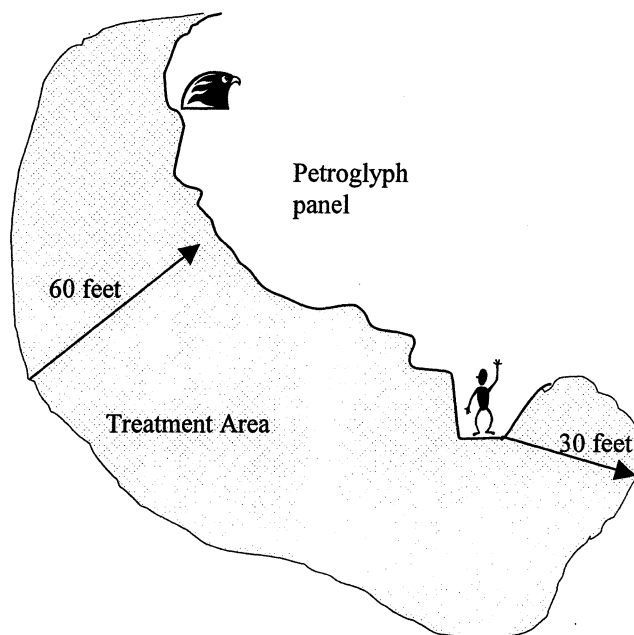
This site is located in Red Canyon just off the Turkey Springs Trail in the southwest portion of the Monument. The site includes 36 rock art panels, three small structures, one rock shelter cist with original mortar and plaster, two small cavate storage units, five niches, and a prehistorically worn footpath. This location is the most extensive rock art site that is known within the boundaries of the Monument at this time.

Fuels on and down slope from the panel include open-canopy pinyon/juniper, with scattered shrubs, grasses, forbs and litter cast, and abundant slickrock and bare soil areas. The drainage bottom below the site shows ponderosa pine overstory with mixed riparian and pinyon/juniper understory. To the west of the site fuels have been effectively reduced by the passage of the Dome Fires in 1994 and 1996. There are no signs of previous burning on or east of the site.

As a result of these circumstances, the ASHFAP team believes that aerial suppression (*water drops*) in front of the site is the only sure-fire way to protect this site from a large, plume dominated wildfire. The recommendations that follow can guarantee reasonable protection for

the site from a smaller wildfire event (and prescribed fire). The ASHFAP team believes there can be no guarantee of protection for the site when the “big one” occurs, since the plume alone resulting from this type of fire will be sufficient to severely damage the rock art panels.

- Mechanically remove all fuels in front of the site for 60 feet (see Figure 1.)
- Scatter debris far enough away from the treatment area that it will not add to any potential fire behavior near the site.
- An archeological monitor should be present during this work.
- Labor estimate is 120 hours (not including hiking time).
