**PRELIMINARY HYDROLOGIC AND GEOMORPHIC  
ANALYSIS:**

\_\_\_\_\_ **SCORPION CREEK FLOOD  
DECEMBER 5, 1997  
SANTA CRUZ ISLAND  
CHANNEL ISLANDS NATIONAL PARK  
CALIFORNIA**

**William L. Jackson**

**Technical Report NPS/NRWRD/NRTR-98/172**

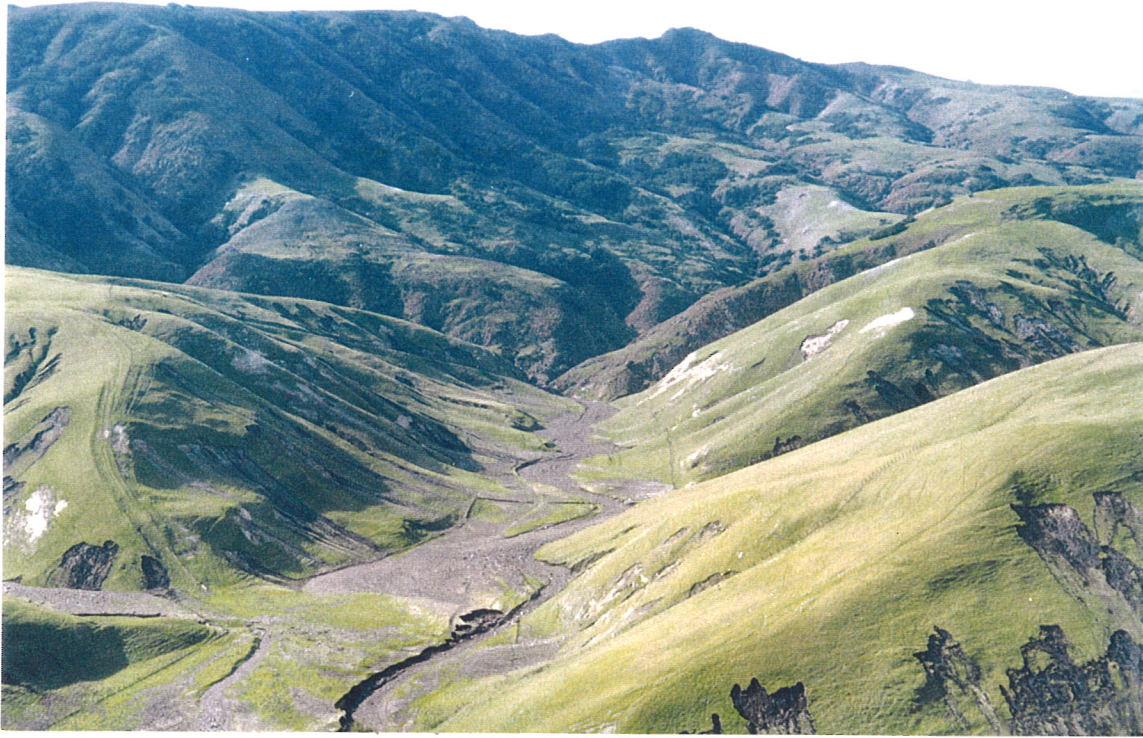
One of the most significant aspects of this flood was the enormous amount of sediment production and delivery within the watershed (Figure 2). Mass hillslope failures and debris flows occurred within the lower mile of the watershed, and huge volumes of coarse sediment (sand, gravel, cobble, and boulder-sized materials) were delivered to the main channel of Scorpion Creek. To understand this flood and its implications for floodplain management requires that the event be considered as much a "sedimentation event" as a hydrologic event.

Figure 2. Post-flood photograph of the upper portion of the alluvial reach of Scorpion Creek, showing evidence of hillslope erosion and sediment delivery to the channel. Note the extent to which some channel reaches have lost definition because they have filled with sediment.

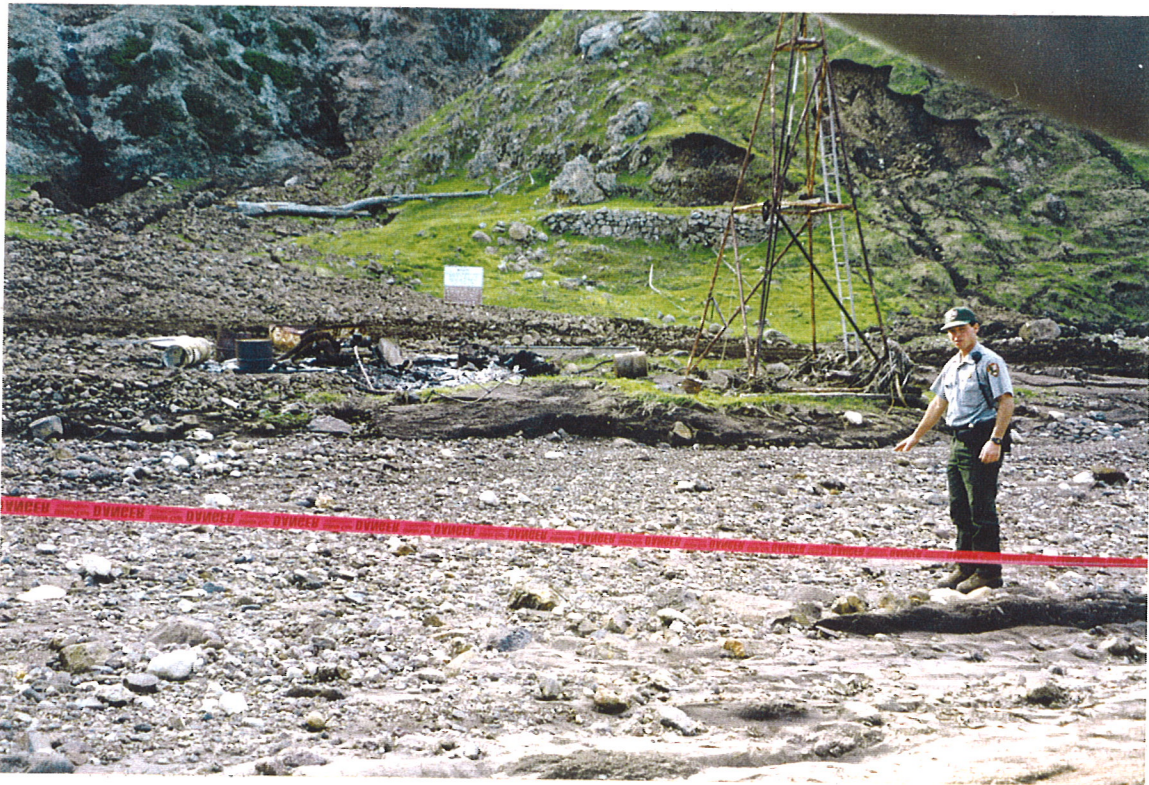
Massive sediment deposition occurred throughout the lower mile of the Scorpion Creek Channel. In at least four major reaches coarse sediment deposition completely filled and obliterated the channel that existed prior to the flood (Bo Stone, pers. comm., 1998) (Figure 3). Major zones of sediment deposition seemed to correspond to reaches upstream from flow constrictions or sharp bends, and in association with tributary debris flows. It is probable that some sediment deposition in the lower 800 feet of channel was also influenced by reduced channel gradients, high storm tides and ponding behind the cobble beach berm that forms annually as the result of coastal processes. This berm effectively closes off the mouth of Scorpion Creek until it is breached by storm flows. Historic structures are located at about 8 ft. above mean sea level. Storm tides are known to be as much as 6 1/2 feet above mean sea level in this location. Downstream from each major zone of deposition, the channel remained largely well-defined and resembled its pre-storm character (Bo Stone, pers. comm., 1998). These reaches functioned more as sediment transport zones than as sediment deposition zones.

Figure 3. Post-flood photograph of lower Scorpion Creek showing the extent to which the pre-flood channel was filled with sediment. The person is standing on a constructed berm that used to represent the left bank of the channel. Flows were to the left in this photo. Note the delivery of sediment from a tributary debris flow on the right side of the channel.

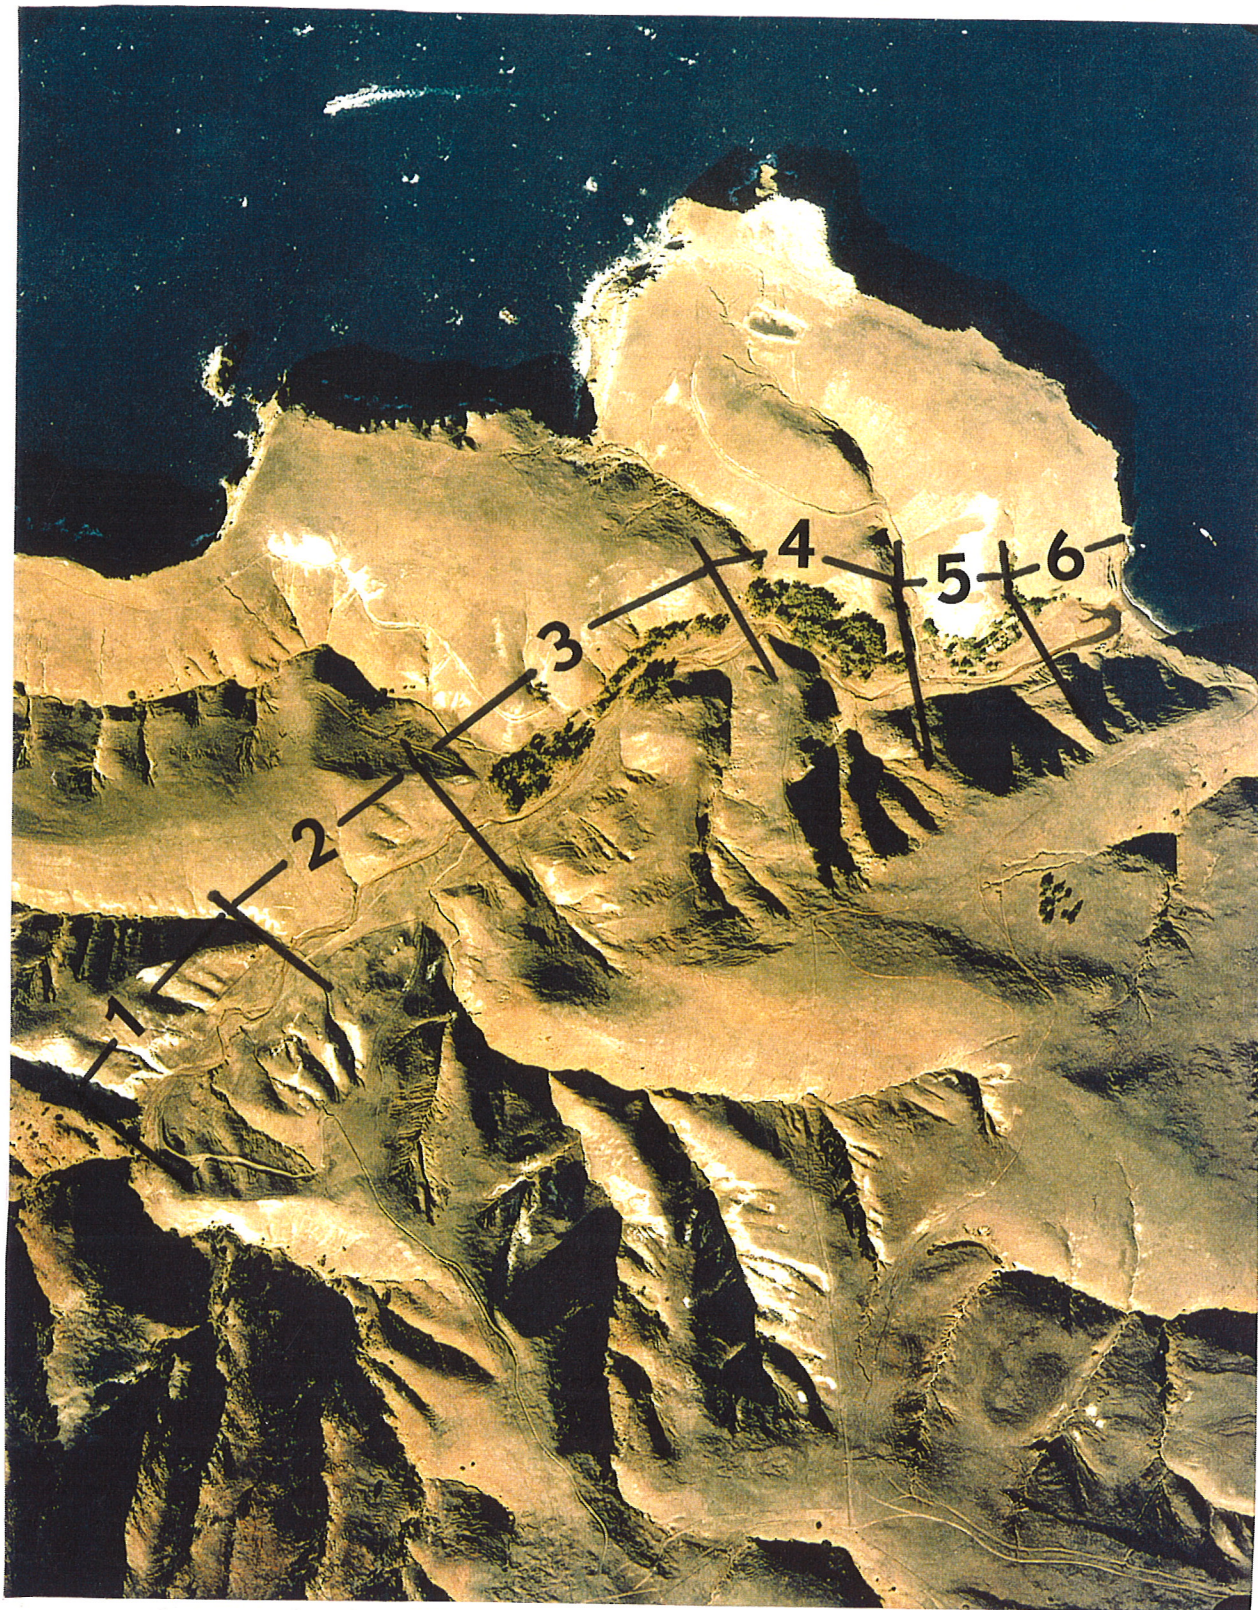
Massive volumes of sediment were delivered from the upper watershed and deposited in the uppermost 1000 feet of the alluvial reach of Scorpion Creek (Reach 1, Figure 4). The channel throughout much of this reach was completely filled and obliterated. Some fencing was buried by sediment, but otherwise impacts to human infrastructure were minimal. The significance of this reach is that it now contains an enormous volume of sediment, that eventually will be routed downstream.

Reach 2 (Figure 4) encompasses the reach of stream from Reach 1 to just upstream of the upper eucalyptus grove. This reach of stream is strongly influenced by a large tributary and associated alluvial fan that comes in from the right side. The tributary and associated fan force the main channel of Scorpion Creek along the left edge of the valley and contain it there. While some erosion and deposition occurred in this reach, it generally functioned as a "throughput" zone and the channel was maintained largely intact. This was the reach where a rough indirect estimate of peak flood discharge was made.

Main channel and tributary fluvial processes were very active in the vicinity of the upper eucalyptus grove and impacted the NPS campground at this site (Reach 3, Figure 4). This site is a low alluvial fan created by a fairly large tributary that enters the middle of the grove from river left. A large zone of main channel sediment deposition occurred in the lower portion of this reach, essentially filling the pre-flood channel. Sediment deposition may have been induced by a slight backwater effect associated with a constriction of the valley and a sharp bend in the channel. A large, deep-seated mass hillslope failure occurred on the right valley across from this site, but it does not appear that there was significant sediment delivery to Scorpion Creek. Sediment deposition in the main channel forced main channel flow across the upper eucalyptus grove, and forced the beginning of a new "cutoff" channel downstream on river right. The channel remains fairly poorly defined in the lower portions of this reach, which may make the campground more prone to flooding from future floods of smaller magnitude than this event. This site also experienced significant flooding and sediment deposition from the tributary. Continued occupation of this site by a campground may

Figure 4. November 1997 aerial photograph of Scorpion Creek, depicting the six reaches of the lower river discussed in the text.

Reach 4 (Figure 4) encompasses the lower eucalyptus grove, and includes the lower campground. This area was profoundly impacted by massive sediment deposition. Contributing to sediment deposition in this area was a large input of coarse material from a debris flow on river right. The channel throughout this reach was filled and is now very poorly defined. Channel filling caused flows to spill over and wash through the eucalyptus grove and campground. With the main channel now so poorly defined in this area the lower grove and campground are now extremely vulnerable to additional flooding from significantly smaller floods than the December 5, 1997, flood.

Reach 6 (Figure 4) encompasses the lower 700-800 feet of channel downstream from the adobe building to the mouth. The channel here was excavated and diked along the right side of the valley. The channel did not fill significantly during this flood and remains in a functional condition. The channel in this reach is vulnerable to filling during small events, especially prior to breaching of the ocean berm. However, it is not known to what extent ponding behind the ocean berm might have occurred during the December 5, 1997, flood. Historically, continued excavation was required to maintain a defined channel through this reach.

require reexcavating the channel through the sediment deposit in the lower portion of the reach or, at a minimum, excavation of a channel for the tributary, so as to make the site less prone to flooding from tributary runoff. Downstream from the upper eucalyptus grove the channel goes around a large point bar on the left. An impressive amount of boulder-sized material was deposited on the point bar, but the channel remains fairly well defined in this area.

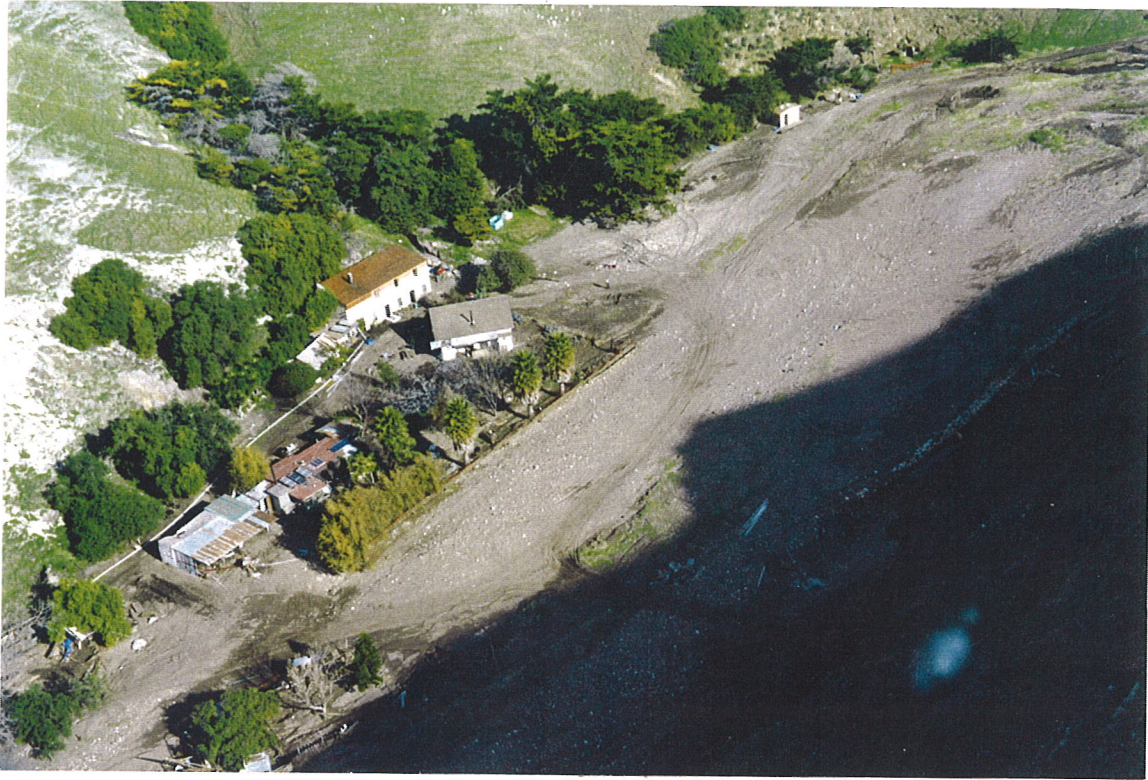
Reach 5 (Figure 4) extends from the lower eucalyptus grove downstream to a point roughly across from the adobe building (Figure 5). This reach continues as an area of massive sediment deposition. The channel has been completely filled and obliterated in this reach. Contributing to deposition in this area were (1) the large sediment input from the tributary debris flow immediately upstream, (2) the constriction caused where the river was channelized between the bulldozer garage and the windmill, (3) reduced channel gradients, and (4) likely backwater effects from water impounded behind the ocean berm and/or high storm tides.

Floodwaters were 3-4 feet deep on several park structures (e.g., the "adobe" house). It is likely that maximum flood depths were influenced, in part, by water backing up from the river mouth because of high tides and/or impounding behind the beach berm. The highest velocity and highest energy flows in the vicinity of the historic structures probably occurred at depths less than the maximum depths indicated by mud lines on the structures, when flows were not influenced by backwater effects.

Channel deposition was so complete upstream from the bulldozer that flows readily broke out of the pre-flood channel and ran through the complex of historic buildings. A new channel did not form upon recession of the flood, and currently no well-defined channel exists. The developed site is now extremely vulnerable to future flooding from events much smaller than the one that occurred on December 5, 1997. The filling of the channel on the right side of the valley means that flows have easy access to the breakout channel that now flows through the present location of the buildings. Emergency/short-term measures are warranted at this site to protect structures from future flooding this winter (see recommendations below).

Figure 5. Post-flood aerial photograph of lower Scorpion Creek in the vicinity of the historic ranch structures.

Massive sediment deposition and filling of the channel in the vicinity of the lower grove and the historic buildings make this reach extremely vulnerable to additional flooding from events much smaller than the December 5, 1997, flood. Given that it is still early in the winter rainy season, it may be prudent to give consideration to some emergency actions to help reduce the vulnerability of the historic buildings to future flooding until decisions can be made about long-term occupation of the site.

Re-excavating a channel from a point roughly 300 feet downstream from the windmill to a point somewhat upstream of the confluence of the horse corral tributary would help route modest flood flows around the area where the buildings are located, and would make it less likely that flows would access the breakout channel.

Another option might be to develop sandbag berms around the immediate structures of concern. In this case, some ability to pump water out of the buildings might be needed.
