U.S DEPARTMENT OF THE INTERIOR  
NATIONAL PARK SERVICE  
HUBBELL TRADING POST NATIONAL HISTORIC SITE, ARIZONA  
MAINTENANCE, OPERATION, AND SAFETY OF DAMS PROGRAM

2001 Joint National Park Service and Bureau of Reclamation  
Literature Search and Review and Site Visit Report

Hubbell Reservoir

Prepared By  
Technical Service Center  
Bureau of Reclamation  
Denver, Colorado  
January 2003

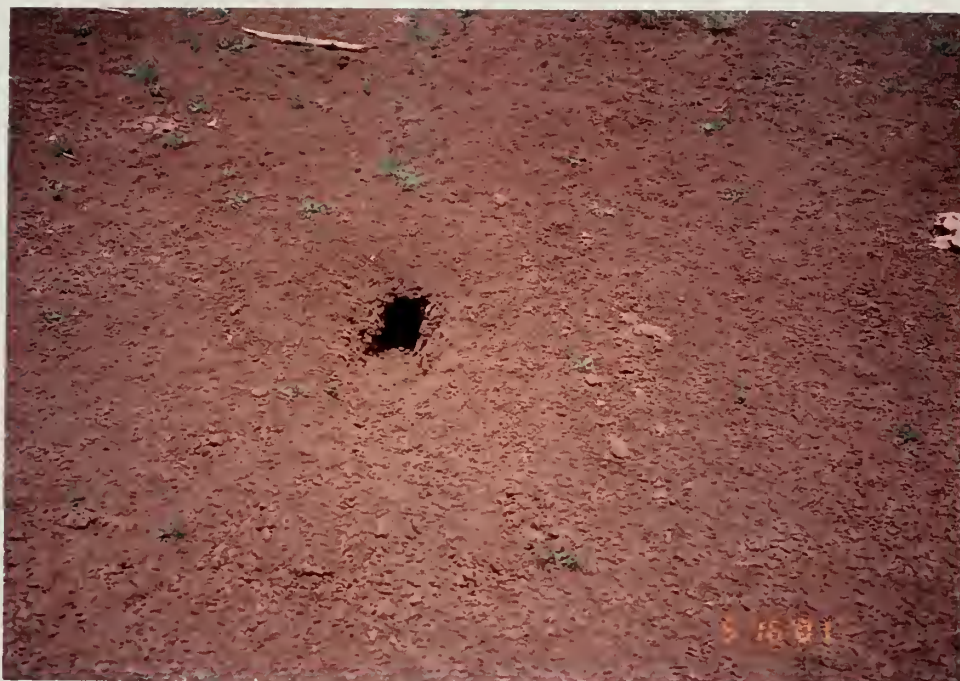
Photo 5. Hubbell Reservoir - Animal burrow on the upstream edge of the main embankment segment.

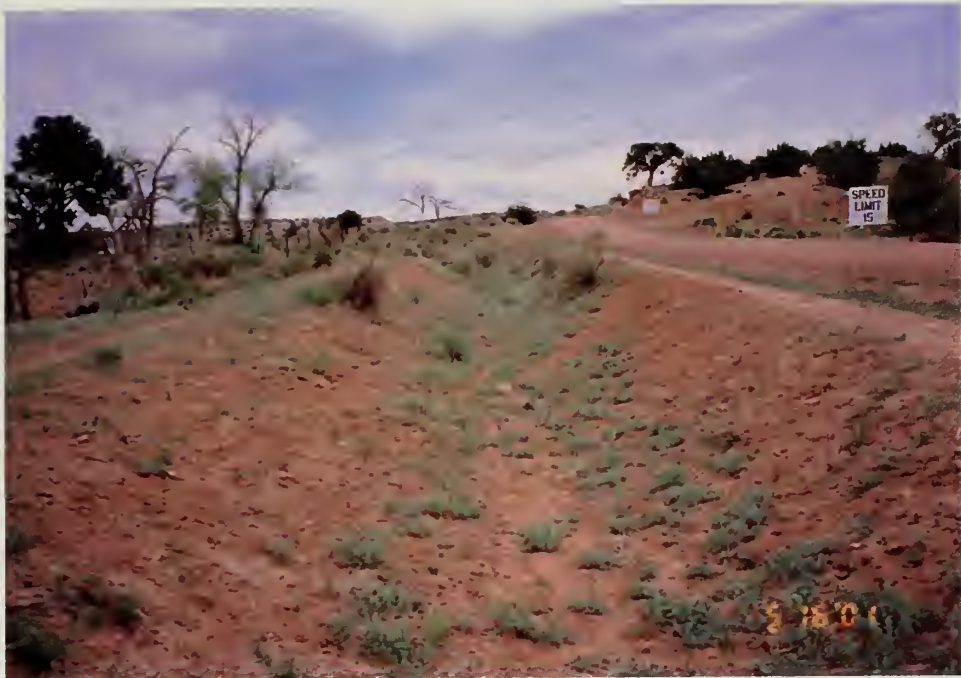
Photo 7. Hubbell Reservoir - Supply ditch looking right (east) along the southern embankment segment. 5/16/01

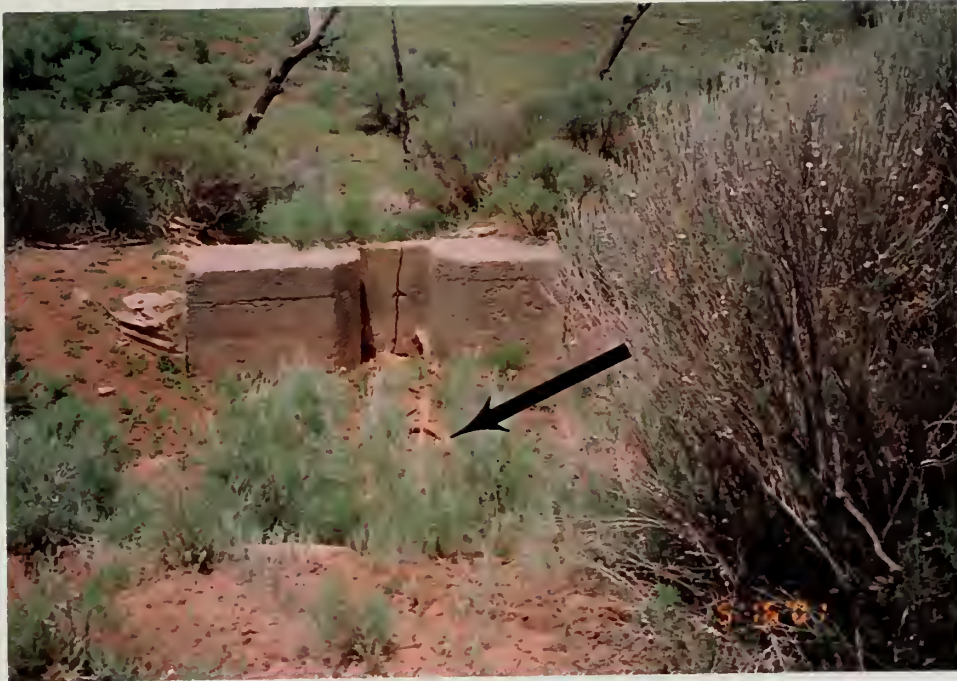
Water was supplied to the reservoir from the ditch between the road and the upstream embankment (photos 6 and 7) through inlets at the right (photos 6 and 8) and left (photos 9 and 10) ends of the upstream embankment. Releases were evidently made through the outlet works located at the right downstream corner of the reservoir shown in photographs 1 and 2. Outlet works discharges would flow onto the area downstream from the dam (photo 11) through the terminal structure, the remnants of which consist of two small masonry training walls shown in photograph 3. The low-level outlet is currently inoperable [OP]. There is no well-defined outlet channel downstream from the dam.

Photo 9. Hubbell Reservoir - Left reservoir inlet near the southwest corner of the reservoir, looking toward the reservoir. The arrow indicates the partially plugged inlet pipe. 5/16/01
