## Evaluation of Geotechnical Alternatives for the Navajo Loop Trail, Bryce Canyon National Park, Utah

**Deanna Greco**, Geomorphologist

*National Park Service, Natural Resource Program Center (NRPC)  
Geologic Resources Division (GRD), Geoscience and Restoration Branch (GRB)  
Denver, Colorado*

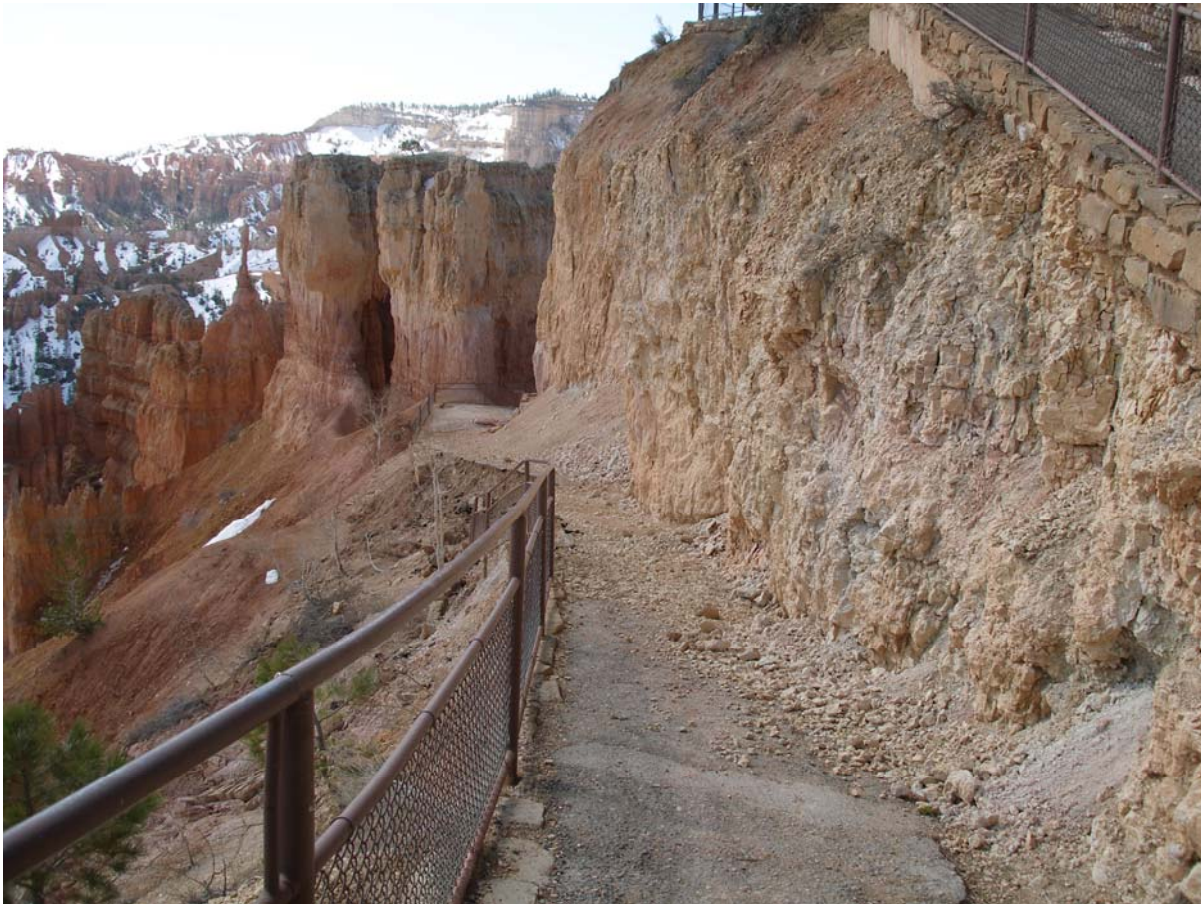
At the beginning of the Navajo Loop Trail at Sunset Point, the trail is full bench construction. This has produced an exposed rock cut that is highly fractured and prone to regular rock fall. Rocks regularly fall off the face and litter the trail. During spring thaws and heavy rain events, the amount of rock debris coming from the face is increased. This produces a potential hazard to anyone hiking the Navajo Loop Trail. In addition, Park maintenance staff periodically removes fallen material from the rock cut, which is a hazardous duty.

**Figure 2.** The rockcut and rockfall hazards at the top of the Navajo Loop Trail.

The rock fall hazard found at the beginning of the Navajo Loop Trail needs attention. Maintenance staff previously have cleaned up the rock face to remove most of the hazardous material. But this activity is very dangerous and puts park staff at risk of injury or even fatality. Options such as shotcrete or wire mesh with rockbolts can be expensive and are very unsightly, but new rock fall mitigation materials can reduce visual impacts and have been used by numerous state and federal agencies. GRD staff can assist the park with making contacts with state highway agencies as well as the Federal Highway Administration for recommendations.

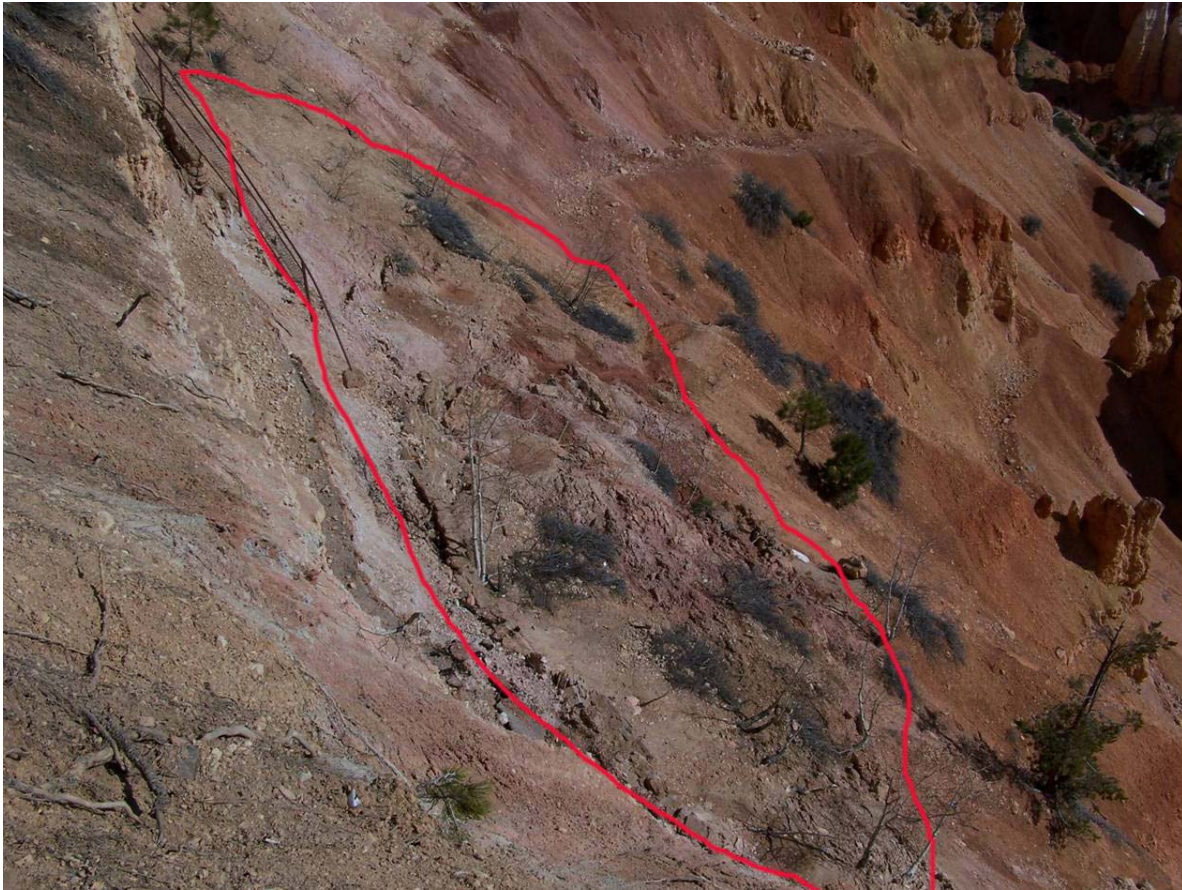
Just below the rock cut portion of the trail, the slope has suffered a major landslide failure. The landslide has obliterated an entire segment of the return portion (past Thor’s Hammer) of the Navajo Loop Trail. An obvious indication of slope instability at this site is the loss of the trail tread. Indicators are present that determine there were signs that this site was more than just a small shallow failure and that it was destined to fail. The Aspen trees are one indicator, because they thrive in disturbed settings. Aspen have the ability to grow rapidly enough to keep up with the rate of movement of the slope. In addition, the aspens are “pistol butted” or growing in a curved upward motion. This is due to the adjustment they are making to keep up with slope movement. The slope is also hummocky, and fractures and slide scarps are apparent; all are surface expressions of deep seated instability in the slope.

**Figure 3.** The landslide area below the asphalt section on the Navajo Loop Trail.

This alternative addresses the need to stabilize the slope failure just below the asphalt ramp at the start of the Navajo Loop Trail. One technique is to remove the loose, unstable debris down to bedrock. This would require the use of heavy equipment, possibly a crane. It would require haul costs for transporting and disposing the material offsite. This is a very costly option and has the drawback of requiring that the trail excavated into bedrock. This could possibly lead to a full bench trail with the possibility of producing another area of rockfall hazards.

Another landslide stabilization technique is the use of a retaining structure. This would only require minimal removal of material offsite. This option would require heavy equipment and logistical hazards such as working on very steep slopes in an unstable environment. Retaining wall systems such as those produced by Hilfiker Retaining Walls have been very effective at stabilizing slide prone areas. The costs vary depending on the chosen system and logistical issues. More information on Hilfiker systems can be found at <http://www.hilfiker.com>.

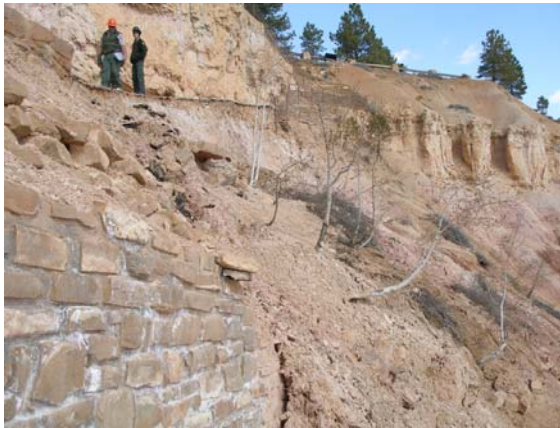
**Figure 4a.** The landslide with tension cracks, scarps and “pistol butted” aspen trees on the slope.

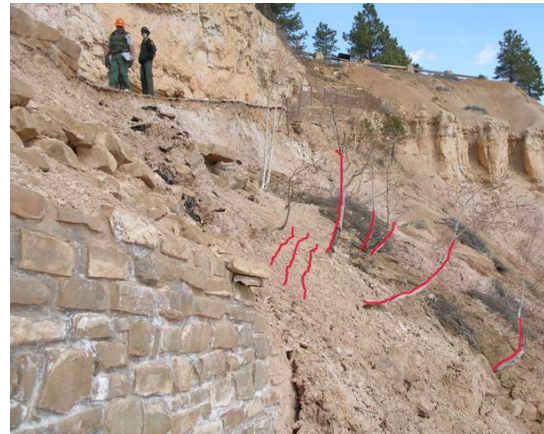
**Figure 4b.** The landslide annotated to show the tension cracks, scarps and “pistol butted” aspen trees on the slope highlighted in red.

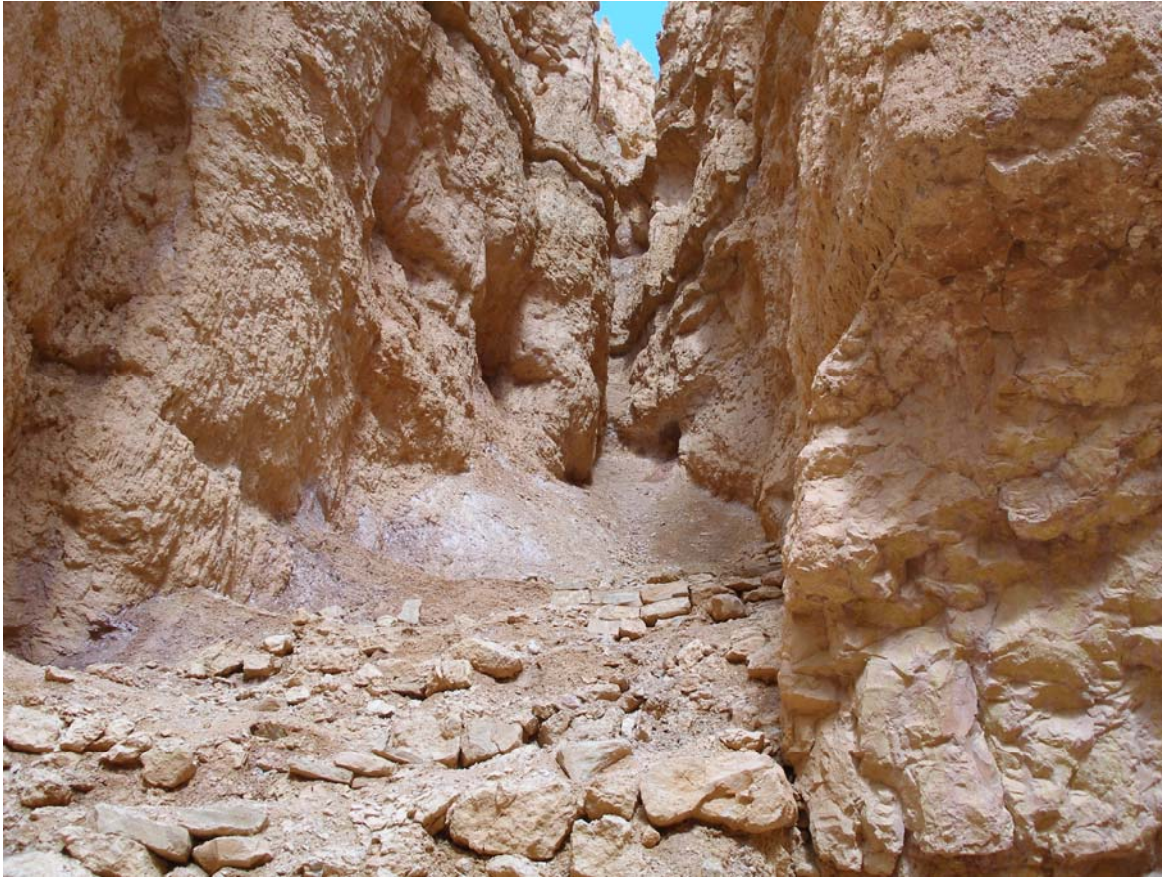
The series of switchbacks leading into Wall Street suffered heavy damage during the winter of 04-05. The damage from heavy snow and runoff resulted in the collapse of CCC era retaining

walls, loss of trail tread, gullies and deposition of large amounts of sediment on the trail. In addition, this portion of the trail is very steep with unstable footing. Many visitors to the park are not experienced hikers, do not wear the proper foot attire and often do not realize the hazards of navigating this segment of trail.

**Figure 5.** Switchbacks above Wall Street.

The Park may want to consider constructing a stair system from the top of the switchbacks to the entrance of Wall Street. Stairs would eliminate the need for constant maintenance on the switchbacks down to Wall Street and reduce the steep trail hazards to visitors. The use of stairs is favorable because it allows natural slope processes to go mostly unimpeded and without constant maintenance. The drawback to this alternative is that the stair system would be more expensive in the short term. It would require regular inspection and would be a conspicuous structure that might not be aesthetically compatible with the natural surroundings. Commercial stair systems have been successfully implemented in other units of the National Park Service.

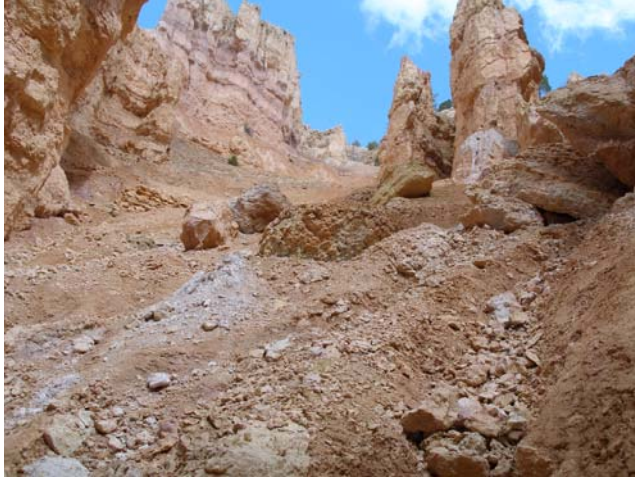
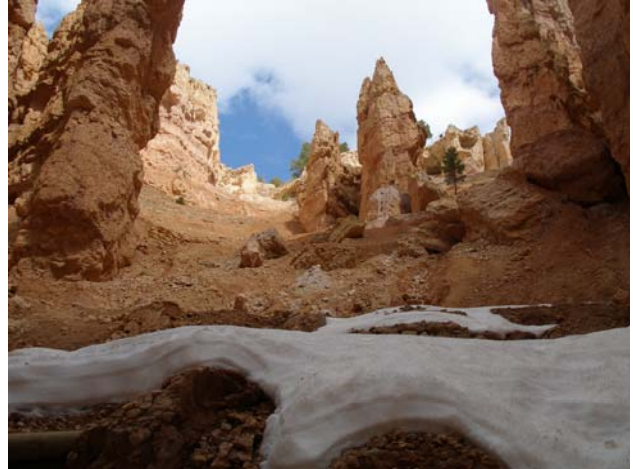
In addition to the trail damage, geohazards such as rockfalls and debris flow potential was exacerbated. Looking upslope and to the right at the entrance to Wall Street, there is a large gully that contains large amounts of loose rock and sediment. There is potential for the material to come down in a massive pulse such as a debris flow or a rockslide. This would occur during heavy snowmelt runoff or summer monsoons. Wall Street is a narrow slot canyon and it is the only outlet for runoff from the slope containing the switchbacks and the previously discussed gully. With this in mind, scour marks are apparent on the walls of the canyon. This is indicative of past events during which rocks and debris flowed through Wall Street.

**Figure 6a.** Slope above Wall Street containing large amounts of loose debris.

**Figure 6b.** Slope above Wall Street containing large amounts of loose debris.

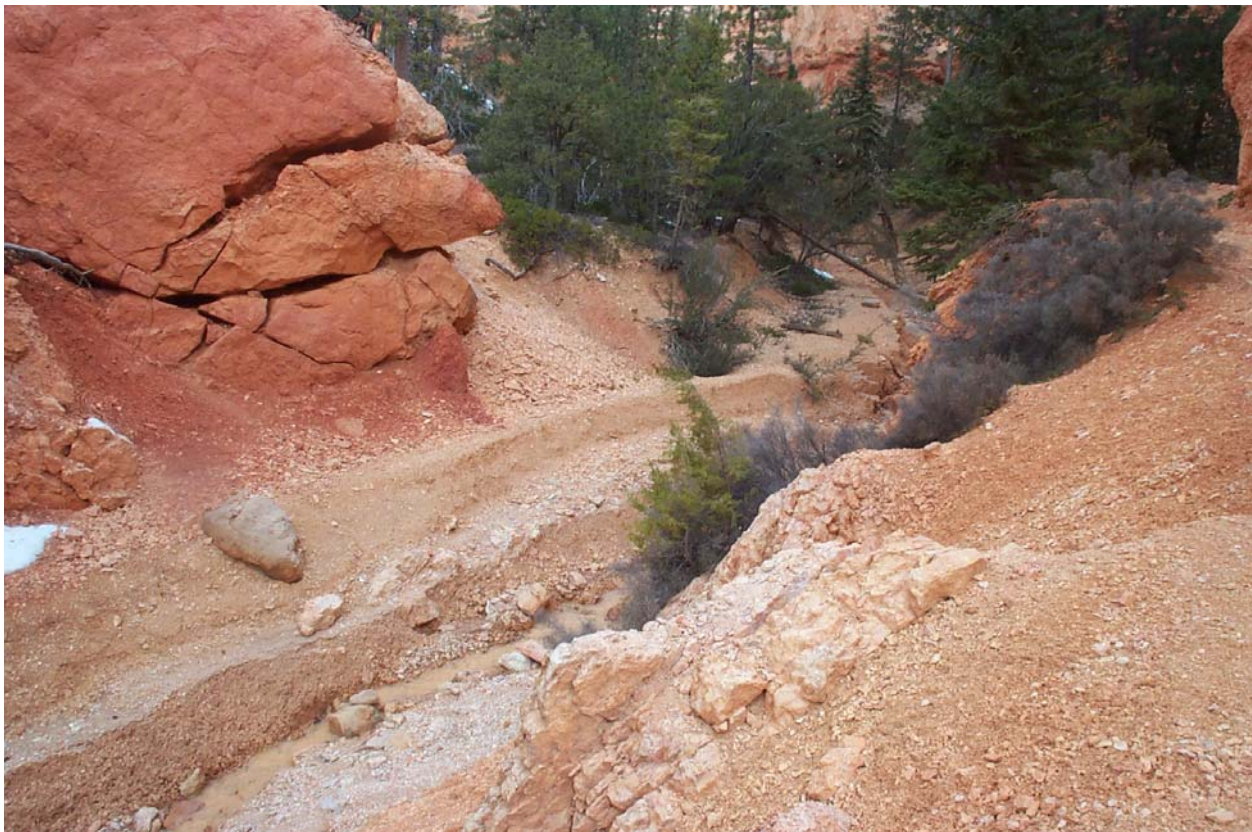
After exiting Wall Street, an unnamed wash is the primary drainage for the entire amphitheater that extends from Sunset point to Inspiration Point. In the past year, the wash transported large amounts of sediment and experienced substantial geomorphic change. In freshly exposed channel banks there is evidence of heavy runoff from past flood events.

**Figure 7.** The wash just below Wall Street. It demonstrates sediment loading and channel morphology, after high flows during the winter.
