# Erosion Assessment for Montezuma Castle and Tuzigoot National Monuments

Natural Resource Technical Report NPS/SODN/NRTR—2010/281

January 2010

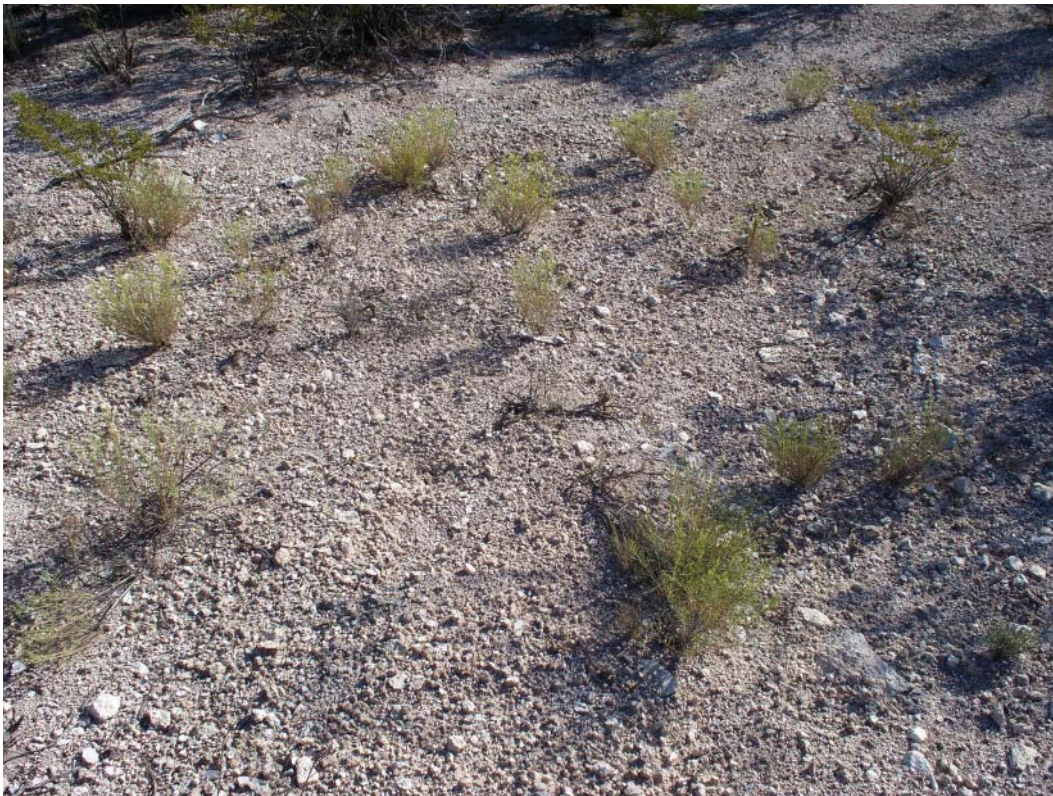
Limestone hills in the northwestern part of the monument show dense numbers of small to mid-sized rill and sheet-erosion features (Figure 3.1.2). Gullies in some of the small drainages associated with these hills probably resulted from high-energy runoff and erosion on adjacent hillslopes.

Figure 3.1.2. Area of sheet erosion with slightly pedestalled sparse vegetation, located on a slope in the northwestern part of MOCC.

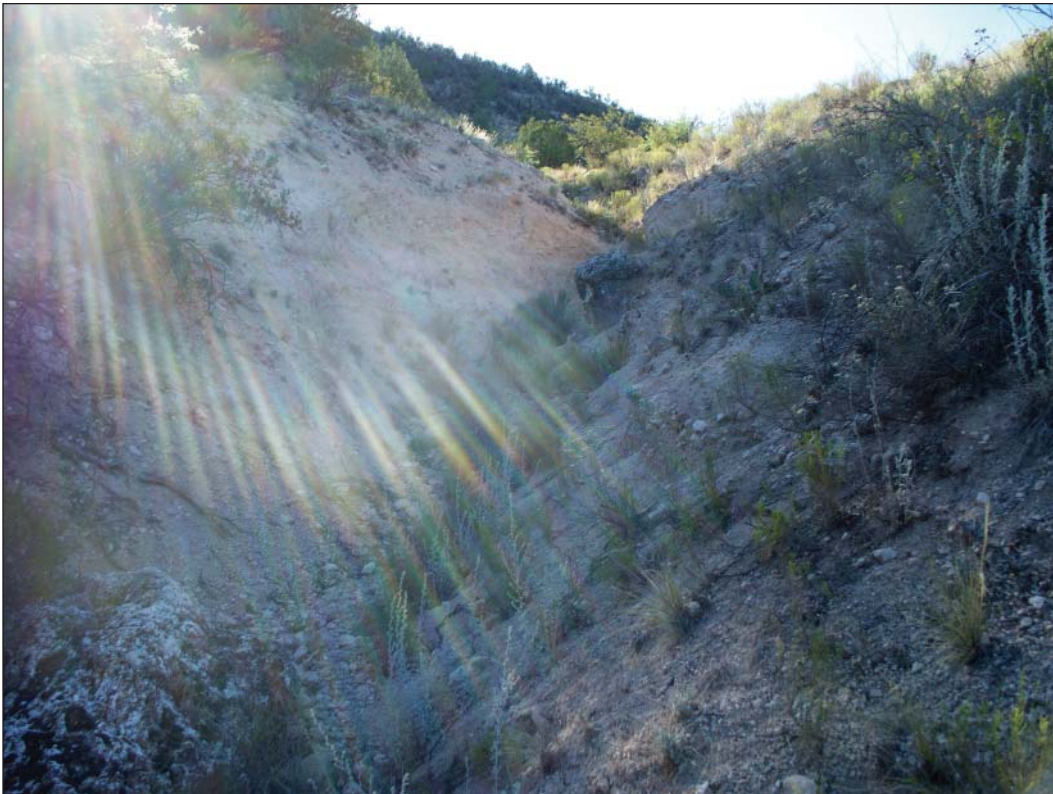
Slopes coming off the highlands in the extreme southeastern part of MOCC showed susceptibility to gully cuts. A series of gullies and associated rilled sideslopes were observed roughly every 30–40 meters along a traverse of the backslope (Figure 3.1.3).

Figure 3.1.3. Gully cutting into slope above Beaver Creek, southeast corner of MOCC.

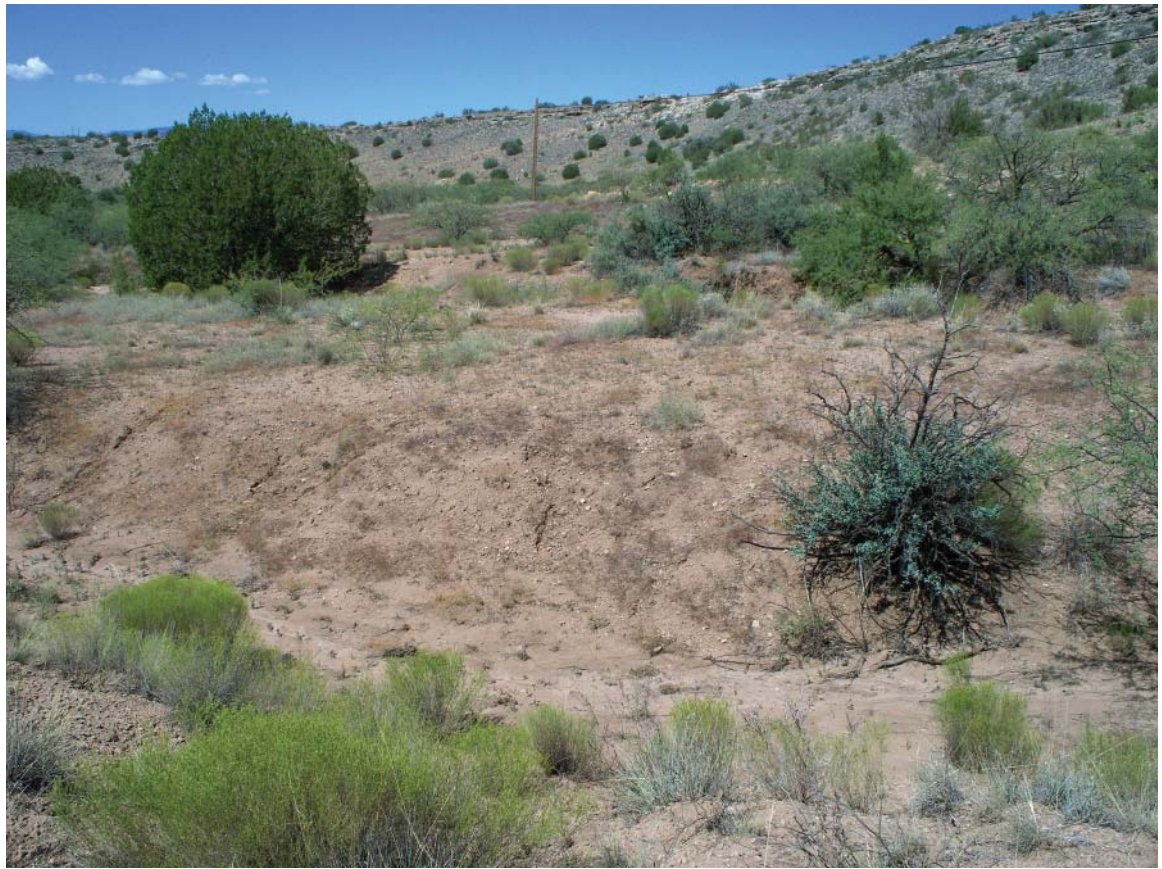
A series of gullies has cut through the northeast part of the park just below the Beaver Creek Road. Some are not downcutting as sharply as they may have in the past, but do appear to be widening (Figure 3.2.2). Also, some side gullies and rills have begun to form from the central gully channels.

Because gully cuts tend to move upstream, these gullies probably will not extend down into other parts of the monument, but still may change the hydrology of the area. The small size of the watershed above these cuts will probably not encourage upstream growth, either, but the side branches off the main gully could continue to erode and effectively lower the overall base level of the draw in this area, resulting in large movements of sediment downstream.

Figure 3.2.2. This gully, in the northeast corner of MOWE, has begun to widen since its initial downcutting.

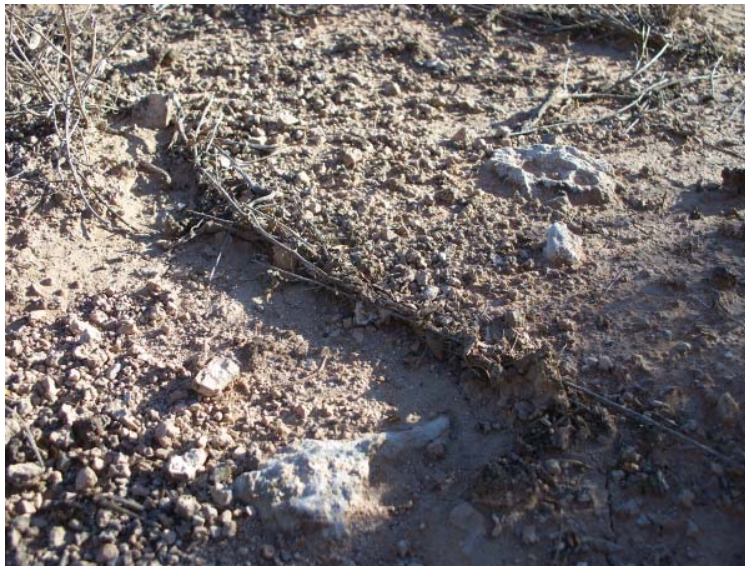
erode easily if surface crusts or litter covers are disturbed. Many rimtop areas showed signs of sheet flow slowed by small litter/soil-crust dams that keep levels of both flow energy and sediment transport relatively low (Figure 3.2.3). These areas are so close to becoming erosional that even a couple of people walking through them could disturb the dams and crust enough to allow the next flow event to start displacing surface soil. This situation appears to have already occurred in the extreme northwest corner of the park, where some of the rills and sheet erosion are collocated with a trail evident on the aerial imagery and observed during field efforts.

Figure 3.2.3. This small dam of litter and soil crust is helping to prevent sheet flow from gaining too much energy on the northwest rim of MOWE.

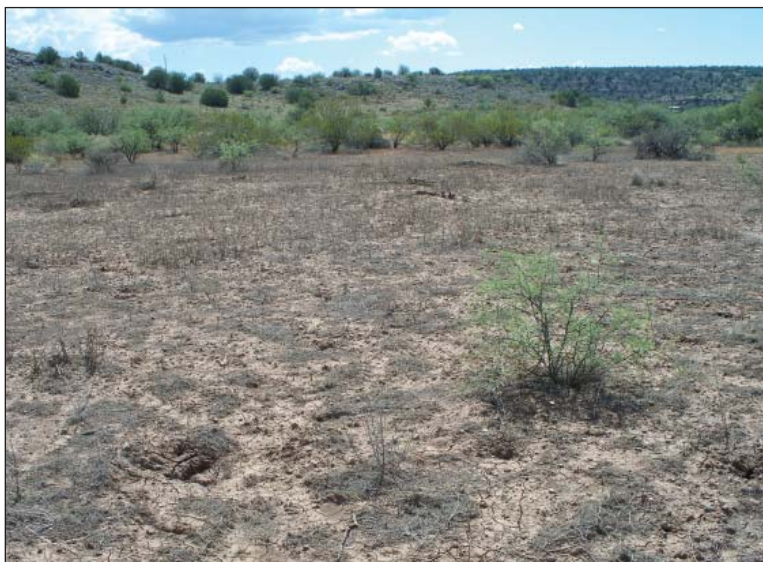
Located just south of Beaver Creek Road, after it turns east, are some relatively flat areas with clayey soils that exhibit high shrink-swell activity during dry-wet cycles (Figure 3.2.4). That activity leaves cracks and depressions in the landscape that help to slow surface flow, but also make it difficult for vegetation to establish. This area's lime-rich geology also means that its soils are high in calcium

carbonate and other more soluble minerals. Dissolution is likely occurring along the subsurface cracks, and probably playing a role in creating the depressions, through a process called subsidence. This subsidence, and the extensive animal burrowing observed in these areas, are two factors generally associated with shrink-swell soils and the probable loss of soil minerals dissolved by subsurface water flow. The shrink-swell activ-

ity associated with precipitation events makes it difficult to gauge the amount of surface erosion occurring. However, lack of continuous flow patterns in interplant areas, and well-structured, high-activity clays (i.e., very sticky and probably well-flocculated due to high  $\text{Ca}^{2+}$  concentration) suggest that not much soil is moving via water or wind erosion in these areas (see pink polygon in Figure 3.2).

Figure 3.2.4. Area of high-activity clay in central part of park. Only certain grasses and mesquite are lightly established on this soil type, with large areas of bare ground exposed. The cracking and associated macropores and burrows in this soil cause pedestalling around plants and patterns of depressions that help to slow surface flow.

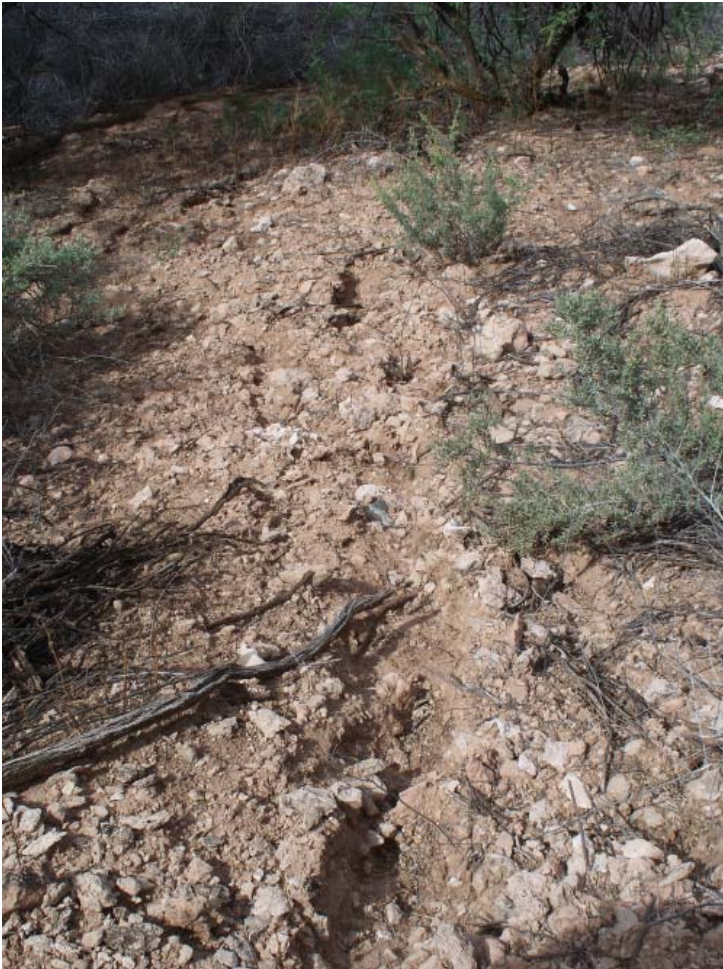
This area includes the monument's primary attraction, where ruins are located along a ridgetop. Both the western and eastern slopes of the southern three-quarters of the main ridge exhibited extensive rilling and sheet erosion (Figure 3.3.1). Areas on the steep slopes on either side of the main pueblo showed some of the most prolific rilling in the monument, along with general hill-slope instability.

Figure 3.3.1. Rilling on southwest side of the main ridge.

Erosion levels in these areas were surprising, given the rocky character of the slopes and presence of the park road, which might be expected to block or at least slow runoff from the mesquite shrubland. Under current conditions, it is possible that the slopes could eventually undercut sidewalks and infrastructure, especially below the ridgetop walkways. This is a particular concern given the number of cultural artifacts concentrated in this area. Some of the steep slopes in this area are off-limits to visitors; keeping that rule in place will benefit both visitor safety and the area's natural and cultural resources. In addition, regular inspection of slopes, from the walkways, may be warranted after storm events.

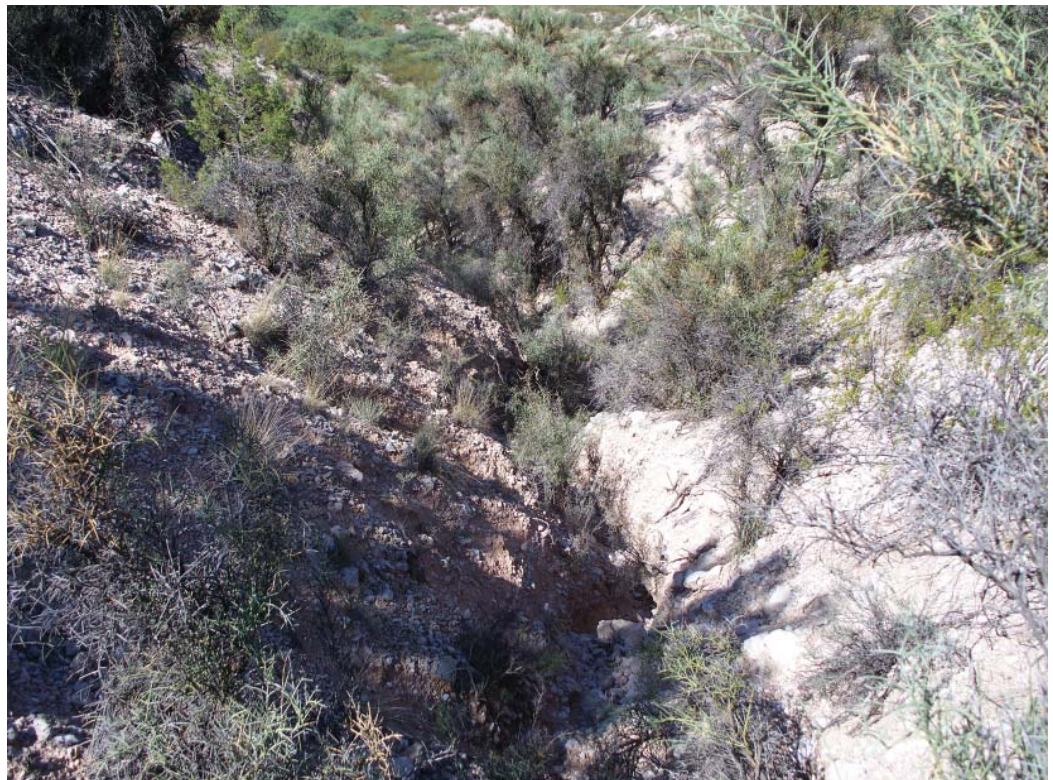
Washes in the northwestern part of TUZI have cut into the higher upland areas and appear to have triggered large numbers of gully cuts and rilling of associated backslopes (e.g., Figure 3.3.3). In these areas, the well-defined cliffline, such as that found along the monument's eastern side, has eroded away to create topography and slopes more susceptible to soil loss. Weathering on the resulting hillsides has left finer materials exposed on the surface. These materials are highly erodible in the absence of vegetation to stabilize slopes.

Figure 3.3.3. Gully in the northwestern-drainages area, showing an unstable sideslope above the actual cut.

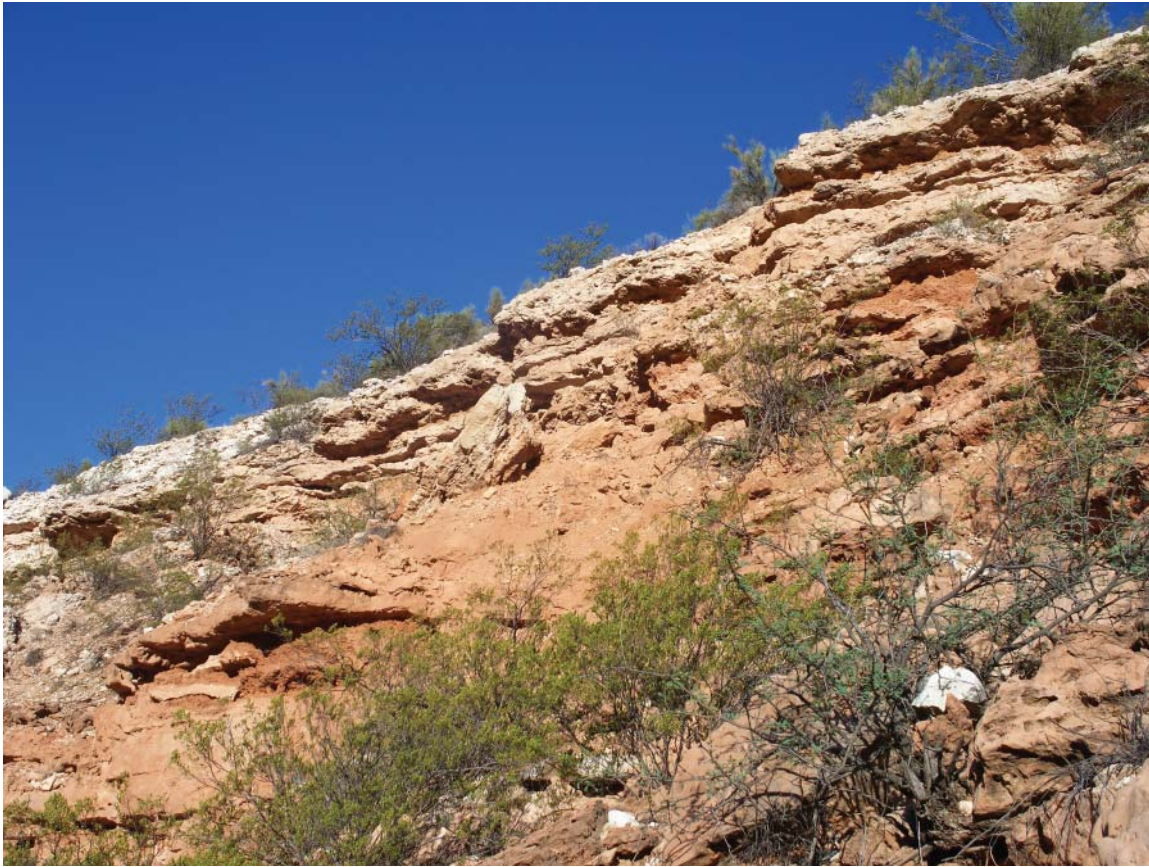
rim directly above these cliffs, a lack of small side-canyon cuts and gullying indicated limited acceleration of soil loss above natural rates. However, some large rock movements and rilling were observed in the red sandstone deposit beneath the limestone deposits along the scarp (Figure 3.3.5).

Figure 3.3.5. Limestone–Sandstone interface on scarp. This spot showed evidence of accelerated slope movement in the less-stable sandstone layer, where some large boulders have recently detached.
