# **Hydrological Investigation at El Morro National Monument**

## **Final report**

National Park Service  
U.S. Department of the Interior

March 2007

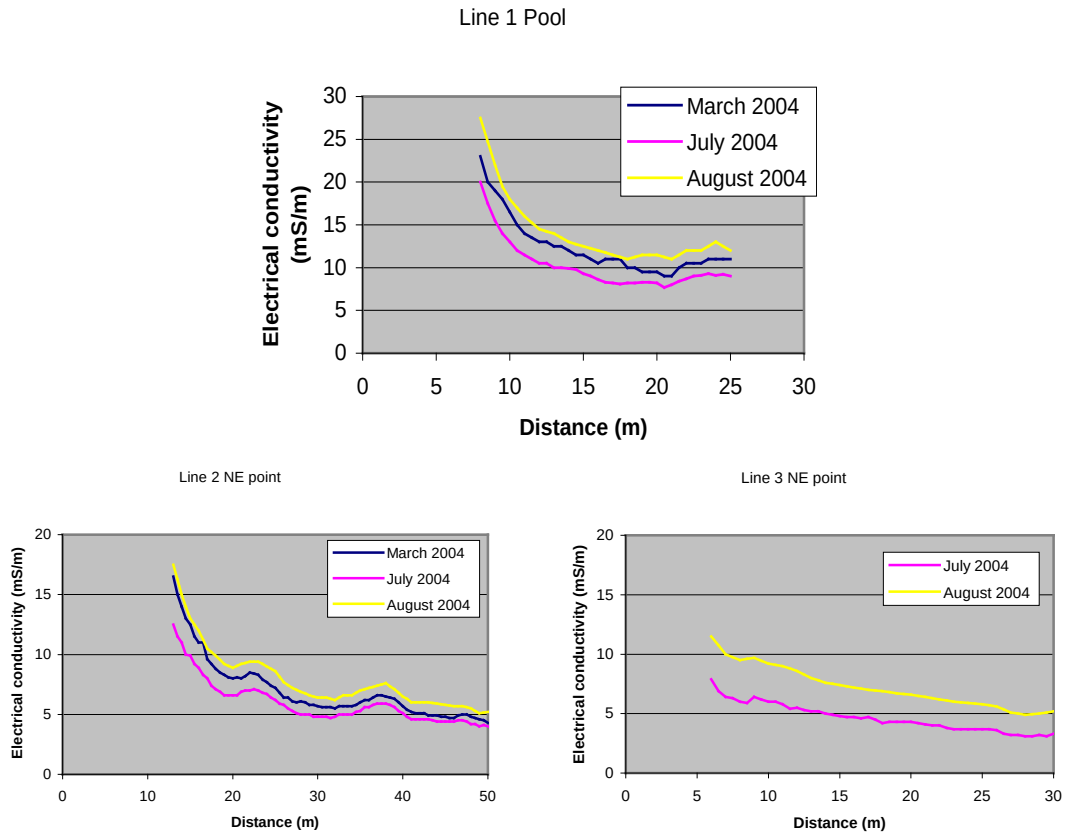
Comparison of EM31 measurement results from March, July, and August show clear variations in electrical conductivity (Figure 1). In July the electrical conductivity was one to two mS/m lower than in March. Taking soil temperature effects into account the true differences are probably three to four mS/m (Hendrickx and Kachanoski, 2002) which indicates a decrease in moisture content over the first 5 to 6 meters of the soil profile. However, in August the electrical conductivity has risen back to values just above those in March. Again, taking soil temperature effects into account there is no discernible difference which indicates similar soil moisture conditions in March and August 2004. Elevated soil moisture in March and August was, respectively, caused by snowmelt and summer monsoon precipitation. Figure 2 shows the difference in electrical conductivity between August (wet) and July (dry). The differences are largest near the cliff wall / pool, which indicates that the seasonal variations are not just related to precipitation differences but that the presence of the cliff has a significant impact.

**Figure 1.** Comparison of seasonal electrical conductivity variations at the pool and the northeast point.

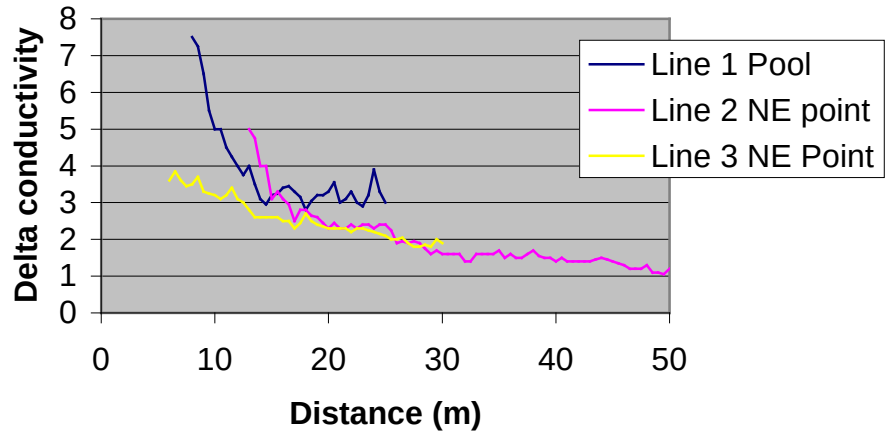
**Figure 2.** Differences in electrical conductivity between August and July

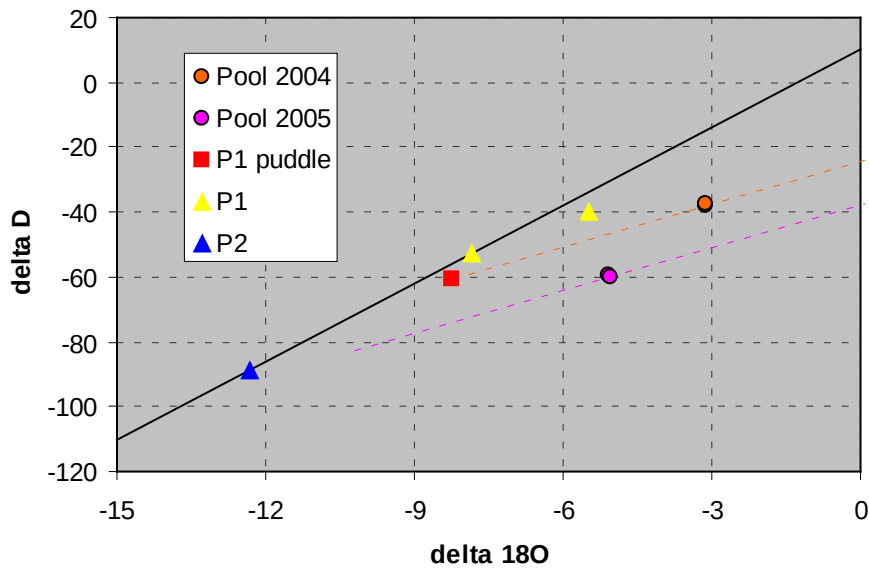
Water is composed of molecules of different weight. Because lighter water molecules evaporate easier than heavier molecules, evaporation changes the isotopic composition of the remaining water. This leads to a deviation from the meteoric water line. The four samples from the pool (two collected in August 2004, two in July 2005) have been subject to evaporation and have higher  $\delta^{18}\text{O}$  values. Evaporation causes the  $\delta^{18}\text{O}$ - $\delta\text{D}$  ratio to change at a constant rate (dashed lines in Figure 3).

**Figure 3.**  $\delta^{18}\text{O}$  and  $\delta\text{D}$  values for water samples from pool and piezometers.

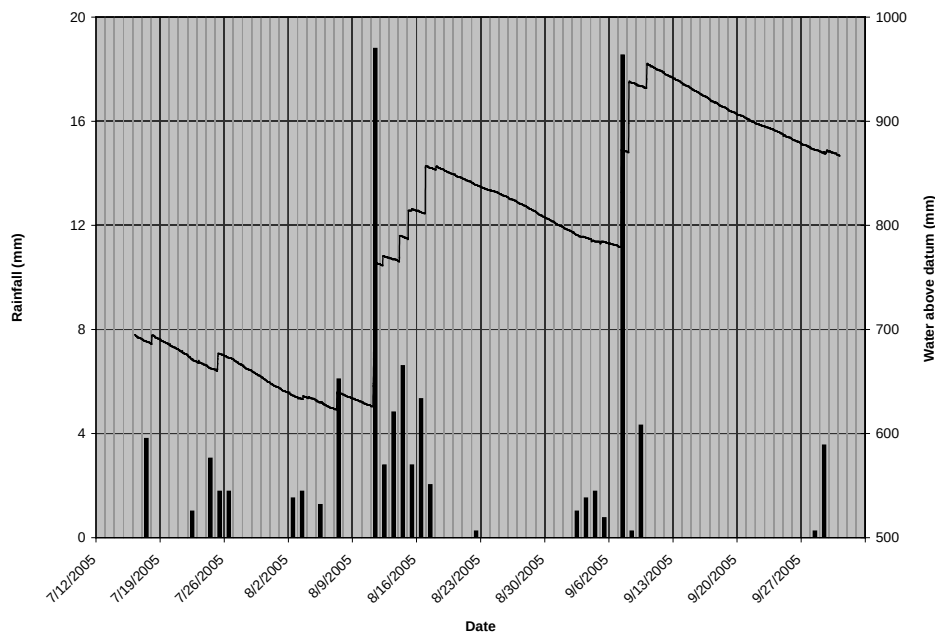
The pool is fed by three catchments, with an aggregate size of 1.55 acres (about 6273 square meters) (Pranger, 2002). The response time of the system is very fast, as can be expected from the small size of the catchment area. Some rainfall events cause very rapid changes in pool level (Appendix G). The ratio of rainfall amount over change in pool level is about 0.1 to 0.25 (Table 2). The pool has an approximate size of 3500 square feet (~380 square meters) (Sayre, 1997), which makes the ratio of the pool size over the catchment size about 0.06. This suggests that less than 50% of the rainwater reaches the pool through runoff (Figure 6).

**Figure 4.** Water level of the pool and corresponding precipitation events (in millimeters). Detailed plots of the individual precipitation records in the pool level are given in Appendix G.

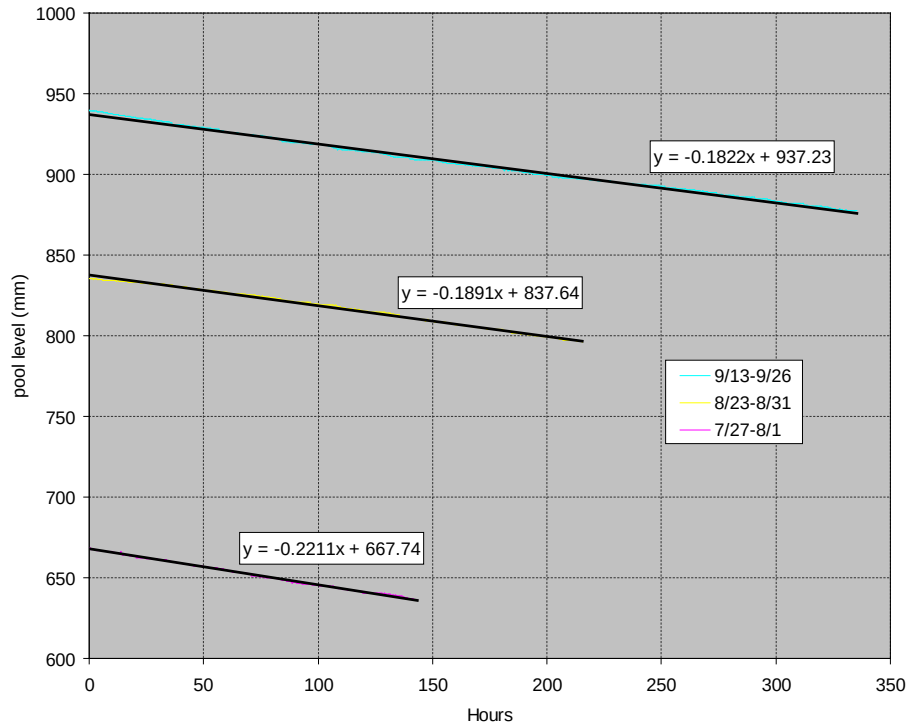
In the absence of any rainfall events it is possible to calculate the change in pool water level due to evaporation (E, negative effect), recharge (Qr, negative effect), infiltration in the cliff (Ql, negative effect) and percolation through the cliff (Qc + Qp, positive effect). The recharge is expected to stay constant throughout time while the other variables may change. Figure 5 shows that for three one- to two-week periods (7/27-8/1, 8/23-8/31, and 9/13-9/26) the pool level decreased at a rate of 1 millimeter per 4.52, 5.29, and 5.49 hours, respectively. Although the rate of decrease in pool level is reasonably close between the three periods, the results indicate that later in the monsoon season, the pool level decreases more slowly. Therefore, we believe that water infiltrated on the top of the cliff increases inflow of water (Qc + Qp) in the pool. The process that is involved in the delayed inflow into the pool may be similar as that what caused the delayed inflow of water in P2 on August 22, 2004 (Appendix D).

**Figure 5.** Decrease in pool water level during periods without precipitation; from bottom to top: 7/27-8/1, 8/23-8/31, and 9/13-9/26. See Figure 1 for reference.

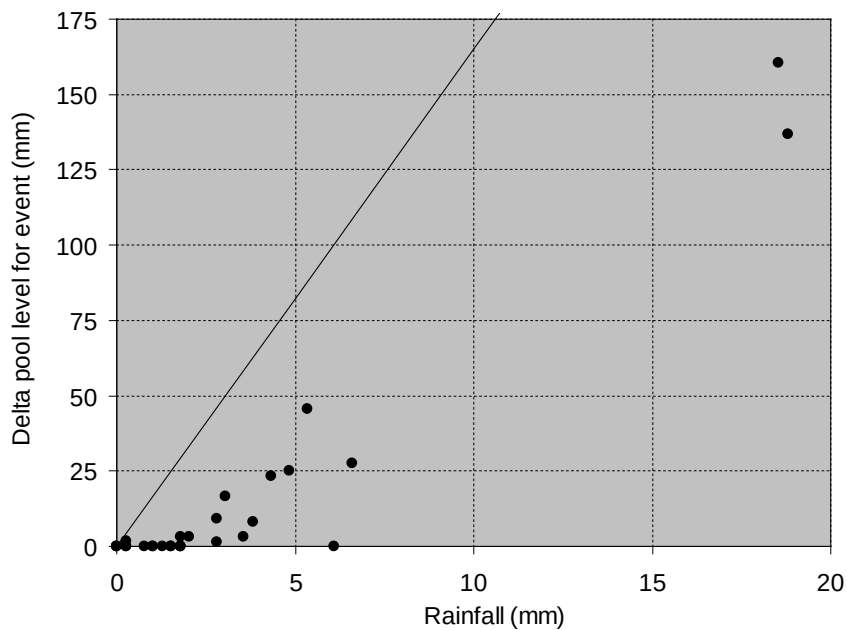
**Figure 6.** Cross plot of rainfall amounts and associated changes in water level in the pool. The duration of the individual events (as recorded in changes in pool level) is given in Table 1. The solid line is ratio of pool size over catchment size.

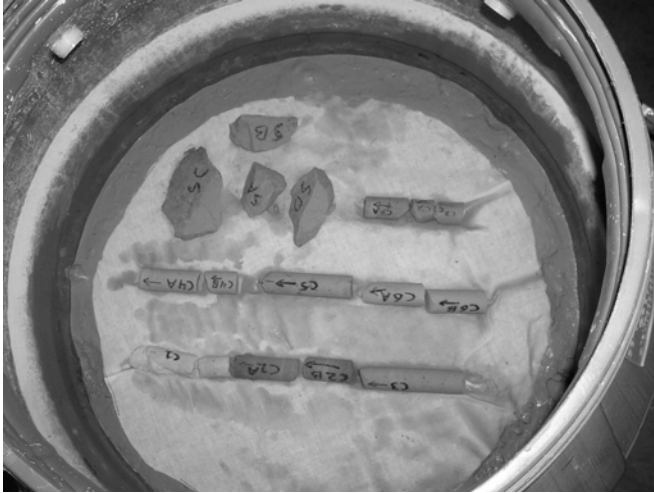
*How much exposure to moisture is needed to deteriorate the sandstone* – The laboratory experiment clearly demonstrated that the sandstone disintegrates after exposure to

**Figure 7.** Rock cores and solid rock slabs in the water retention tank, in which the water level can be varied (Hendrickx's soil physics laboratory at New Mexico Tech)

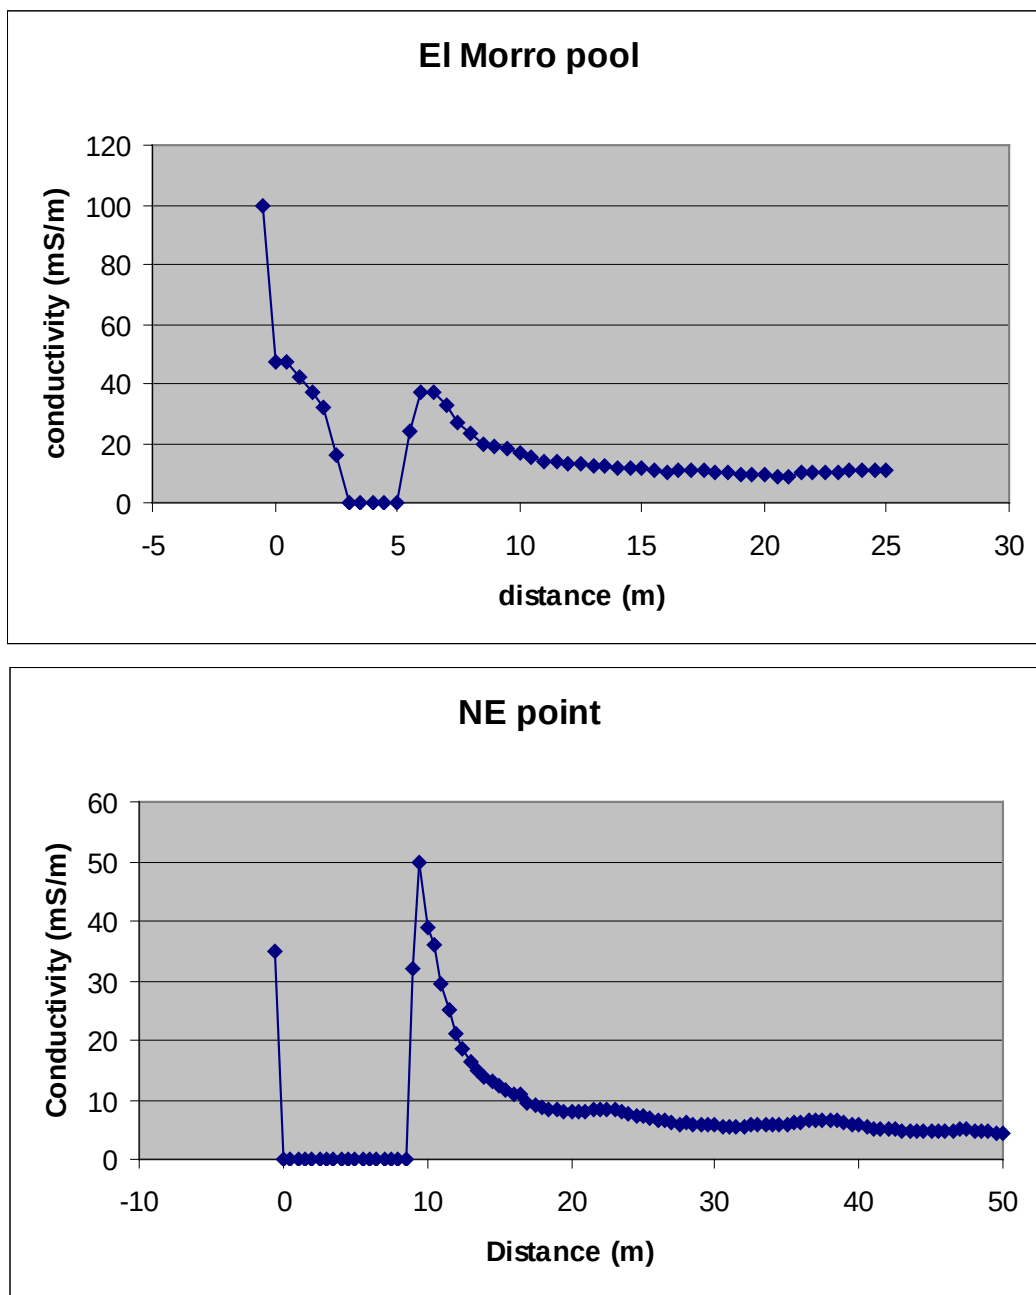
**Electromagnetic induction** was used to study the spatial variability in soil moisture content in the pool area and at the northeast point. At both locations a Geonics EM31 system was used to measure the bulk apparent electrical conductivity of the subsurface along transects. At both locations the results show a clear increase in conductivity towards the pool and cliff wall, respectively. In both cases the distance of 0m is the intersection of the transect with the wooden fence. The values that drop to zero are caused by the steel reinforced footpath.

**Figure B-1.** Electrical conductivity variations at the pool and the northeast point.

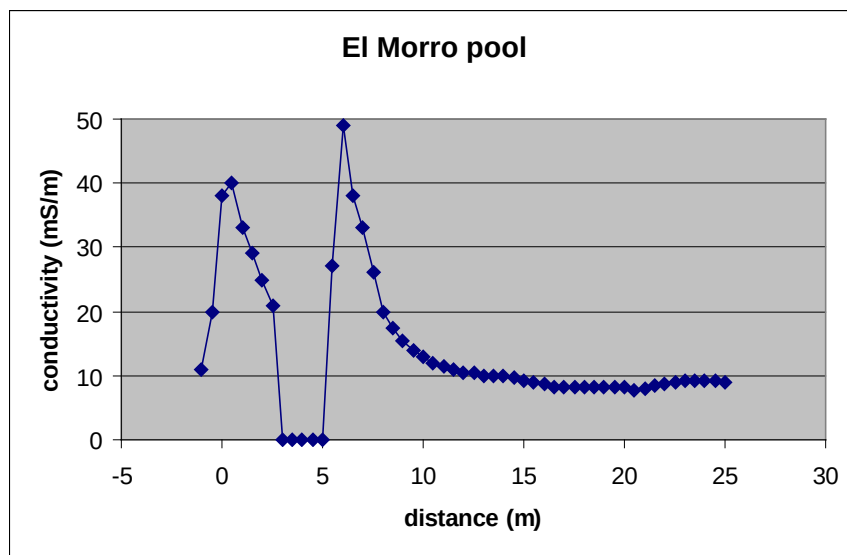
**Figure C-1.** Electrical conductivity variations at the pool.

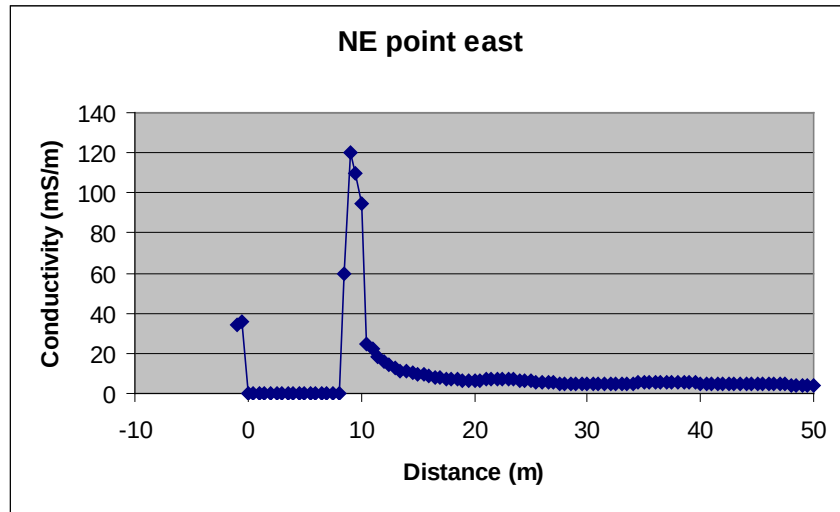
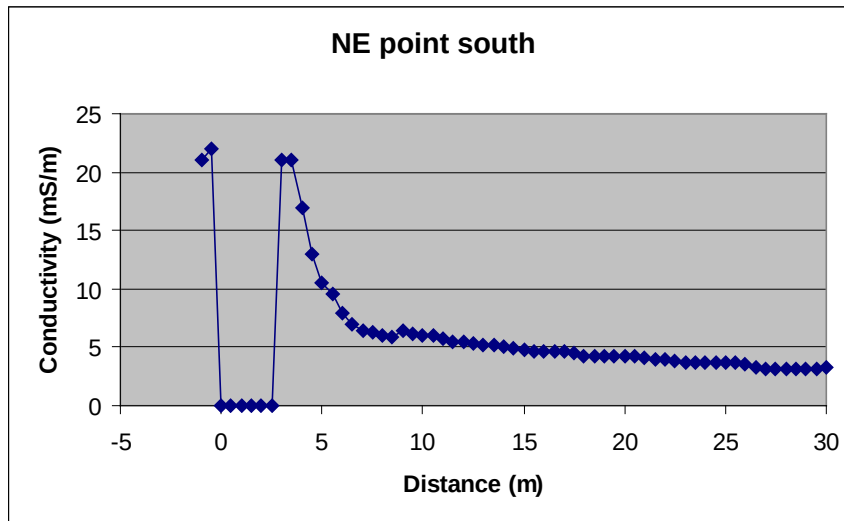
**Figure C-2.** Electrical conductivity variations at the northeast point.

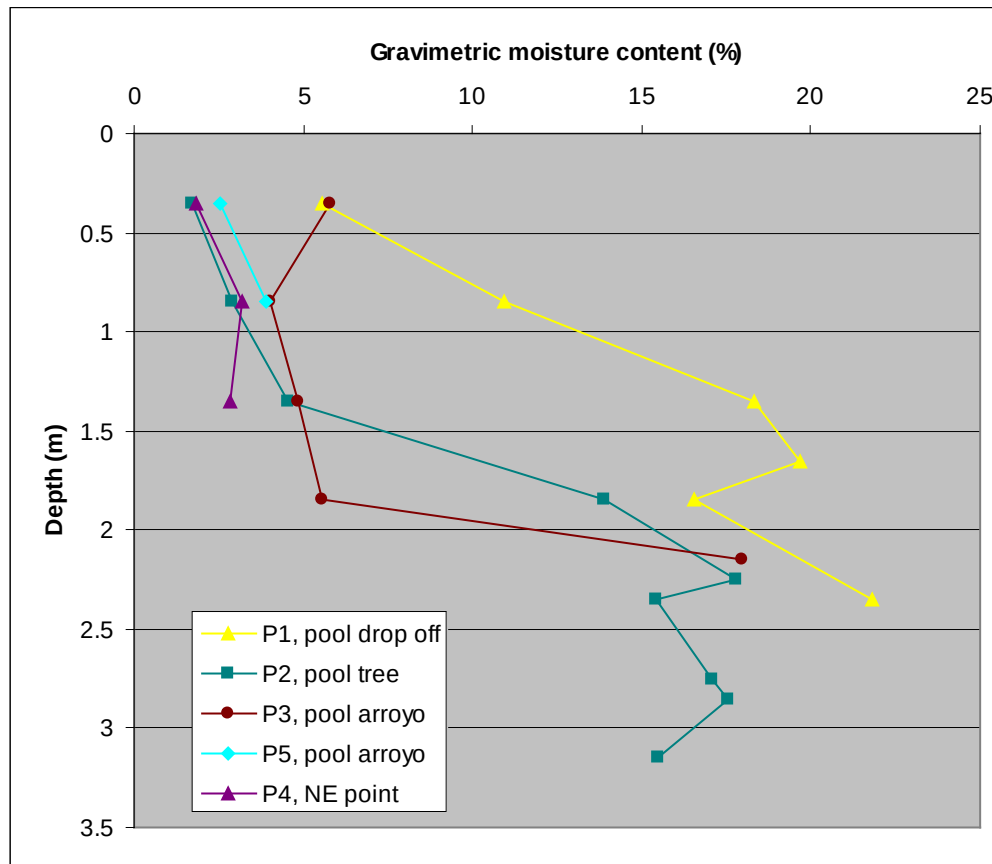
Samples collected from the piezometer holes were used to estimate the moisture content at different depths in the arroyo and near the cliff. These measurements give an indication of the level of saturation in locations around the pool and near the northeast point. The three boreholes near the pool all show a significant increase in soil moisture content with depth. However, all these boreholes ended on bedrock without reaching a water table.

Figure C-7. Gravimetric moisture content for samples from different piezometer holes.

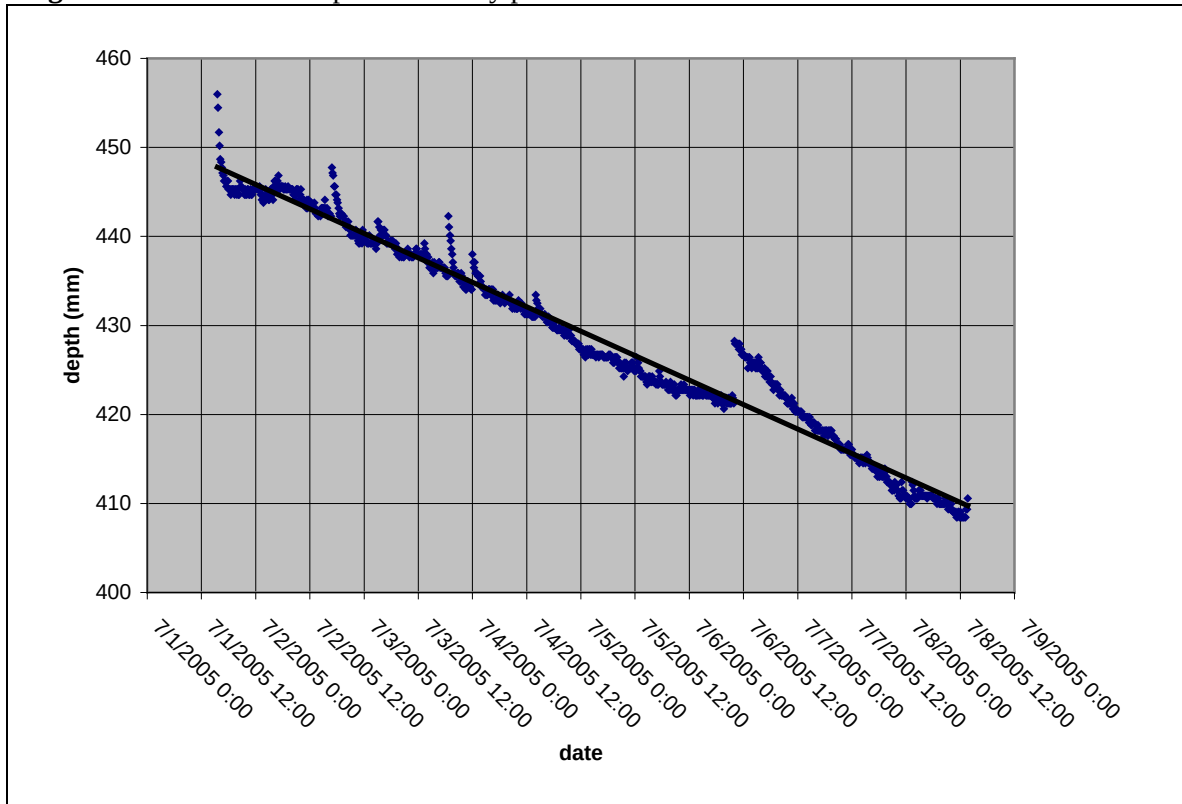
The data collected directly after installation of the water level logger seemed to indicate the presence of diurnal cycles (Figure E-3). However, no such cycles were found in the data from July through September.

**Figure E-3.** Pool water depth for a 7 day period from 7/1/05 to 7/8/05

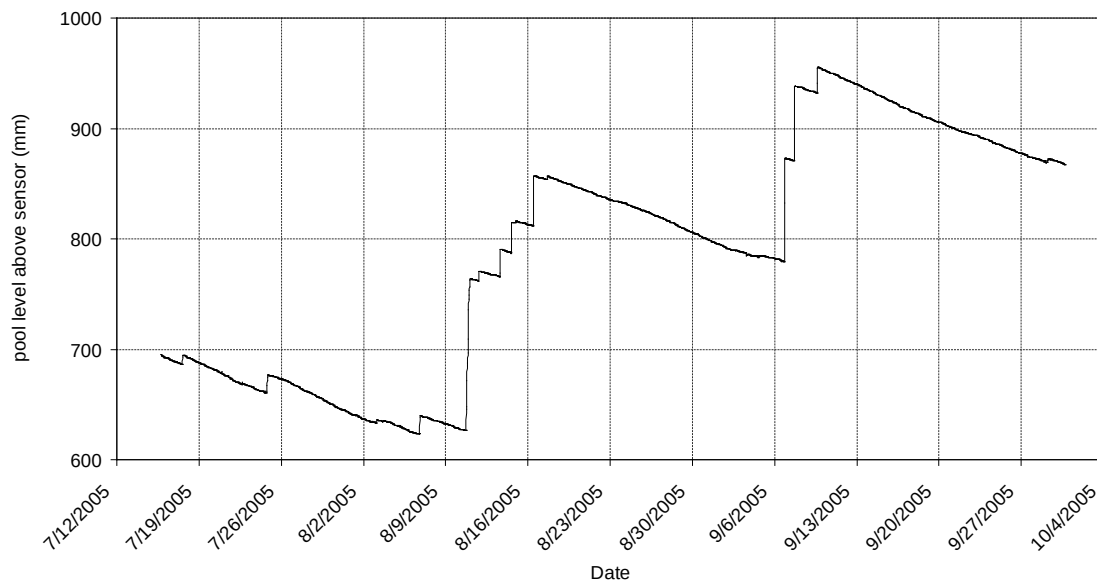
**Figure F-1.** Plot of pool water level (in millimeter above datum) versus time, for the period 7/12/2005 through 9/30/2005.
