**REDWOOD NATIONAL PARK**

**WATERSHED RESTORATION PROJECT**

**UNIT 89-3: LOST MAN CREEK UPPER DAM REMOVAL**

**SUMMARY REPORT**

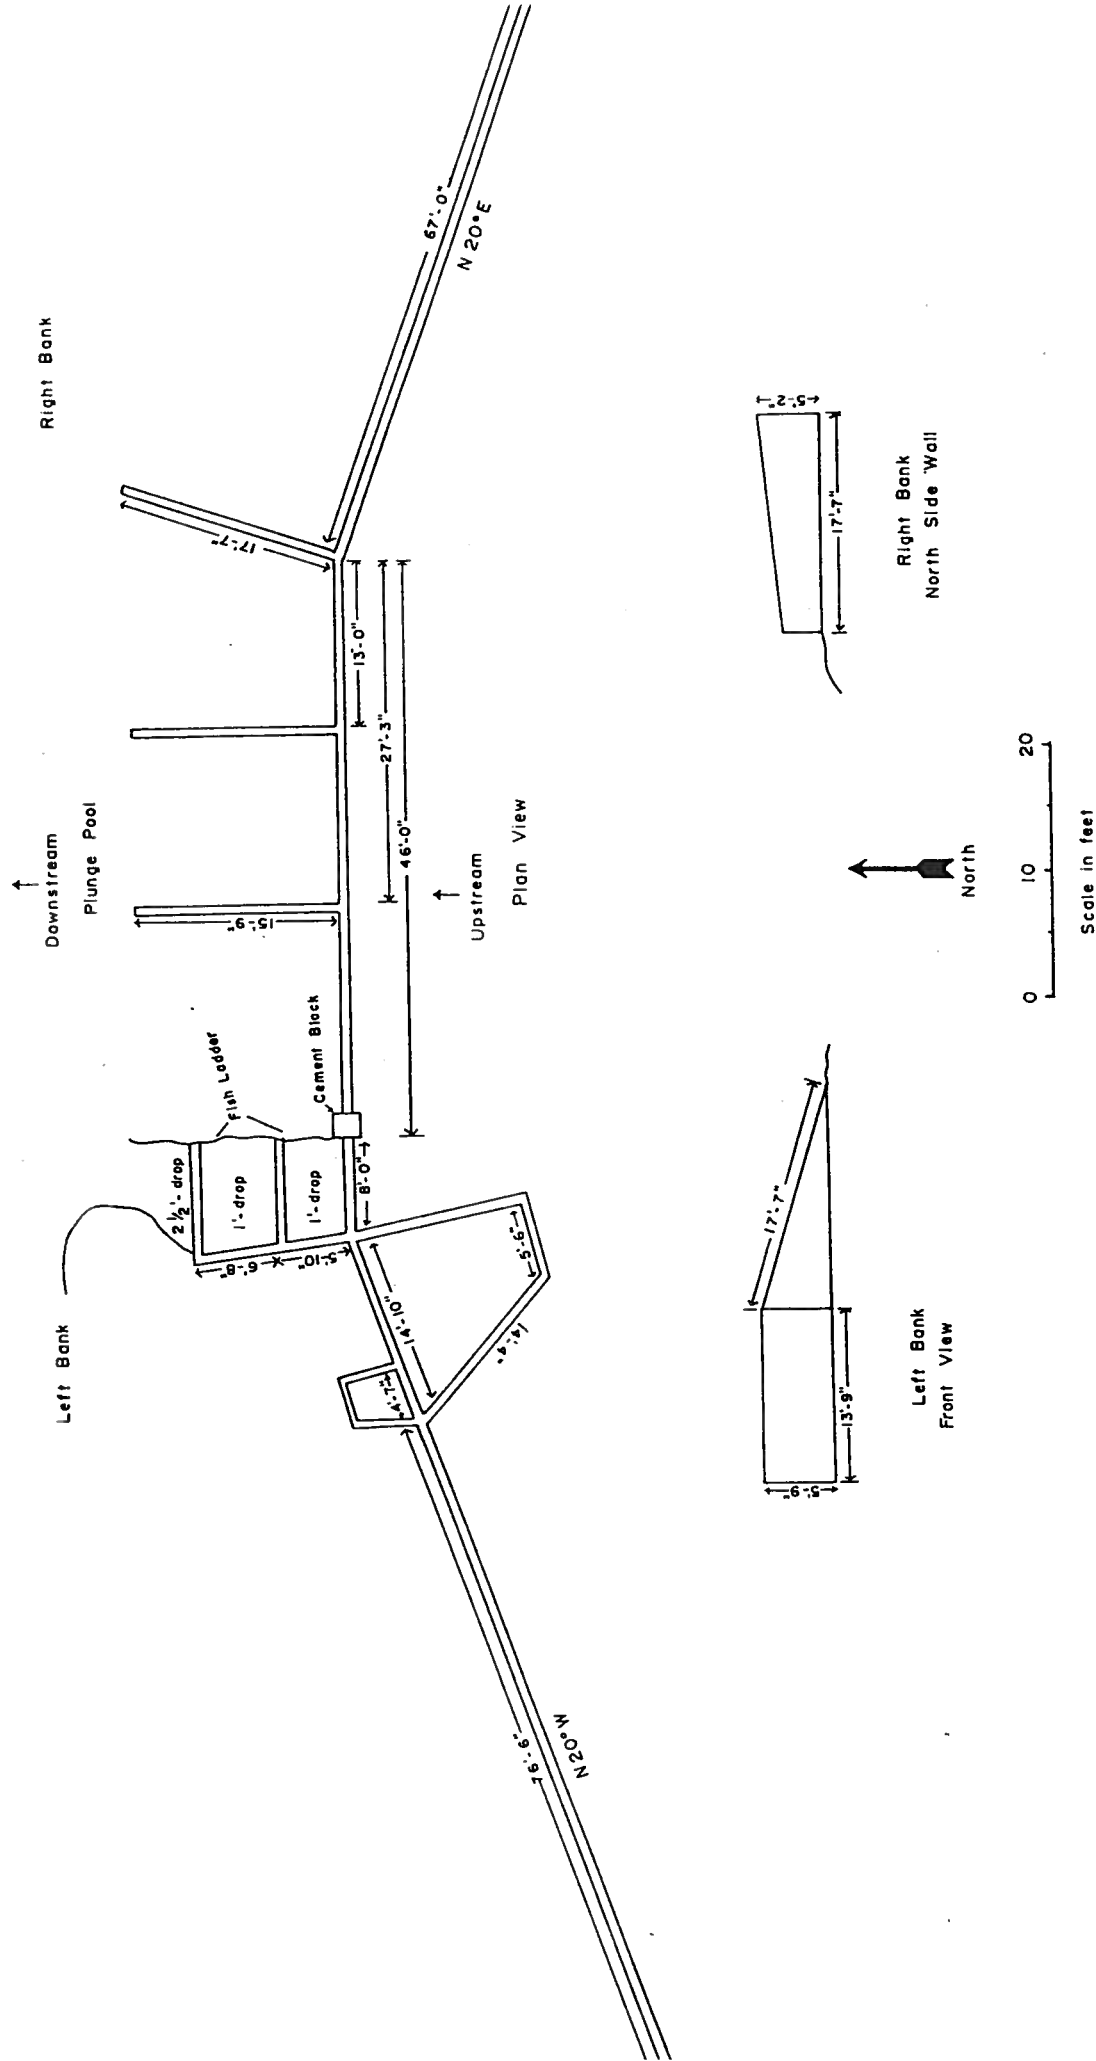
# LOST MAN CREEK DAM

The concrete dam structure spanned 57 feet of stream, was 7 feet tall and had wing walls on each side extending 86 feet on the south side and 67 feet on the north side (Appendix). The former water intake basin was located adjacent to the south side of the dam at the terrace edge and consisted of two cement-lined sumps, each five to eight feet deep.

As built drawing of Lost Man Creek Upper Dam. Measured by J. Sacklin and A.K. Smith, spring, 1989.  
Drawing by T. Hardt.

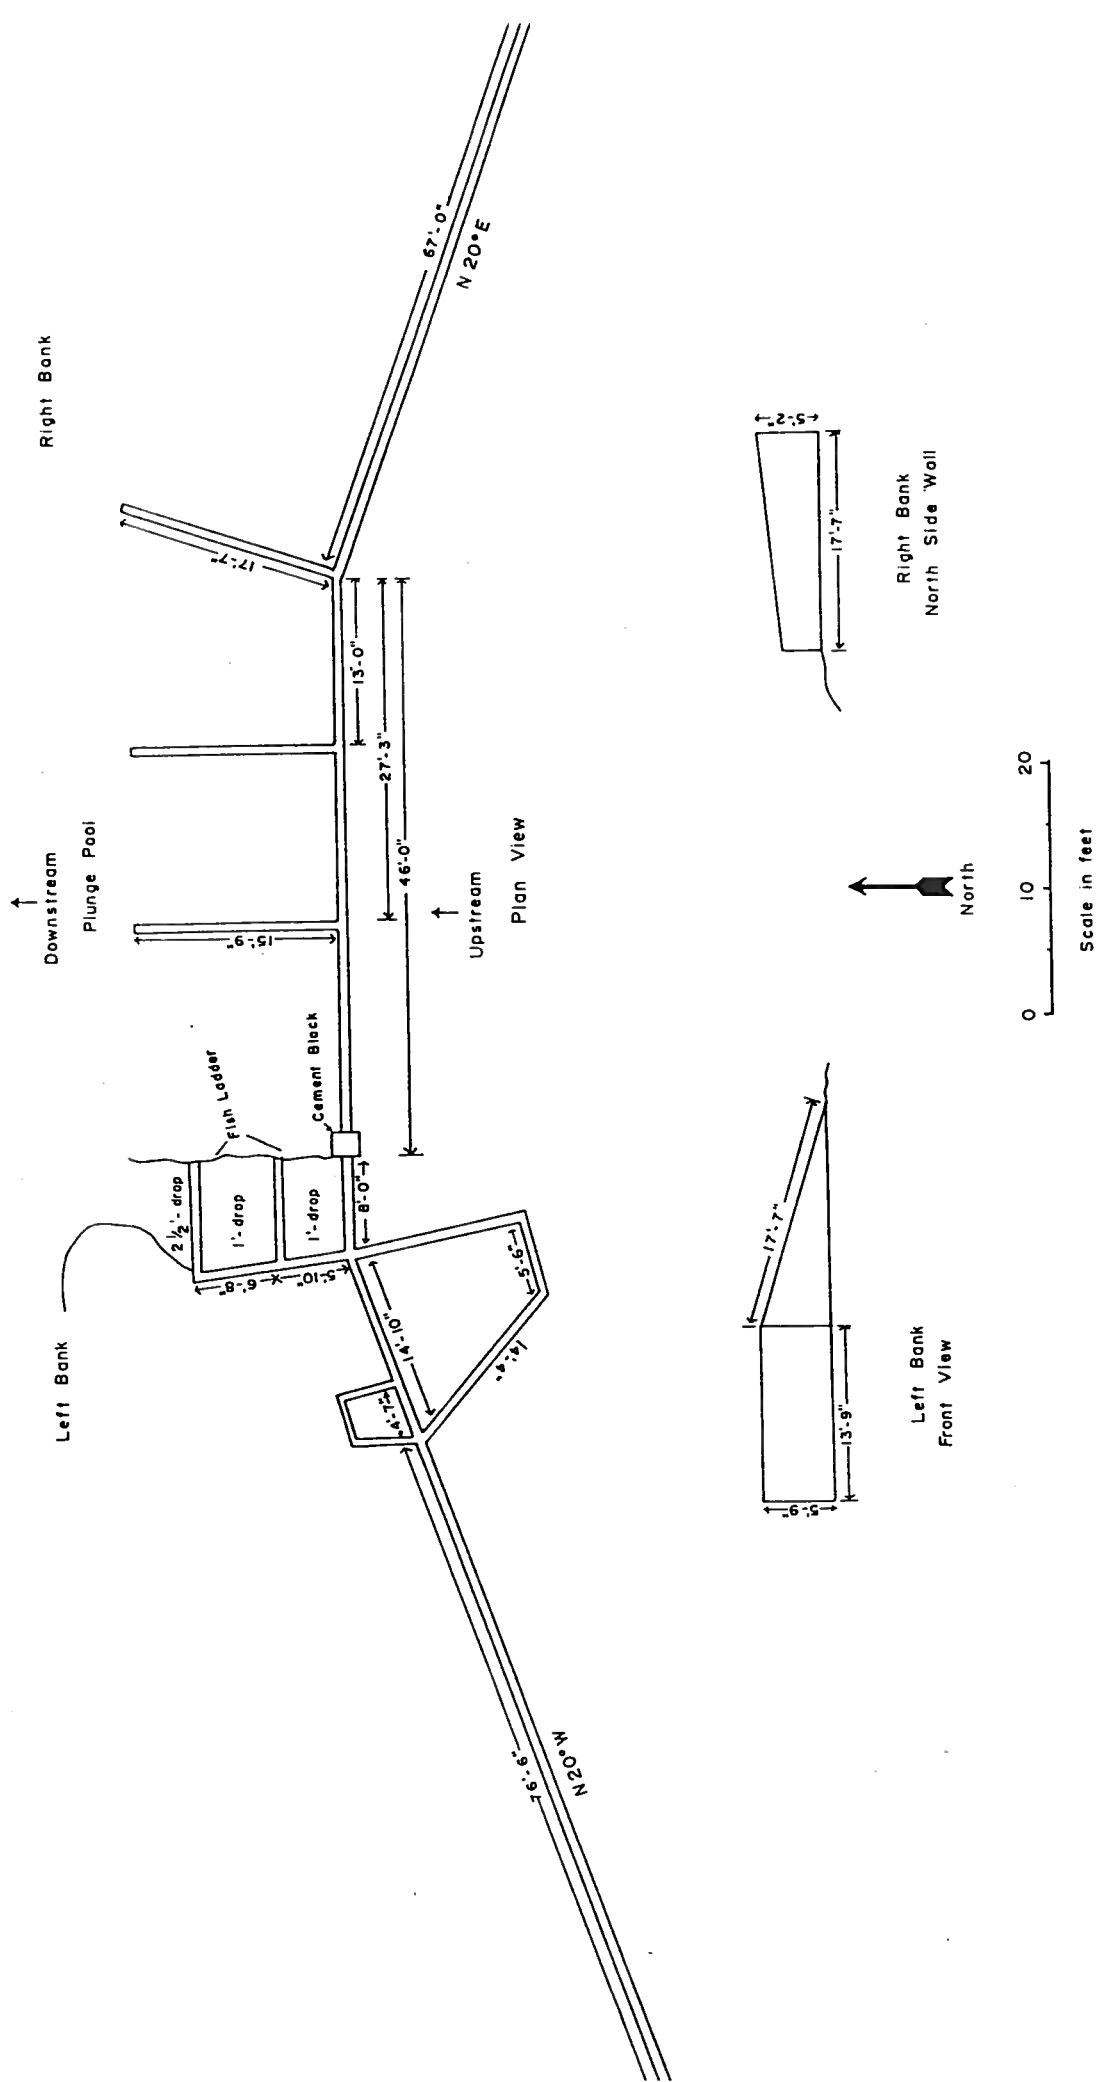
# LOST MAN CREEK DAM

As built drawing of Lost Man Creek Upper Dam. Measured by J. Sacklin and A.K. Smith, spring, 1989.  
Drawing by T. Hardt.
