REDWOOD N. P.  
LIBRARY  
South Operations Center

REPORT ON EROSION CONTROL WORK ON TEST AREA FOUR, REDWOOD NATIONAL PARK, SEPTEMBER - OCTOBER, 1977

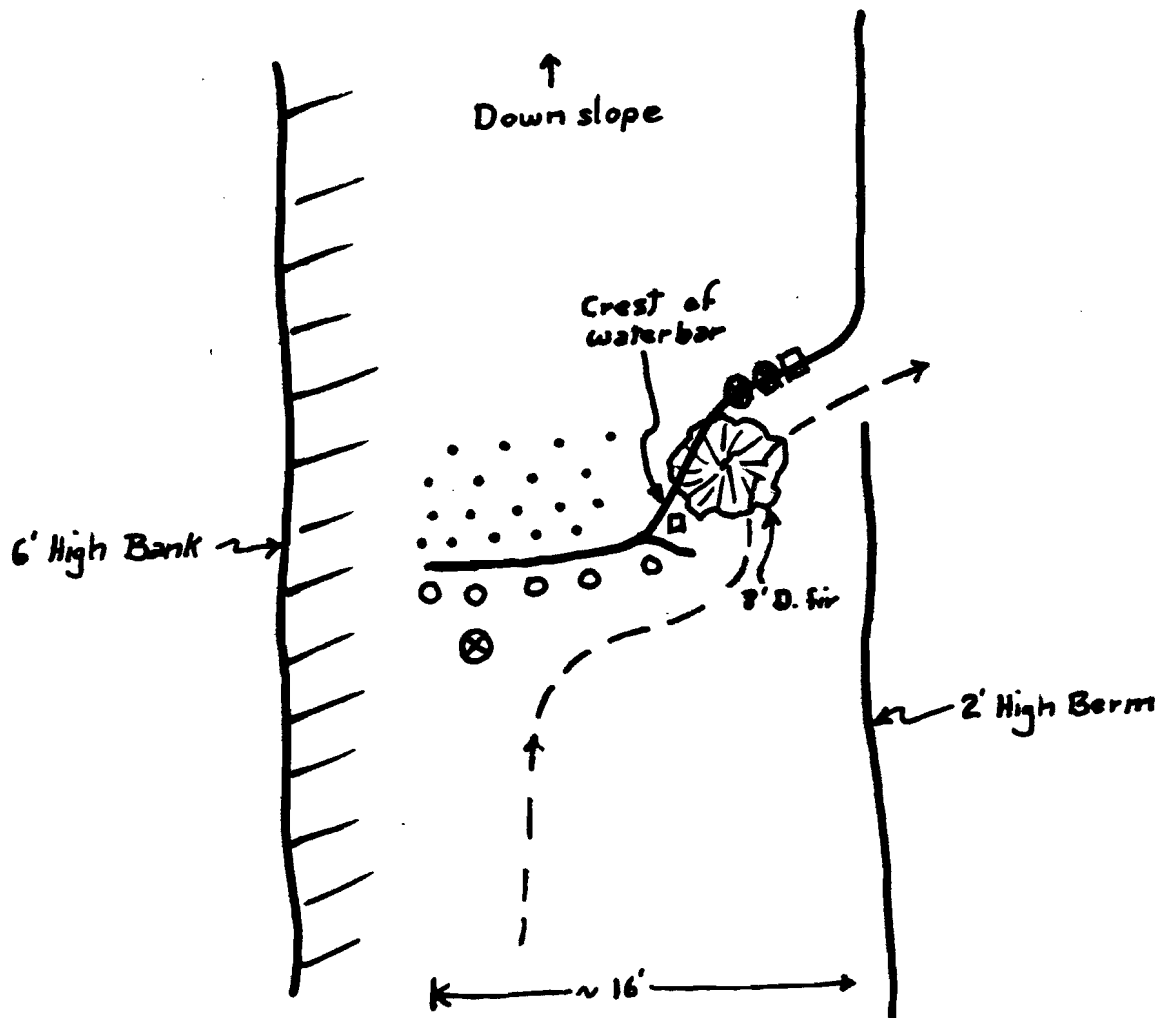
# APPENDIX B

Sketch map of trial planting on the lower of two old cat dug waterbars along the logging road in work area 3. The planting area is marked with red flagging.

mound of earth which constitutes the lower cat waterbar. The planting includes eighteen cuttings of baccharis, 3/8" to 3/4" in diameter; three 2"-3" douglas fir transplants, four small salal plants, and 2 small huckleberry bushes. A sketch of the planting is included in Appendix B.
