## **Revegetation and Monitoring the Cactus Forest Loop Road Saguaro National Park**

Kara O'Brien and Dana Backer

May 18, 2009

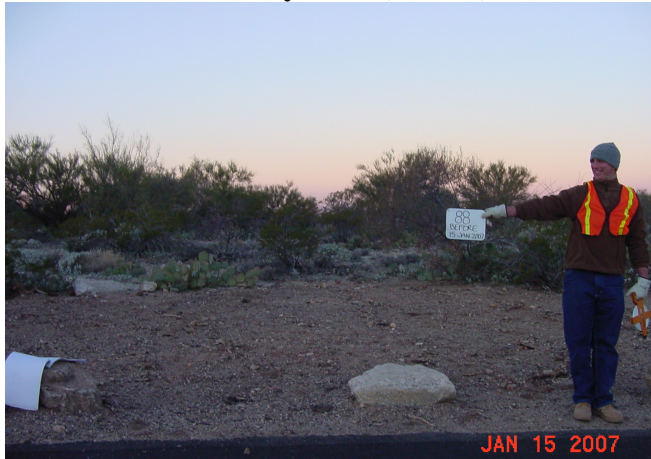
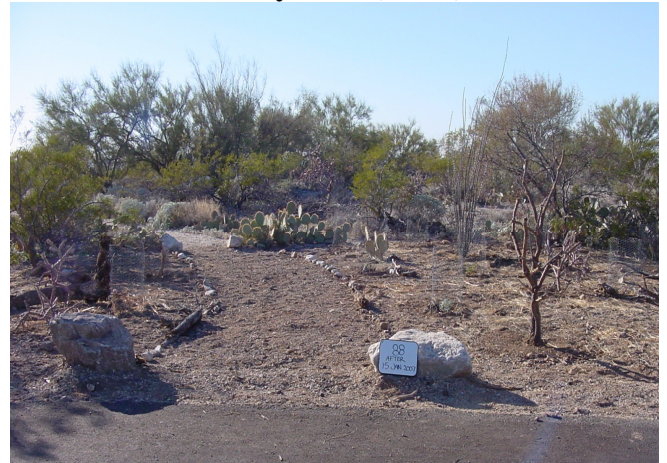
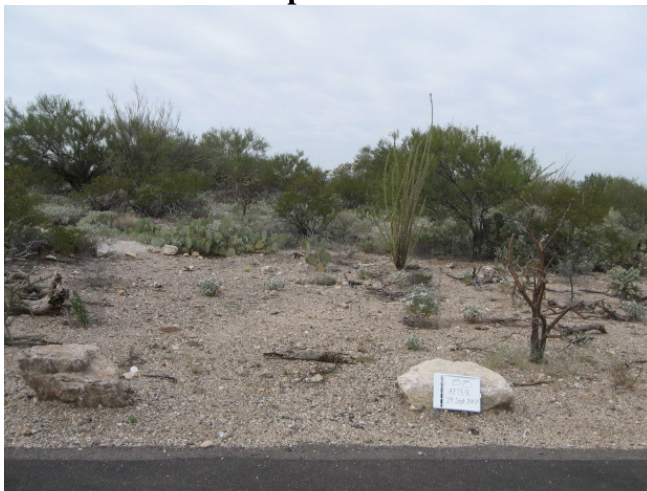
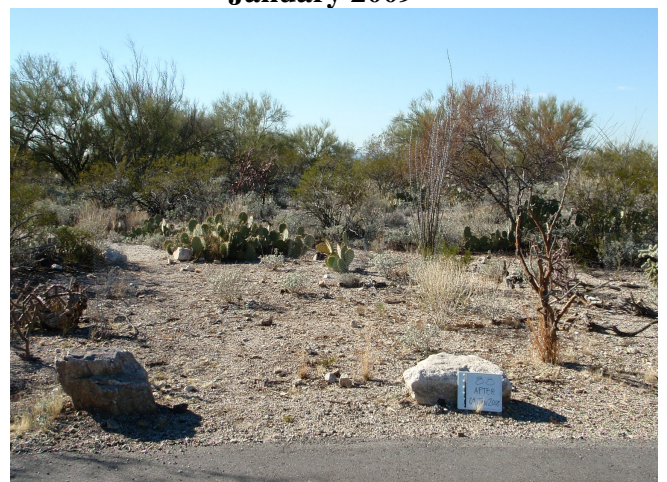
## Site 88

Site 88 experienced a low survival rate for trees. Three out of the six trees died. All of the trees that did not survive were velvet mesquite (*Prosopis velutina*). Overall this site saw a 71.4% survival rate where ten out of the fourteen plants survived. The only other plant that did not survive was a single senna (*Senna covesii*). African lovegrass was present at this site.

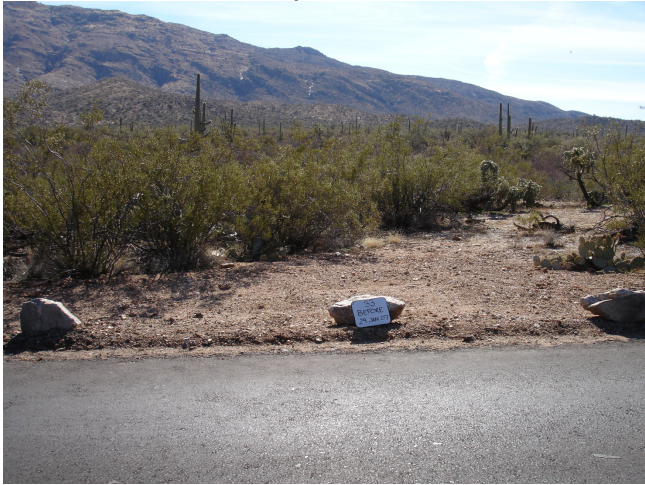
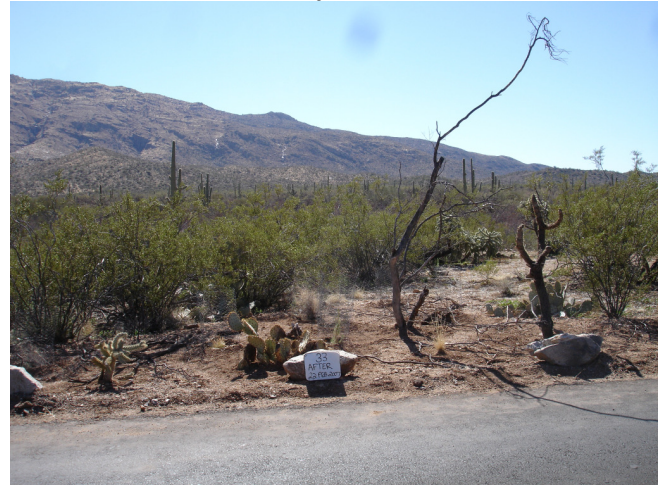
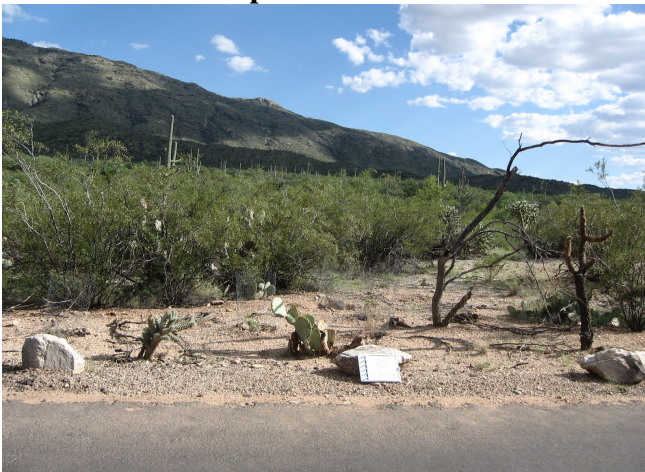
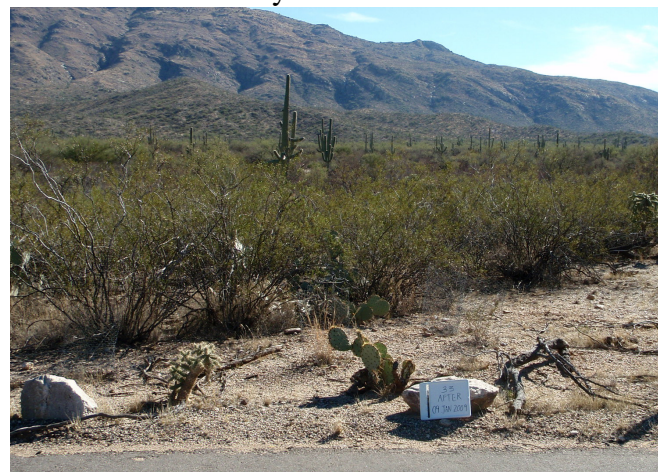
## Site 33

Site 33 is site that still needs more work. It experienced a 41.7% survival rate. Only five out of the twelve plants survived. One of the plants that perished was the only tree at this site, a foothills palo verde (*Cercidium microphyllum*). The five plants that survived include: catclaw acacia (*Acacia greggii*), side oats grama (*bouteloua curtipendula*), creosote bush (*larrea tridentata*), senna (*Senna covesii*), and zinnia (*Zinnia acerosa*).

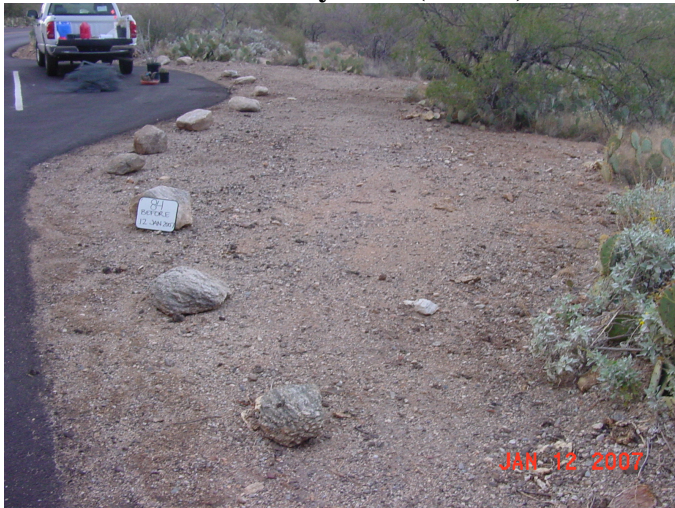
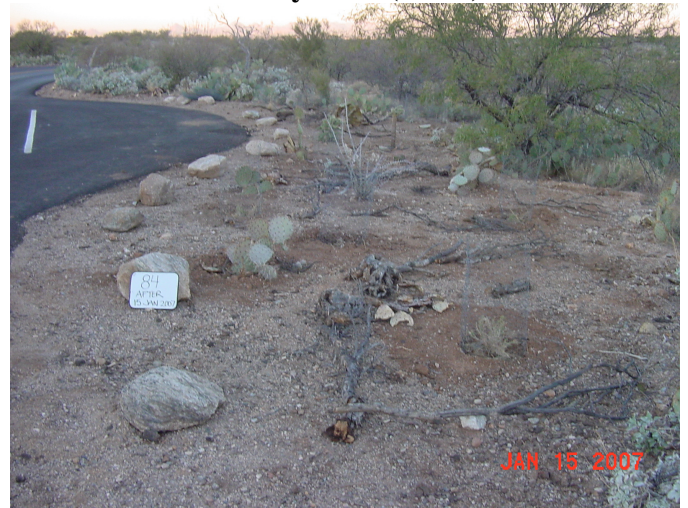
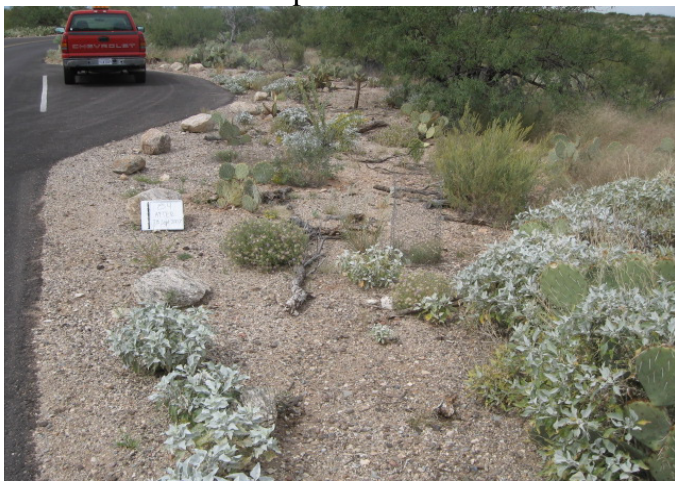
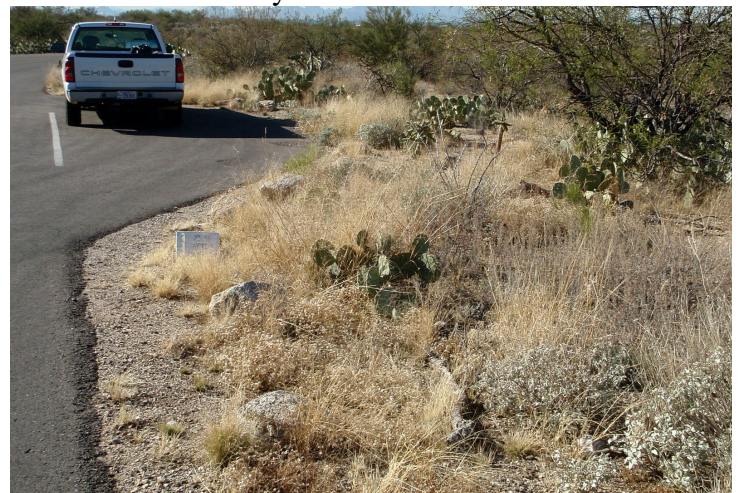
## Site 84

Site 84 experienced a 100% survival rate with all sixteen plants flourishing. The lone tree, a velvet mesquite, is thriving. On top of that, many plants have come up from seed, including several brittlebush (*Encelia farinosa*).

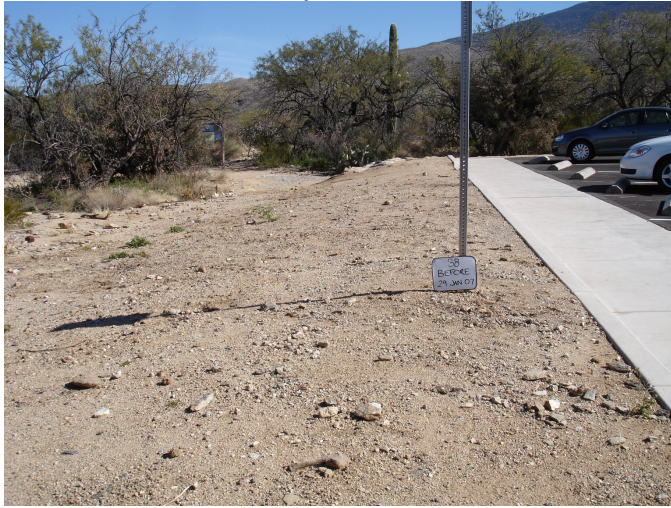
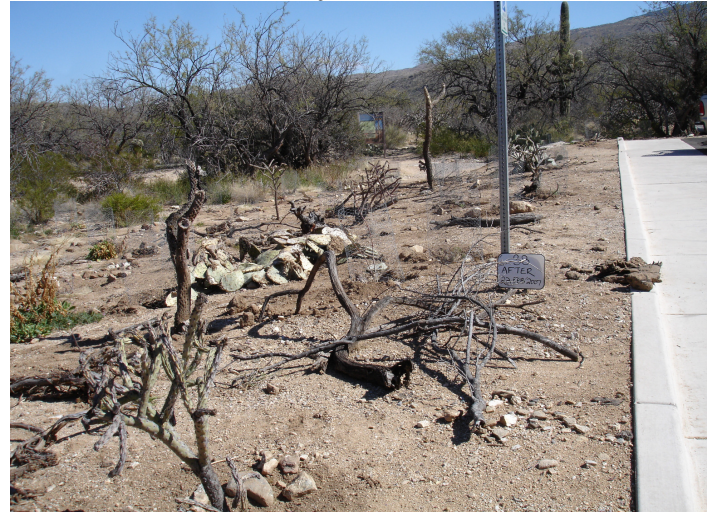
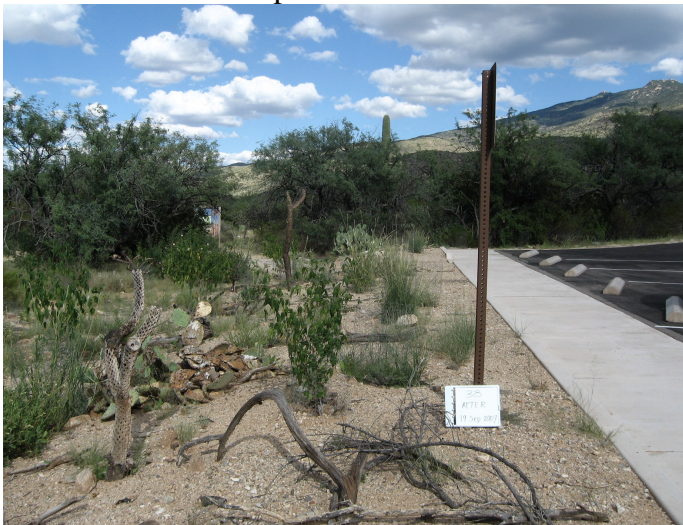
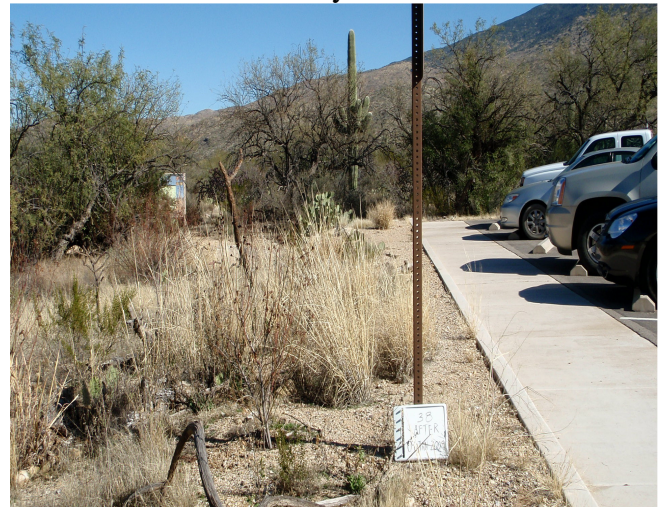
## Site 38 (Loma Verde Trailhead)

The Loma Verde Trailhead is one of the many successes of this project. This site consisted of fairly large area to revegetate. Despite this, it had an excellent survival rate. Out of the forty-eight plants to be monitored, only three did not survive. This is a 93.8% survival rate. The three plants that did not survive consisted of two of the thirteen desert cotton (*Gossypium thurberi*) and one foothills palo verde (*Cercidium microphyllum*). Seven out of the eight trees survived.
