# Proper Functioning Condition Assessment of the Little Bighorn River

*Little Bighorn Battlefield National Monument, Montana*

Natural Resource Report NPS/NRSS/WRD/NRR - 2013/707

August 2013

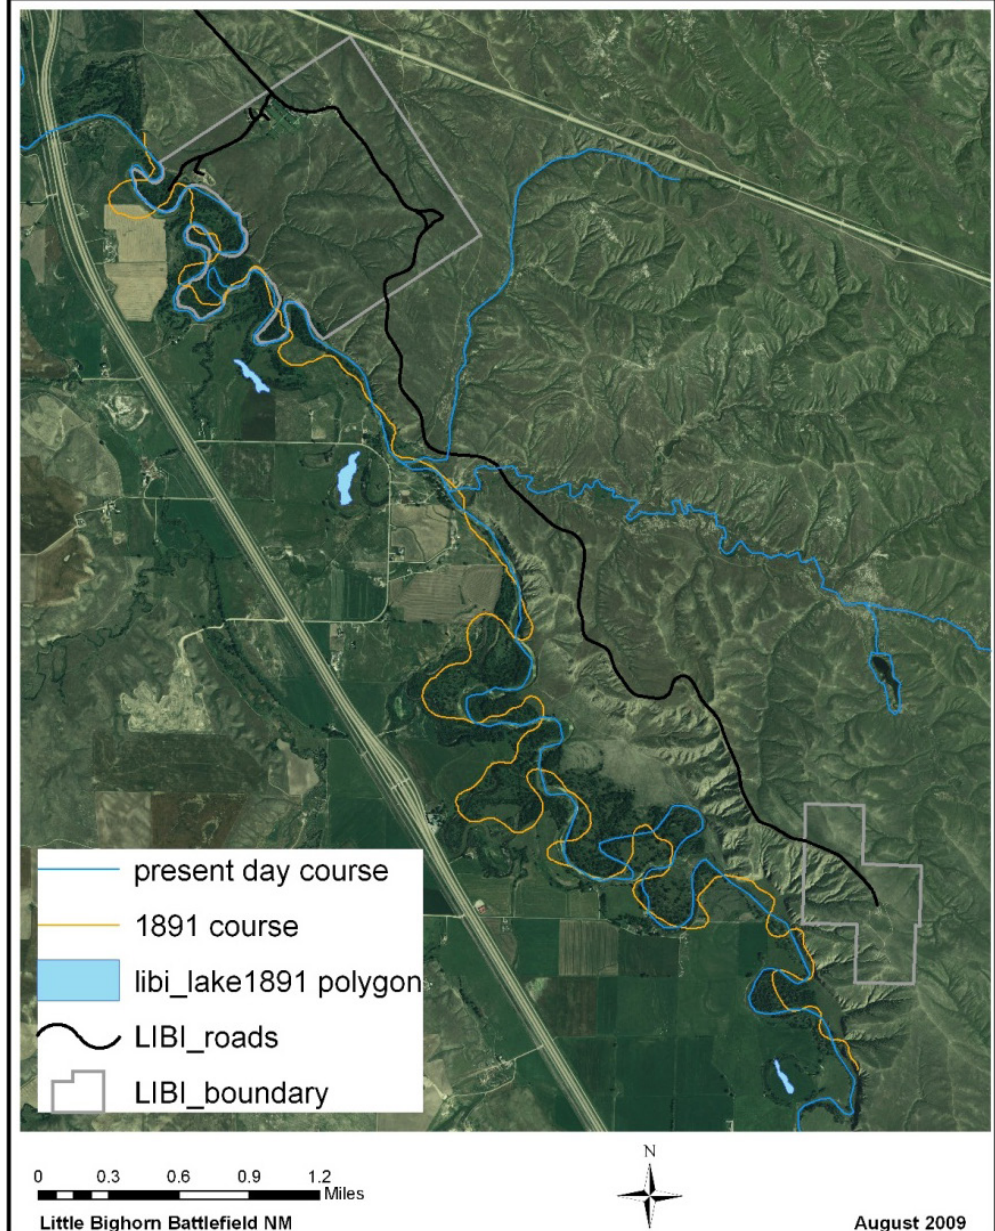
Figure 1. Geographic Information Systems overlay of hand drawn 1891 channel alignment and modern aerial imagery. Note the similar sinuosity of the two channels and the occupation of the same side of the valley.

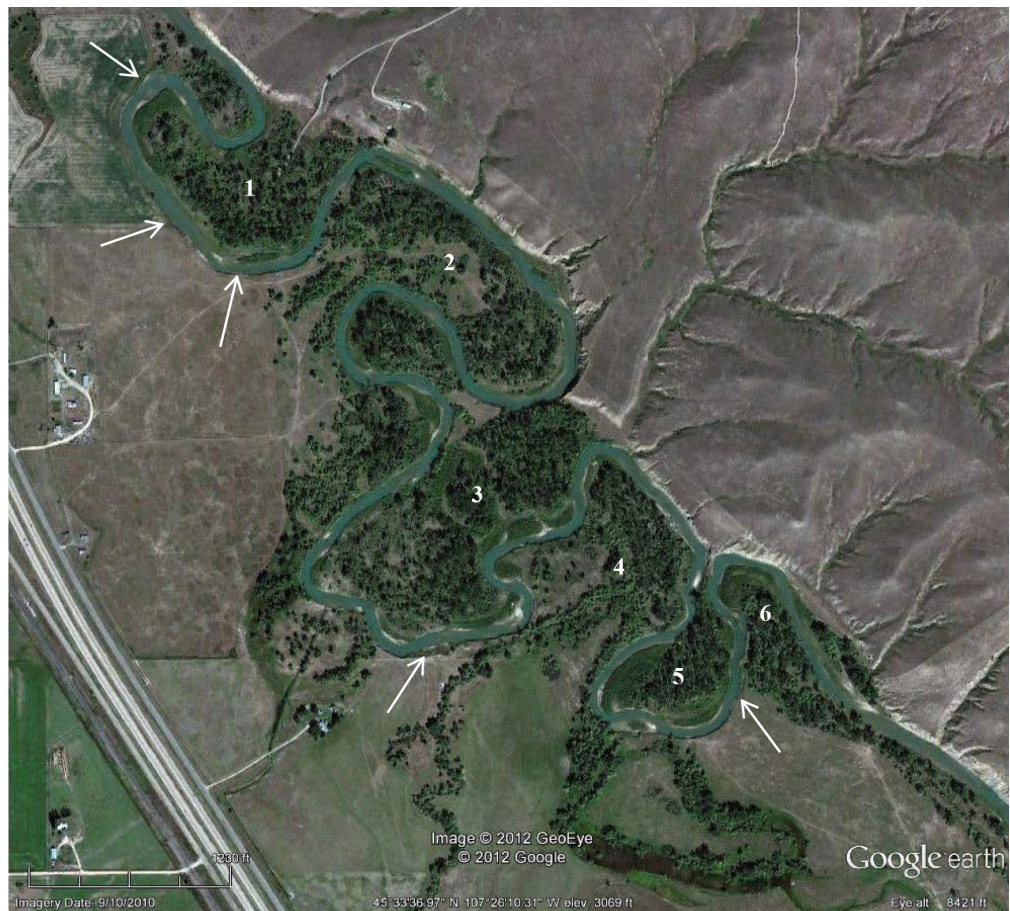
**Figure 2.** Google Earth image of the portion of the LBR that borders LIBI. Note the apparent sinuosity and the evidence of abandoned meanders. Also note the proximity of the high bluff (Judith River Formation) to the northeast demarcated by a distinct white outcrop. Lastly, note the presence of pasture land south and west of the river, continuing up to the active channel in some locations. White numbers represent a meander numbering system used during our assessment. White arrows indicate cutbank sites where bank-stabilizing riparian vegetation is absent.

Based on previous field work at LIBI and examination of aerial imagery of the river and riparian system, there was no obvious reason to separate the LBR into different reaches for individual assessment. Therefore, the entire length of the river within and adjacent to the Monument is covered in the following discussion. This assessment included about 3.5 river miles of the LBR where it borders the Custer Unit of LIBI (Figure 2).

In examining the aerial image of the study area, note the sinuous channel pattern and the evidence of abandoned meanders, as well as the relatively constant channel width (with some variability) along this reach. Meandering rivers of this type generally migrate through their associated floodplains, eroding older terrace and floodplain alluvium at the cutbanks and depositing new alluvium on the point bars (insides of meander bends). Evidence of this process is visible in the image with many of the point bars expressing a different vegetation signature. Ground reconnaissance during the site visit confirmed that many of the point bars are slowly aggrading and support a sequential gradation of riparian vegetation. Additionally, abandoned meanders, cutoff channels and the various terrace levels exemplify natural stream channel evolution in this type of system. These observations led us to

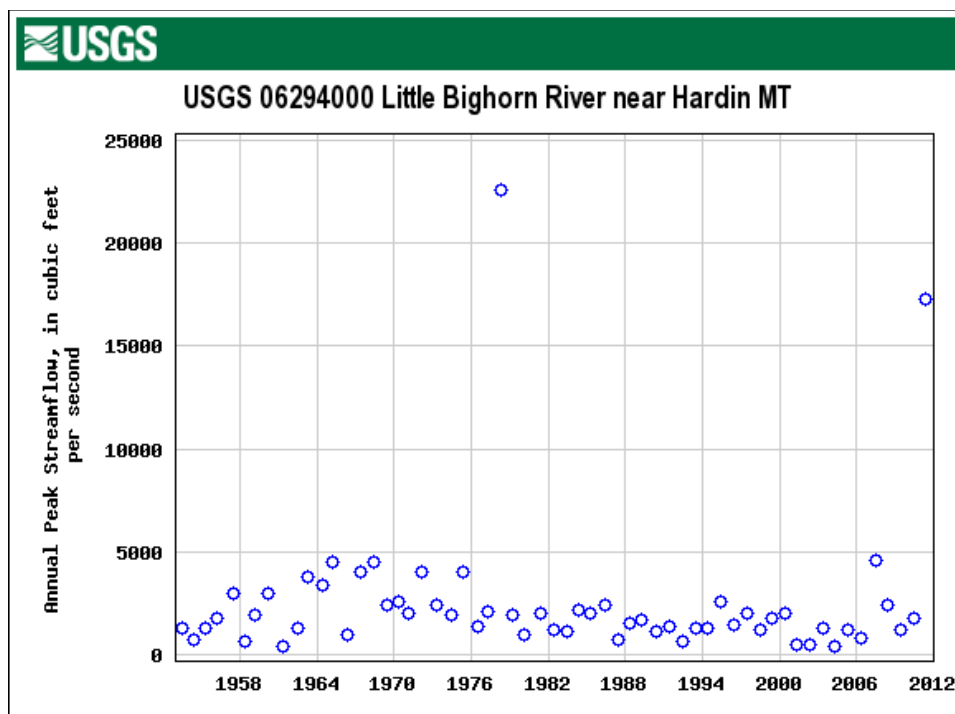
The flood of record for the gage at Hardin occurred on May 19, 1978 with a flow of 22,600 cubic feet per second (cfs). The second largest flood recorded at this gage took place on May 23, 2011,

reaching a peak of 17,300 cfs (**Figure 3**). This spring peak, driven by the melting of a deep snowpack, was a sustained high flow for over a month, and also resulted in the flood of record at the State Line gage with a discharge of 17,600 cfs on June 30, 2011.

The event of 2011 was an extreme flow. The 500-year flood previously calculated by the USGS for the Hardin Gage is reported as 14,600 cfs. Consequently, the 2011 peak flow was in excess of the calculated 500-year flood by about 18 percent. This is a significant occurrence, as a critical element of our riparian condition assessment was to evaluate the stability of the channel and floodplain form under moderate flood conditions. The fact that this reach of the river experienced an approximate 500-year flood a little more than a year before our site visit allowed us to evaluate the degree that the active floodplain and channel responded to an extreme event.

Figure 3. Graph depicting the peak flow record for the gage at Hardin, MT. Note that all peaks from this 59 year record are below 5000 cfs (between the 10- and 25-year floods) except the 1978 and the 2011 flows, which are both in the range of a 500-year flood (USGS, 2012).

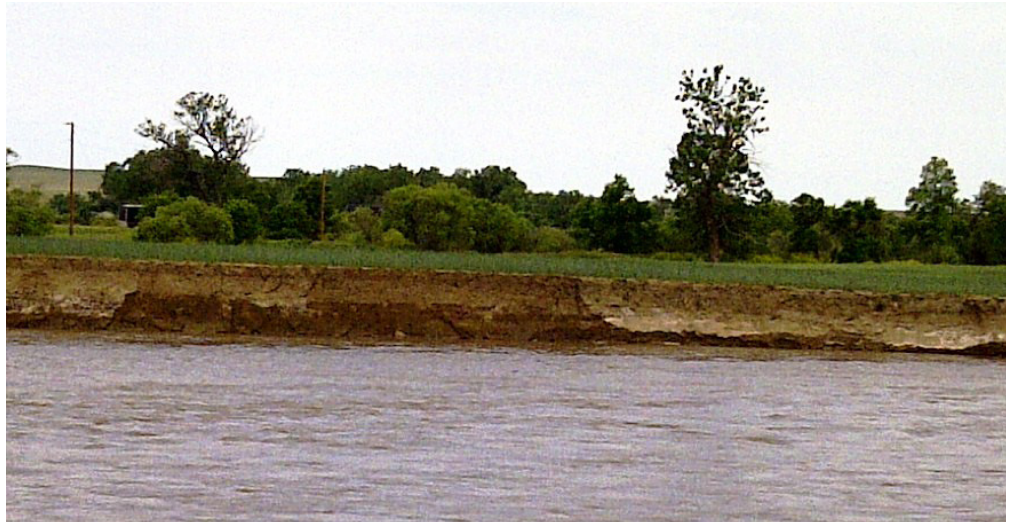
Due to the apparent stable channel morphology present along this reach, particularly the relatively constant channel width, we concluded that the riparian corridor has reached its potential width through most of this reach. Of very notable exception are the segments where the entire left bank floodplain (privately owned) is used for agriculture and the riparian vegetation has been completely removed (Figure 4). Generally, meandering rivers that have lost significant riparian vegetation undergo channel widening and may reach a state of instability. Some channel widening is obvious at isolated locations and examination of satellite imagery suggests that the channel adjacent to these agricultural fields has widened

**Figure 4. Absence of bank-stabilizing riparian vegetation on a cutbank in an agricultural field (meander 1, on private land) increases bank erosion, channel widening, and sediment loading**

somewhat, but no dramatic channel changes were observed. Nevertheless, the complete lack of riparian vegetation, especially the woody species, raises concern of potential instability.

1) Three cutbank sites on adjacent properties with pasture/agricultural land uses (**Figure 2**) are missing most bank-stabilizing riparian vegetation, especially woody species. These sites are eroding into uplands more rapidly and the channel is noticeably wider than at comparable sites in the park with well-developed riparian vegetation, which raises a concern of channel instability. The left bank on meander 6, shown in **Figure 7**, illustrates how cottonwood roots can help stabilize streambank soils against the erosive forces associated with high flows. The reaches lacking riparian vegetation are in private ownership and LIBI has little control over land use practices. However, preservation of a healthy river system should be of interest to all riparian landowners, not only because of ecosystem and other environmental values, but because channel instability would very likely destroy portions of the agricultural fields and pastures. Perhaps there is an opportunity to re-establish a corridor of protective riparian vegetation

3. Overall channel sinuosity, gradient, width/depth ratio and channel/floodplain form are in balance with the landscape setting. There are three locations where cutbanks are migrating into an agricultural field (meander 1 in Figure 2 of this report) or pastures (meanders 3 and 5), with minimal riparian vegetation present to protect banks. Channels appear to be somewhat wider (and presumably shallower) at these locations compared to cutbank locations with riparian vegetation. While of resource management interest, these sites don't threaten the stability of the entire reach.

along these degraded reaches through consultation with local landowners.

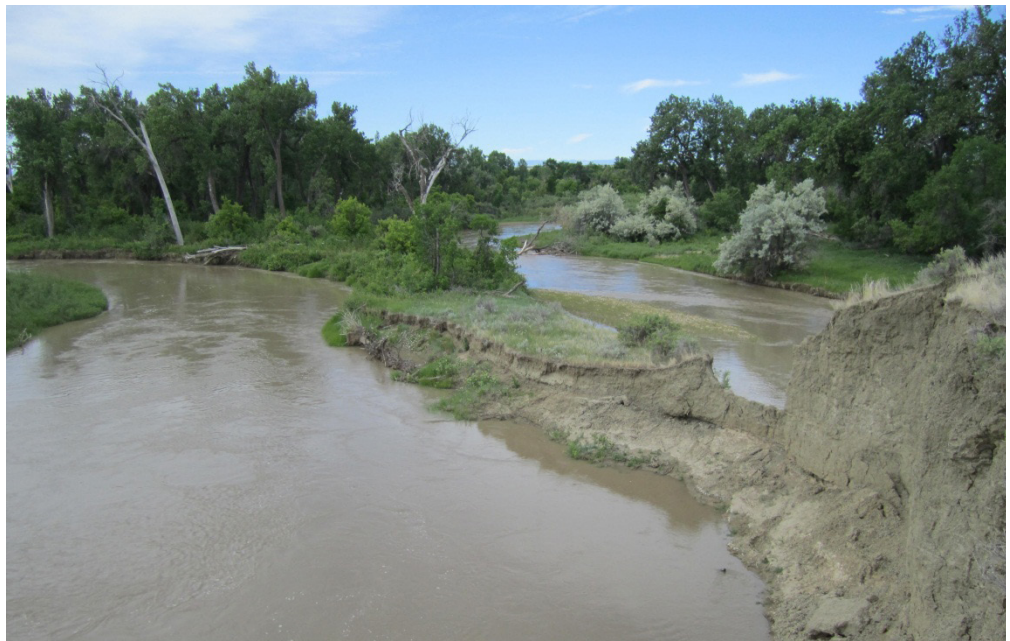
**Figure 5. A very narrow neck of land (center) between meanders 4 and 6 will eventually erode and cause the river to abandon meander 5.**

variety of wetland/riparian vegetation. One such neck cutoff is about to occur between meanders 4 and 6 (**Figure 5**).

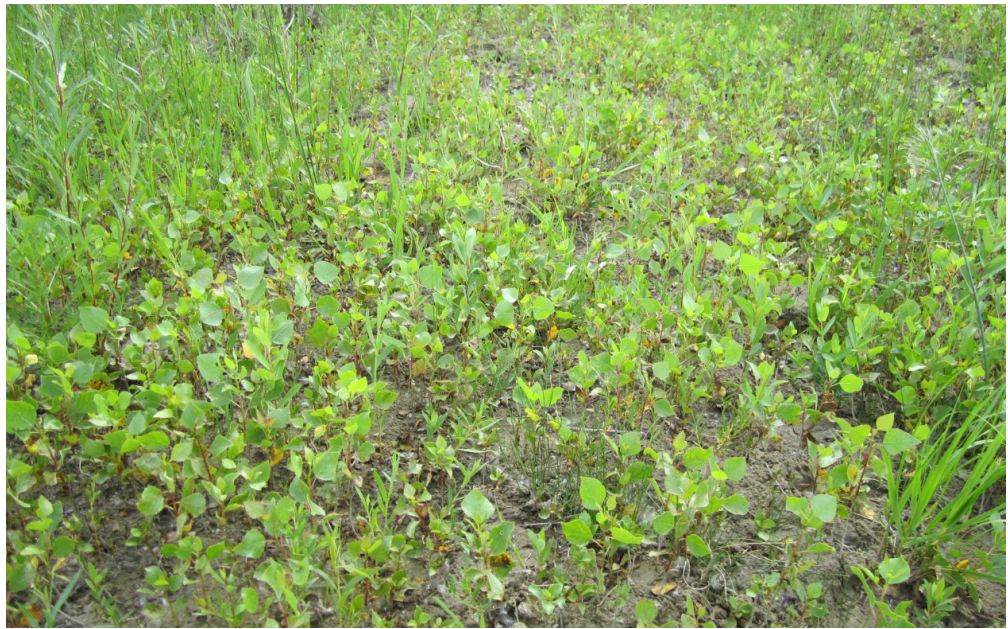
**Figure 6.** Cottonwood seedlings cover large portions of point bars and other active floodplain surfaces, from just below to 3 feet above bankfull stage.

and 2 (Figure 2). However, a few dozen vigorous seedlings and saplings were observed on bars farther upstream. Most notable was the abundance of cottonwood seedlings on virtually all point bars and side channel bars throughout the assessment reach, from just below to 3 feet above bankfull stage (Figure 6). Although seedlings at some locations showed signs of water stress and other low-lying seedlings will not survive high-energy flows from future runoff events, the huge numbers of seedlings over a broad elevation range suggests that a new cottonwood recruitment age class may be establishing, most likely triggered by the 2011 flood.

6. Abundant cottonwood seedlings (*Populus deltoides*) observed on virtually all point bars and side channel bars on a broad range of elevations (just below to 3 feet above bankfull stage). This suggests that a recruitment age class may be establishing. Lack of cottonwood sapling age class noted throughout meanders 1 and 2, though a few dozen large, healthy seedlings/small saplings (0.5 – 5 feet tall) were observed on bars further upstream, 1 - 3 feet above bankfull stage. A few mid-sized (0.3 - 1.3 foot dbh) cottonwoods were observed in an abandoned channel within meander 3. Mature cottonwoods are common on older floodplain surfaces where expected (except where apparently cleared on private land). Sand bar willow (*Salix exigua*) is abundant on most river bars, especially point bars, ranging from seedlings/small shrubs 1 - 3 feet tall to thick stands 6 - 12 feet tall. Peach-leaf willow (*S. amygdaloides*) is not nearly as common as sand bar willow, but is scattered on bars throughout the reach as young shrubs/trees.

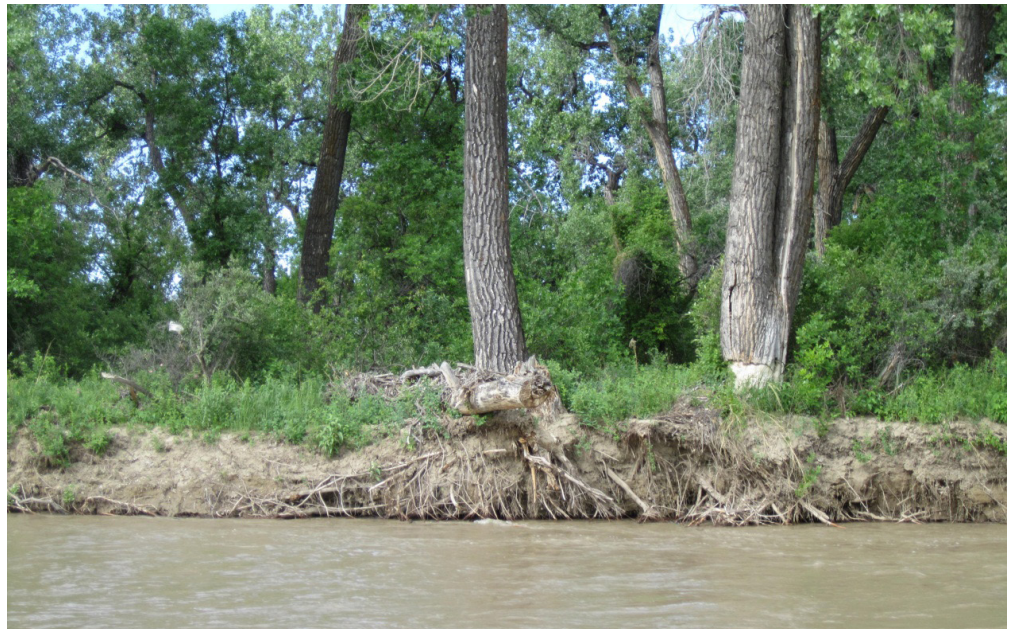
**Figure 7. Cottonwood roots help bind streambank soils and slow the cutting action of high energy flows.**
