# **Canoa Ranch at the Santa Cruz River Photo Monitoring**

**Neva Connolly  
Pima County Office of Conservation Science  
March 29, 2011**

Report by Neva Connolly, Frank Postillion, and Julia Fonseca

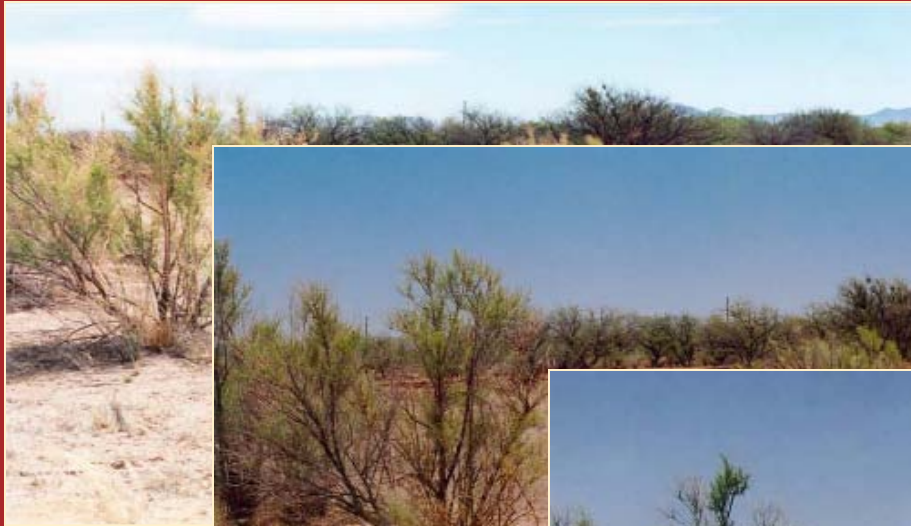
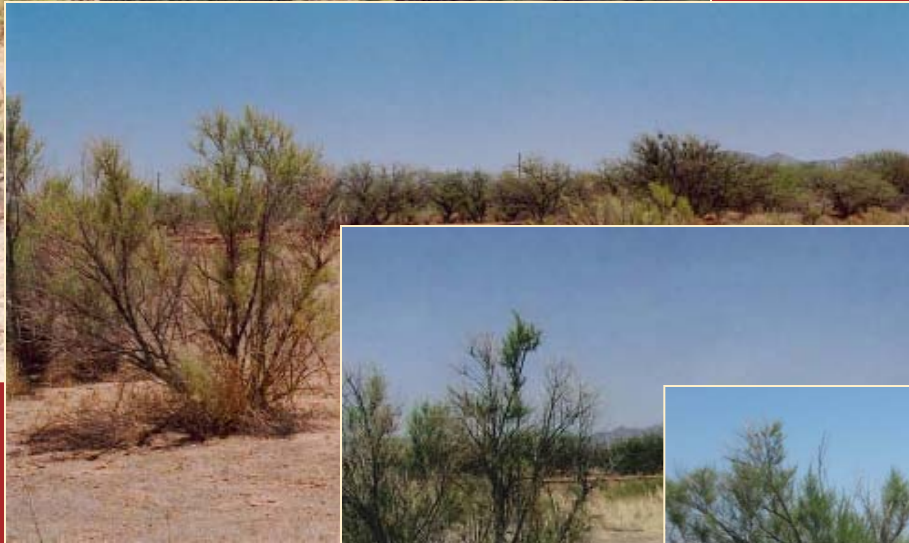
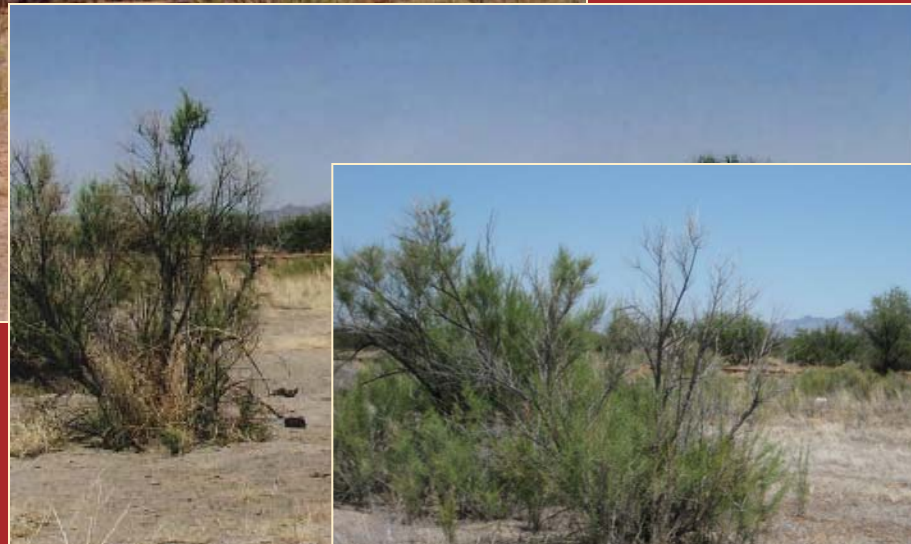
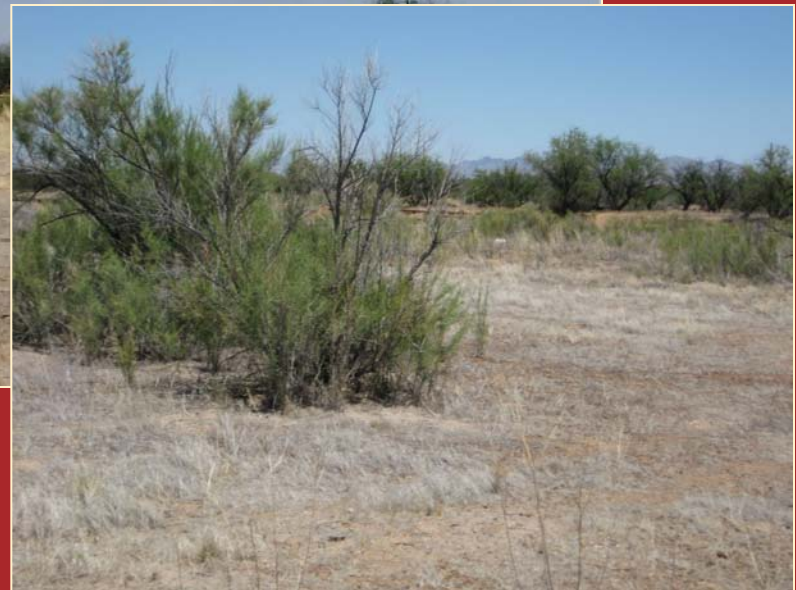
Photo Point 10 East

# No major change

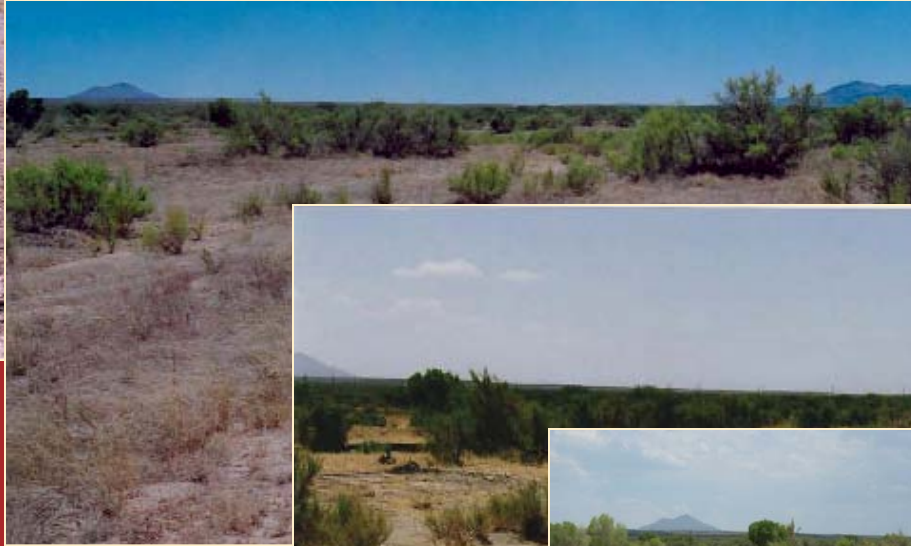
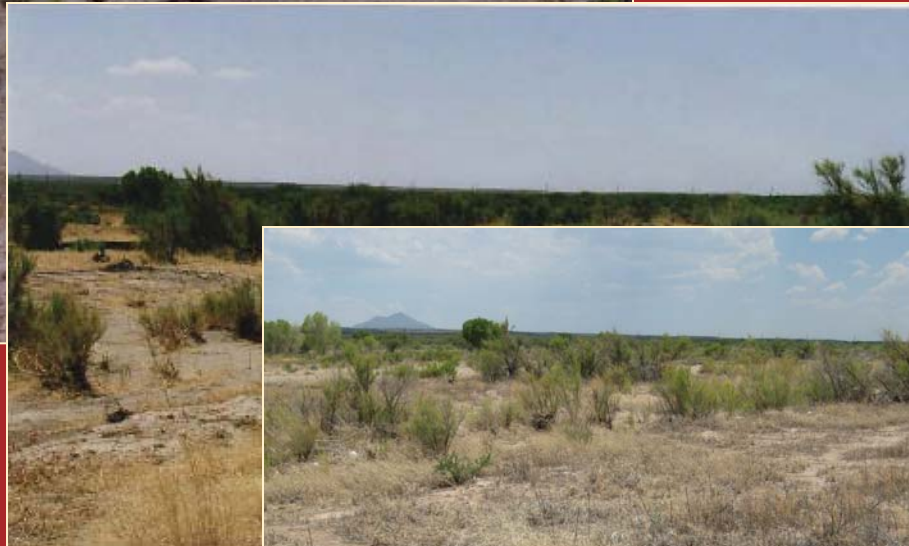
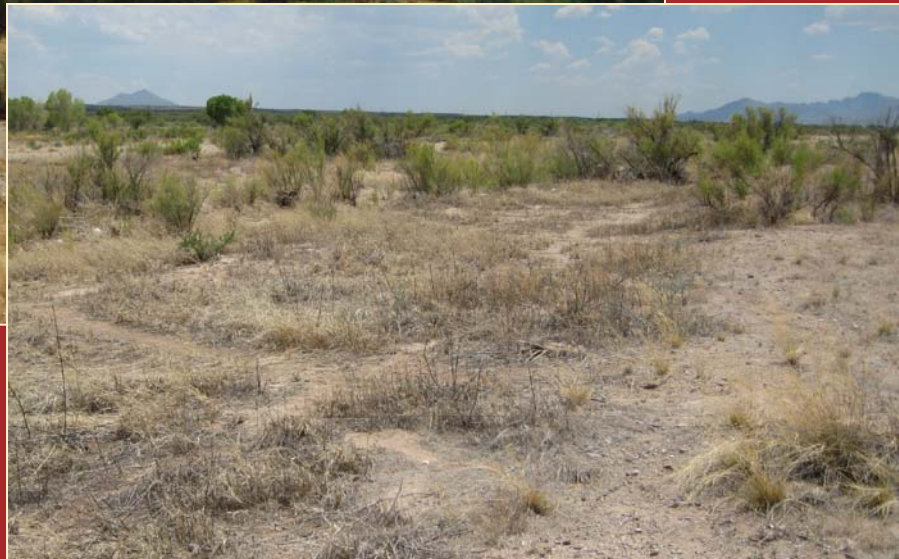
Photo Point 4 South

# Increase in channel vegetation

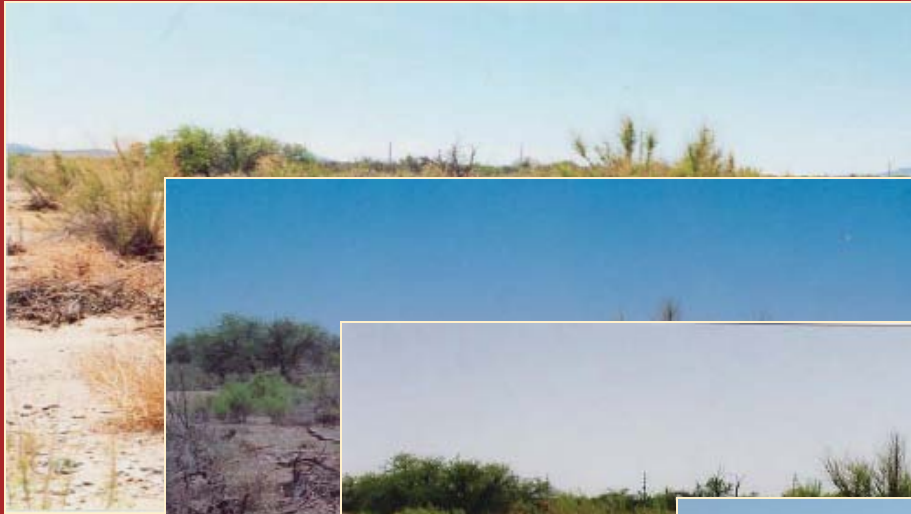
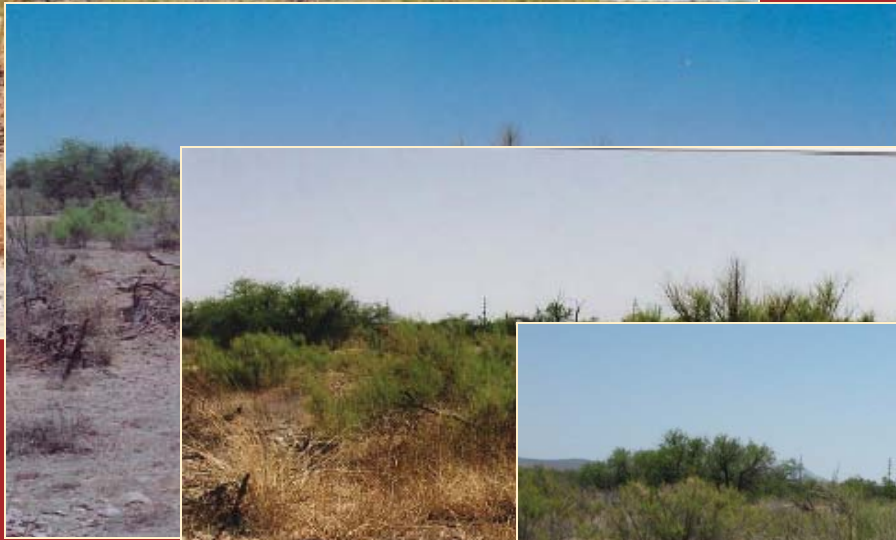
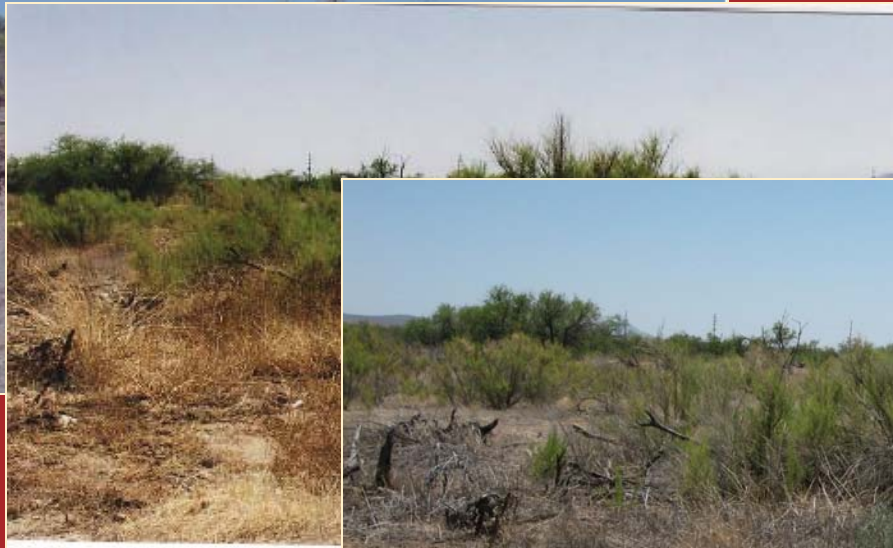
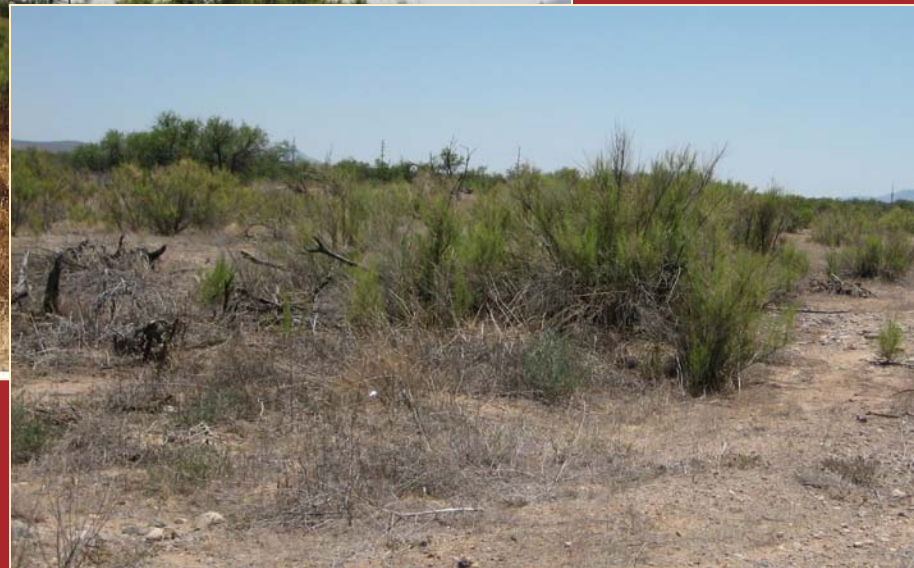
Photo Point 11 South

# Increase in channel vegetation

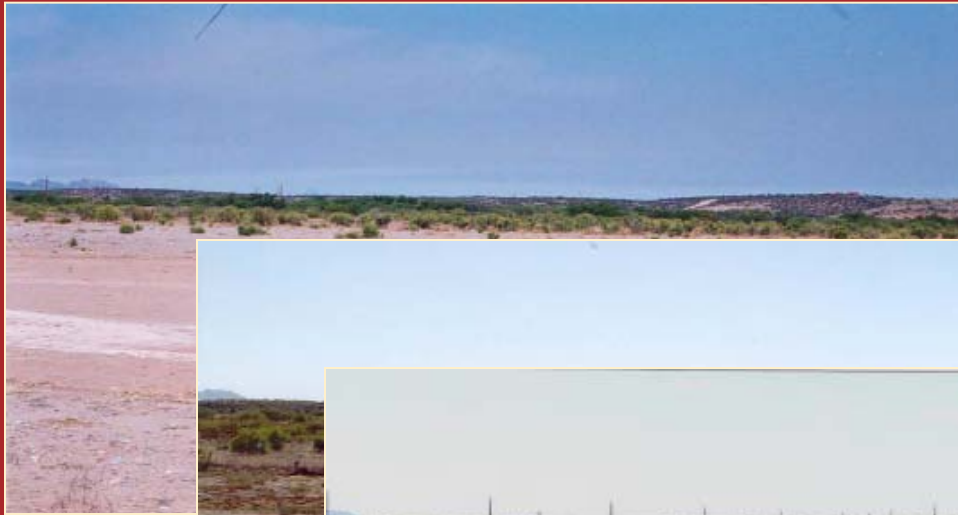
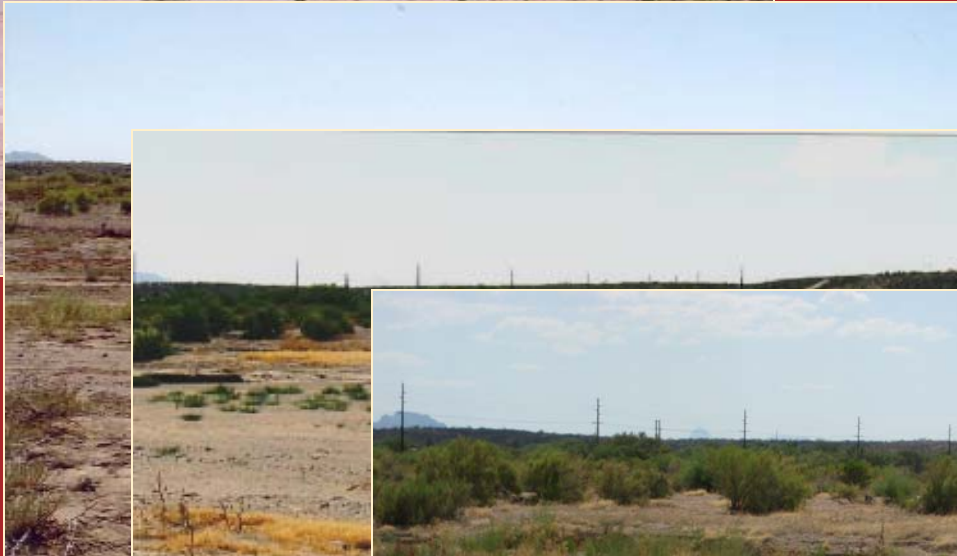
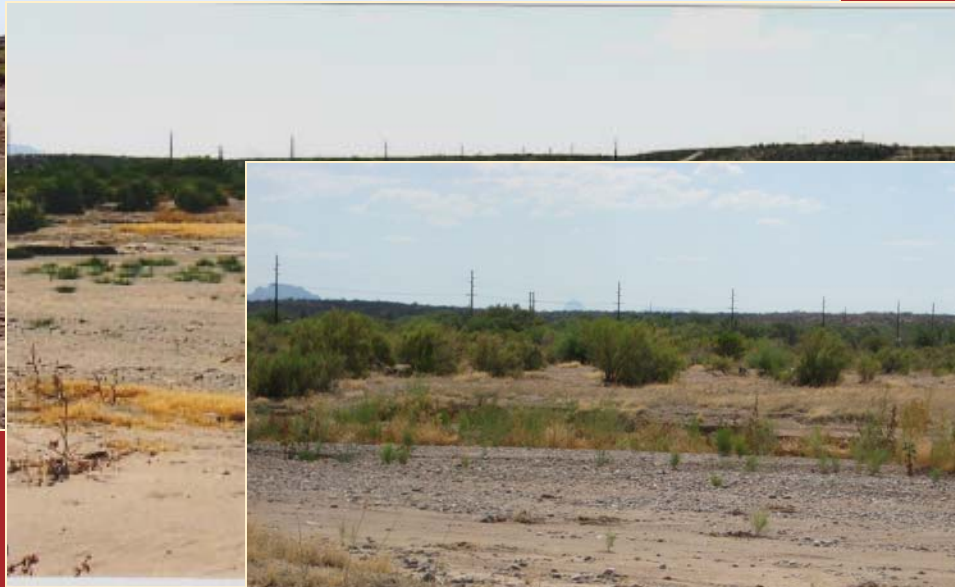
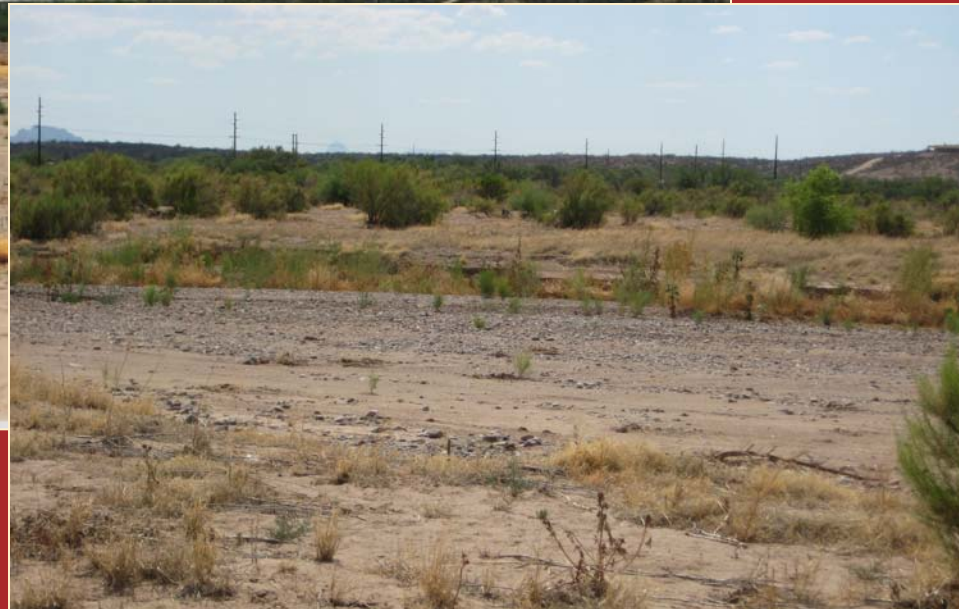
Photo Point 1 West

# Increase in channel roughness

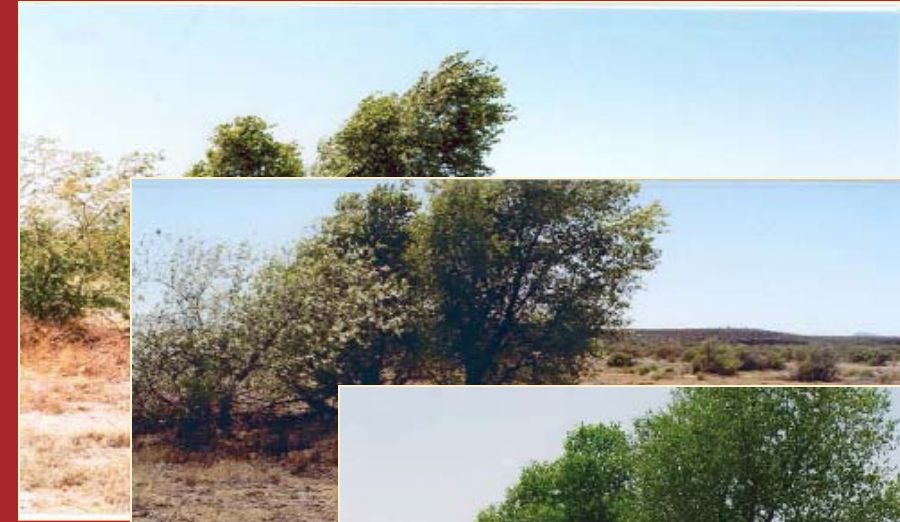
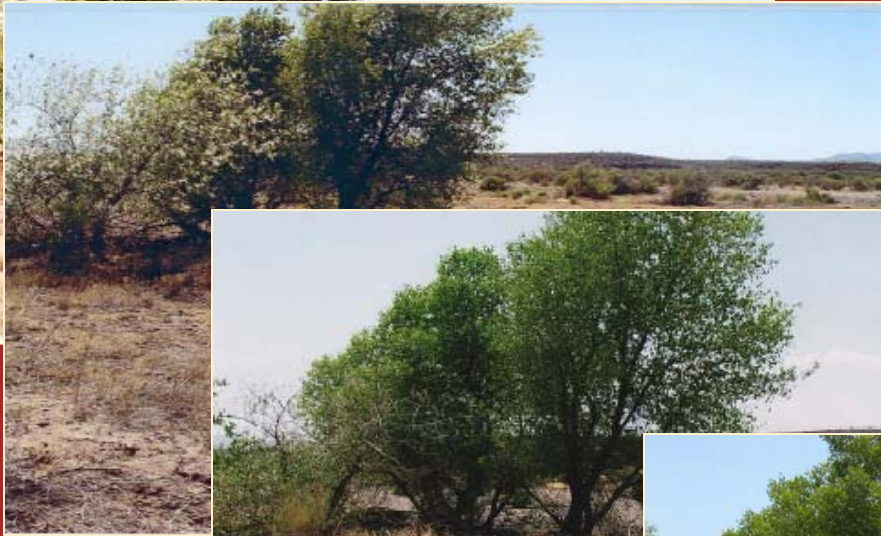
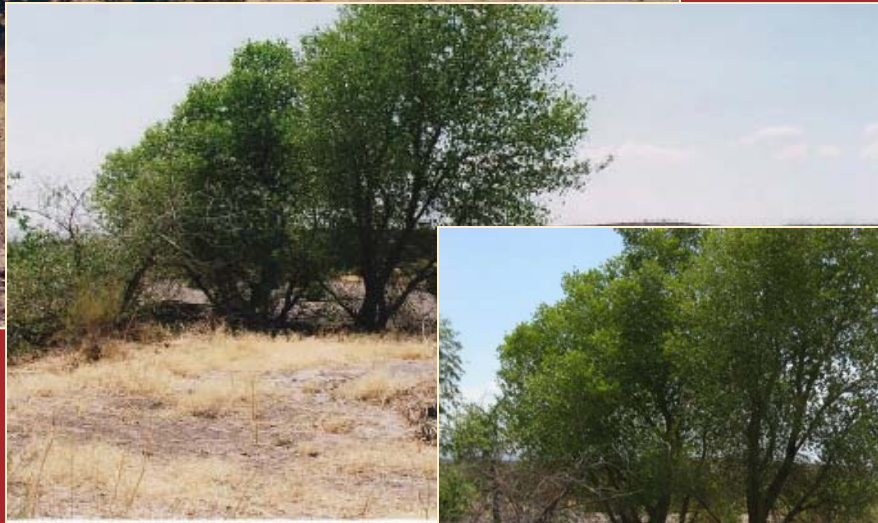
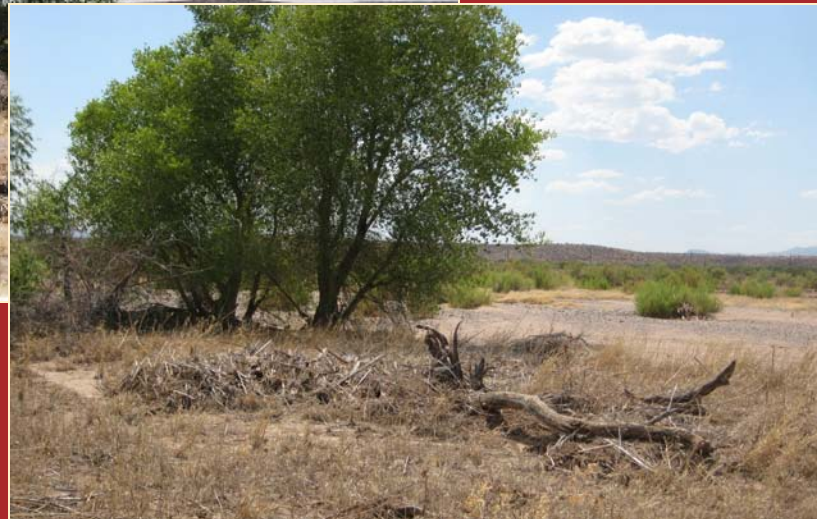
Photo Point 14 West

# Increase in vigor

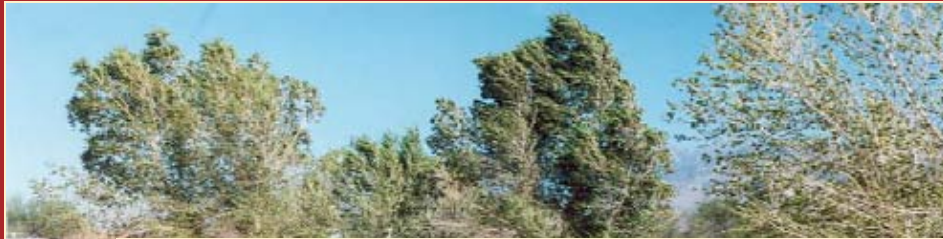
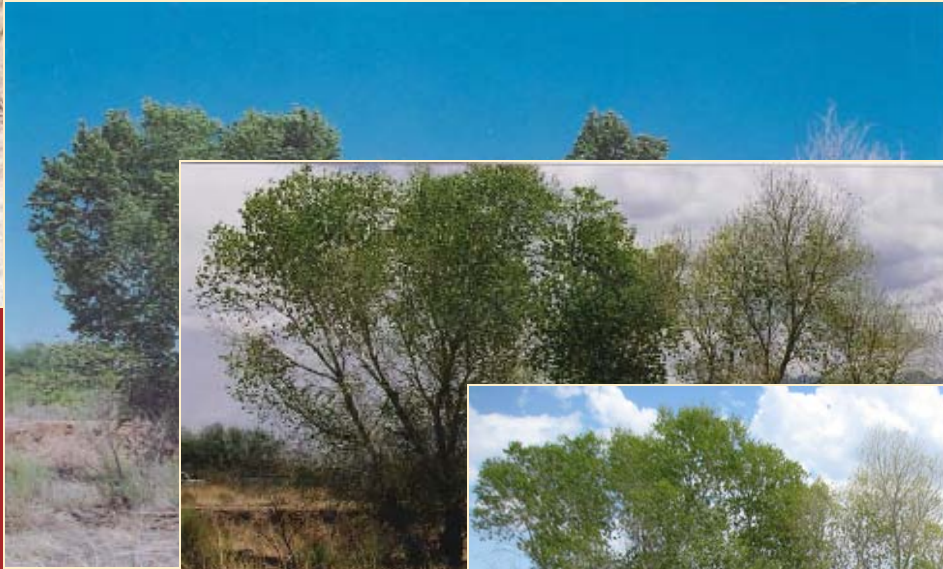
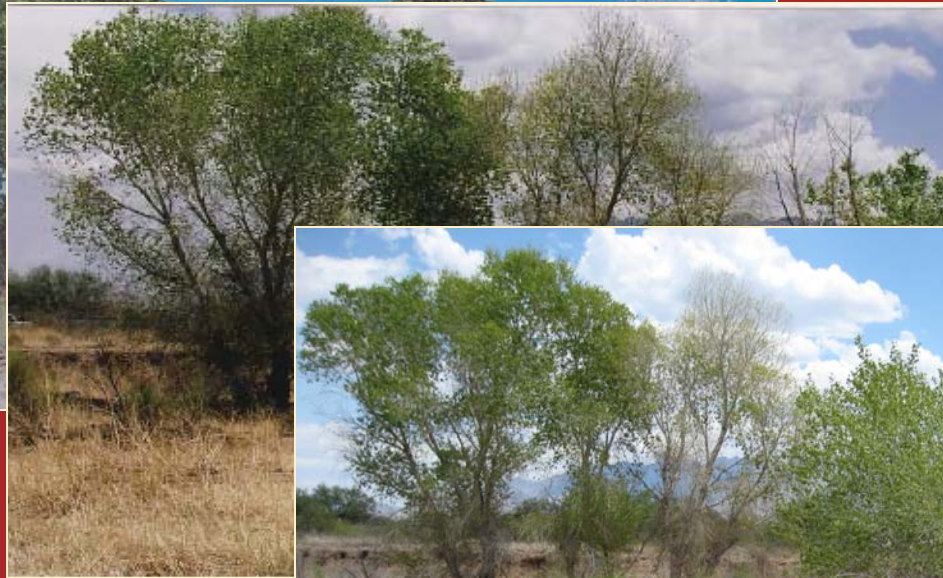
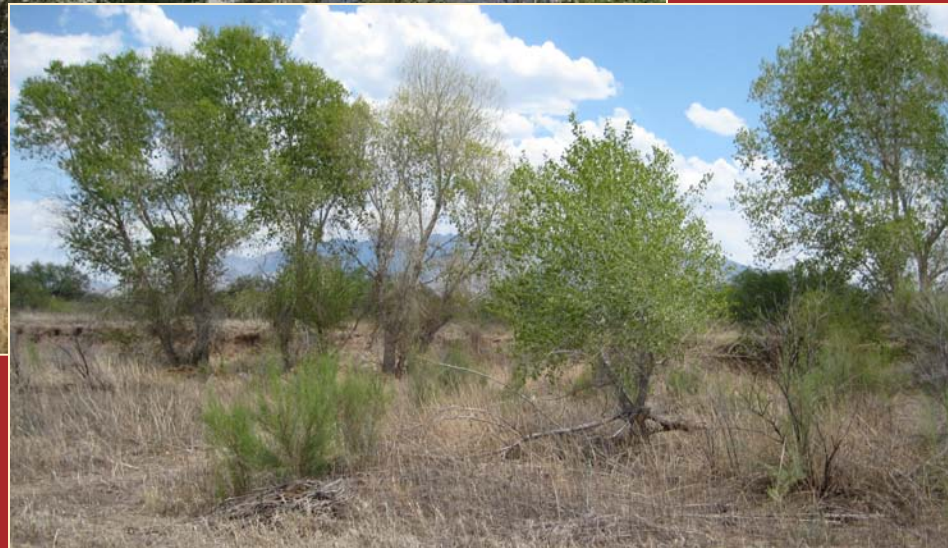
Photo Point 16 East

# Loss of vigor

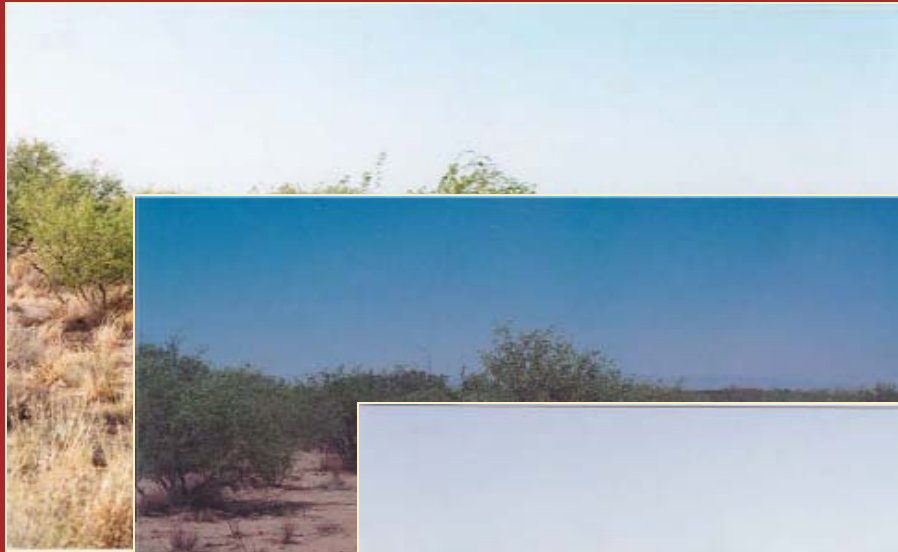
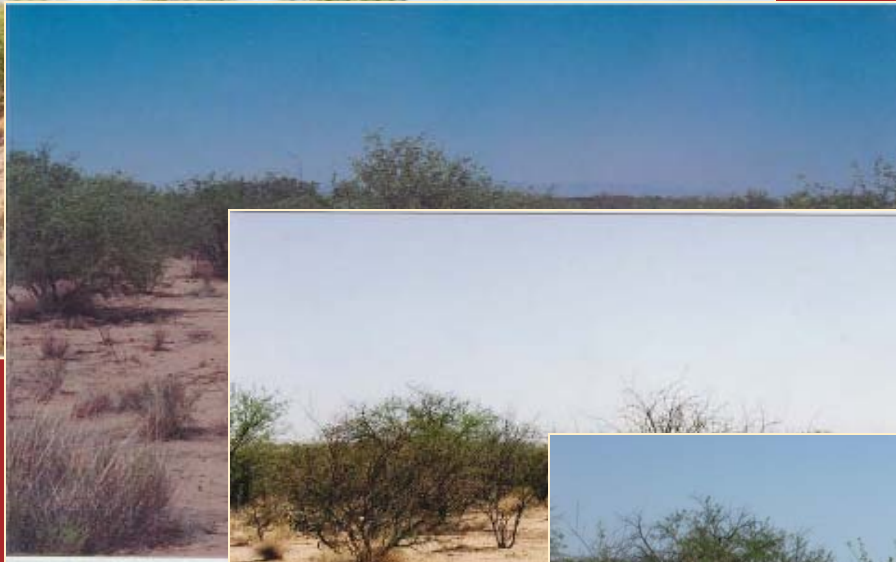
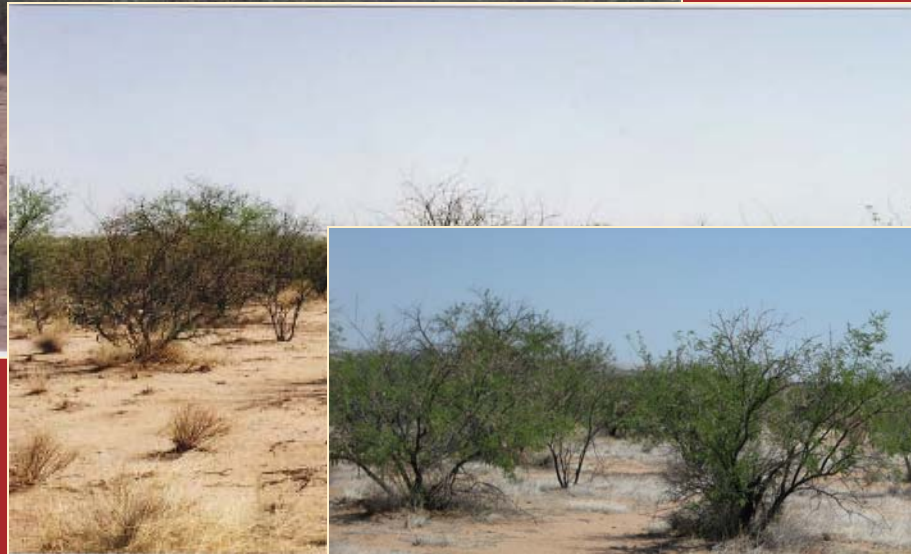
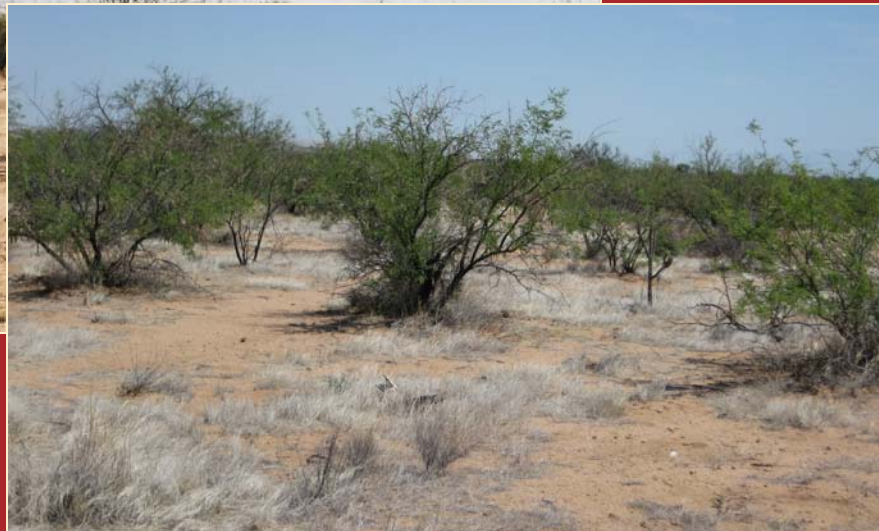
Photo Point 19 North

# Loss of vigor
