# Monitoring of Wadeable Streams

## A Flood of Changes: East Fork Virgin River, Zion National Park

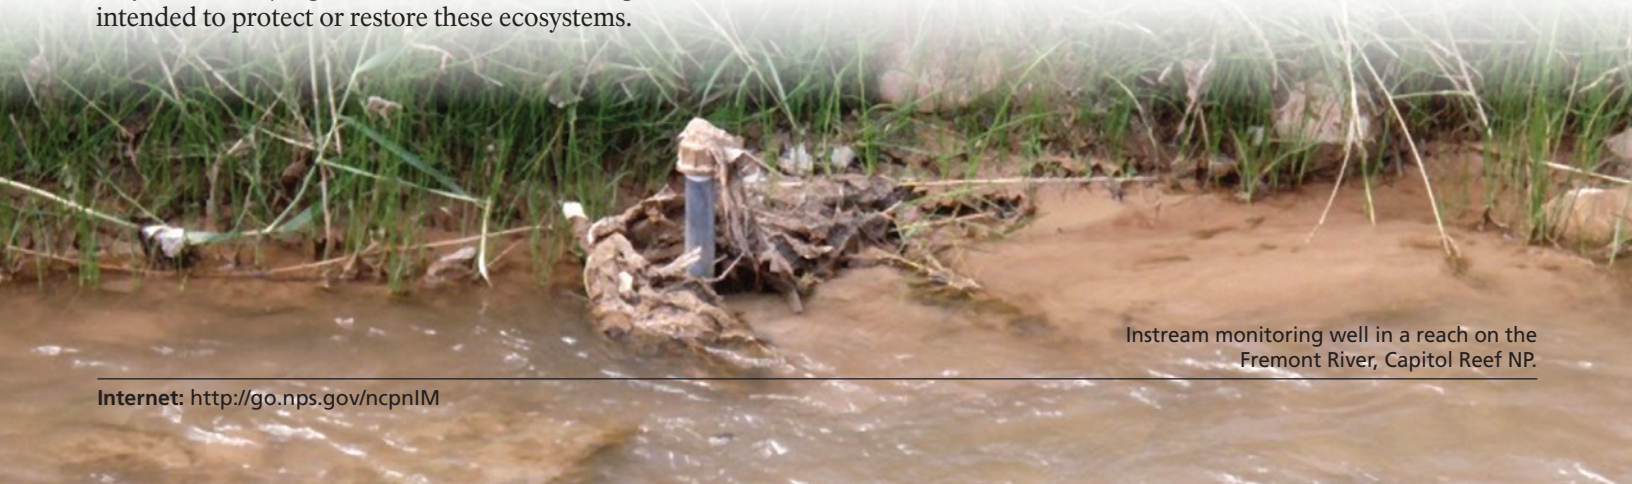
Instream monitoring well in a reach on the  
Fremont River, Capitol Reef NP.

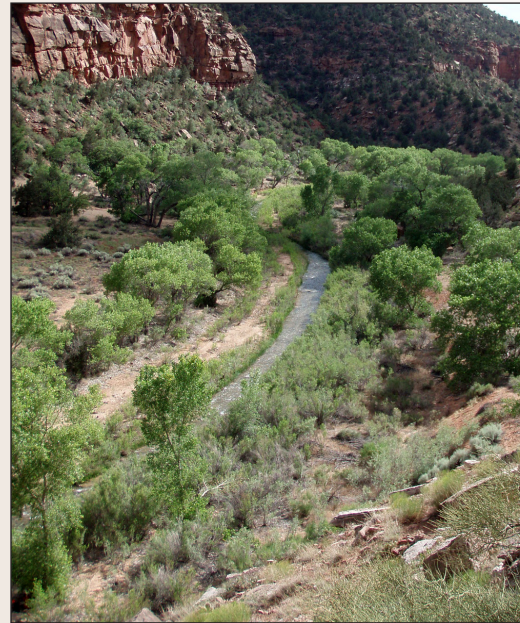
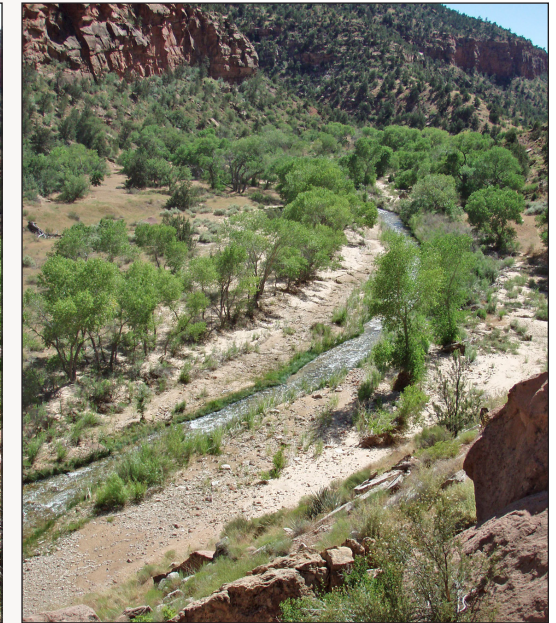
Our surveys of Reach 1 revealed that the flood left substantial deposition on the terrace closest to the floodplain (the “modern terrace” in the figure below). To the degree that response to a single flood event can indicate a pattern, our data show that the East Fork Virgin River is currently in a cycle of deposition, which tends to occur during drier periods. Data from regional weather stations also indicate a general increase in average annual minimum temperature over the past 30–50 years for Zion NP. Increased temperature can affect the water balance of watersheds by increasing evaporation of soil moisture and transpiration by vegetation. After the flood, the channel also became wider and shallower at Reach 1 (see figure), and remained this way for over a year afterward. Changes detected at Reach 3 suggest that this reach experienced changes similar to those seen at Reach 1.

East Fork Virgin River in Parunuweap Canyon near reach 2, Zion National Park, August 2008 (left) and July 2011 (right).

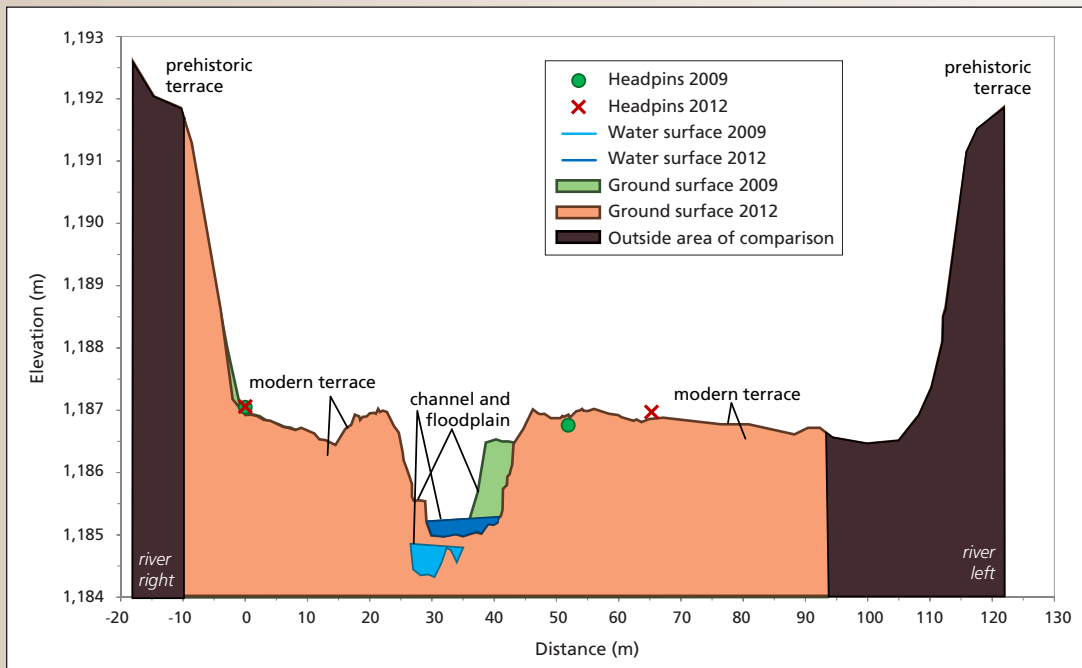
Cross-section of reach 1, transect 2, East Fork Virgin River, showing morphological changes between 2009 and 2012.
