# Riparian Condition Assessment for the Pawnee River (Version 2.0)

*Fort Larned National Historic Site, Kansas*

Natural Resource Report NPS/NRSS/WRD/NRR—2016/1246

July 2016

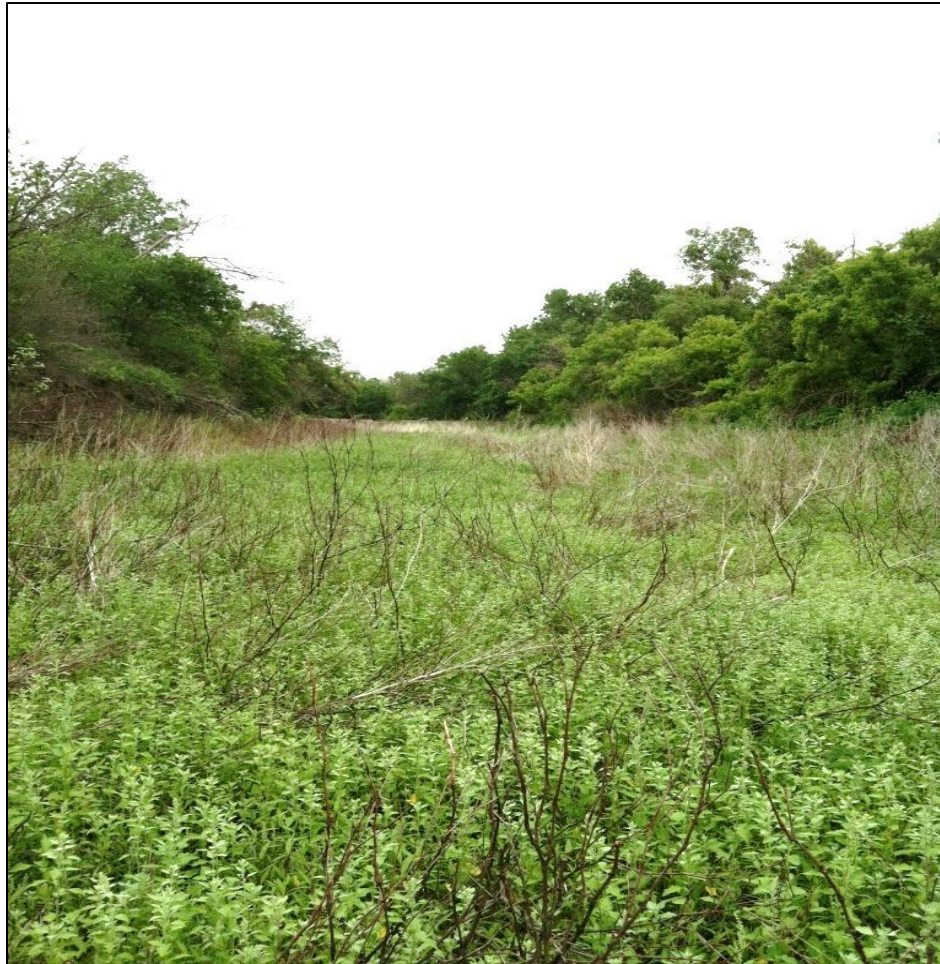
The river is alluvial, which means that its bed and banks are composed of sediment recently transported (in a geologic sense) by the watercourse. This sediment is mostly fine-grained sand with some silts and clays (Fishel, 1953). The channel itself is deeply incised into the landscape, varying in depth from about 15 to 25 feet below the valley surface. Top width, the distance between the tops of the banks, ranges from about 100 to 200 feet. The overall shape of the channel is somewhat trapezoidal with steep banks and a broad, relatively flat bottom about 50 to 80 feet wide (Figure 2).

**Figure 2.** A typical view of the Pawnee River channel at FOLS (NPS, 2013).

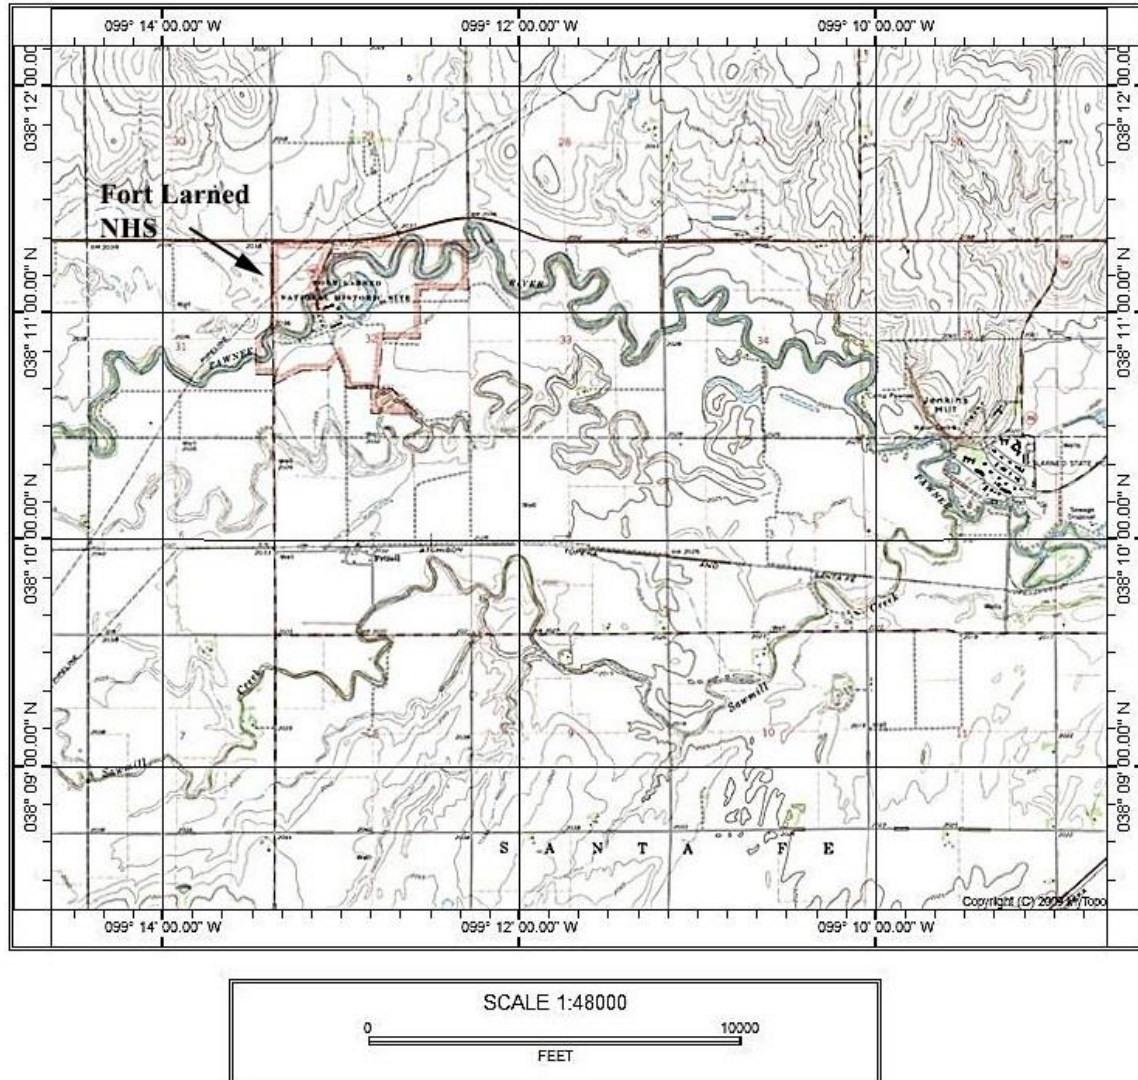
The portion of the river within FOLS is about 2.5 river-miles long and includes about five prominent meander loops (Figure 3). Additionally, there is at least one relatively recently abandoned meander bend adjacent to the active channel and an oxbow just east of the Fort grounds (Figure 4). Numerous remnant meander scrolls exist about 200 to 500 feet south of the current channel (Figure 3). Based on their position and sinuosity, these abandoned channel features appear to be a former alignment of the Pawnee River.

**Figure 3.** Topographic overview of the Pawnee River Valley and some of the adjacent uplands. Note the remnant meander scrolls just south of the present-day Pawnee River channel. Also note the prominent tributary, Sawmill Creek, along the southern margin of the Pawnee River Valley. Image acquired from USGS quadrangle, Fort Larned, Kansas (1970).

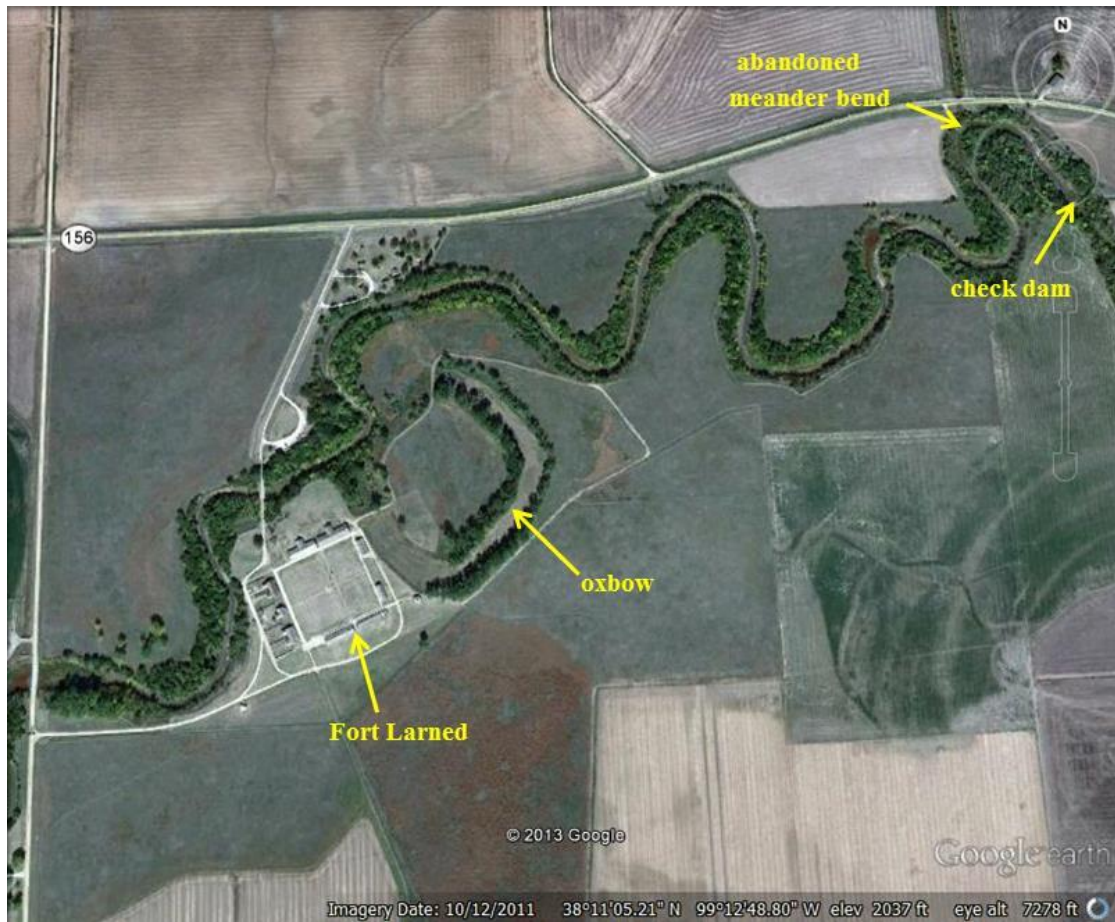
**Figure 4.** Google Earth image of the Pawnee River at FOLS. Note the prominent oxbow near the center of the image and the continuous lines of riparian vegetation along both sides of the channel and oxbow.

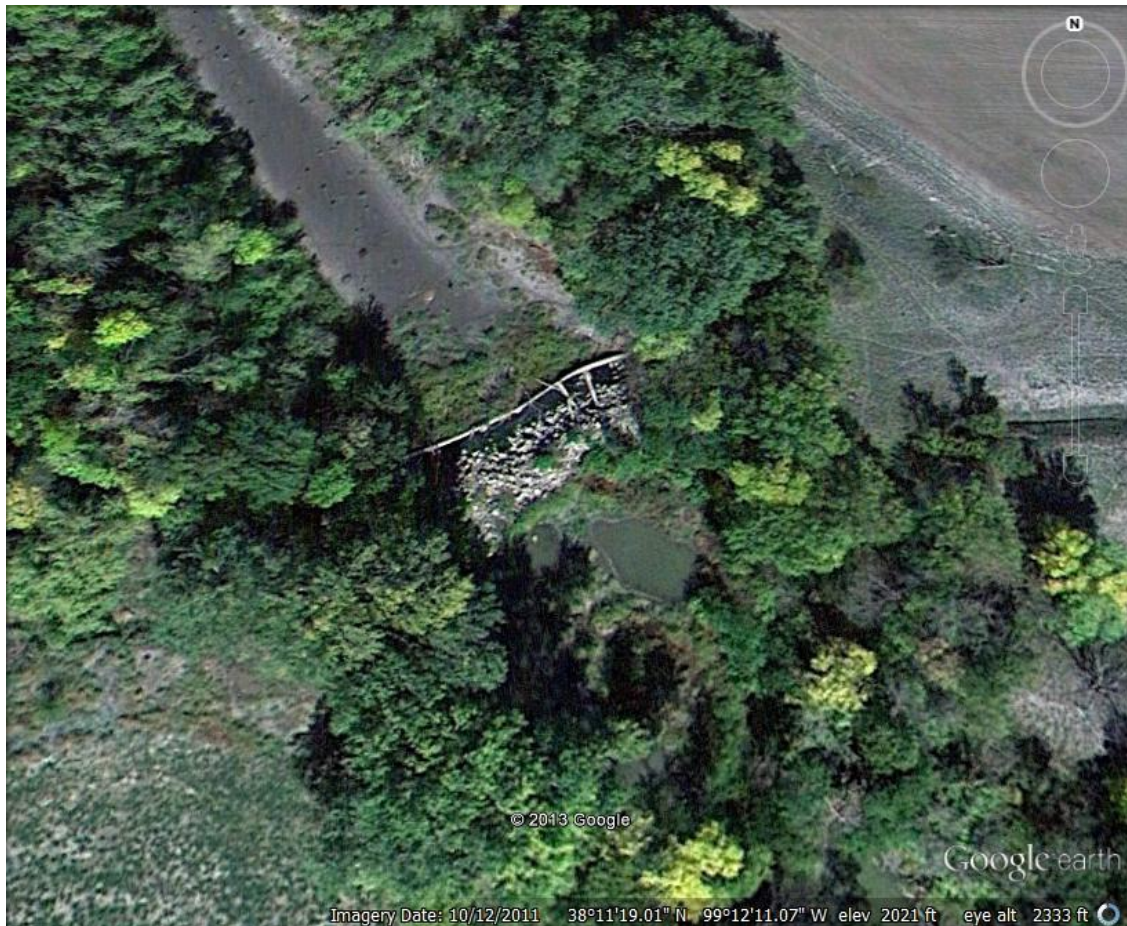
At some time in the early 20th century, a large concrete check dam was installed about 500 feet downstream from the current park boundary (Figure 4). This dam is about 15 feet high and completely spans the channel (Figures 5 and 6). Its presence has had a dramatic effect on the gradient and elevation of the river channel as well as on channel forming processes. The apparent purpose of the structure was grade control, as there are no appurtenant features associated with the dam. No type of spillway is present and there is no indication that the structure was ever used to capture and redirect water for irrigation. Therefore, it was most likely placed to arrest channel incision and retain sediment, rebuilding the grade of the channel. Currently, there is about 10 feet of sediment and debris that has accumulated on the upstream side of the dam (Figure 6), and this “wedge” of sediment continues upstream through the entire park reach. There is still about six feet of freeboard on the check dam, so some sediment that enters the river upstream will probably be retained and the aggradation will continue.

**Figure 5.** Oblique aerial Google Earth image of the check dam that spans the channel of the Pawnee River about 500 feet downstream of the park boundary. Note the pool of open water downstream of the dam, which suggests a connection to the local water table at that elevation.

Controlled dam removal with careful management of the accumulated sediment and re-establishment of a natural river grade through FOLS is probably the only possible means of restoring a more functional riparian system along this reach. Despite the regional decline in the water table and an apparent reduction in flow frequencies and magnitudes over the last few decades, we observed ponds in the channel immediately downstream of the dam (Figure 6). USGS records from the Pawnee River gage at Rozel show zero flow for more than 2 months prior to our assessment, so these ponds may be surface expressions of local groundwater conditions and evidence of a direct connection between the channel and the water table at this lower bed elevation. Therefore, reestablishment of the natural grade of the channel bed within FOLS could potentially restore at least some connectivity between the channel and the water table, perhaps enough to support perennial riparian-wetland vegetation.

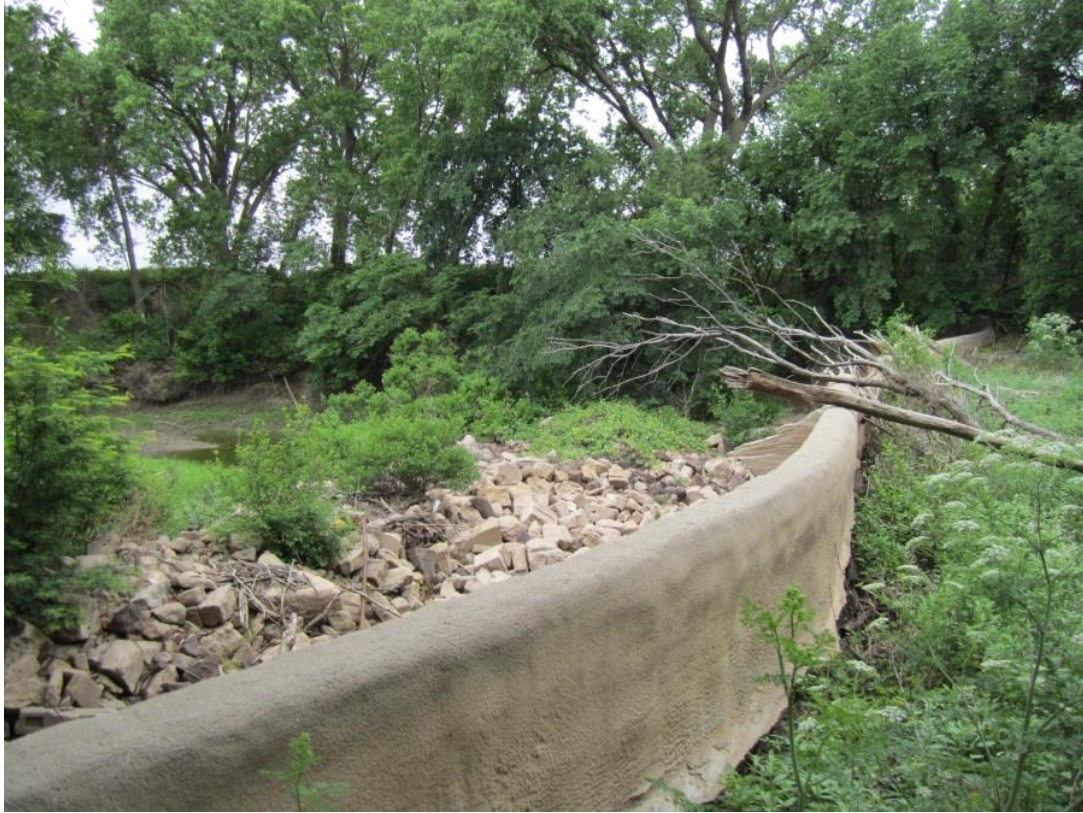
In addition to the water table decline, the channel has aggraded about 10 feet above its base level due to a concrete check dam just downstream of the park boundary. The sediment that has deposited upstream of the dam since it was constructed exacerbates the problem of disconnection between the channel and the water table. The most dramatic effect of this disconnection is the almost complete lack of perennial riparian-wetland vegetation in the channel bed and on its lower banks.

**Figure 6.** Concrete check dam located just downstream from FOLS. Note the height of the riverbed on the right (upstream) side of the dam due to sediment accumulation compared to the downstream riverbed height on the left (bed elevation difference of approximately 10 feet). Also note the presence of surface water in the riverbed on the downstream side, possibly indicating a connection between the channel and the water table there.

The downstream check dam has held the riparian ecosystem at FOLS in an artificially stable, very early successional state. If the structure were to fail catastrophically, the Pawnee River at FOLS would undergo dramatic incision and a great deal of sediment would likely be released into downstream aquatic habitats. A significant lowering of the channel bed would pose an immediate threat to bridge pier foundations and buried utilities. Significant bed lowering would also increase bank height and bank instability, which may trigger channel widening and further threaten infrastructure at FOLS.

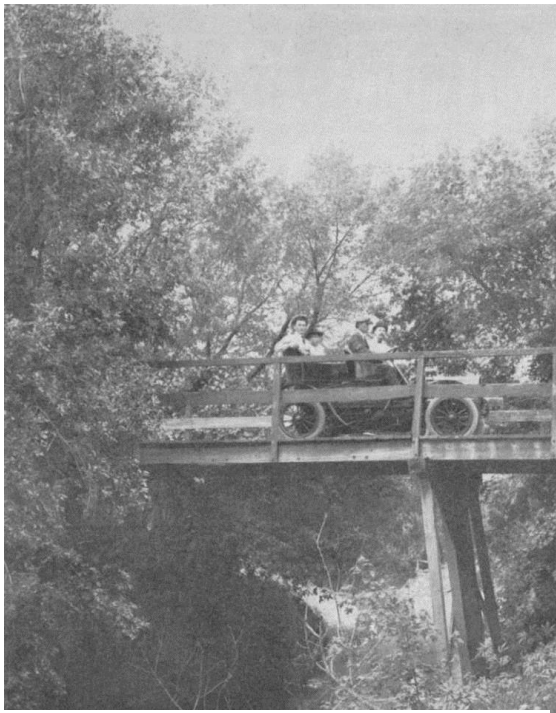
Fort Larned was purposefully sited along the banks of the Pawnee River, indicating that its current alignment existed in the mid-1800's. We know that the channel was at least somewhat incised at that time because a photo of the Fort Larned Army Bridge, which was built soon after the Fort's establishment, shows a relatively deep channel (Figure 7).

**Figure 7.** Photo of first army bridge built in 1868 across the Pawnee River at FOLS.

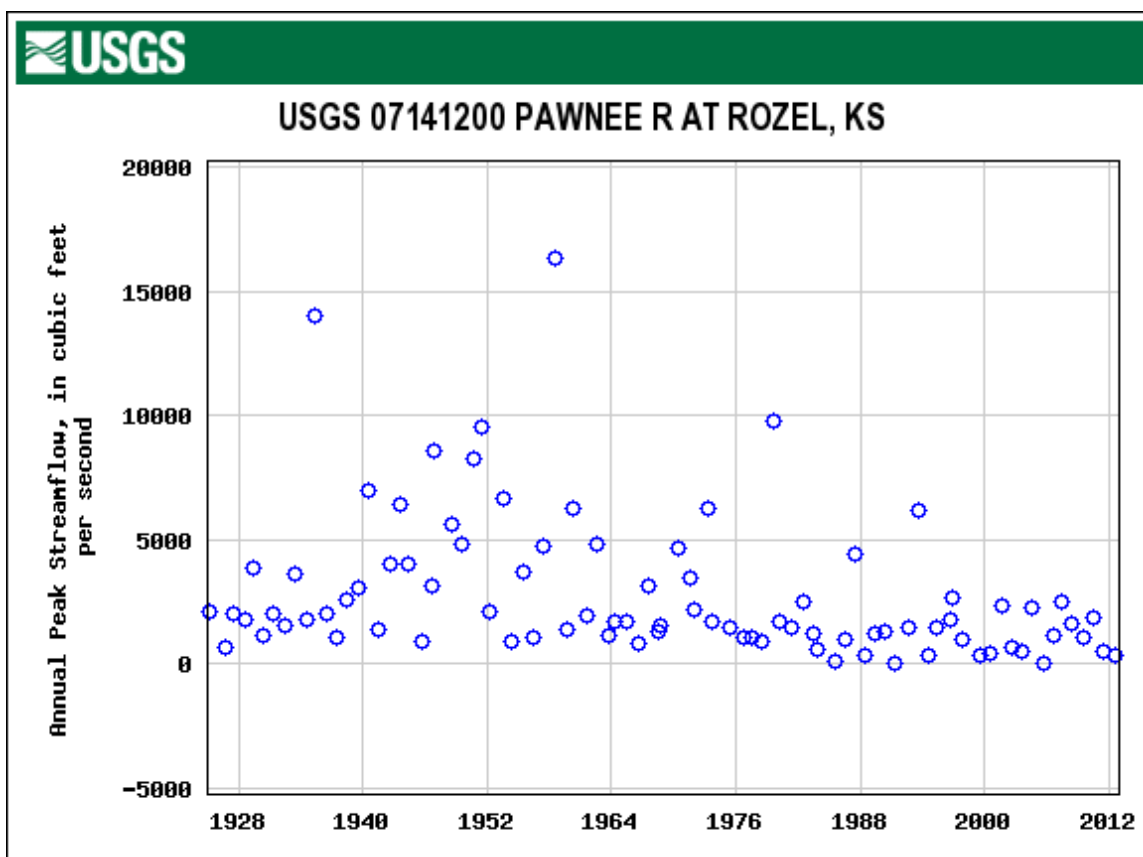
**Figure 8.** Annual peak flow record from USGS gage #07141200, Pawnee River at Rozel, KS. Note the high variability in magnitude between near zero and over 15,000 cfs.

While this reach of the Pawnee River is generally dry, runoff events (usually short-term seasonal flow) do occur periodically, and occasionally there are very large, out-of-channel floods. Park staff report that there is seasonal flow present in the channel in about three out of four years, and there have been at least seven flood events that have reached the Fort grounds in the last 36 years (about once every five years). We do not have specific dates for these events, but review of the gage record indicates that there have been about five annual peaks that approached or exceeded 5000 cfs in the last 40 years or so (Figure 8).

The flood frequency distribution calculated from a gage record provides a good view of prevailing flow magnitudes for that reach of the stream. The 2-year event is generally accepted as being in the range of bankfull discharge, a flow level that helps drive channel formation and maintenance processes. A USGS analysis from the gage record at Rozel calculated 2250 cfs for the 2-year flow event (Rasmussen and Perry, 2000). This is a sizable flow for a relatively frequent event, suggesting that this watershed is (or was) capable of regularly producing substantial flows under the prevailing climate. During the first 36 years of records for the Rozel gage (1927 -1962), discharge nearly equaled or exceeded the calculated 2-year flow at least every other year, which is very consistent with the Rasmussen and Perry (2000) analysis. However, by the mid-1960's, it appears that the frequency of the annual peak discharge approaching the calculated 2-year flow began to diminish. In the last 40 years the annual peak discharge has exceeded 2000 cfs only eight times, meaning that the calculated 2-year flow only occurred about once every five years during this period (i.e., bankfull flows occurred less frequently than expected). This trend may be related to changing precipitation patterns, but it also could be related to a drop in the water table (see following section) and a corresponding reduction or loss of base flow contributions. The record also suggests there may have been a downward trend in the magnitude of annual peak flows over the last 50 years or so. Prior to the mid-1960's, there were eight annual peaks that exceeded 5000 cfs, while after that time there were only three (Figure 8).
