## GLACIER BAY LODGE COMPLEX HISTORIC DISTRICT VEGETATION TREATMENT AND PRESERVATION MAINTENANCE PLAN

Glacier Bay National Park and Preserve  
Park Cultural Landscapes Program

Prepared by  
Corinna Welzenbach, Historical Landscape Architect

June 2018

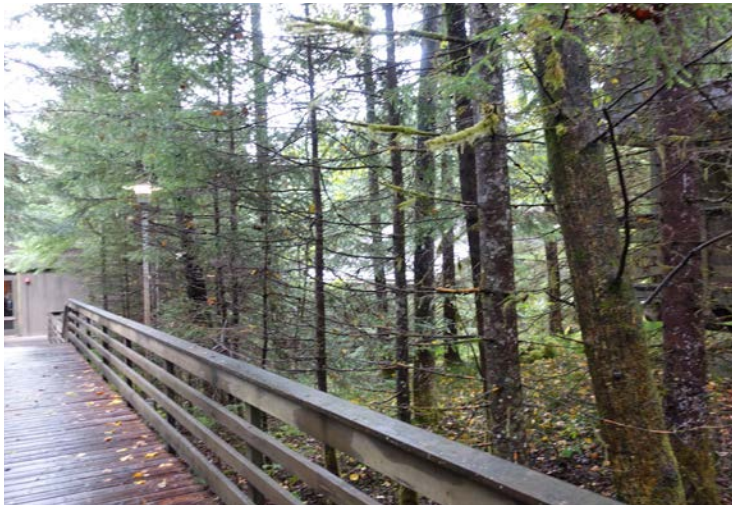
Figure 5. Dense spruce along boardwalk, view to northeast (NPS, 2017).

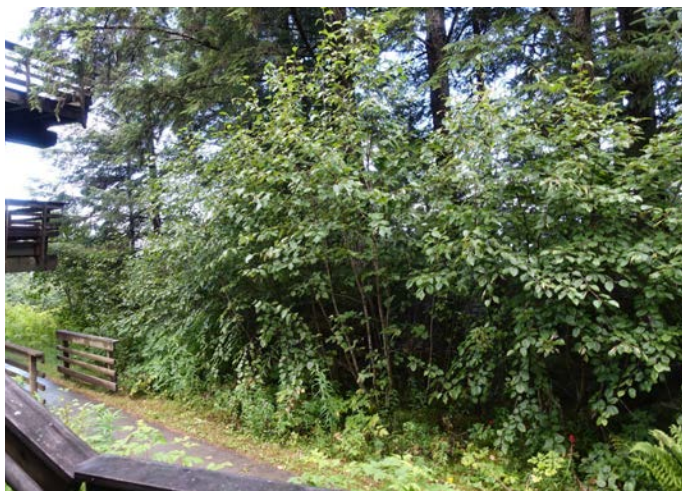
Figure 6. Overgrown Alder east of the lodge.

high. Therefore, removing alder in the viewshed between the lodge and the beach trail (C1) is recommended. Park staff have found that cutting alder shrubs to ground level for 3-4 years will reduce the plants vigor and prevent resprouting. Removing young alder plants before roots are established will prevent colonization and reduce future shrub removal. Use of a weed wrench can facilitate shrub and root removal.

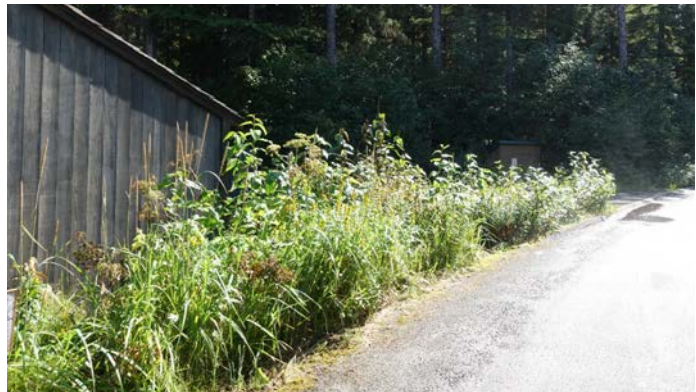
Figure 10. Cottonwood volunteers to east of driveway to be removed.

Cottonwood growth should be limited within the historic district. An arborist, or park staff with significant felling experience, should remove the largest cottonwood trees in E3, while being careful to avoid damage to buildings

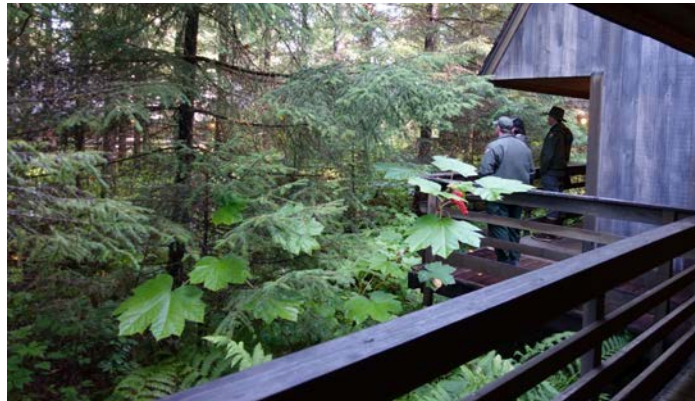
Figure 12. Dense spruce trees growing in courtyard E1, to be thinned.

Spruce trees should be thinned in a naturalistic pattern, leaving small groupings to avoid a grid. The youngest and least vigorous spruce trees should be prioritized for removal. Trees should be cut flush to the ground, roughened with an axe (to encourage decay), and concealed with duff. In order to avoid over-thinning, a staff member with training in preservation horticulture and view management should flag initial trees for removal and monitor thinning progress. The Alaska Regional Office Landscape Architects can provide on-site technical assistance with tree flagging, which could be completed in one to two days.

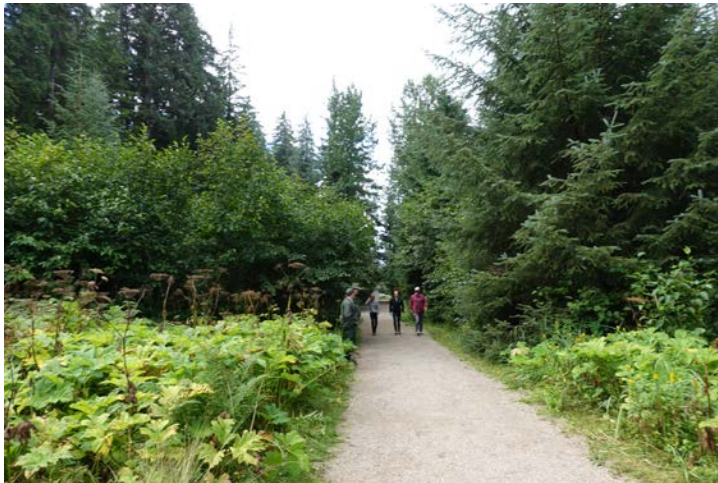
Figure 21. Beach trail with overgrown vegetation, view to west.

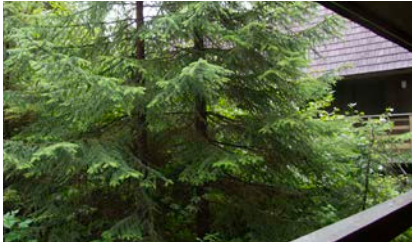
| Vegetation Zone | Existing Conditions and Primary Plant Palette | Existing Conditions Image | Treatment Recommendation |
|---|---|---|---|
| W1 | <p><b>Existing Conditions:</b> A diverse mixture of shrubs grow in this open courtyard. Young Sitka spruce grow on the south side.</p> <p><b>Plant Palette:</b> Sitka spruce (<i>Picea sitchensis</i>), blueberry &amp; huckleberry (<i>Vaccinium spp.</i>), salmonberry (<i>Rubus spectabilis</i>), currant &amp; gooseberry (<i>Ribes spp.</i>), bunchberry (<i>Cornus canadensis</i>), horsetail (<i>Equisetum sp.</i>), baneberry (<i>Actaea rubra</i>), cow parsnip (<i>Heracleum lanatum</i>)</p> | | Thin spruce and prune alder to reduce density. Retain three specimen spruce trees. |

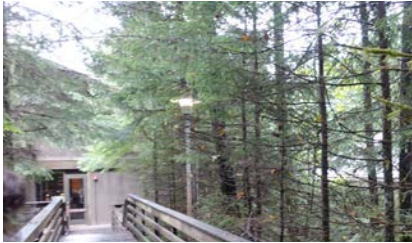
| Vegetation Zone | Existing Conditions and Primary Plant Palette | Existing Conditions Image | Treatment Recommendation |
|---|---|---|---|
| W2 | <p><b>Existing Conditions:</b> This zone along the western boardwalk is a dense canopied Sitka spruce forest.</p> <p><b>Plant Palette:</b> Sitka spruce (<i>Picea sitchensis</i>), black cottonwood (<i>Populus balsamifera</i>)</p> | | Remove cottonwood. Remove dead trees and branches. Thin young living spruce (approximately 50% of trunks). Plant infill shade tolerant native shrubs harvested from local forest or park construction projects in fall. |

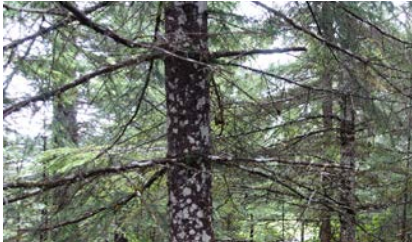
| Vegetation Zone | Existing Conditions and Primary Plant Palette | Existing Conditions Image | Treatment Recommendation |
|---|---|---|---|
| W3 | <p><b>Existing Conditions:</b> The canopy is dominated by Sitka spruce with some hemlocks. A shrub understory grows in the forested portion, and herbaceous groundcovers grow at the edge of trails.</p> <p><b>Plant Palette:</b> Sitka spruce (<i>Picea sitchensis</i>), western hemlock (<i>Tsuga heterophylla</i>), blueberry &amp; huckleberry (<i>Vaccinium spp.</i>), salmonberry (<i>Rubus spectabilis</i>), Sitka alder (<i>Alnus viridis</i>), devil's club (<i>Oplopanax horridus</i>)</p> | | Selectively thin young spruce and hemlock trees under 5" diameter (approximately 50% of trunks). Retain enough trees so that the Whale Skeleton Shelter remains concealed |

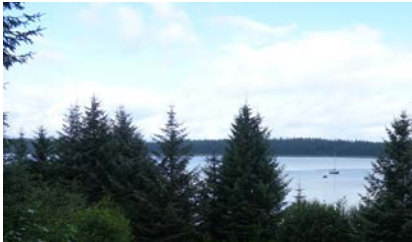
| Vegetation Zone | Existing Conditions and Primary Plant Palette | Existing Conditions Image | Treatment Recommendation |
|---|---|---|---|
| C1 | <p><b>Existing Conditions:</b> This open area in front of lodge is dominated by alder. Maintenance staff has periodically cleared trees to maintain views.</p> <p><b>Plant Palette:</b> Sitka spruce (<i>Picea sitchensis</i>), Sitka alder (<i>Alnus viridis</i>), cow parsnip (<i>Heracleum lanatum</i>), bunchberry (<i>Cornus canadensis</i>), beach strawberry (<i>Fragaria chiloensis</i>)</p> | | Remove alder annually. Thin trees on edge of view to create feathered edge. Remove spruce trees that emerge in the clear viewshed area every five years. |

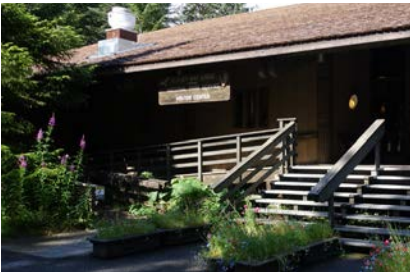
| Vegetation Zone | Existing Conditions and Primary Plant Palette | Existing Conditions Image | Treatment Recommendation |
|---|---|---|---|
| C2 | <p><b>Existing Conditions:</b> Native plants grow in small planting beds at the entry to the lodge. Ornamental flower mixes grow in planting boxes adjacent to steps.</p> <p><b>Plant Palette:</b> Sitka spruce (<i>Picea sitchensis</i>), cow parsnip (<i>Heracleum lanatum</i>), red elderberry (<i>Sambucus racemosa</i>), western columbine (<i>Aquilegia formosa</i>)</p> | | Prune elderberry to form tree-like shrub. Plant existing containers with native plants such as bunchberry and common red paintbrush. Remove spruce tree directly adjacent to building ramp. |

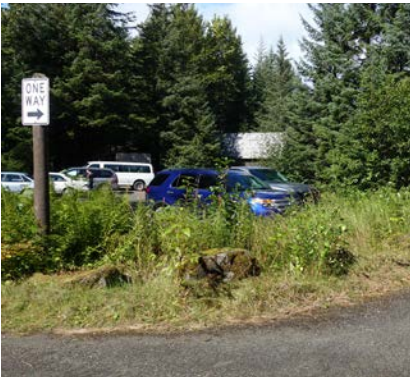
| Vegetation Zone | Existing Conditions and Primary Plant Palette | Existing Conditions Image | Treatment Recommendation |
|---|---|---|---|
| C3 | <p><b>Existing Conditions:</b> The southern section of the driveway island is covered in herbaceous groundcovers with one alder patch. Young Sitka spruce grow to the north.</p> <p><b>Plant Palette:</b> Sitka spruce (<i>Picea sitchensis</i>), Sitka alder (<i>Alnus viridis</i>), black cottonwood (<i>Populus balsamifera</i>), horsetail (<i>Equisetum</i> sp.), common red paintbrush (<i>Castilleja</i> spp.), mixed grasses</p> | | Prune alder to reduce density. Selectively prune limbs on spruce to improve visibility. Plant sun and moisture tolerant herbaceous perennials and low-growing native shrubs (up to 2.5' in height). In small vegetated area to the south of accessible boardwalk, remove cottonwood sprouts and plant with select native shrubs. Install bolder edging around planting island, mimicking historic edging. |

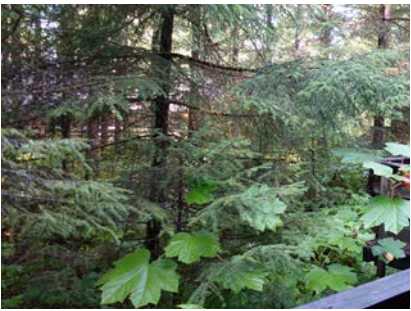
| Vegetation Zone | Existing Conditions and Primary Plant Palette | Existing Conditions Image | Treatment Recommendation |
|---|---|---|---|
| E1 | <p><b>Existing Conditions:</b> A dense, young Sitka spruce canopy dominates this courtyard. Blueberries and other shrubs grow in the understory and on the border.</p> <p><b>Plant Palette:</b> Sitka spruce (<i>Picea sitchensis</i>), Sitka alder (<i>Alnus viridis</i>), western hemlock (<i>Tsuga heterophylla</i>), red elderberry (<i>Sambucus racemosa</i>), blueberry &amp; huckleberry (<i>Vaccinium</i> spp.), salmonberry (<i>Rubus spectabilis</i>), currant &amp; gooseberry (<i>Ribes</i> spp.), devil's club (<i>Oplopanax horridus</i>)</p> | | Heavily thin at least 50 percent of spruce trees trunks (youngest and most diseased). Thin trees in naturalistic pattern (leave small groupings) to avoid grid. Retain hemlocks. Prune alder canes to reduce density. |

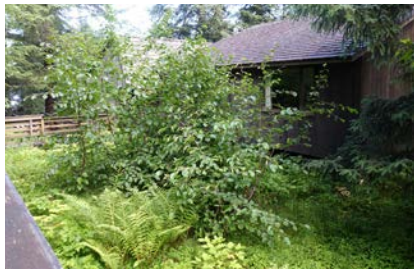
| Vegetation Zone | Existing Conditions and Primary Plant Palette | Existing Conditions Image | Treatment Recommendation |
|---|---|---|---|
| E2 | <p><b>Existing Conditions:</b> This open courtyard contains a mix of low shrubs and groundcovers, with one Sitka spruce and a small patch of alder.</p> <p><b>Plant Palette:</b> Sitka spruce (<i>Picea sitchensis</i>), Sitka alder (<i>Alnus viridis</i>), black cottonwood (<i>Populus balsamifera</i>), red elderberry (<i>Sambucus racemosa</i>), blueberry &amp; huckleberry (<i>Vaccinium spp.</i>), salmonberry (<i>Rubus spectabilis</i>), cow parsnip (<i>Heracleum lanatum</i>), currant &amp; gooseberry (<i>Ribes spp.</i>), bunchberry (<i>Cornus canadensis</i>), horsetail (<i>Equisetum sp.</i>)</p> | | Selectively prune alder branches. Remove cottonwood sprouts. Prune elderberry where touching boardwalk. |

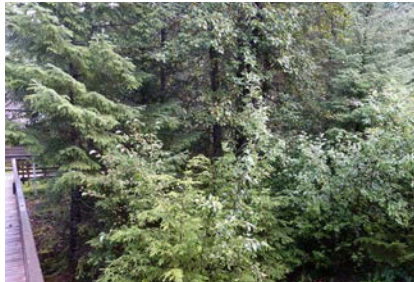
| Vegetation Zone | Existing Conditions and Primary Plant Palette | Existing Conditions Image | Treatment Recommendation |
|---|---|---|---|
| E3 | <p><b>Existing Conditions:</b> A drainage ditch runs along the west side of this zone and is bordered by young hemlocks. The east side of the zone is covered by a canopy of cottonwoods and spruce.</p> <p><b>Plant Palette:</b> Sitka spruce (<i>Picea sitchensis</i>), western hemlock (<i>Tsuga heterophylla</i>), black cottonwood (<i>Populus balsamifera</i>)</p> | | Remove largest cottonwood trees and grind stumps. Retain select cottonwood trees, and all spruce and hemlock. Prune alder branches at base to reduce density. Replant area with three evergreen trees (spruce or hemlock), and shrub mixture of locally harvested shrubs. |

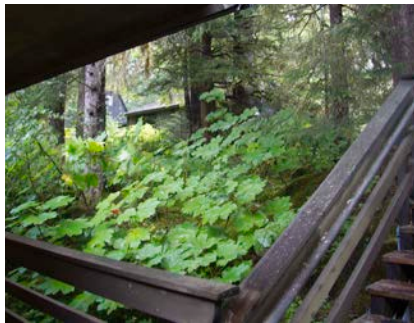
| Vegetation Zone | Existing Conditions and Primary Plant Palette | Existing Conditions Image | Treatment Recommendation |
|---|---|---|---|
| E4 | <p><b>Existing Conditions:</b> An older canopy of Sitka spruce with a blueberry and moss understory grows in this zone. Open areas are covered in alder and other shrubs.</p> <p><b>Plant Palette:</b> Sitka spruce (<i>Picea sitchensis</i>), western hemlock (<i>Tsuga heterophylla</i>), Sitka alder (<i>Alnus viridis</i>), blueberry &amp; huckleberry (<i>Vaccinium spp.</i>), salmonberry (<i>Rubus spectabilis</i>), currant &amp; gooseberry (<i>Ribes spp.</i>), devil's club (<i>Oplopanax horridus</i>), lady fern (<i>Athyrium filix-femina</i>)</p> | | Prune alder branches at base to reduce density. Keep large spruce and hemlocks. As new trees grow, retain some spruce and hemlocks for replacement trees and thin remainder to maintain an open character. Cut a few inches off the top of large Sitka spruce root where touching foundation of boardwalk. (Other roots will compensate for light root damage.) Monitor and remove tree if necessary. |

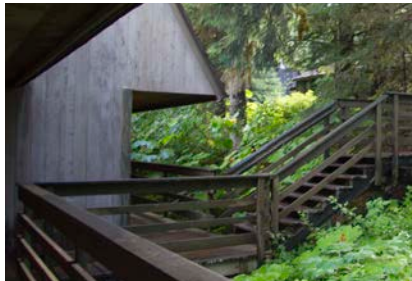
| Vegetation Zone | Existing Conditions and Primary Plant Palette | Existing Conditions Image | Treatment Recommendation |
|---|---|---|---|
| E5 | <p><b>Existing Conditions:</b> Two large spruce grow at the west and east side of this zone. Alder and other shrubs cover the middle of the site.</p> <p><b>Plant Palette:</b> Sitka spruce (<i>Picea sitchensis</i>), Sitka alder (<i>Alnus viridis</i>), blueberry &amp; huckleberry (<i>Vaccinium spp.</i>), red elderberry (<i>Sambucus racemosa</i>), currant &amp; gooseberry (<i>Ribes spp.</i>), devil's club (<i>Oplopanax horridus</i>)</p> | | Prune alder to reduce density. Retain large spruce. Allow for occasional replacement trees to grow. |

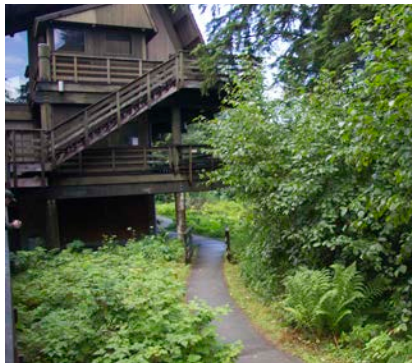
| Vegetation Zone | Existing Conditions and Primary Plant Palette | Existing Conditions Image | Treatment Recommendation |
|---|---|---|---|
| E6 | <p><b>Existing Conditions:</b> Older spruce and hemlock canopy with shrub understory grow in the northern portion of this zone. Alder, mixed shrubs, and herbaceous groundcovers grow on the forest edge.</p> <p><b>Plant Palette:</b> Sitka spruce (<i>Picea sitchensis</i>), western hemlock (<i>Tsuga heterophylla</i>), Sitka alder (<i>Alnus viridis</i>), black cottonwood (<i>Populus balsamifera</i>), blueberry &amp; huckleberry (<i>Vaccinium spp.</i>), devil's club (<i>Oplopanax horridus</i>), salmonberry (<i>Rubus spectabilis</i>), currant &amp; gooseberry (<i>Ribes spp.</i>), lady fern (<i>Athyrium filix-femina</i>), baneberry (<i>Actaea rubra</i>), cow parsnip (<i>Heracleum lanatum</i>), goat's beard (<i>Aruncus dioicus</i>), common red paintbrush (<i>Castilleja spp.</i>), mixed grasses</p> | | Prune alder to reduce density. Retain large spruce. Retain select younger trees as replacements. |

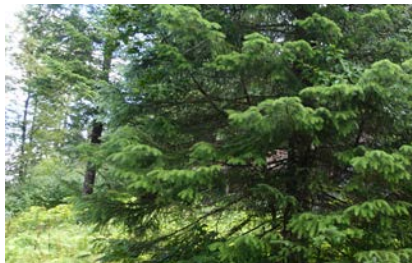
| Vegetation Zone | Existing Conditions and Primary Plant Palette | Existing Conditions Image | Treatment Recommendation |
|---|---|---|---|
| E7 | <p><b>Existing Conditions:</b> This zone is primarily open with low shrub cover. An alder thicket grows on the eastern edge.</p> <p><b>Plant Palette:</b> Sitka spruce (<i>Picea sitchensis</i>), Sitka alder (<i>Alnus viridis</i>), devil's club (<i>Oplopanax horridus</i>), salmonberry (<i>Rubus spectabilis</i>), red elderberry (<i>Sambucus racemosa</i>), currant &amp; gooseberry (<i>Ribes spp.</i>), lady fern (<i>Athyrium filix-femina</i>), cow parsnip (<i>Heracleum lanatum</i>)</p> | | Prune alder heavily to reduce density, remove if needed. Remove majority of young hemlocks to maintain views in front of cabins, retain select specimen trees. Create feathered edge at adjacent forest over time. |

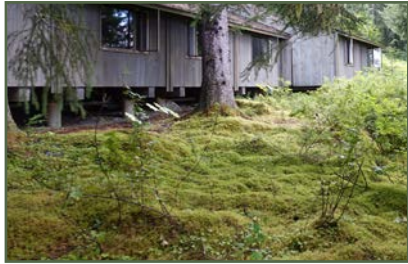
| Vegetation Zone | Existing Conditions and Primary Plant Palette | Existing Conditions Image | Treatment Recommendation |
|---|---|---|---|
| E8 | <p><b>Existing Conditions:</b> Large spruce grow on the eastern section of this zone. Alders and other shrubs grow in the more open areas.</p> <p><b>Plant Palette:</b> Sitka spruce (<i>Picea sitchensis</i>), Sitka alder (<i>Alnus viridis</i>), blueberry &amp; huckleberry (<i>Vaccinium spp.</i>), currant &amp; gooseberry (<i>Ribes spp.</i>), salmonberry (<i>Rubus spectabilis</i>)</p> | | Prune alder at edge of viewshed to reduce density. Remove alder in the center of viewshed. Retain specimen trees for filtered view. |

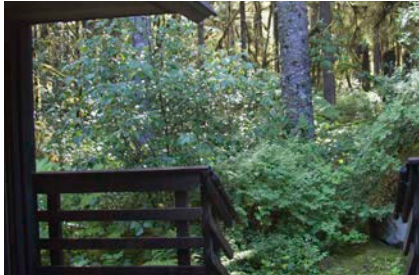
| Vegetation Zone | Existing Conditions and Primary Plant Palette | Existing Conditions Image | Treatment Recommendation |
|---|---|---|---|
| E9 | <p><b>Existing Conditions:</b> The forest edge is dominated by alder mixed with grasses and other shrubs. Sitka spruce and some hemlocks grow in the adjacent forest.</p> <p><b>Plant Palette:</b> Sitka spruce (<i>Picea sitchensis</i>), western hemlock (<i>Tsuga heterophylla</i>), Sitka alder (<i>Alnus viridis</i>), blueberry &amp; huckleberry (<i>Vaccinium spp.</i>), horsetail (<i>Equisetum sp.</i>), mixed grasses</p> | | Remove alder within 10' of buildings. Prune alder to reduce density from 10-25' of buildings. |

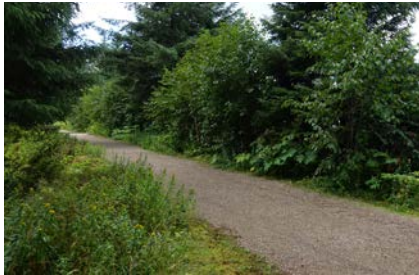
| Vegetation Zone | Existing Conditions and Primary Plant Palette | Existing Conditions Image | Treatment Recommendation |
|---|---|---|---|
| B1 | <p><b>Existing Conditions:</b> Alder, young spruce, and hemlock grow on the upper shore. The mid-shore is covered in herbaceous groundcovers.</p> <p><b>Plant Palette:</b> Sitka spruce (<i>Picea sitchensis</i>), western hemlock (<i>Tsuga heterophylla</i>), Sitka alder (<i>Alnus viridis</i>), cow parsnip (<i>Heracleum lanatum</i>), beach pea (<i>Lathyrus japonicus</i>), Nootka lupine (<i>Lupinus nootkatensis</i>), beach strawberry (<i>Fragaria chiloensis</i>), chocolate lily (<i>Fritillaria camschatcensis</i>), beach grass (<i>Leymus mollis</i>)</p> | | Thin large thickets of spruce on shoreline to create and maintain views. Over 50 percent of the trees can be removed, while retaining at least an overall 30 percent canopy cover. Remove alder on the beach annually. Consider moving kayak shelters. If retained, keep adjacent spruce and alder to conceal shelters. Zone will expand with isostatic rebound. Continue to maintain open view in front of lodge and filtered view in front of cabins in expanded vegetated zone. |
