# Wadeable Stream Habitat Monitoring at Ocmulgee Mounds National Historical Park

## *2019 Change Report*

Natural Resource Report NPS/SECN/NRR—2020/2200

December 2020

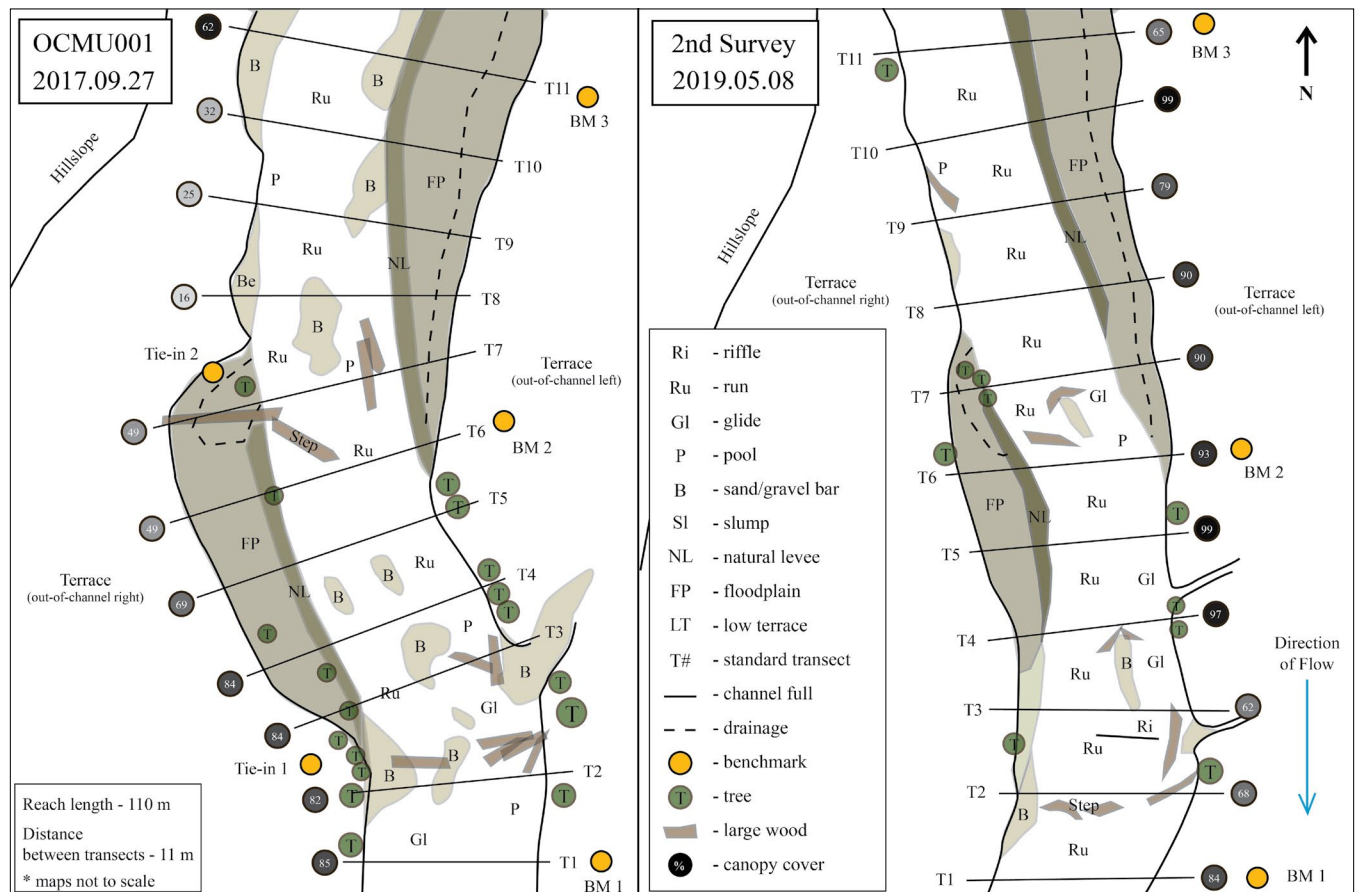
OCMU001 is located on Walnut Creek approximately 400 meters (1,312 ft) south of the railroad tunnel on the main park road. There is a social trail along the hilltop in the vicinity of OCMU001, though tree falls continue to block most of this trail. Similar to what was observed during the 2017 survey (Cooper et al. 2019), OCMU001 has a sandy bed throughout the survey reach and the channel has a low degree of entrenchment. Floodplains were again observed, inset within the higher valley bottom surface, between T3 and T8 on river right, and between T6 and the upper extent of the reach on river left (Figure 6). Similar to the 2017

survey, natural levees were observed along the channel-side edge of both floodplain surfaces. Two well-developed ephemeral side channels enter the reach on river left between T2 and T3 and between T4 and T5. The reach that was surveyed was 110 meters (361 ft) long with 11 meters (36 ft) between transects. The following sections describe the differences in the 2017 and 2019 reach-scale habitat characteristics and channel morphology along OCMU001, as well as the changes that were observed on the detailed transects. Transect-scale survey results for OCMU001 can be found in Appendix B.

**Figure 6.** Reach-scale map of OCMU001. Important geomorphic surfaces and in-channel features are labeled to provide a context for the standard and detailed transect information provided in this report. The canopy cover circles are varying shades of grey which indicate the amount of canopy cover at each transect (high and low coverages are labeled). Only the dominant geomorphic channel units (GCU) are labeled on the map. Differences in planform and size of geomorphic surfaces are due to artistic differences and not actual changes (unless noted in the text).

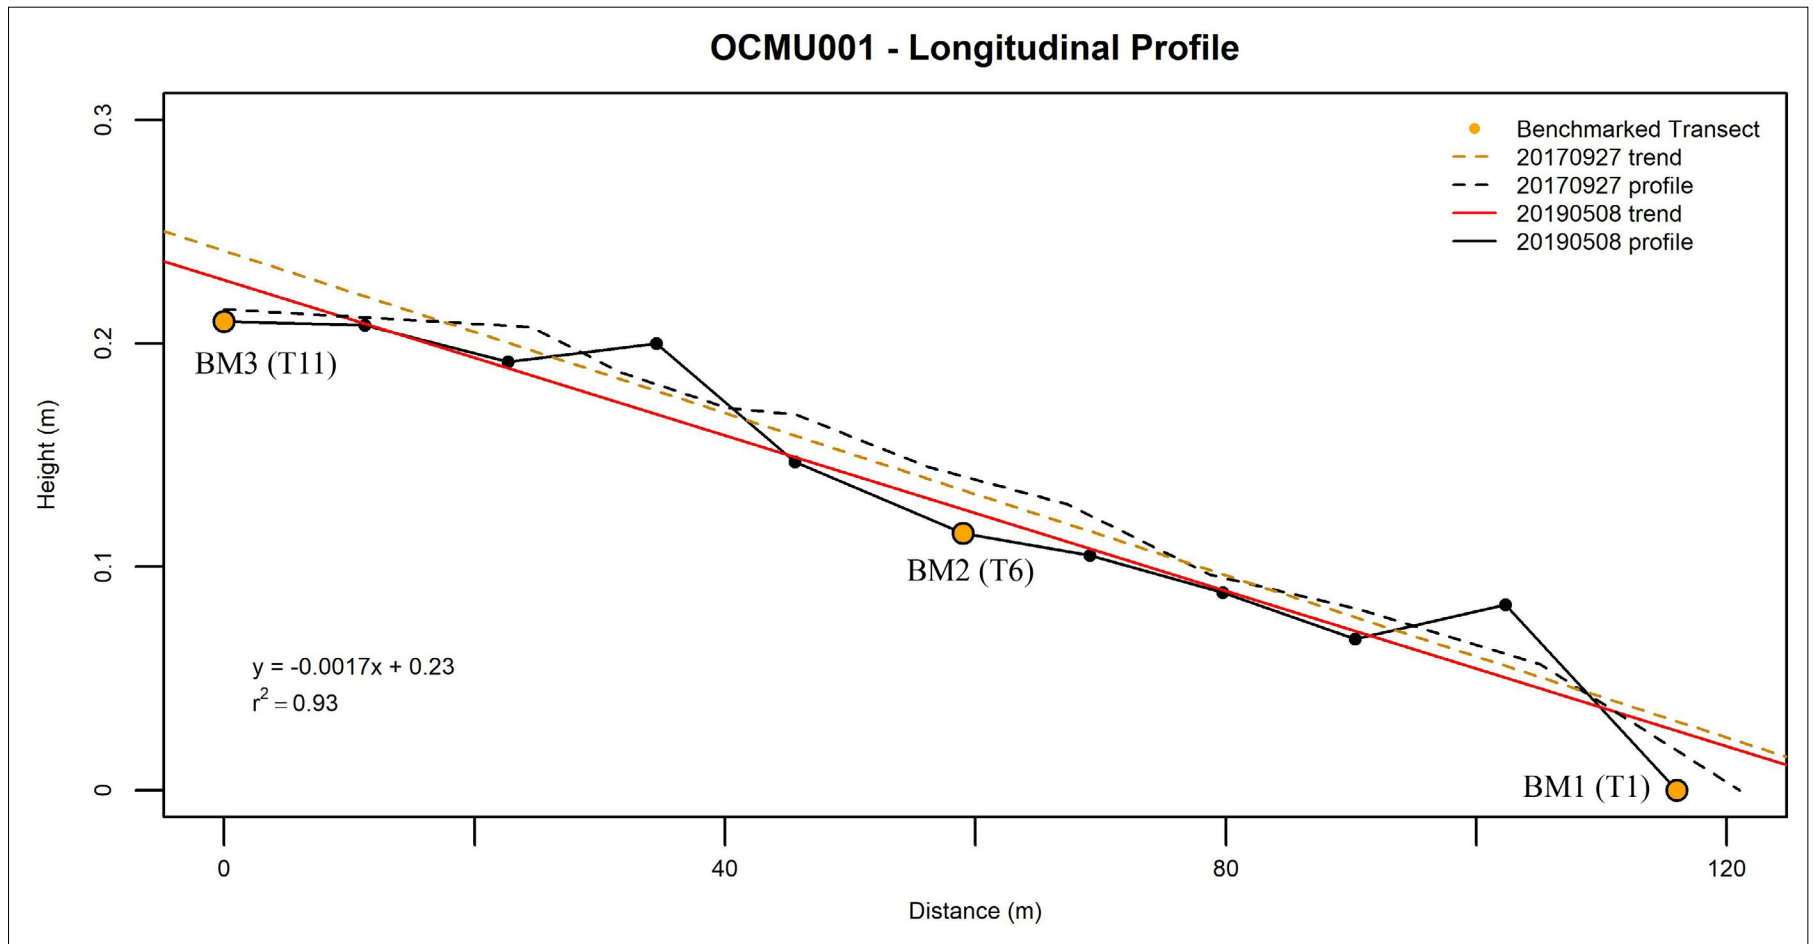
**Figure 7.** Longitudinal profile for OCMU001. The red line on the graph corresponds to the interpreted slope of the reach ( $-0.0017$  m/m). The  $r^2$  value describes the strength of the trend line. The 'T#' in parentheses indicates the standard transect number on which the detailed transects were surveyed.

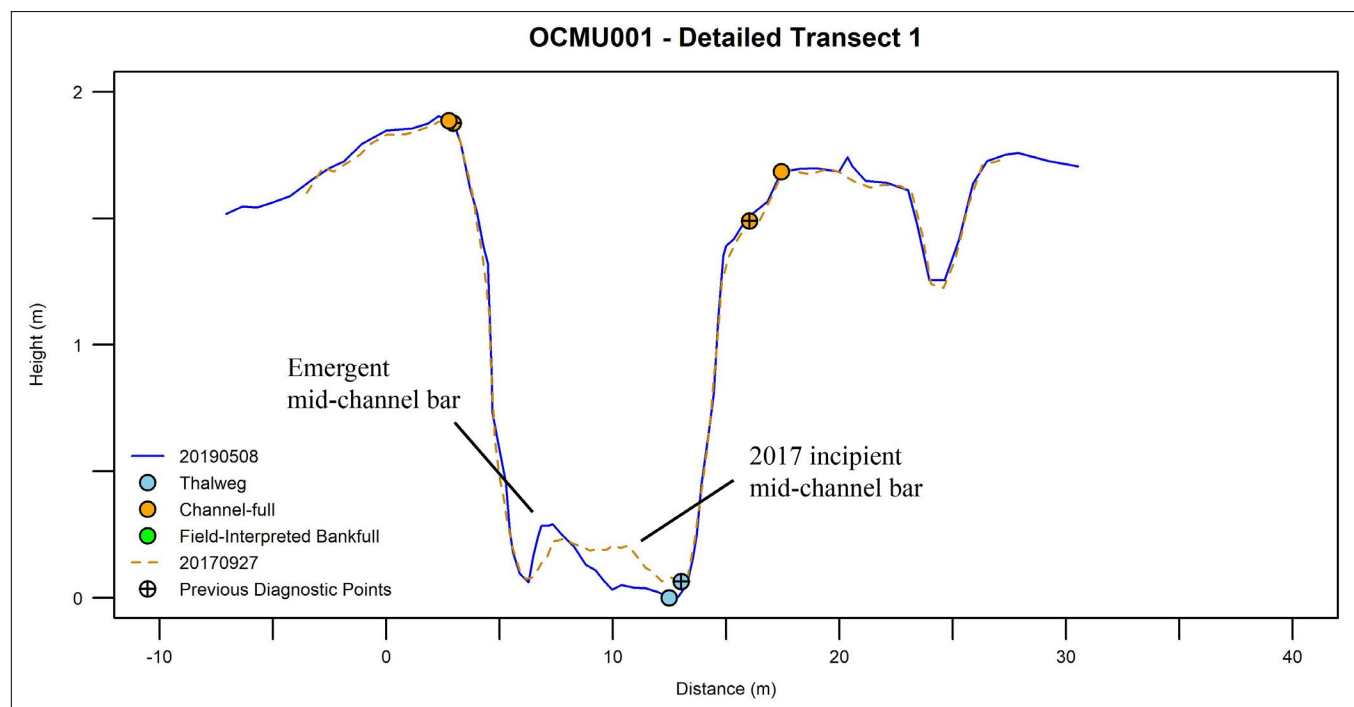
Detailed transect 1 (T1) is entrenched and no floodplains or incipient floodplain surfaces were present (Figure 8). In order for changes in the bed and bank to be quantified, bankfull cross-sectional area and width were estimated using the reach-scale average bankfull height from the 2017 survey. Bankfull cross-sectional area on detailed transect 1 decreased by 0.70 square meters (7.53 ft<sup>2</sup>) and bankfull width decreased by 0.13 meters (0.43 ft; Table 14). The thalweg on detailed transect 1 (T1) has incised slightly and the incipient mid-channel bar that was observed during 2017 has either eroded away or migrated downstream (Figure 8). A new mid-channel bar has developed on detailed transect

**Figure 8.** Differences between 2017 and 2019 surveys of detailed transect 1 at OCMU001. View is in the downstream direction (river left is on the left).

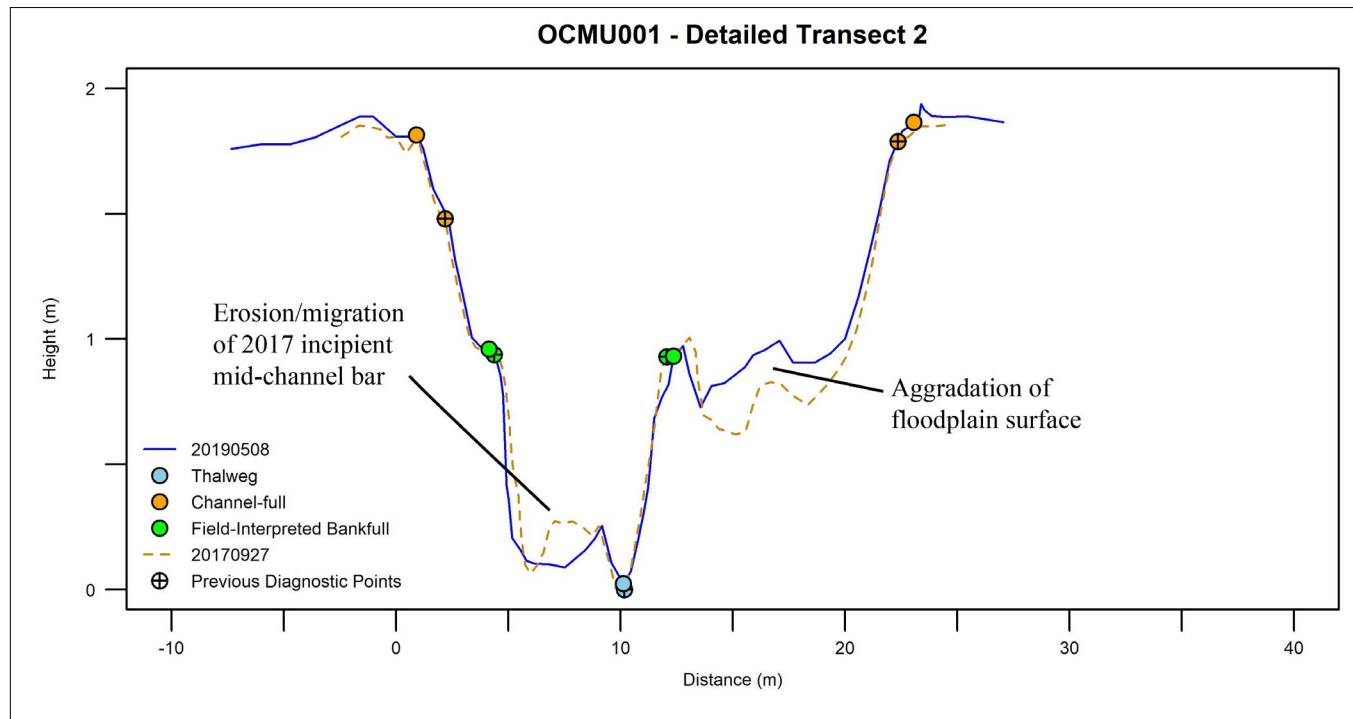
Bankfull cross-sectional area on detailed transect 2 (T6) increased by 1.17 square meters (12.59 ft<sup>2</sup>) from 2017 (2.56 square meters [27.56 ft<sup>2</sup>]) to 2019 (3.73 square meters [40.15 ft<sup>2</sup>]; Table 15). Slightly different interpretations of where the bankfull tops are (Figure 9) led to a slight increase in bankfull width (0.51 meters [1.67 ft]; Table 15). In addition to the increase in bankfull width, erosion of the 2017 incipient mid-channel bar contributed to the increase in bankfull area (Figure 9). Like river right on detailed transect 1, the 2017-interpreted channel-full surface on river left

**Figure 9.** Differences between 2017 and 2019 surveys of detailed transect 2 at OCMU001. View is in the downstream direction (river left is on the left).

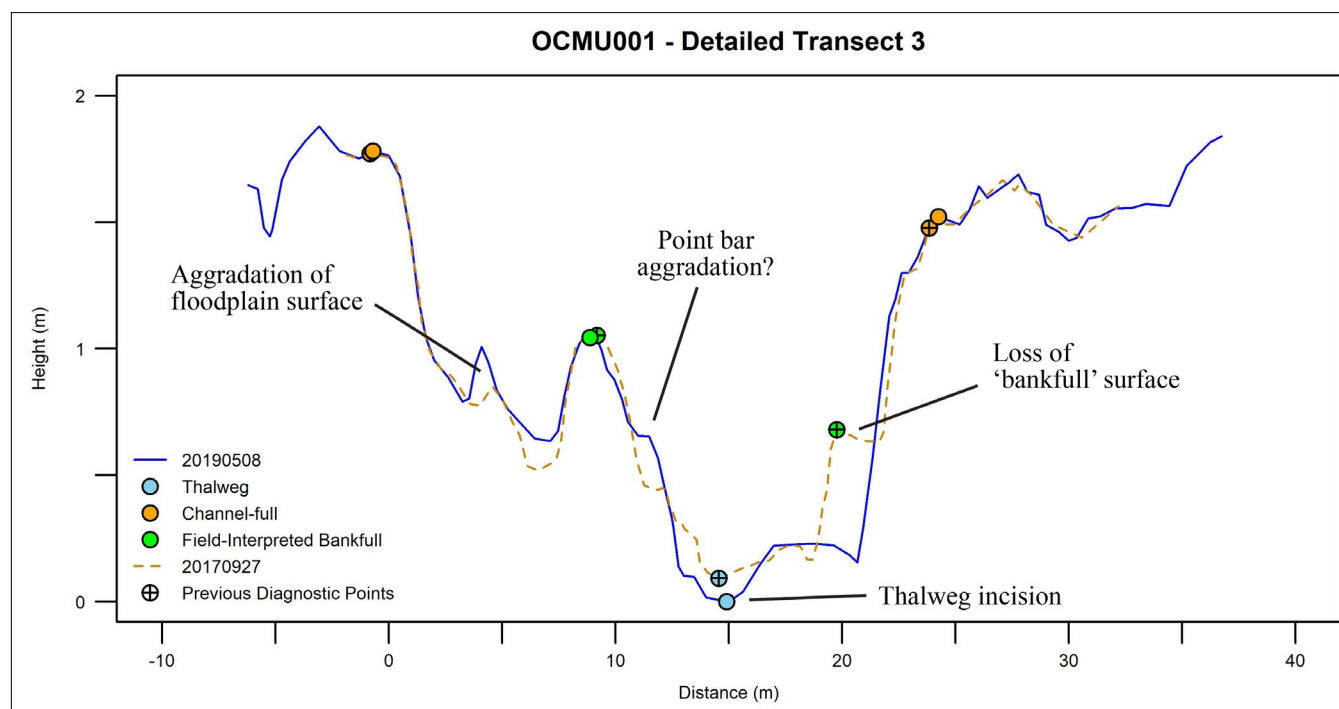
Bankfull cross-sectional area on detailed transect 3 (T11) increased by 2.00 square meters (21.53 ft<sup>2</sup>) from 2017 (2.34 square meters [25.19 ft<sup>2</sup>]) to 2019 (4.34 square meters [46.72 ft<sup>2</sup>]; Table 16). This large increase in bankfull area is due to the loss of the ‘floodplain’ surface along river right that was observed in 2017, coupled with a slight incision of the thalweg (Figure 10). Channel-full area on detailed transect 3

increased by 1.59 square meters [17.11 ft<sup>2</sup>] from 2017 (19.38 square meters [208.60 ft<sup>2</sup>]) to 2019 (20.97 square meters [225.72 ft<sup>2</sup>]; Table 16). Aggradation of sediment on the floodplain surface on river left offset some of the increase in channel-full area caused by the loss of the floodplain surface on river right (Figure 10).

**Figure 10.** Differences between 2017 and 2019 surveys of detailed transect 3 at OCMU001. View is in the downstream direction (river left is on the left).

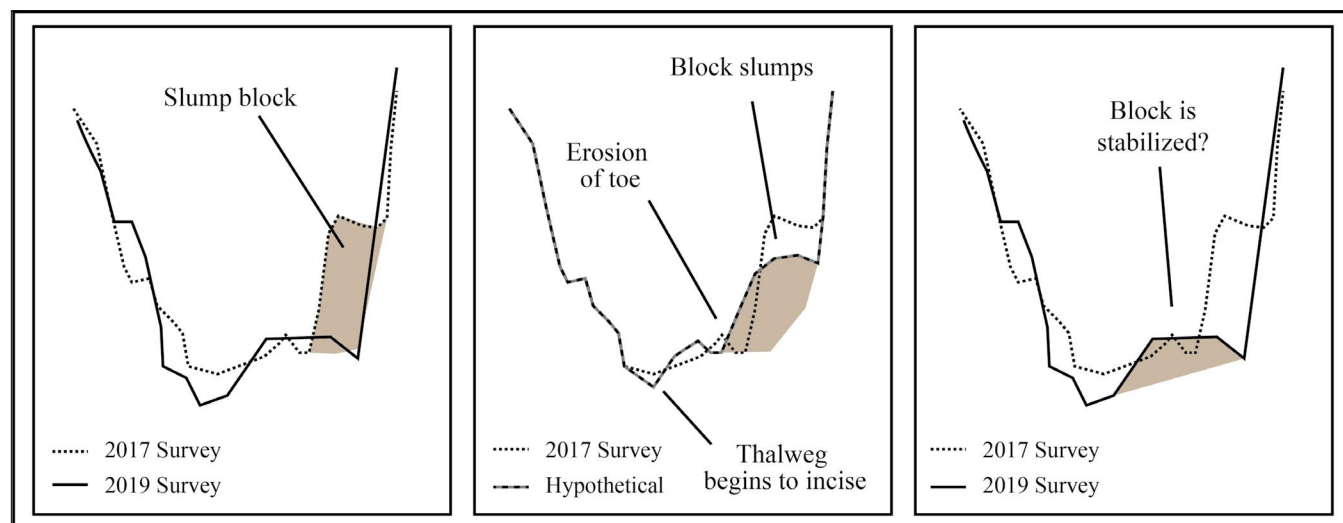
Floodplain aggradation on detailed transects 2 (T6) and 3 (T11), along with the overall shallowing of average thalweg depth within the reach, indicates that a substantial amount of sediment is being supplied to the reach. If this increased sediment supply is not a permanent change to the system, the reach will likely re-establish a more diverse assemblage of in-stream habitats and the floodplain and channel will continue to be connected. If this increased sediment supply continues, there could be substantial changes to the reach that could change the relationship between the channel and its out-of-channel areas. Due to the complex hydrologic conditions that characterize the reach (Cooper et al. 2019), the exact changes that could occur are difficult to predict.

**Figure 11.** Hypothesized process by which the ‘floodplain’ surface on detailed transect 3 (T11) slumped into the channel and contributed to thalweg incision.
