# **STREAM HABITAT SURVEY REPORT: RITO DE LOS INDIOS JUNE 7-JUNE 25, 2007**

REPORT PREPARED BY:  
JEFF NELSON AND ZOE MANICKAM  
BIOLOGICAL FISHERIES TECHNICIANS  
VALLES CALDERA TRUST AND U.S. FOREST SERVICE  
*December, 2007*

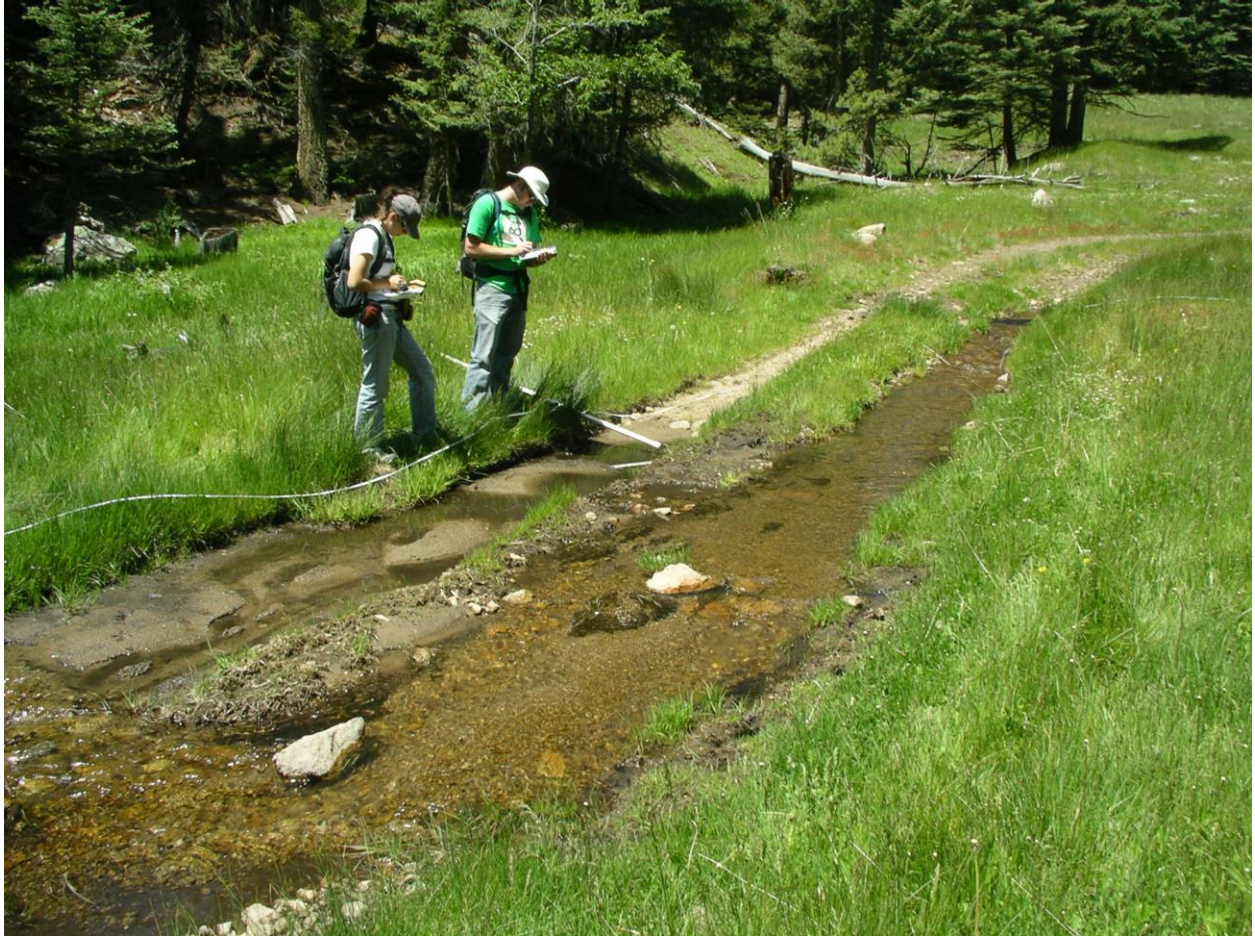
Photo 3: Reach 2, NSO 329 R158, Surveyors note unstable road VC13 ford (18-June-2007).

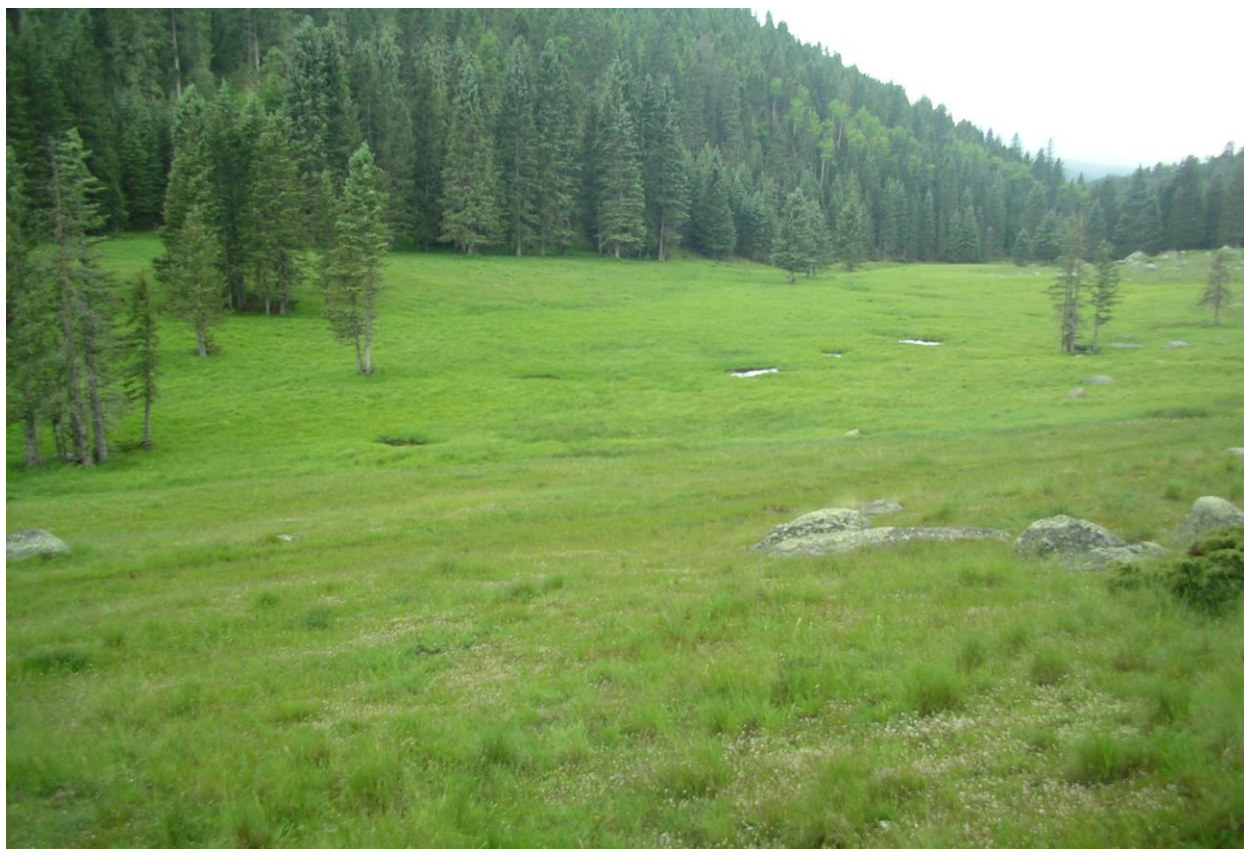
Photo 4: Reach 3, NSO 419, R204, large meadow sink that is the main source of flow for Jaramillo Creek.

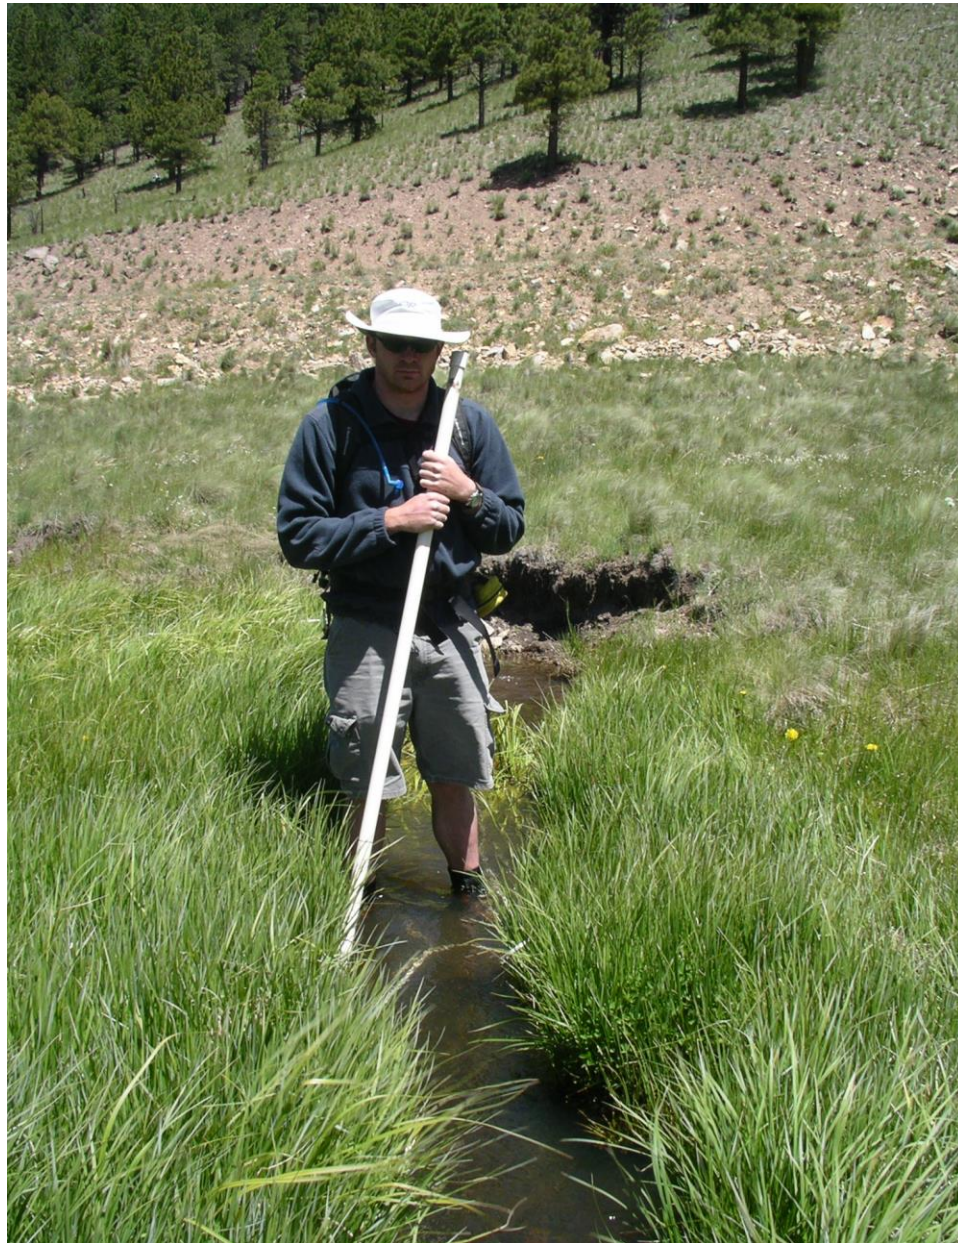
Photo 5: Reach 1, NSO 29, R14, looking downstream at typical riffle habitat

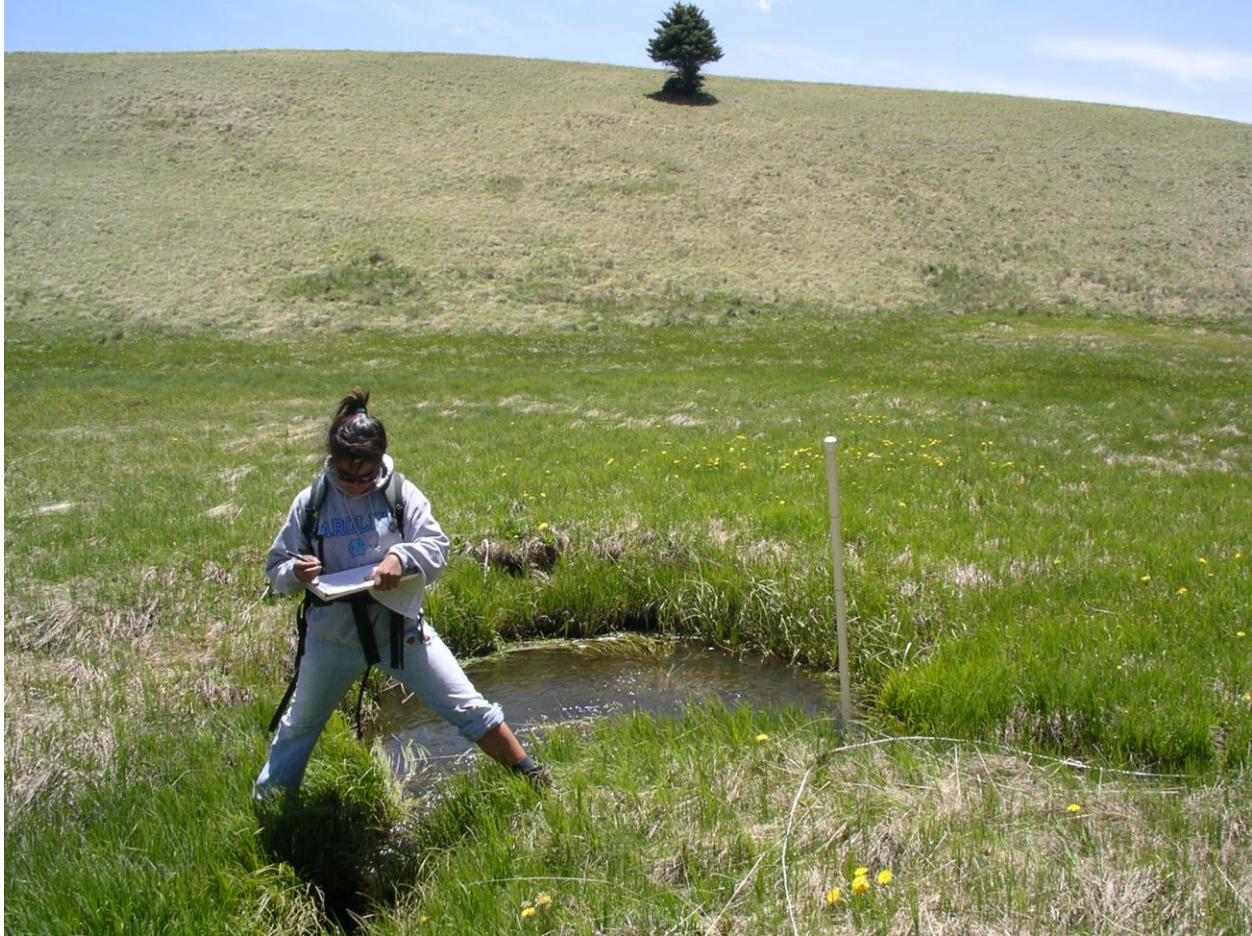
Photo 6: Reach 1: NSO 47, P28, typical small meander pool with Z. Manickam (6-June-2007).

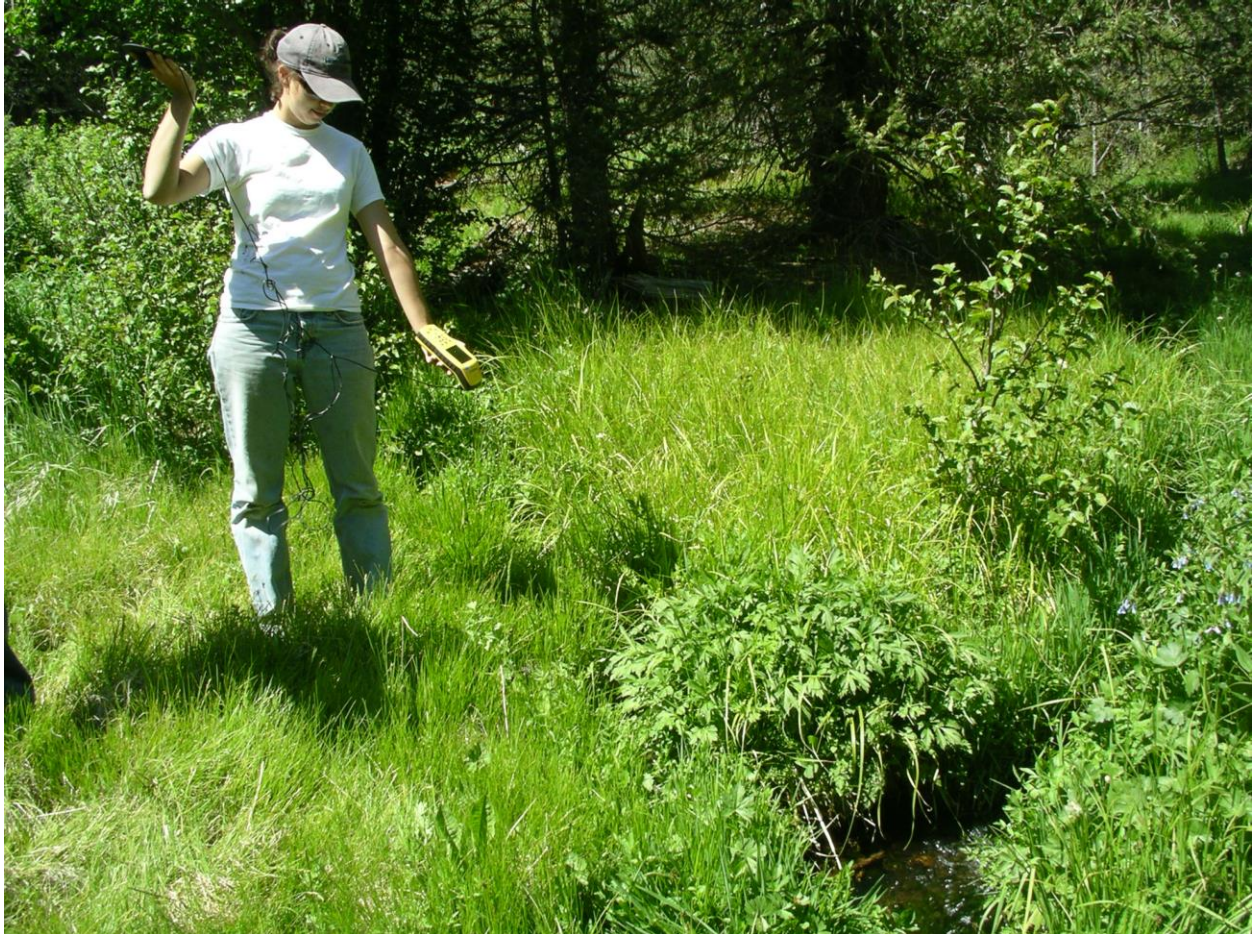
Photo 7: Reach 2, NSO 356 T18, Left bank stream tributary, main stem of the Rito de los Indios is on the right (18-June-2007).

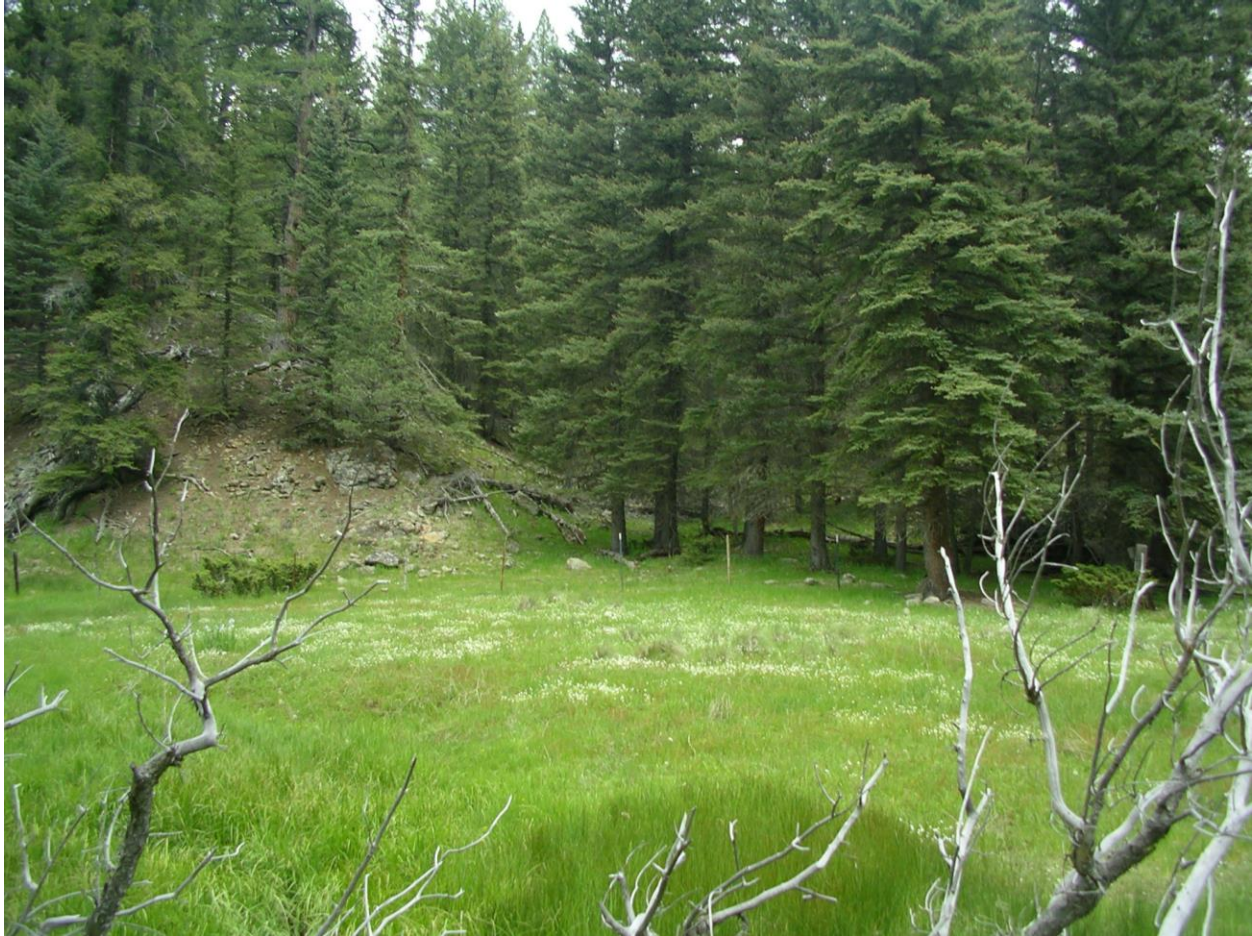
Evidence of once abundant beaver activity in the Rito de los Indios is present in Reach 2. No intact beaver dams were observed, but many collapsed dams were noted throughout Reach 2. Several of these dams have aggraded the stream channel and in some cases have helped reconnect the channel with its historical floodplain. Other historical evidence of beaver activity including old stumps and debris was noted throughout reach 2. While there is no current beaver activity in the Rito de los Indios, it is clear that beavers have been previously active throughout the watershed. Additionally a beaver was observed at the confluence of the Rito de los Indios on the first day of the survey, (June 7, 2007).

Photo 9: Reach 2, NSO 276 P132, looking upstream at historic beaver dam with Z. Manickam, note channel aggradation above dam (13-June-2007).

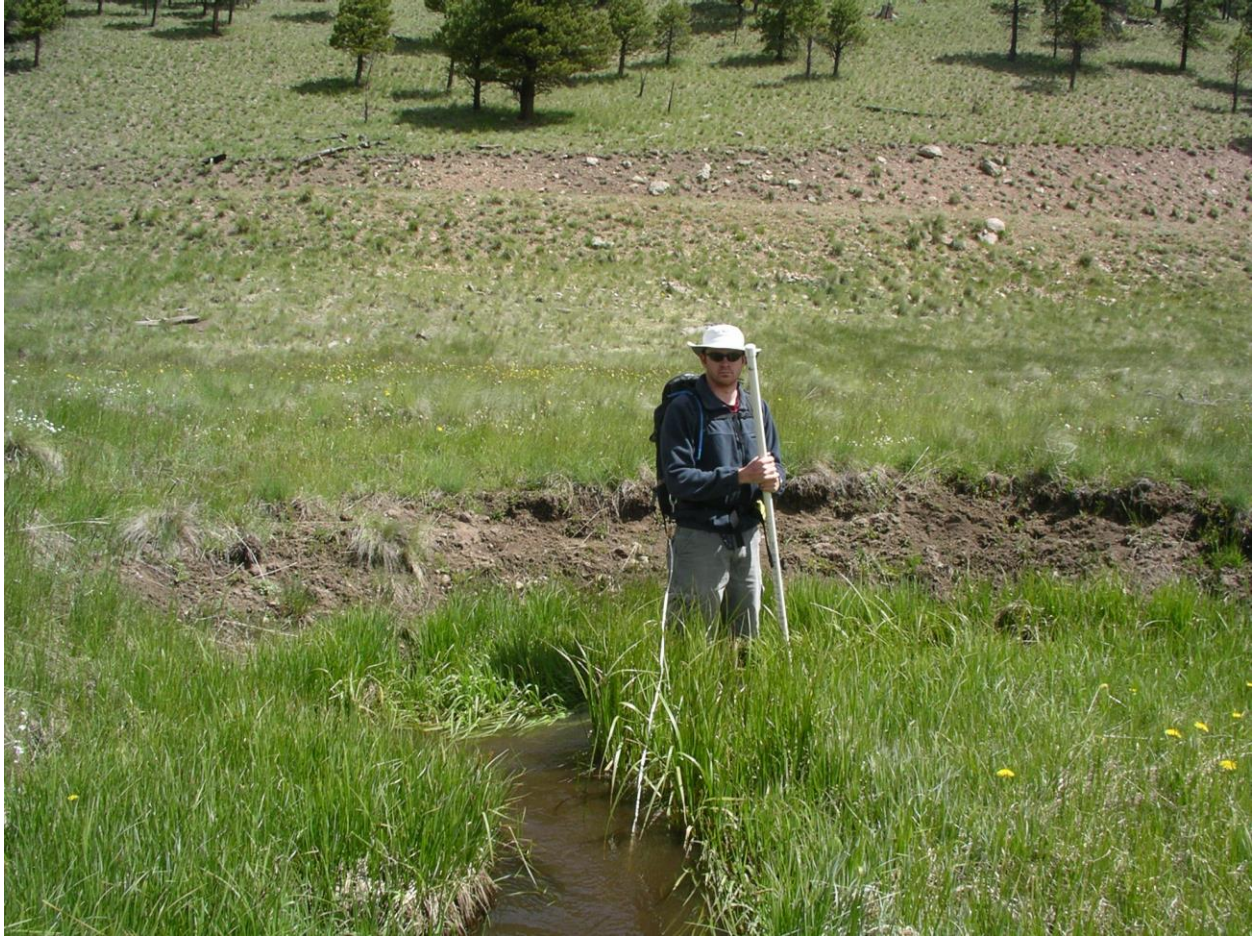
Photo 10: Reach 1, NSO 14 P7, 20 feet of typical left bank instability with J. Nelson (6-June-2007).

Stream bank condition is **not properly functioning** in Reach 1 with 10.6% instability (see Table 16). This is just above the threshold, 10.0%, for properly functioning. The majority of the instability within this reach comes from historic cattle grazing.

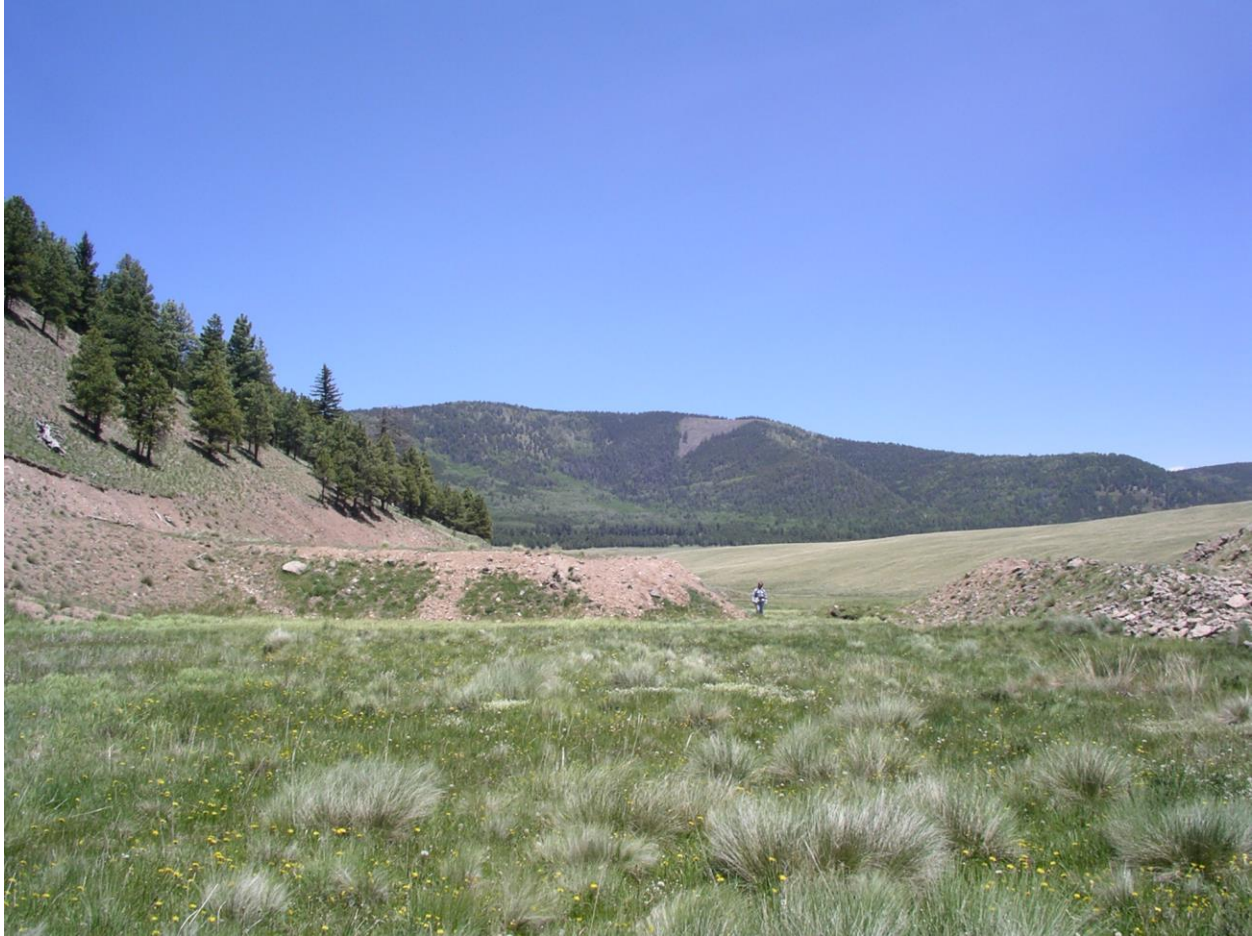
An historic earthen dam exists roughly 825 ft. into the reach. The dam is not longer functioning and the earth that spanned the stream has eroded, leaving behind two mounds roughly 12 feet apart and 12 ft in height on opposite sides of the stream. The left-bank mound connects to VC13. A large wetland exists upstream of the feature with substantial standing water and small pools. Sedges dominate this region. The substrate of the wetland above the dam is dominated by very fine silt. Below the dam the channel is noticeably wider and shallower.

Photo 11: Reach 1, NSO 46 R23, looking upstream at non-functioning, historic dam with Z. Manickam streamside (6-June-2007).

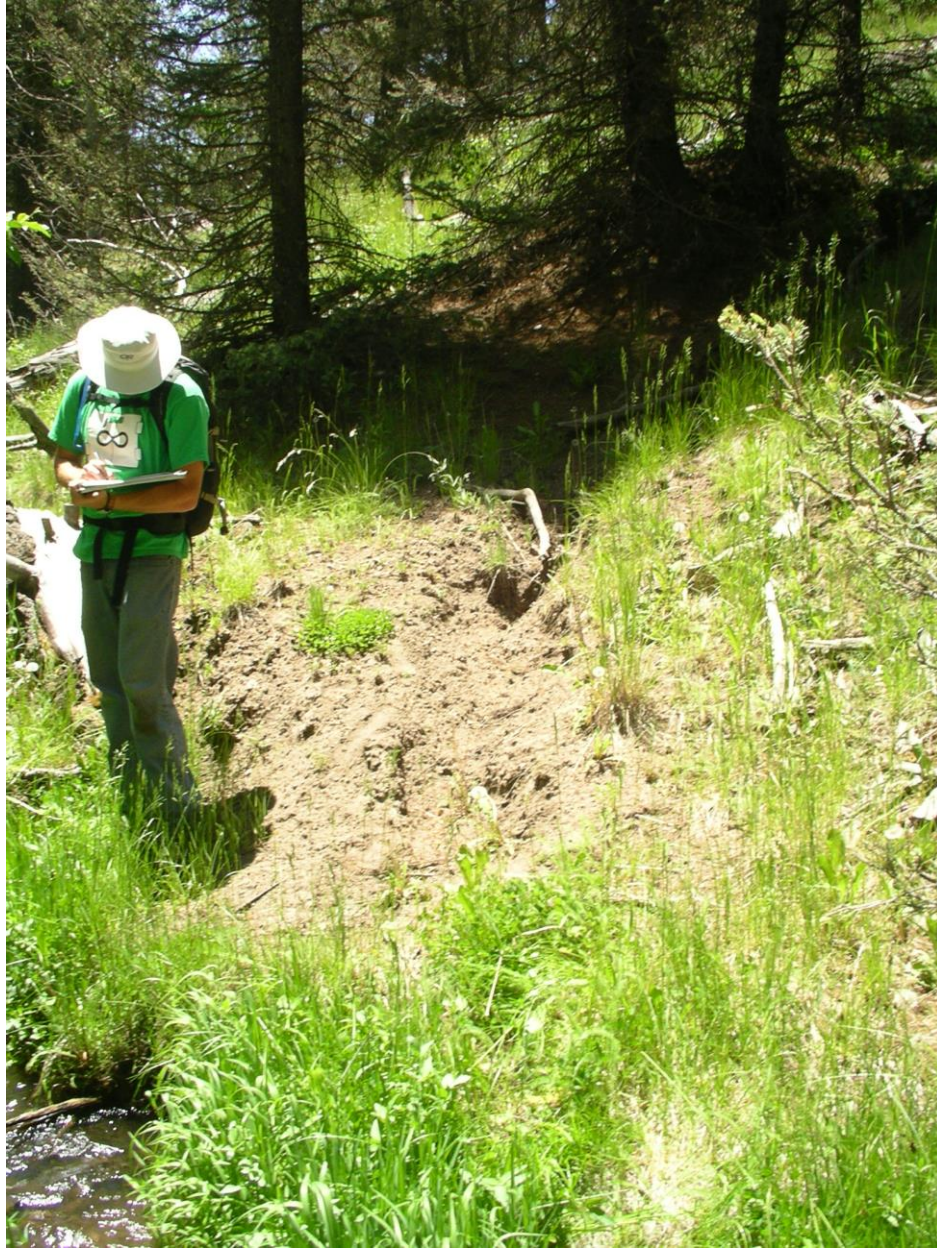
Valles Caldera road VC13 fords the stream in two places in Reach 2. In each location the road has altered the path of the stream as well as significantly widened it. It is evident that these road fords are sources of sediment in the stream. Fish, including trout fry, were observed in both road crossings along with mayflies, mosquito larvae and various aquatic beetles. After the second road ford VC13 climbs the left valley slope and is well above the stream. Overall the road is in much closer proximity to the stream than in Reach 1 and is contributing sediment throughout the reach.

Photo 12: Reach 2, NSO 341 R164, Sediment from road VC13 entering stream with J. Nelson (18-June-2007).

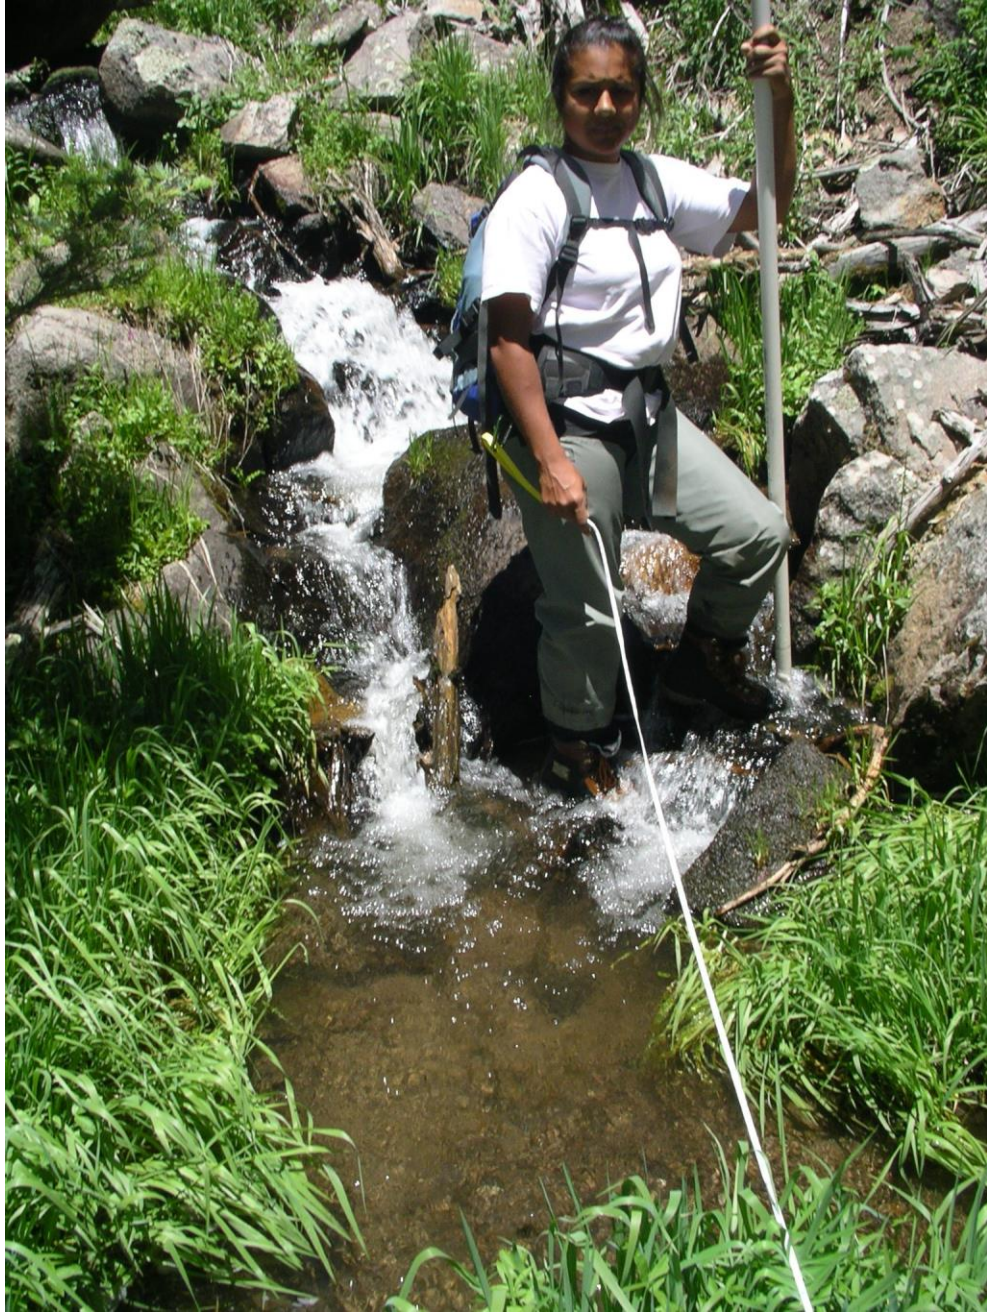
One waterfall is present in Reach 2. The waterfall has a length of 18 feet, a width of four feet and a height of 6 feet. It is not considered a barrier to upstream migration because of many small pocket pools, which could be used as landings by fish traveling upstream. Gradient is estimated at 80%.

Photo 14: Reach 2, NSO 343 F1, looking upstream at waterfall with Z. Manickam (18-June-2007).

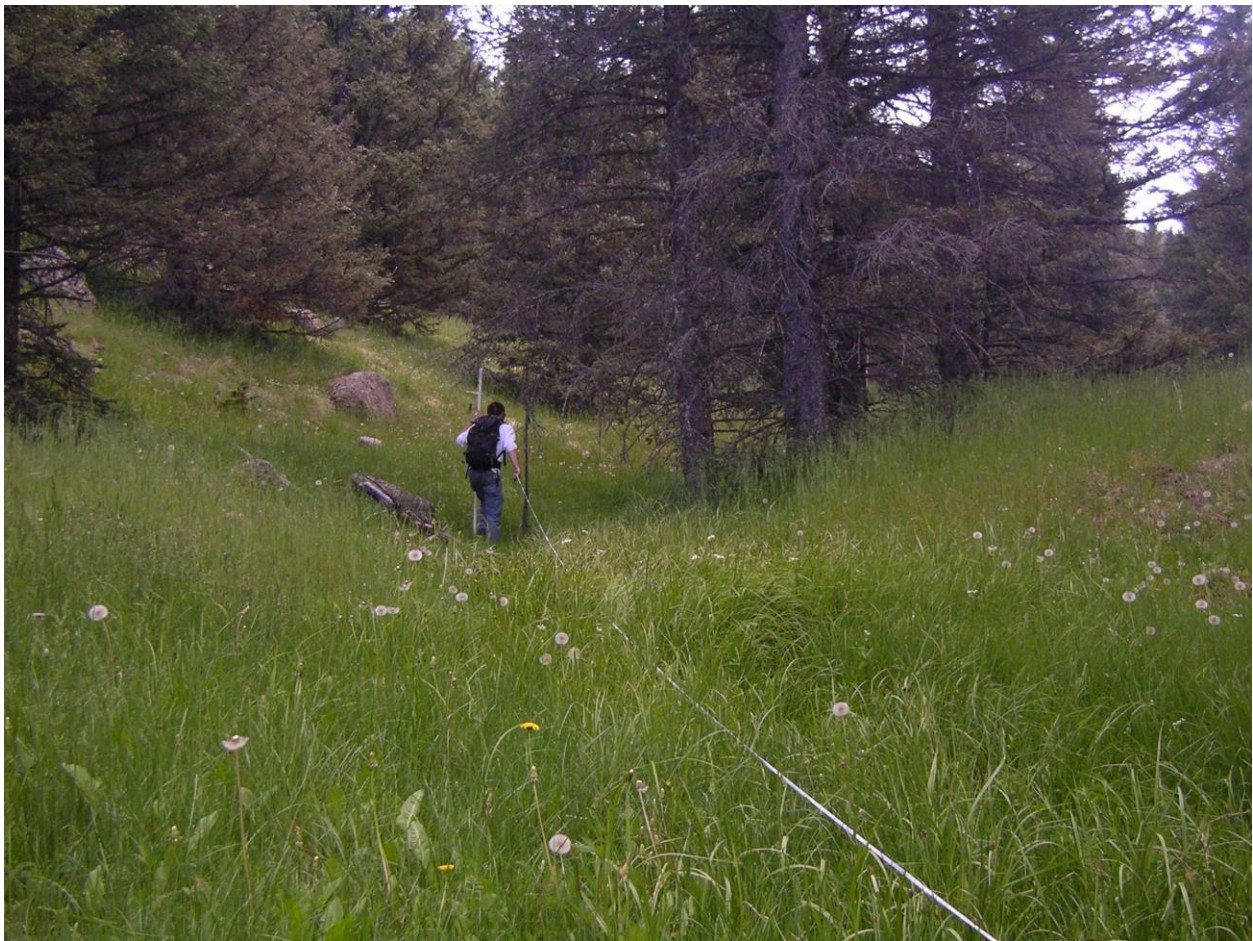
Photo 15: Reach 3, NSO 386 R186, typical indistinct, non-sinuuous riffle in Reach 3 with J. Nelson (21-June-2007).

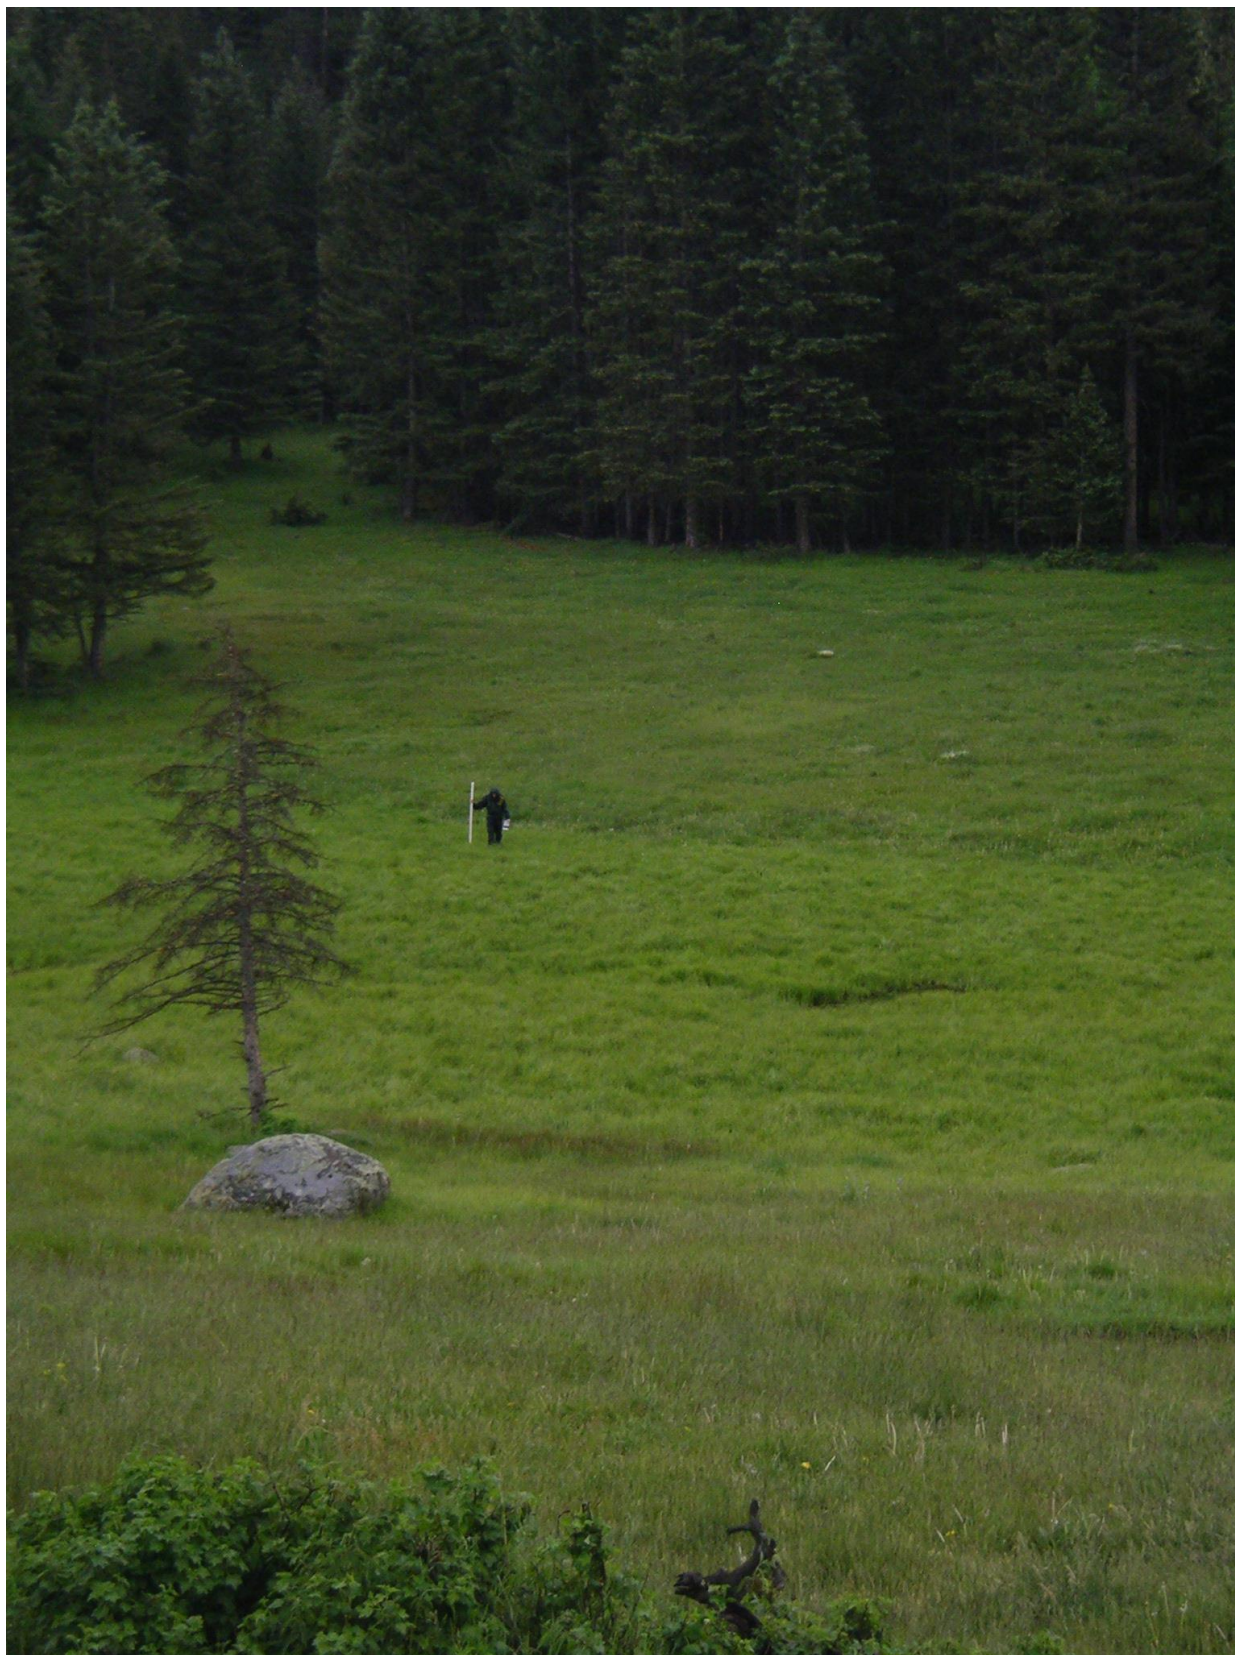
The most notable feature of Reach 3, is the wetland meadow found at the head of the stream (end of the reach). It is very large – estimated 750ft by 300 ft. The meadow appears to be a sink for at least two high-contribution stream tributaries and one seep tributary. This meadow flows into the stream in only two visible places. T25 (NSO 406), stemming from the downstream end of the meadow, is the only noted tributary directly feeding the Indios. This stream's flow contribution is estimated to be 25%. T26 (NSO 412) is a small left bank stream tributary 225 feet upstream from T25. The flow contribution of T26 is estimated at 2%. It is likely that additional water is seeping into the creek.

Photo 16: Reach 3 NSO 419 R204, Rito de los Indios valley with marshy source and J. Nelson (21-June-2007).

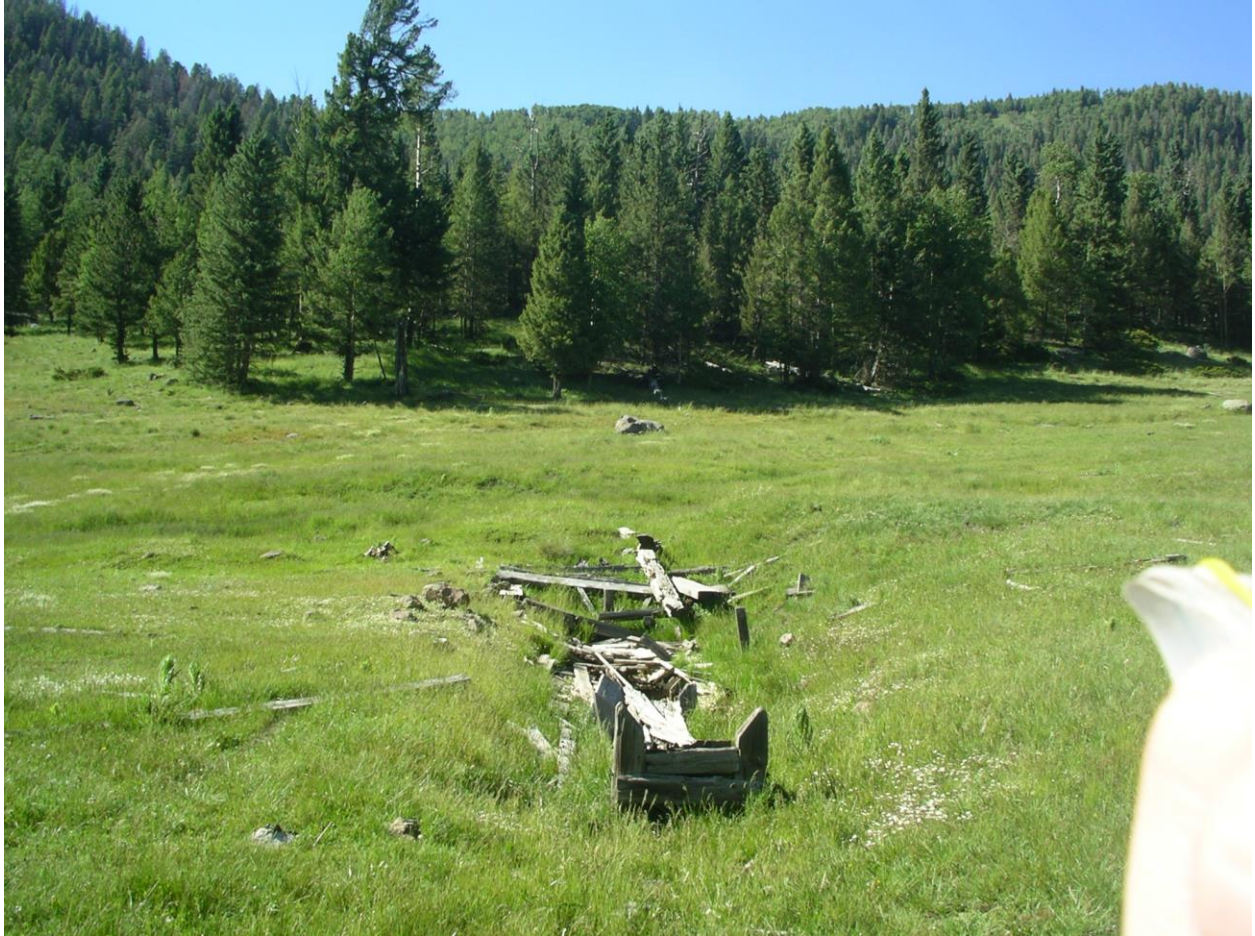
Evidence of historical development and human habitation is immediately evident on the floodplain. An old wood structure on the left bank appears to have once been a sawmill or some other part of a timber operation. An old, non-functional earth tank is associated with this structure. Many old saw logs are visible, some appear to be scattered randomly while it is apparent that some were decked at some point in time. A large pile of mill scrap is streamside on the right bank.

Photo 17: Reach 4, historic structure which may be associated with historic timber operations (21-June-07).
