NATIONAL PARK SERVICE

## **Memorandum**

Subject: Updated Condition Assessments in 2023 for Oak Creek and Pleasant Creek, Capitol Reef National Park

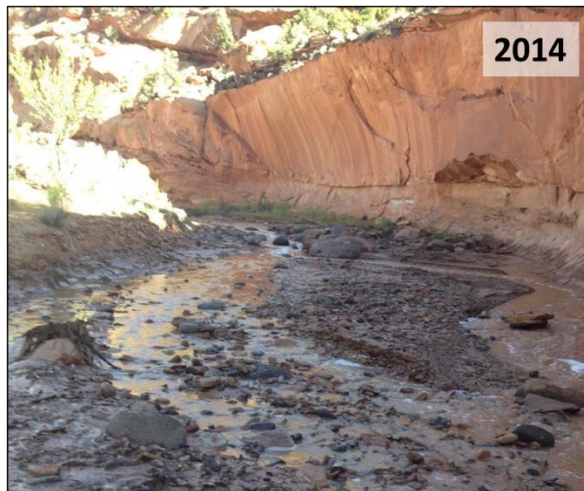
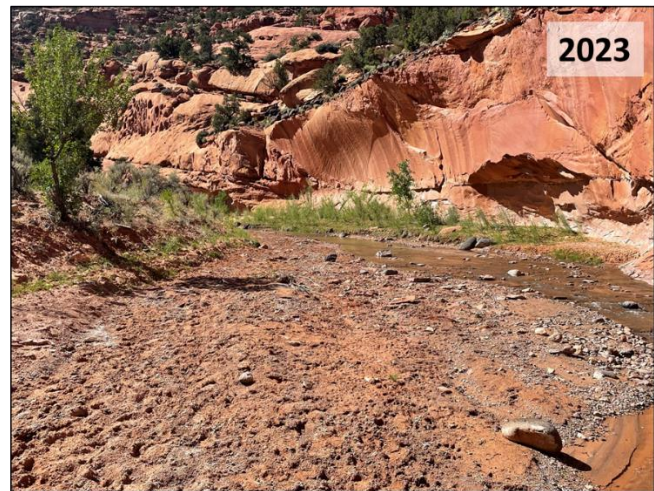
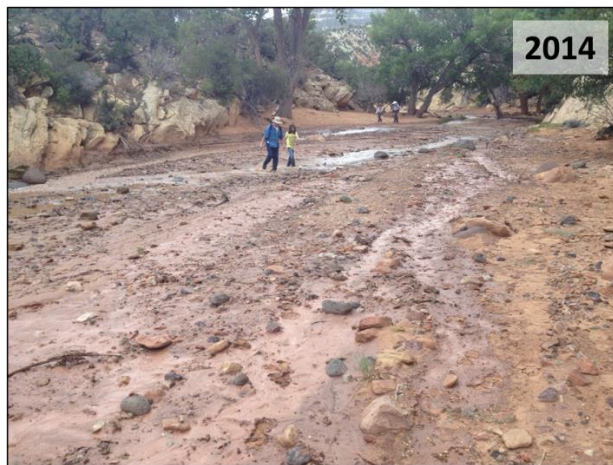
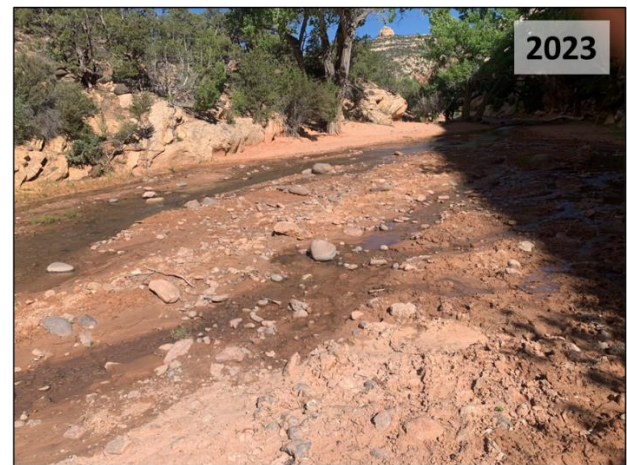
Lower Oak Creek has a high sediment load with single-threaded and braided channel forms in the study reach (Figures 2 and 3). In several areas a floodplain is present or building at the expected height above the channel. Even in areas where the channel is braided, there is often a floodplain feature that is accessed by higher flows. We found widespread evidence of recent overbank sediment deposition, flood debris wracking on overbank riparian vegetation, and floodplain vegetation bent over by floodwaters.

**Figure 2.** Repeat photos of two locations in Lower Oak Creek where the channel remains braided and without well-defined banks. Note that little channel form or streambank development occurred from 2014 to 2023, but in the top right photo willow regeneration has expanded as seen by the green band across the photo center.

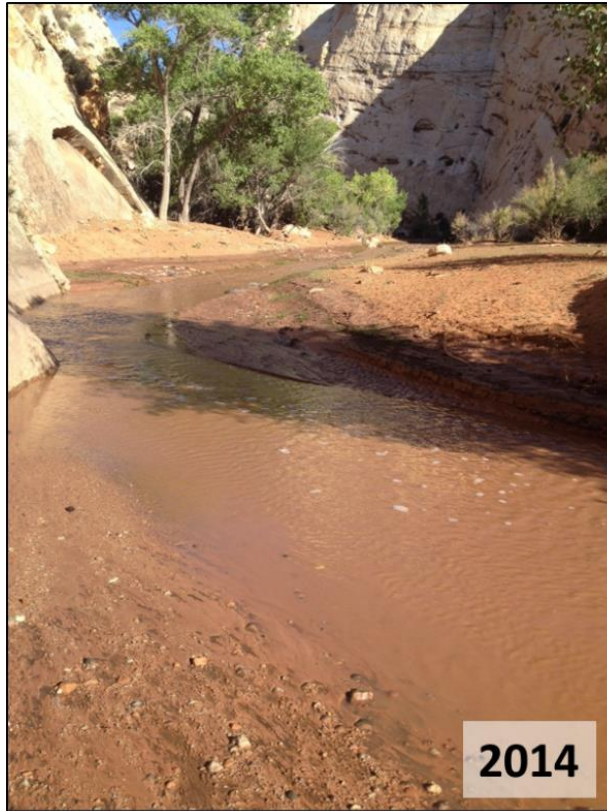
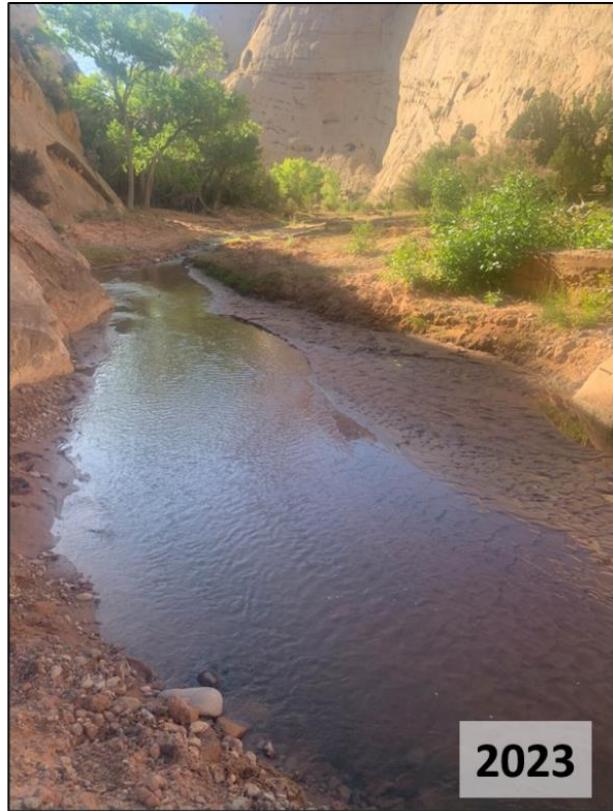
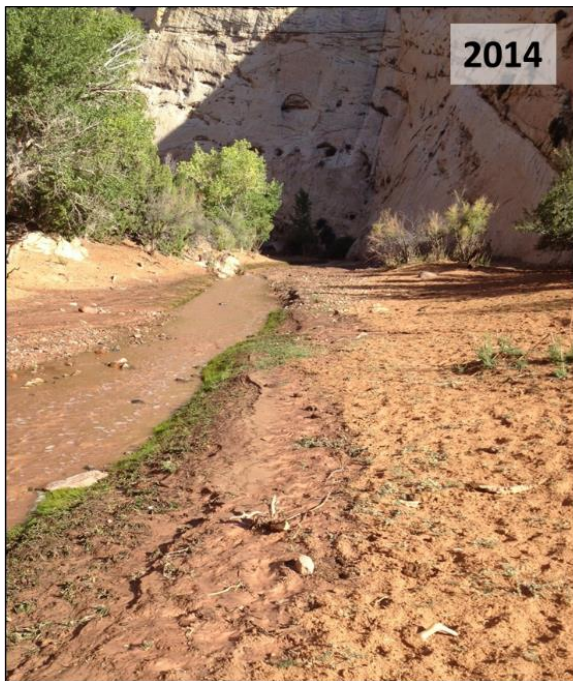
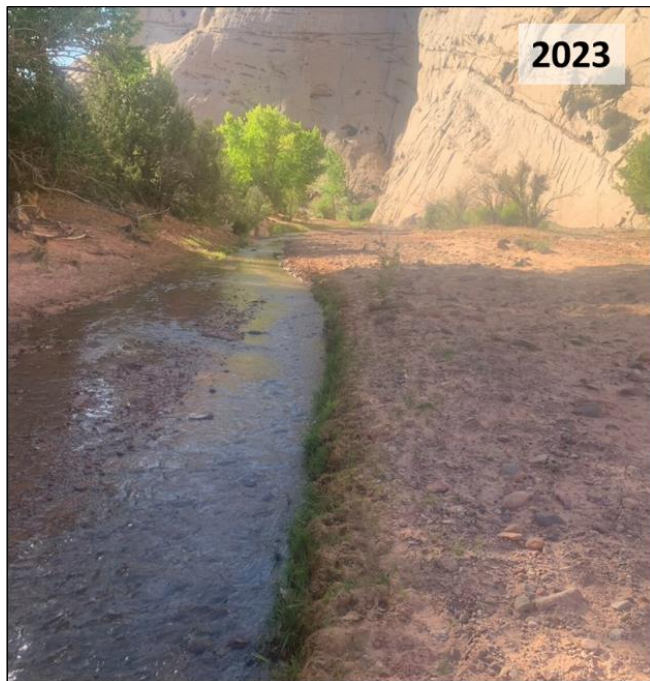
**Figure 3.** Lower Oak Creek repeat photos of two locations showing upstream views of the channel. Note that there is very little riparian vegetation, although in 2023 there are isolated woody riparian plants that have established or grown to be more than a few inches in height.

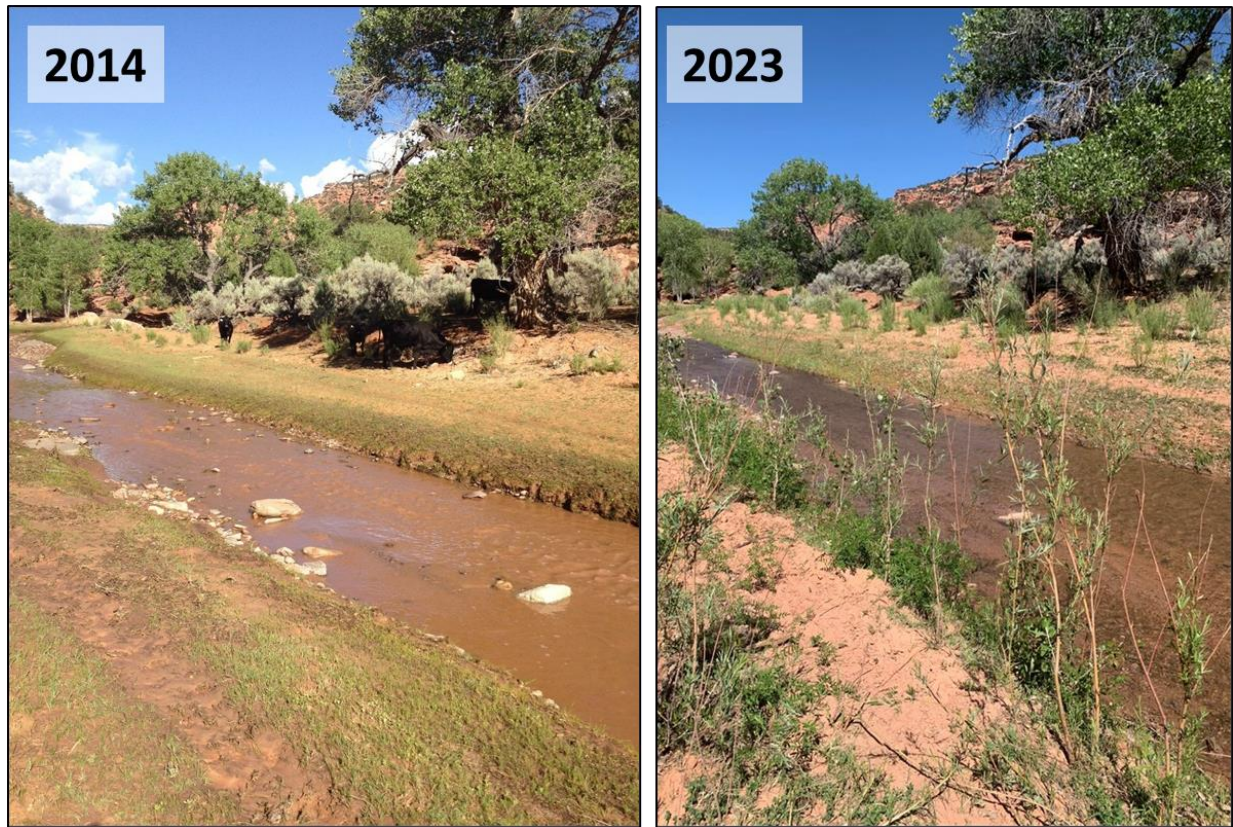
**Figure 4.** Lower Oak Creek repeat photos with upstream view. Note that in 2014 vegetation was heavily grazed to within inches of the ground, while in 2023 there was woody vegetation growing a few feet above ground surface but was still browsed.

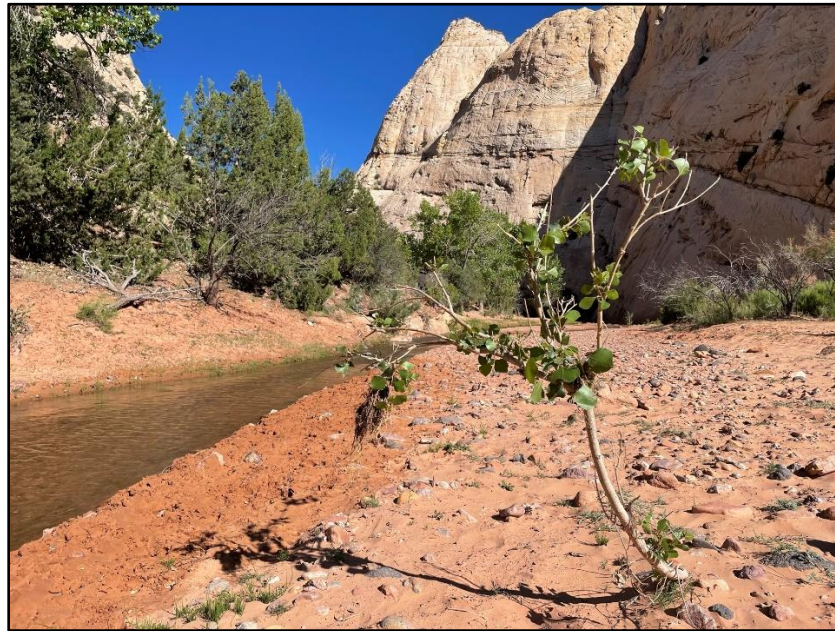
**Figure 5.** Photo from Lower Oak Creek showing a low density (i.e., one plant) of heavily browsed Fremont cottonwoods along a single-threaded channel reach.

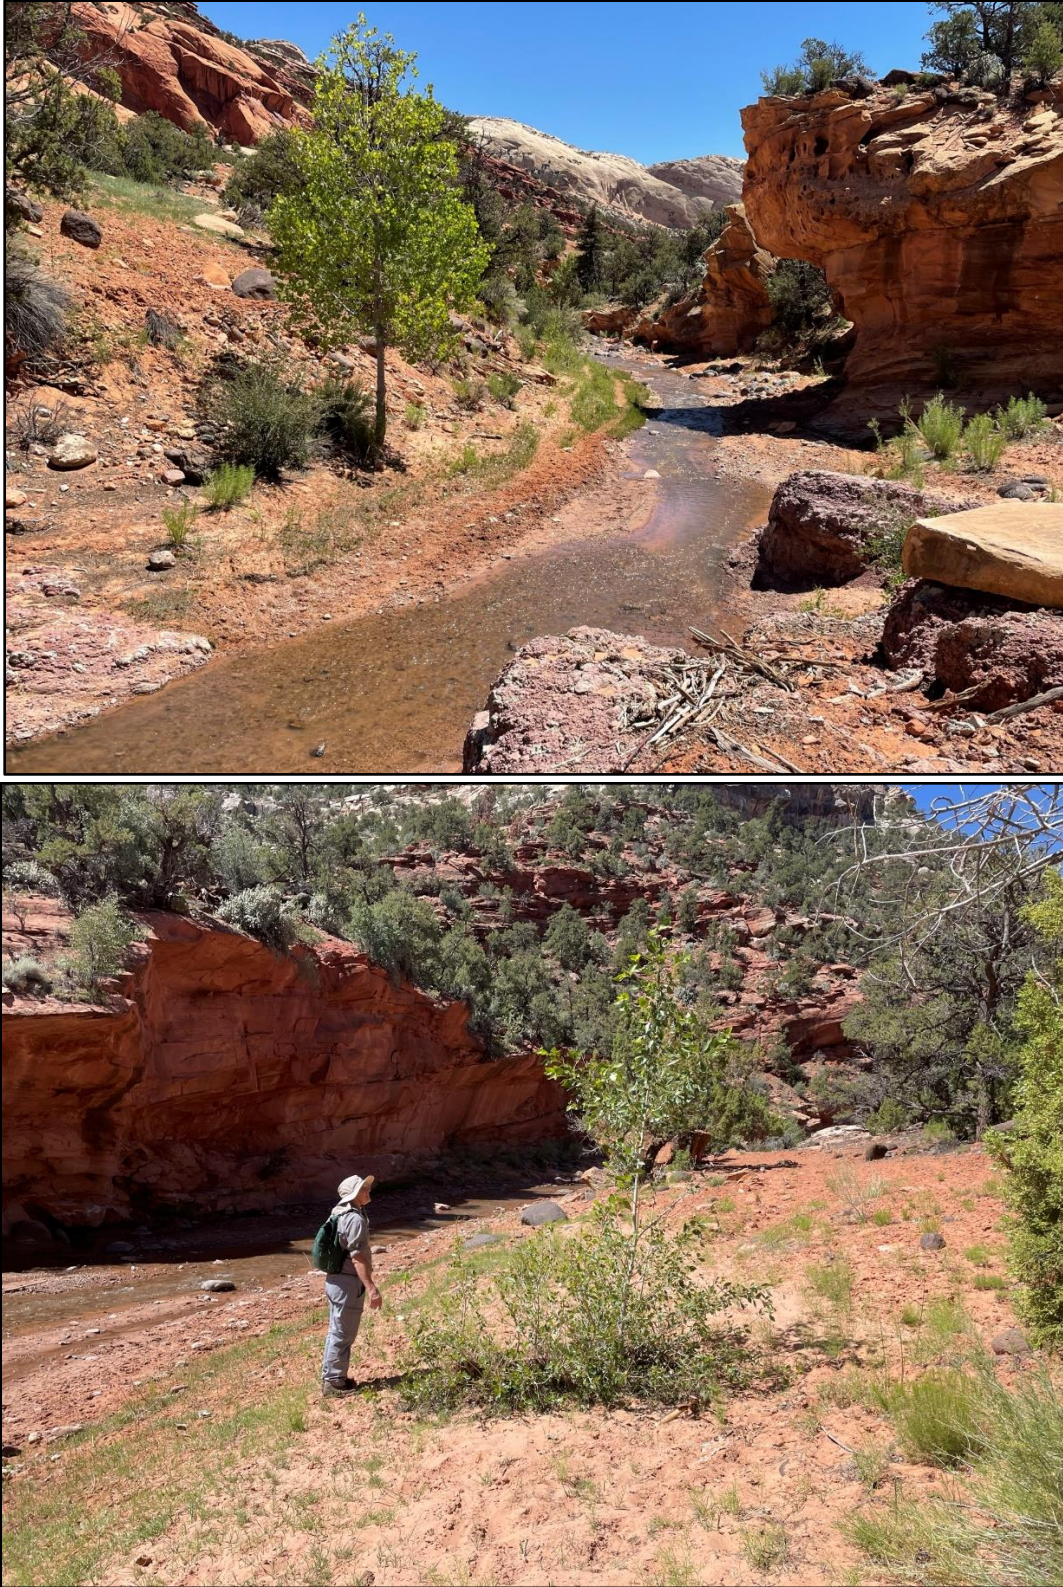
**Figure 6.** Upper (top) and Lower (bottom) Oak Creek photos showing isolated Fremont cottonwoods that have escaped the browse zone and appear on their way to maturity.

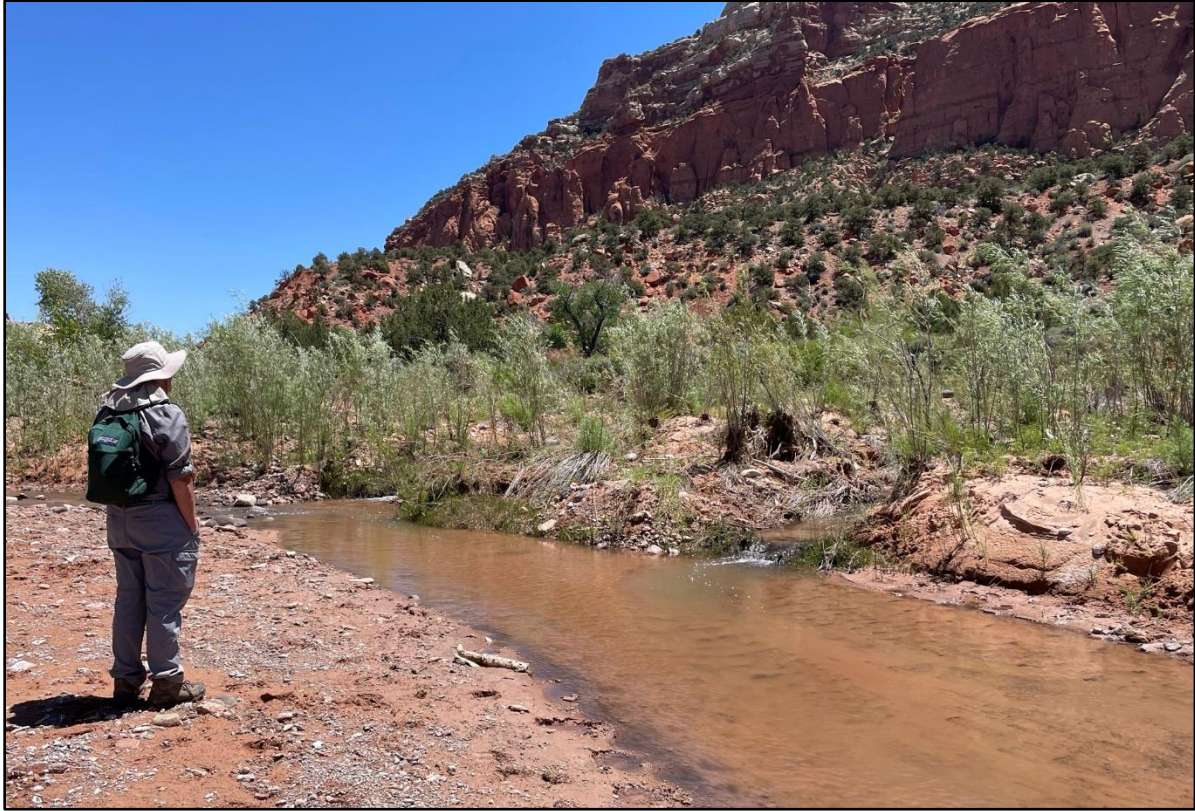
**Figure 7.** Photo of Upper Oak Creek showing an alluvial section with regenerating willows. Note the wider valley setting and greater revegetation that characterized Upper Oak Creek compared to Lower Oak Creek.

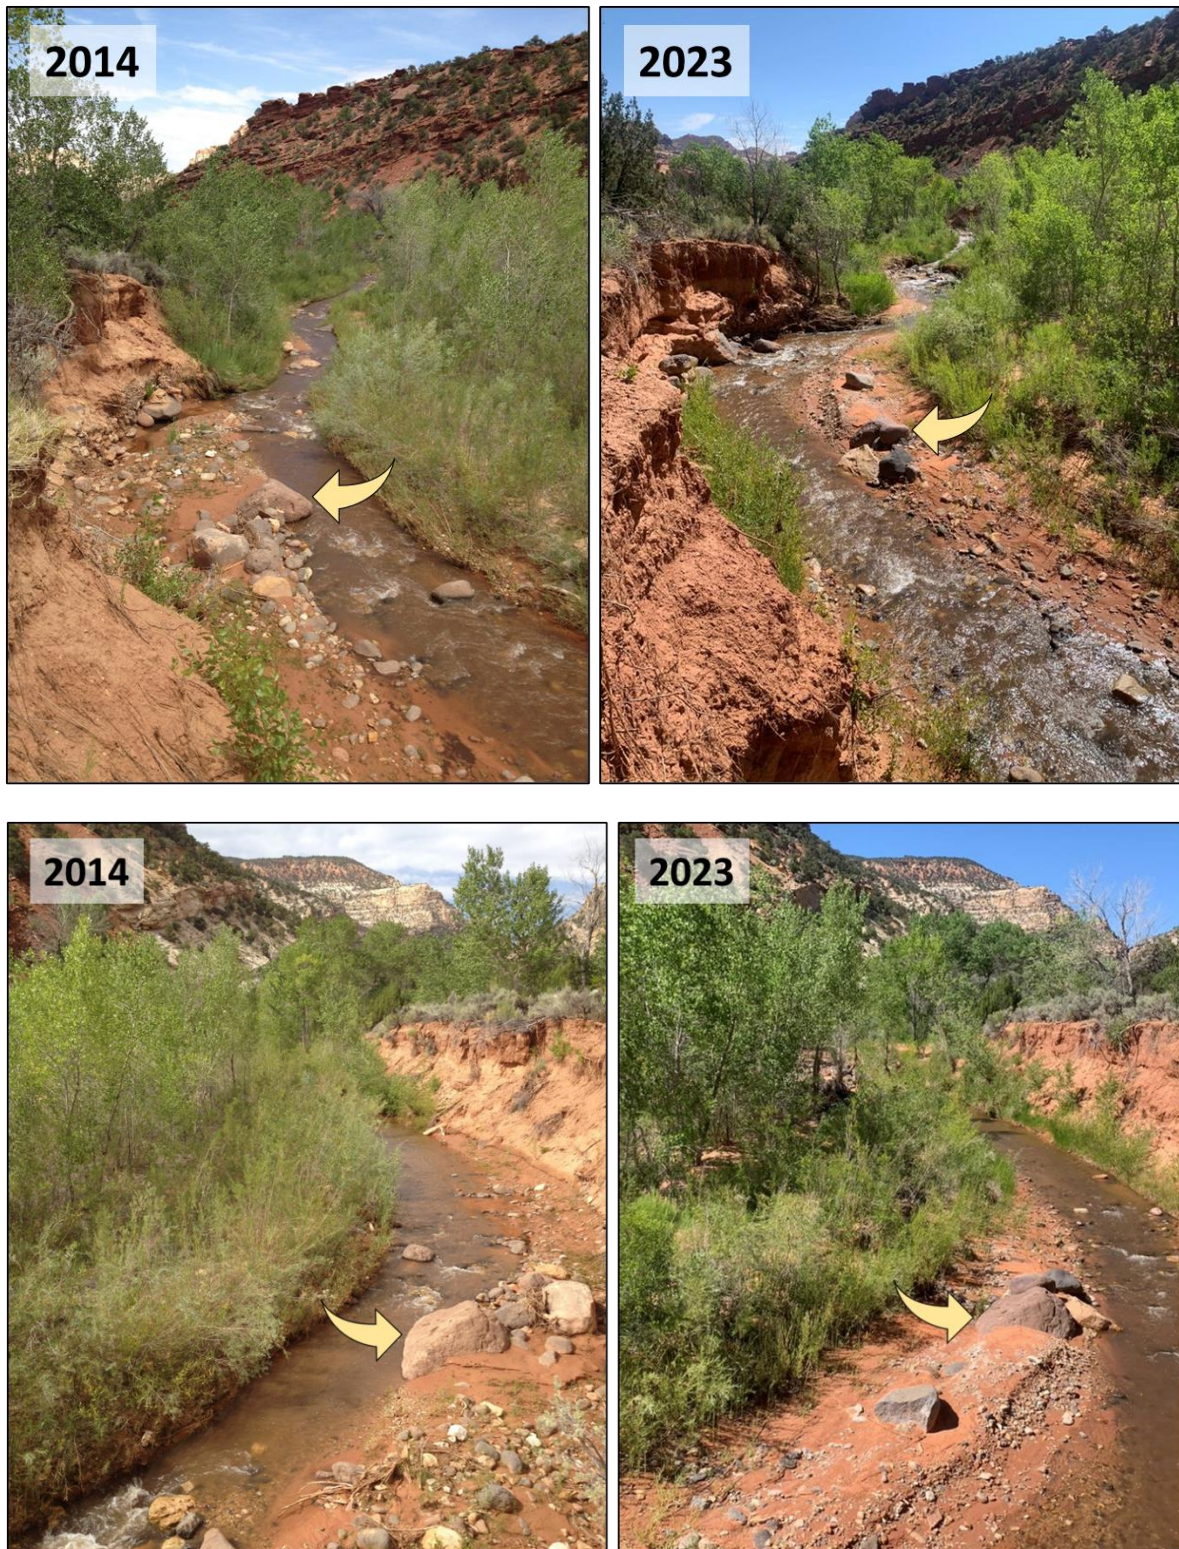
**Figure 8.** Two sets of Pleasant Creek repeat photos showing typical downstream (top) and upstream (bottom) views in an alluvial reach (Figure 7 in Martin, Wagner, and Taliga 2015). Note the low point-bars with dense woody riparian vegetation. The arrow points to the river-right side of the same rock in all four photos. The channel migrated to the outside of the bend (river left) between photo years.

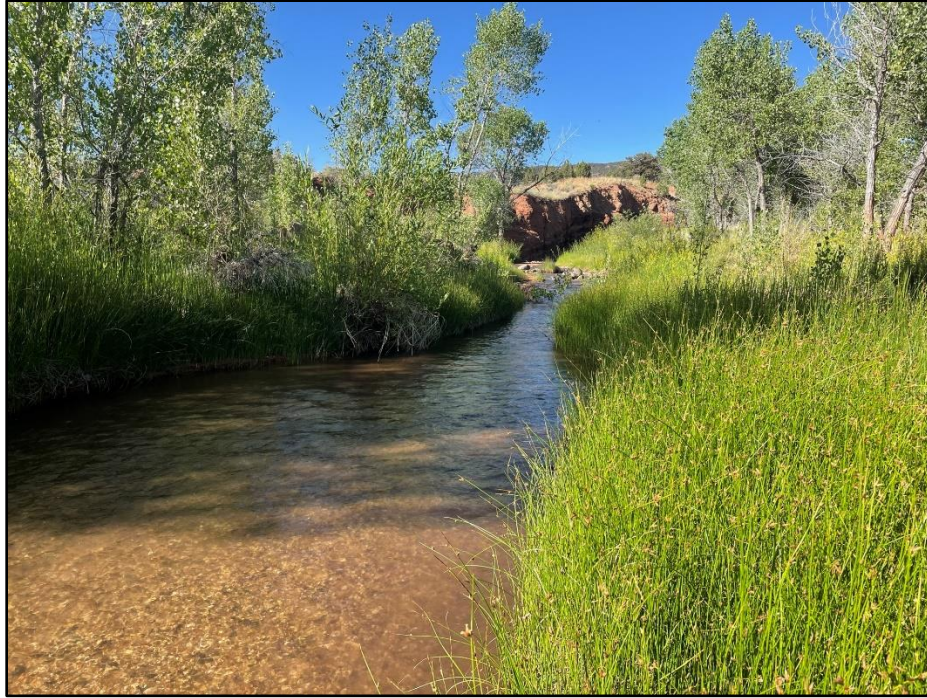
**Figure 9.** Pleasant Creek photo showing dense and vigorous herbaceous vegetation and replacement-class cottonwoods.

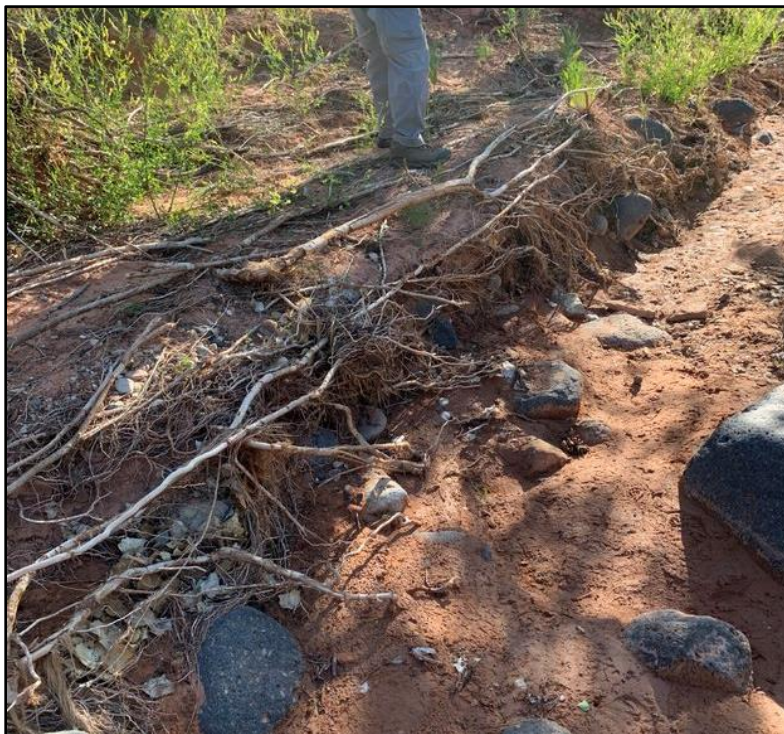
**Figure 10.** Streambank on Pleasant Creek downstream from the park road. A flash flood in 2022 eroded into the bank, but a strong root network from healthy riparian vegetation limited the erosion and stream widening while preserving a single-threaded channel form with identifiable banks.

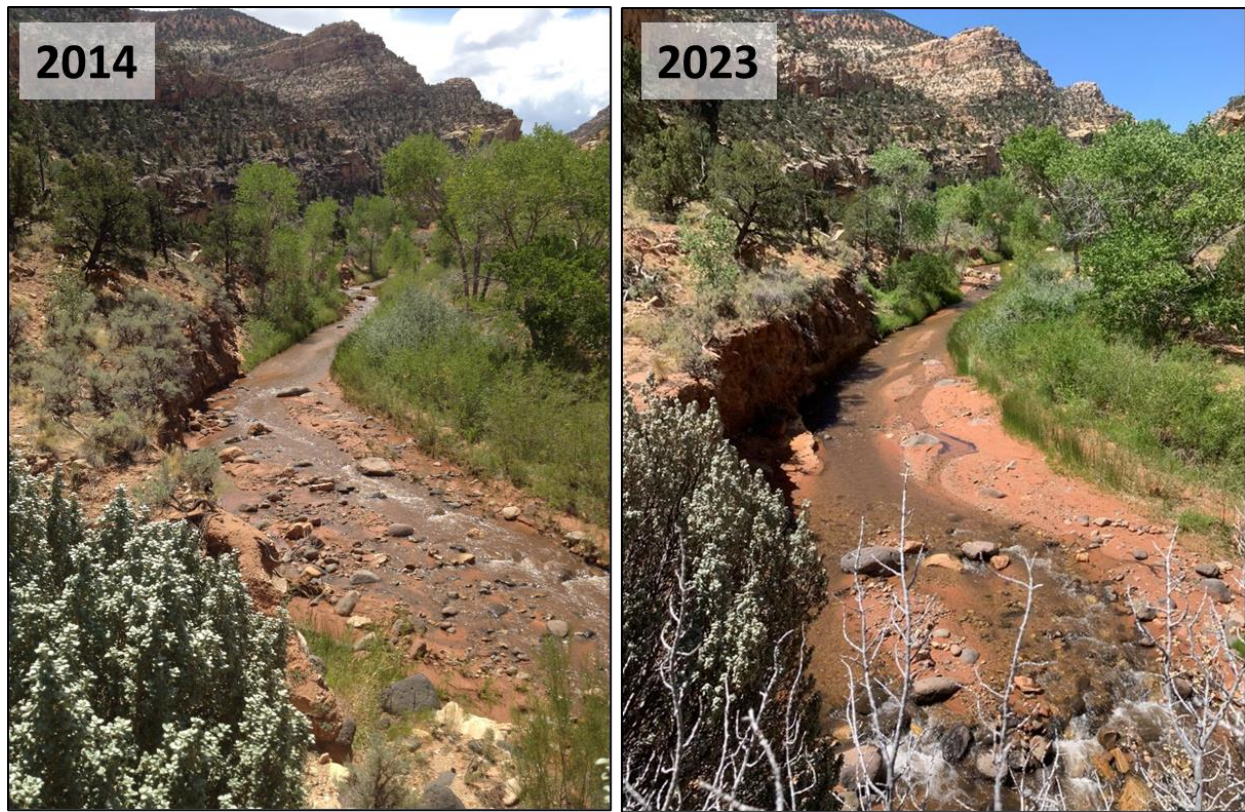
The balance between the Pleasant Creek stream system and its supplied sediment load appeared to be in equilibrium, allowing it to be an effective sediment transport reach. Although there were actively eroding cutbanks (Figure 11), we did not observe areas receiving large amounts of sediment from the uplands, nor did we observe any unnatural degradation of the banks that would increase the sediment supply to the channel. Below the tributary confluence near the park road, there was substantial sediment deposition on the floodplain from recent flash flooding, but

**Figure 11.** Upstream view of Pleasant Creek repeat photos for a migrating cutbank (Figure 8b in Martin, Wagner, and Taliga 2015). Note that the bank has eroded to the left and toward the photo point into the hillslope deposits, and also note the multi-age class woody vegetation on the point bar.

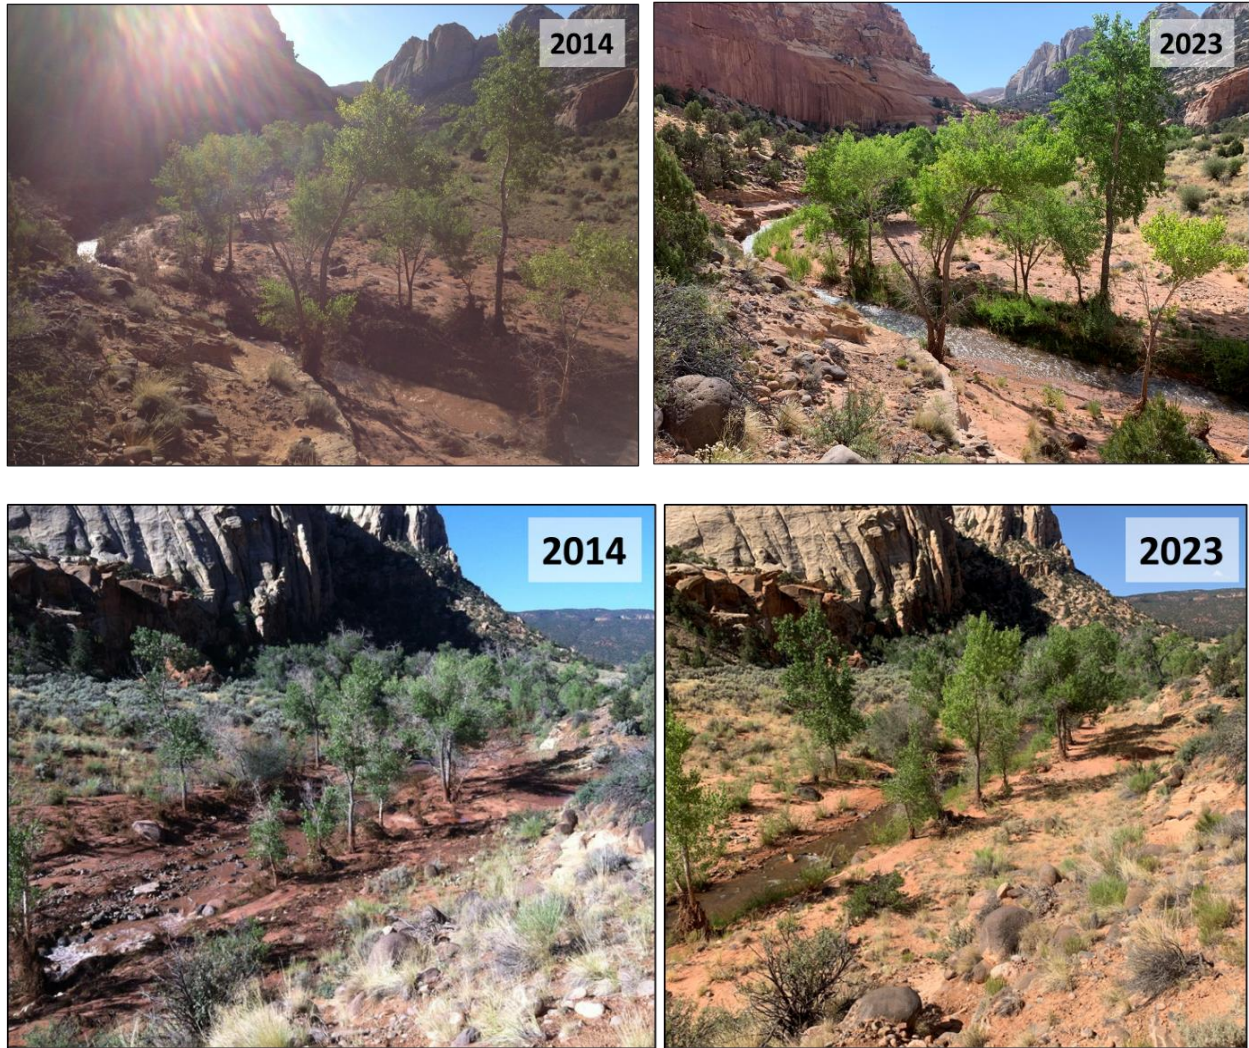
**Figure 12.** Pleasant Creek repeat photos from near the downstream extent of the study reach (Figures 9 and 10 in Martin, Wagner, and Taliga 2015). Note the dark overbank deposits from a flood the day before the 2014 photo, and cottonwoods and riparian vegetation remain relatively unchanged.
